Land Adjacent Meadow Court House, Stanton, SNT 054

Archaeological Evaluation Report

SCCAS Report No. 2013/003

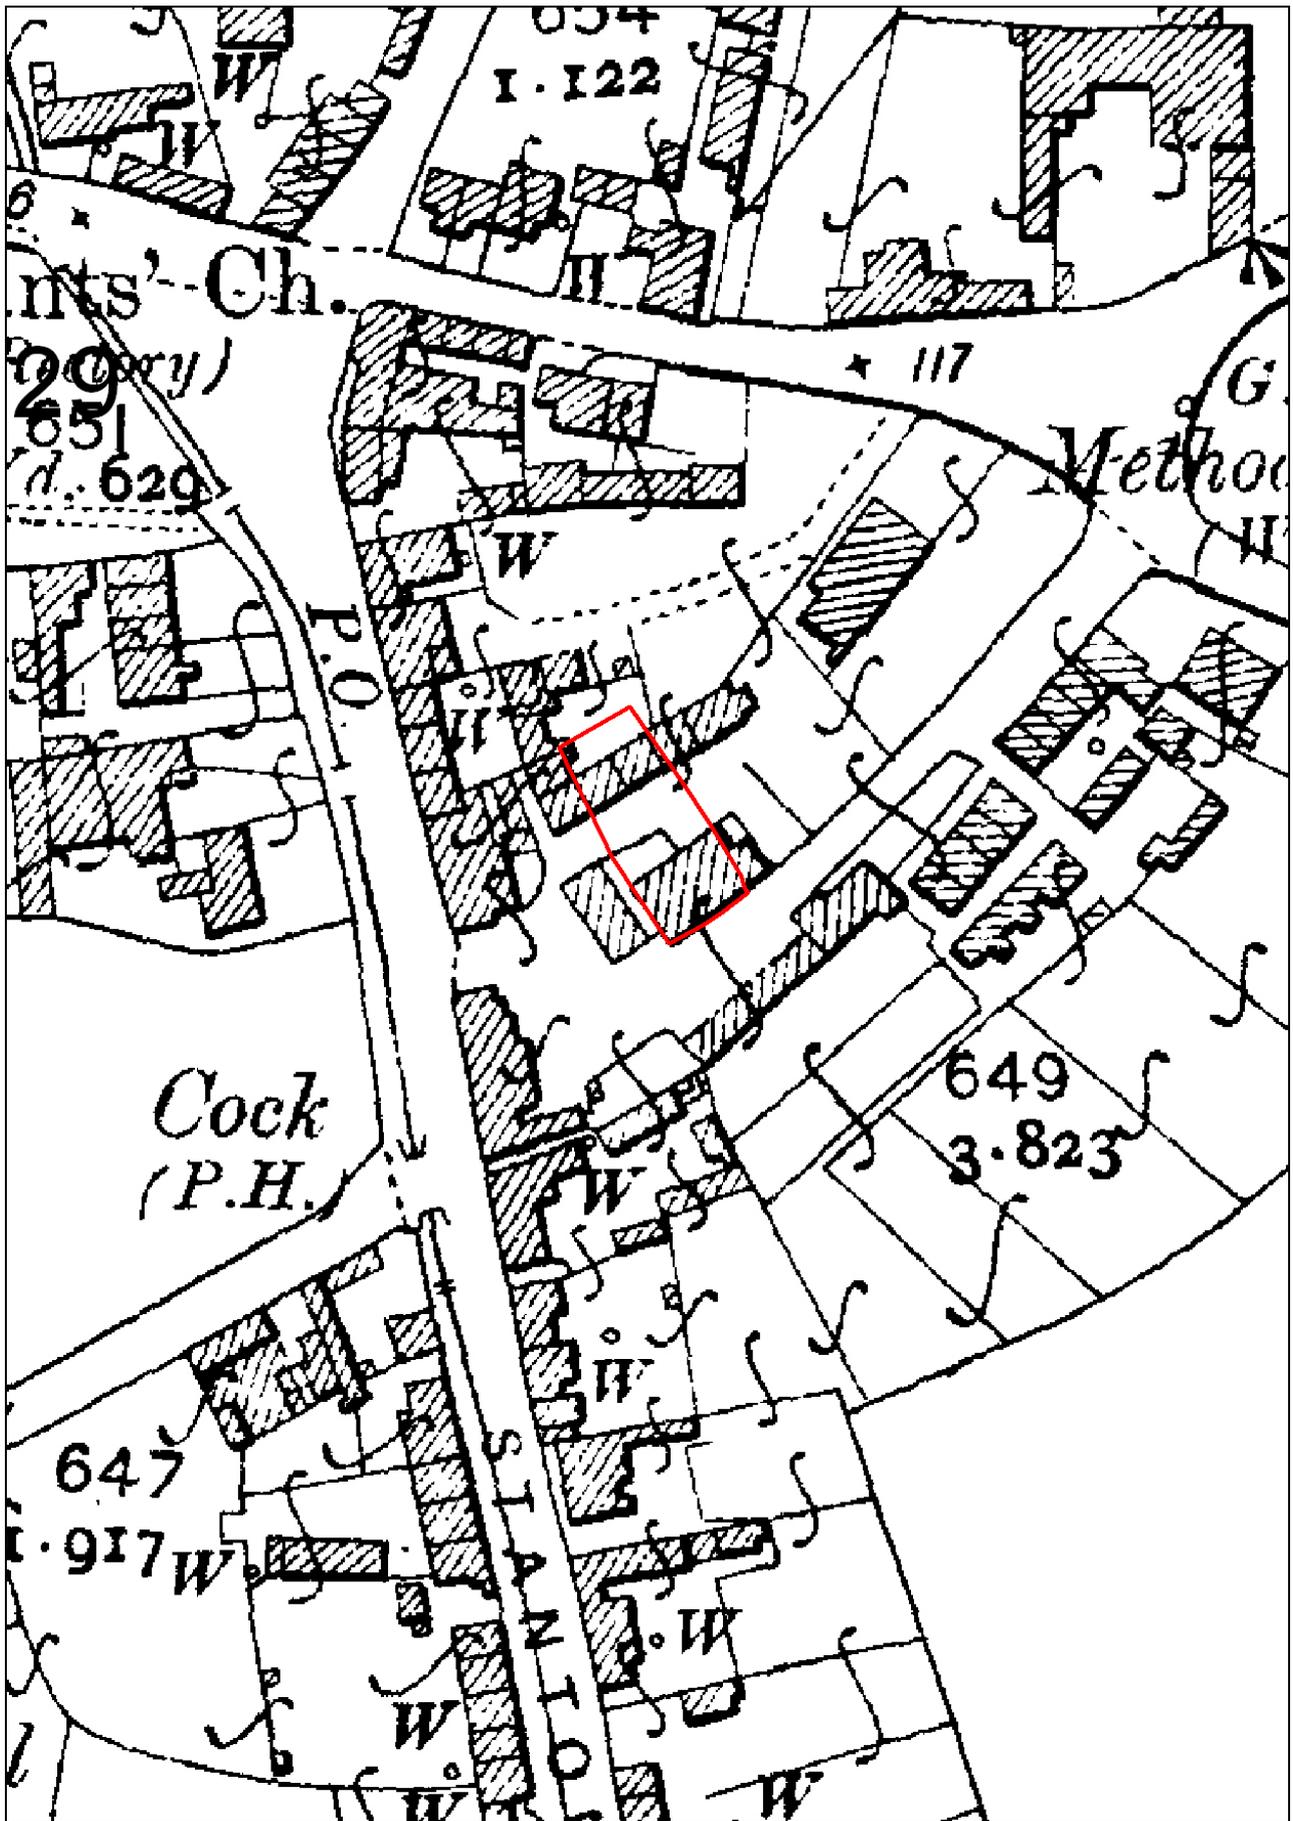
Figure 2. 1904 Ordnance Survey map showing approximate site outline (red)

The 1884 and 1904 Ordnance Survey maps of the site indicate that several buildings were present within the development area, as well the boundary of another property (Fig. 2).

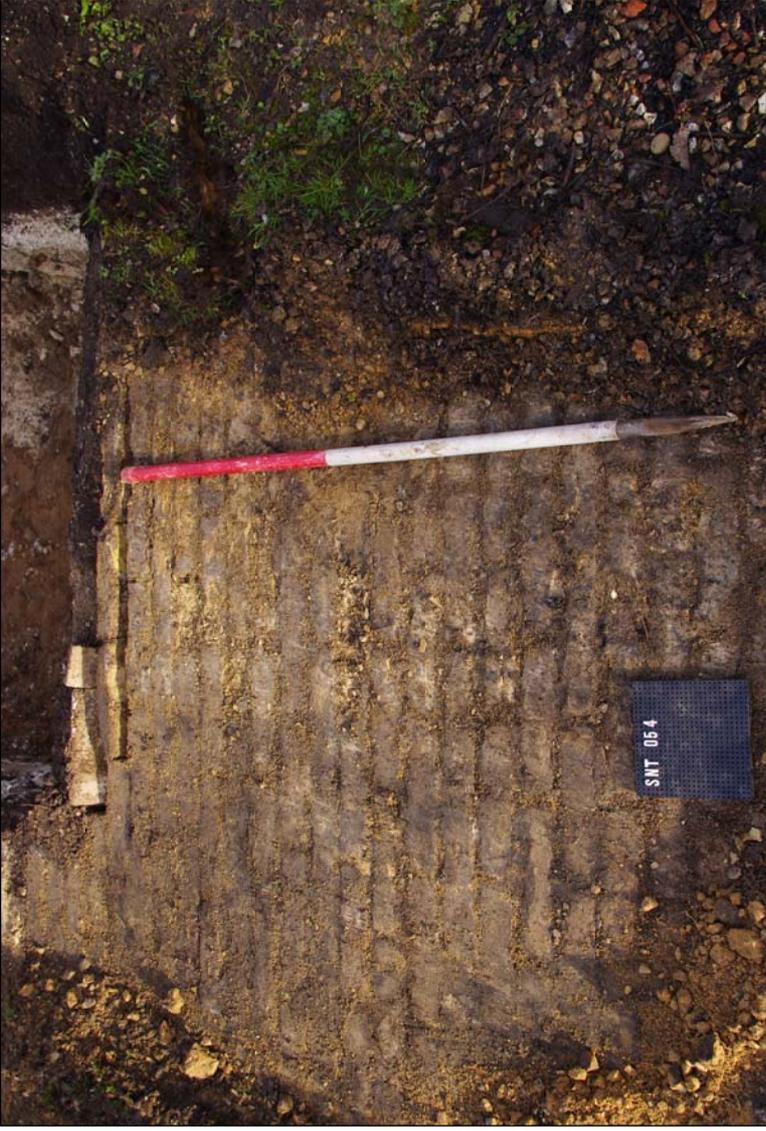
Plate 2. Brick surface 0001, 1m scale

Surface 0001 was made up of yellow bricks and was present in some areas underlying the concrete slab recorded in the southern third of the site. The bricks were laid on their side (stretcher up) to form a robust surface. The surface was interpreted on site as belonging to the structures present on the early Ordnance Survey maps. The relationship between the surface and walls 0002 and 0003 was never firmly established, but it was interpreted that they were contemporary.

A complete brick made in a yellowish-buff fine fabric containing sparse red and pink grog was recovered from surface 0001 (2817g). Dimensions: L228mm, W105mm and T (thickness) 63mm. The brick has mortar on the headers and had been laid on its side. The upper stretcher face shows some indications of a white coating in patches, which has become worn. The white-fired brick is likely to have been produced locally and is of a type which was commonly in use for flooring in this region in the 18th and 19th century. Such bricks are sometimes called 'suffolk whites' (Goffin, pers. comm.).

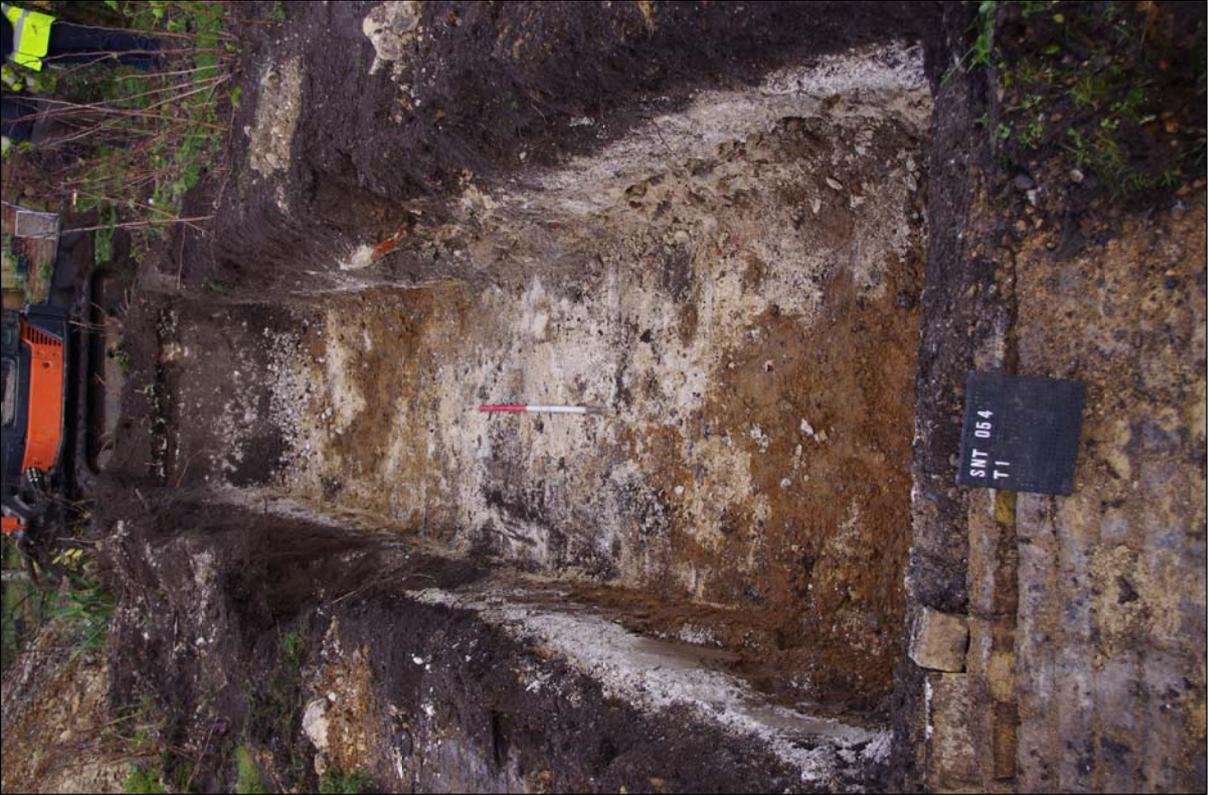
Plate 1. Trench 1, facing north-west, 1m scale

No cut archaeological features were found within the trench, although the remains of a brick floor surface, as well as two post-medieval walls were recorded (Fig. 3). No finds were recovered. A layer of topsoil, 0.1-0.2m deep was recorded across the site, although in the southern third of the area it was thinner where it overlaid a concrete slab. In places this concrete slab also overlaid a brick surface, 0001, which was seen in the trench section. Underlying the topsoil in the trench was a layer of redeposited and compacted chalk with occasional CBM flecks, which was c.0.45m deep and recorded as 0004. This was interpreted as a levelling layer or a screed and was cut by walls 0002 and 0003, which it then extended beyond into the northern half of the trench. This chalk layer in turn overlaid 0005, a 0.25-0.35m thick subsoil of mottled grey and orange silty-sand that was present above the superficial geology of orange sand and chalk patches.

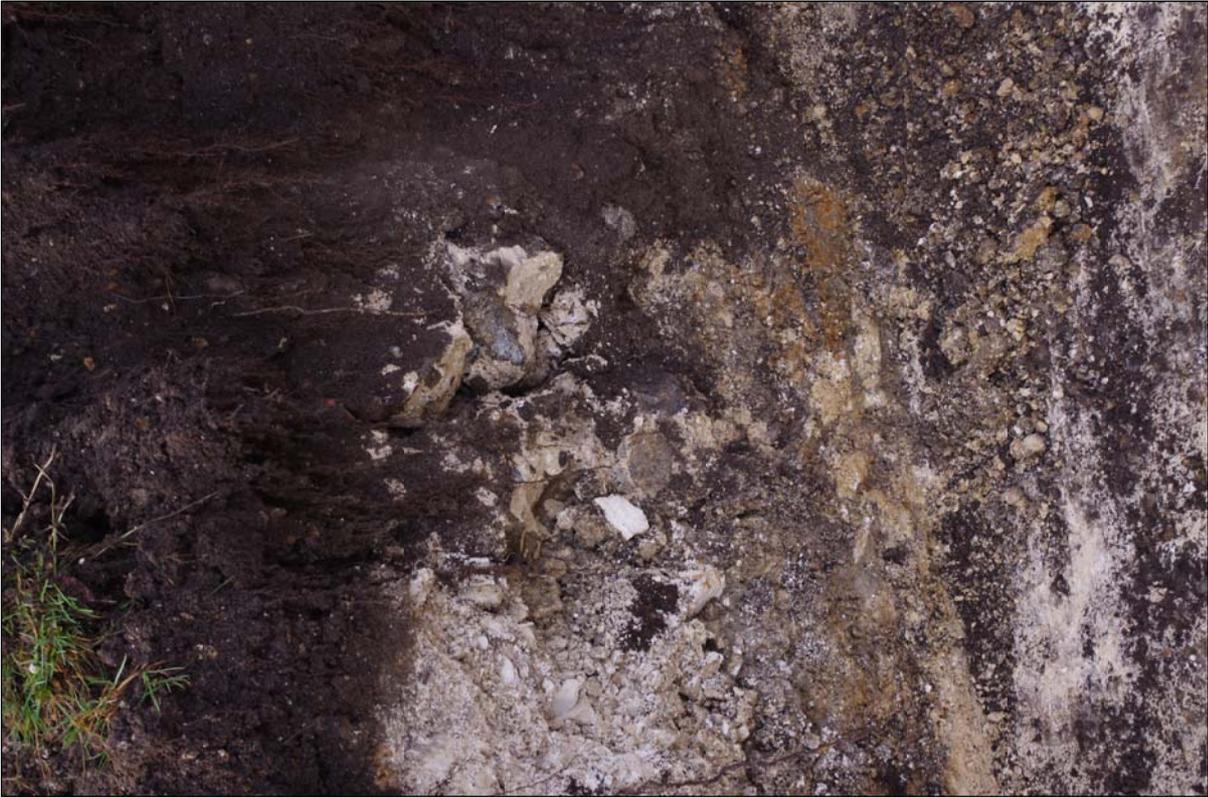
Plate 3. Core of wall 0002

Wall 0002 ran at a 90° angle to the trench, with its return, 0003 flanking the trench's north-east side. Both appeared to be the surviving foundations of the upstanding walls and were made up of yellowish-cream soft mortar, reused bricks fragments and flint nodules. The walls were recorded immediately underlying the topsoil, cutting through layers 0004 and 0005. Wall 0002 was 0.45m thick x 0.7m deep, whilst the full dimensions of wall 0003 were not visible.

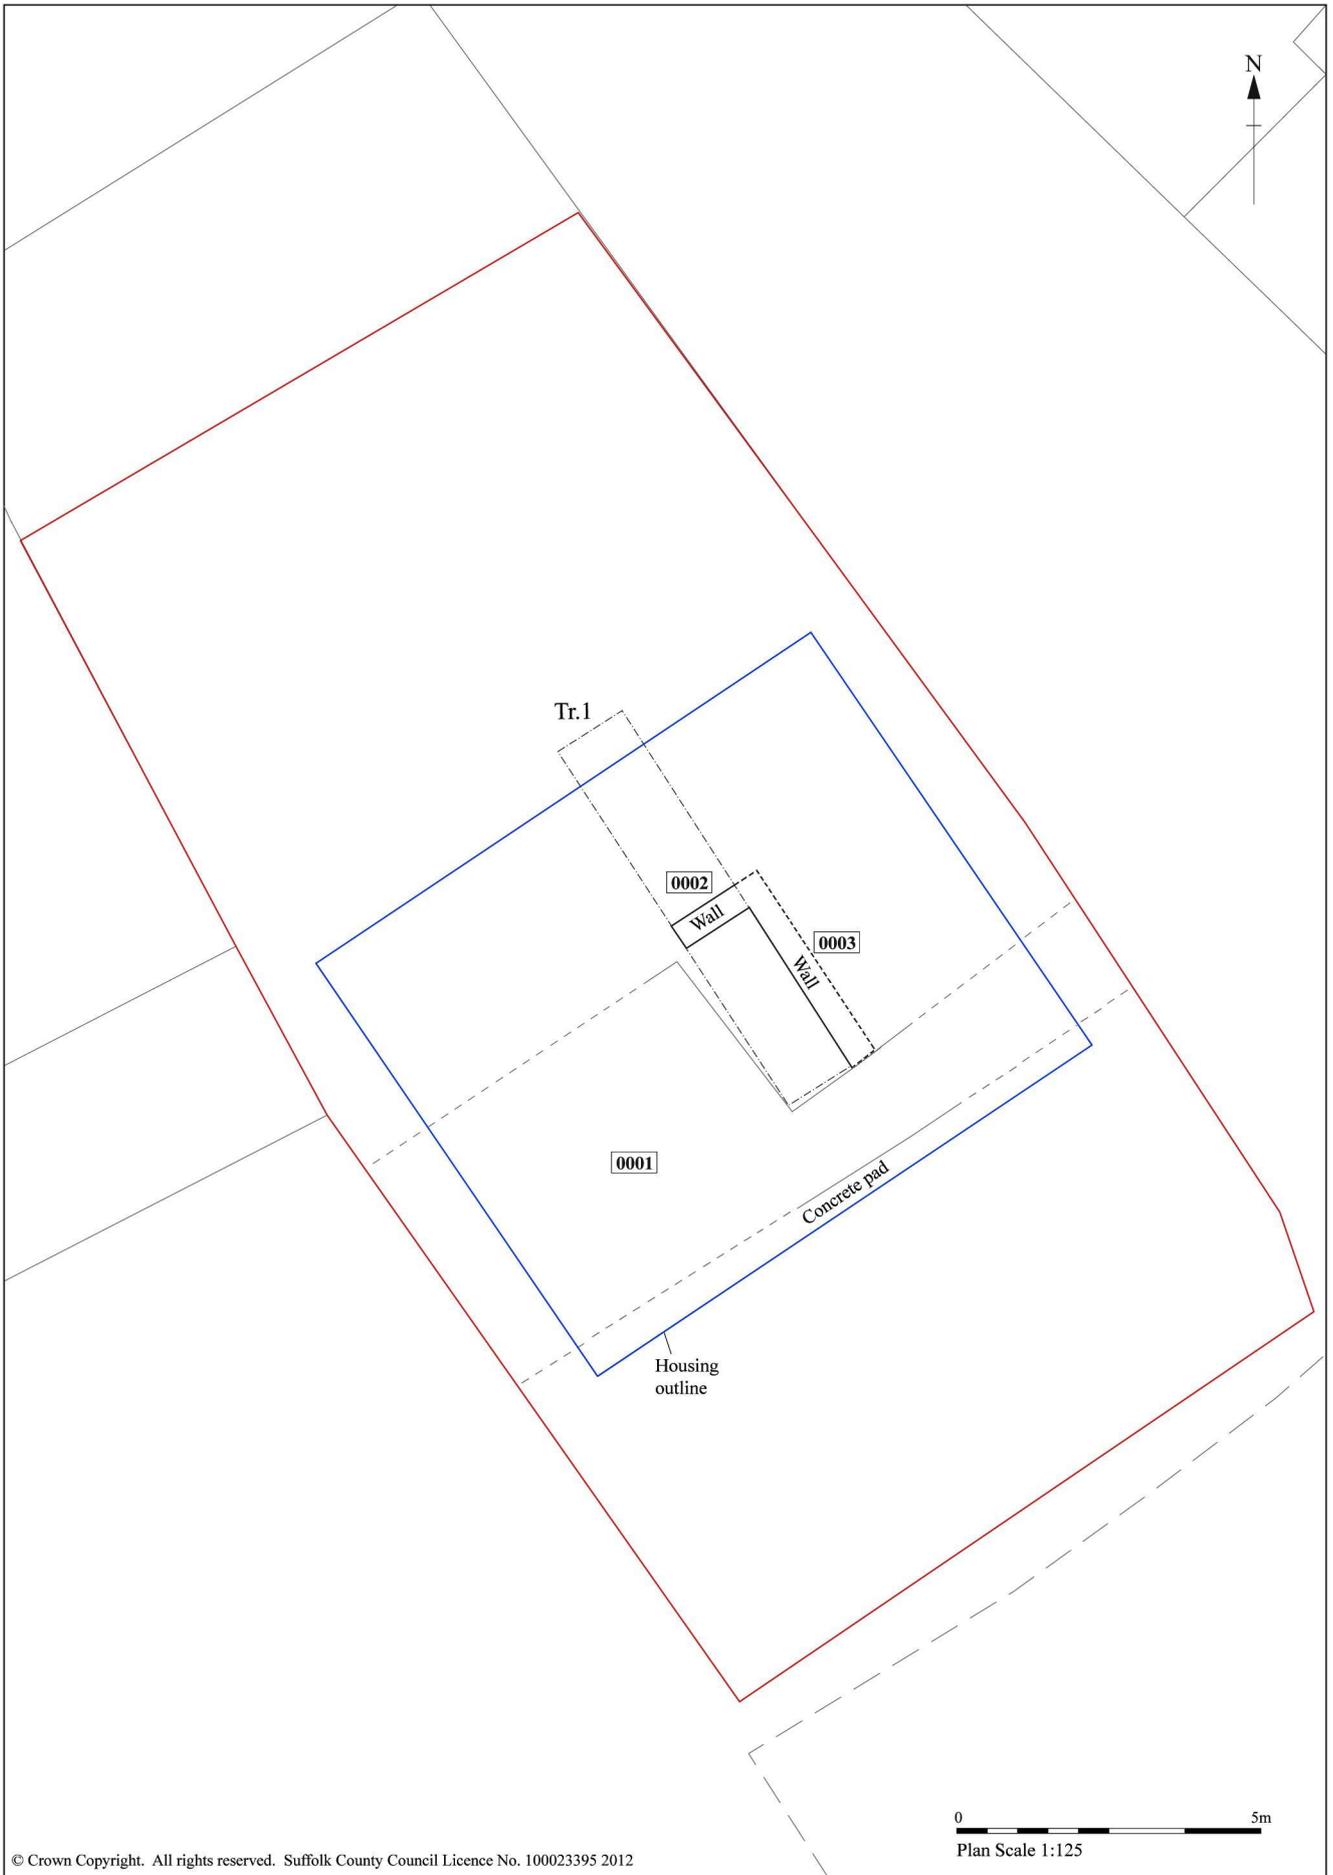
Figure 3. Site plan

The trench was excavated using a machine equipped with a toothless bucket. The excavation was constantly monitored by an experienced archaeologist. Whilst the original WSI specified that a 15m trench would be excavated, extending to the street frontage, this went beyond the property boundary and as such the trench was reduced to 14m. The southern 7m of trenching was abandoned after a concrete pad was uncovered in this area (Fig. 3). However, it was possible to excavate a 7m length within the house footprint, although this was only 1.2m wide due to the positions of brick surface 0001 and wall 0003. It was agreed with Sarah Poppy (SCCAS/CT) that this was sufficient to fulfil the Brief and as such no supplementary trenching was excavated. After the systematic removal of the topsoil, levelling and subsoil deposits, the natural geological levels were exposed. The upcast spoil was monitored for finds. The trench was excavated through the centre of the proposed area of housing, in order to sample the whole area effectively (Fig. 3).

This evaluation has revealed walls and a brick surface that reflect the site's post-medieval occupation as recorded on the early Ordnance Survey maps. Walls 0002 and 0003 appear to be the new north-east corner of one of the buildings shown on the 1884 and 1904 maps. The brick surface almost certainly represents the internal floor for the structures, but the function of these buildings is not clear from either the map or archaeological evidence. The chalk levelling layer is probably associated with the post-medieval buildings that occupied the site (although it was not positively dated).

Judging by the deposits encountered within the trenching, further remains of the walls and brick surface indicating post-medieval buildings will be present within the development area. Further groundworks by the developers may require archaeological monitoring in order to attempt to establish the building's function. However the walls appear to have been truncated to floor level, which would limit any interpretation of the structure. It does not appear that any earlier deposits are present on the site. The need for any further work is ultimately to be determined by Suffolk County Council Archaeological Service Conservation Team.
