**Interim Visitor Centre
Landguard Viewing Area, Felixstowe
FEX 310**

Archaeological Monitoring Report

SCCAS Report No. 2013/010

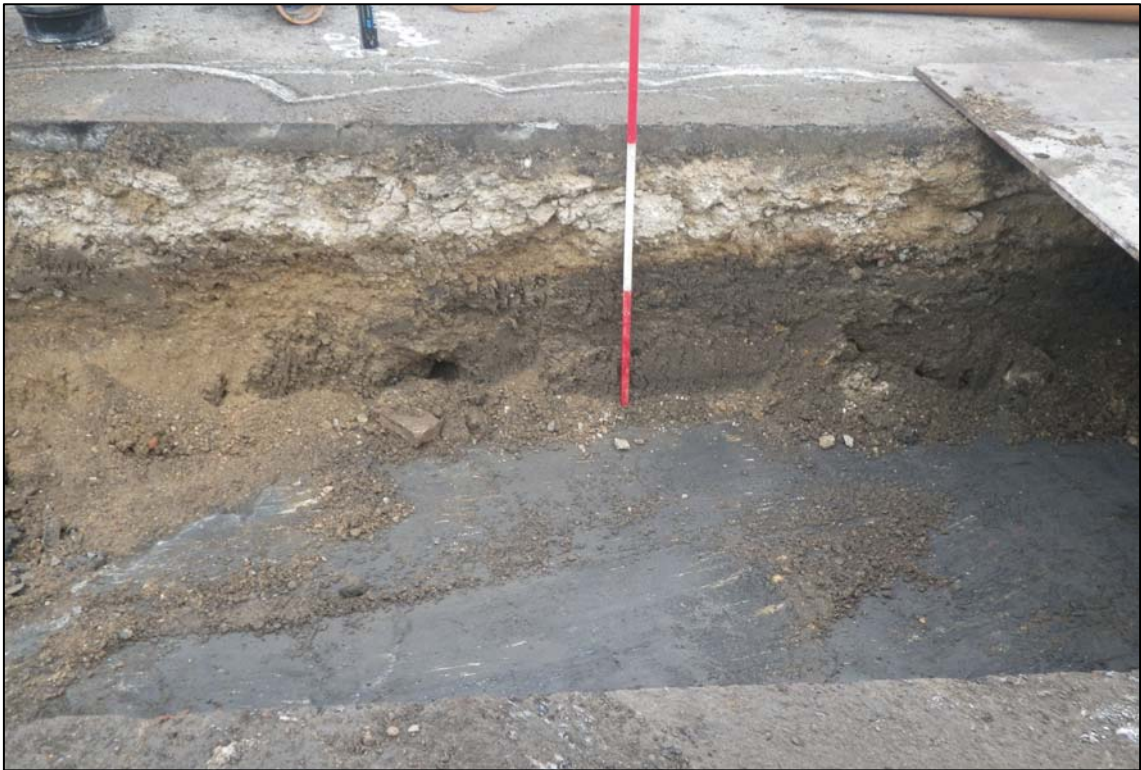
The only archaeological evidence of any significance was noted in a north-east to south-west trench located outside the footprint of the proposed centre. It comprised a large concrete slab bounded by brick walls and was interpreted as the remains of a building (Fig. 3). The concrete slab, which lay a depth of 1m below the present ground level, was 0.13m thick with a smooth upper surface and was interpreted as the building's floor (plate 1). No evidence for any other flooring overlying the concrete was noted.

on the upper face of the brick wall, level with the floor, to provide a barrier to reduce damp (visible in plate 1). A similar wall was identified further to the north-west where it clearly formed a corner to the building (plate 3). The height of the walls had been reduced to the level of the concrete floor.

Plate 1. Concrete floor at west end of the building, camera facing north-east (ref. HSS 03)

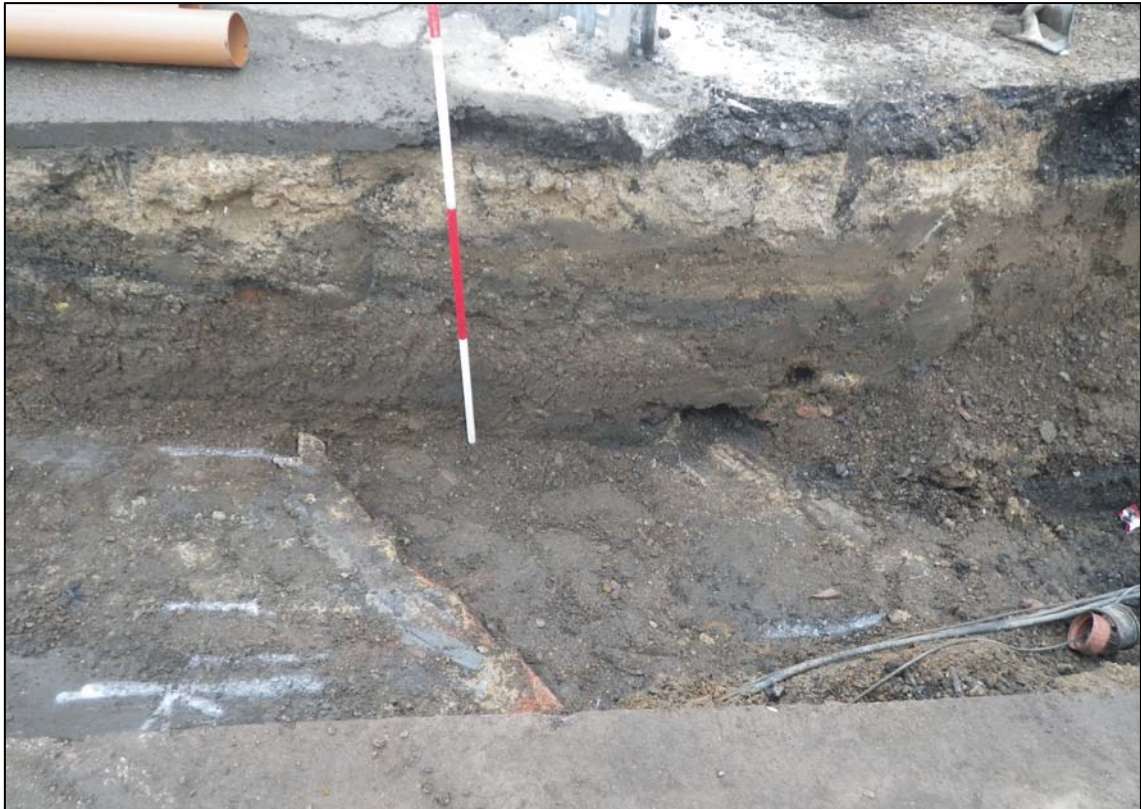
A brick wall ran along the slab's eastern edge (plate 2). It was 0.22m thick and built of hard pink bricks (22cm x 6.5cm x 10cm) with a hard cement. A layer of slate was visible

Plate 2. Eastern wall of the building, camera facing north east (ref. HSS 07)
