**Primitive Methodist Chapel,
Woolpit, Suffolk
WPT 038**

Historic Building Record

Primitive Methodist Chapel, Heath Road, Woolpit, Suffolk

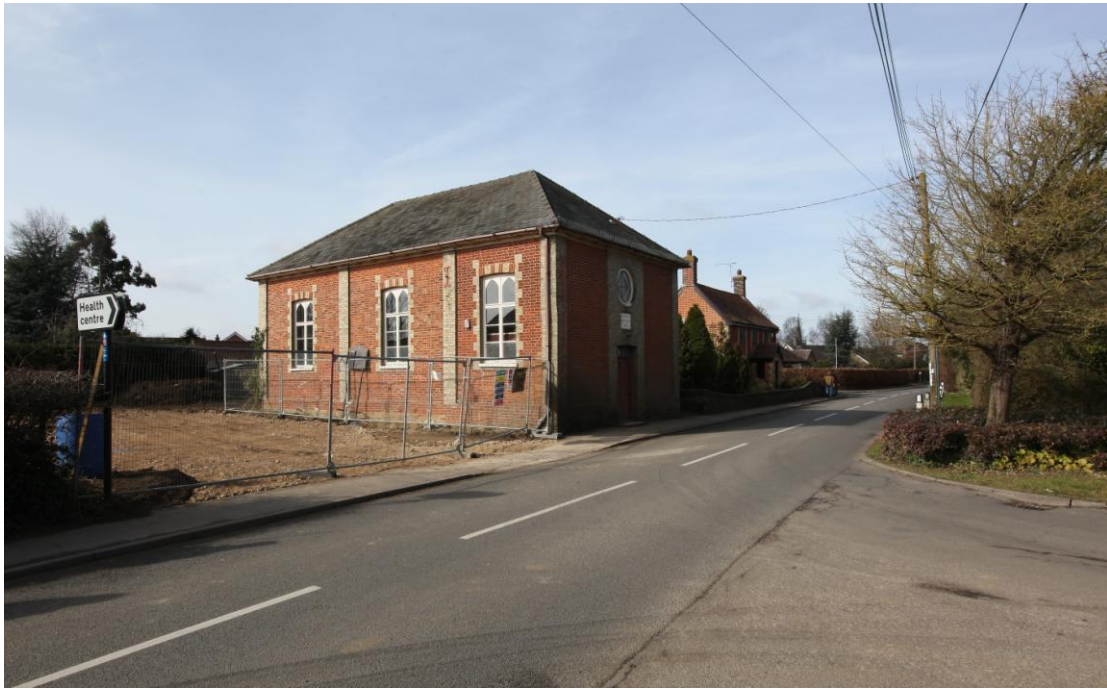
Illus. 1. A general view of the site from Heath Road to the south-east showing the chapel with its adjoining plot of land on the left and the entrance to the modern Health Centre on the right.

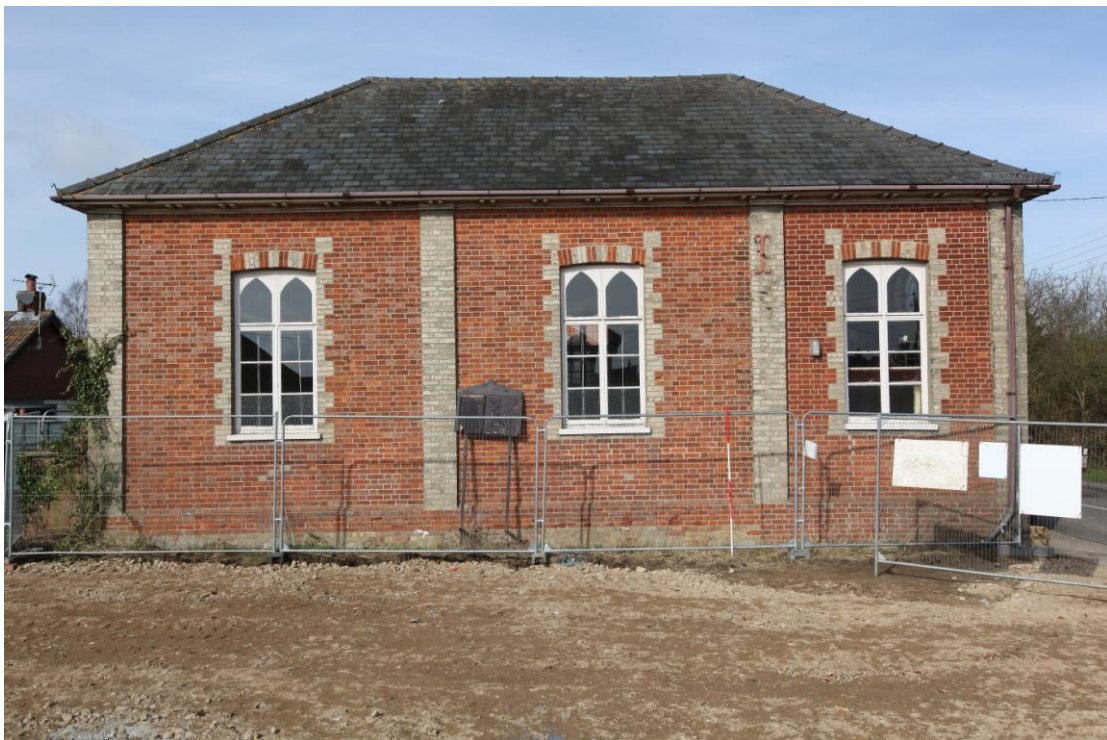
Illus. 2. The southern exterior showing the gault brick pilasters which separate the elevation into three bays. The right-hand bay is narrower and was added as an extension to the original two-bay chapel in the late-19th century. Every attempt was made to match the earlier fabric, but the later brickwork is markedly darker and more uniform in colour.

At first sight the building appears to be a single, unified structure, but the easternmost of its three bays (as defined by gault-brick pilasters) is a late-19th century extension. The new brickwork was carefully matched to the old, but is darker and more uniform in colour and the bay is significantly narrower. The author of the 1961 history was sceptical, noting 'it is stated that the chapel has been somewhat extended and there are those living today who say they can remember a garden being in front of the present building'. The First Edition Ordnance Survey of 1884 shows this garden dividing the then eastern gable from the road, but it had disappeared by the edition of 1904. A small proportion of Methodist chapels possessed burial grounds that were often short-lived and poorly documented, and if the garden was designed for this purpose it is possible that inhumations still lie beneath the floor of the extension. The date plaque was presumably re-set in the new gable, and the present dais is likely to have been inserted as part of this refurbishment. The chapel remains an attractive example of Victorian Mock Gothic brickwork, despite its unfortunate re-pointing in cement, but given its alterations and lack of original fixtures is unlikely to meet the strict criteria for listing.

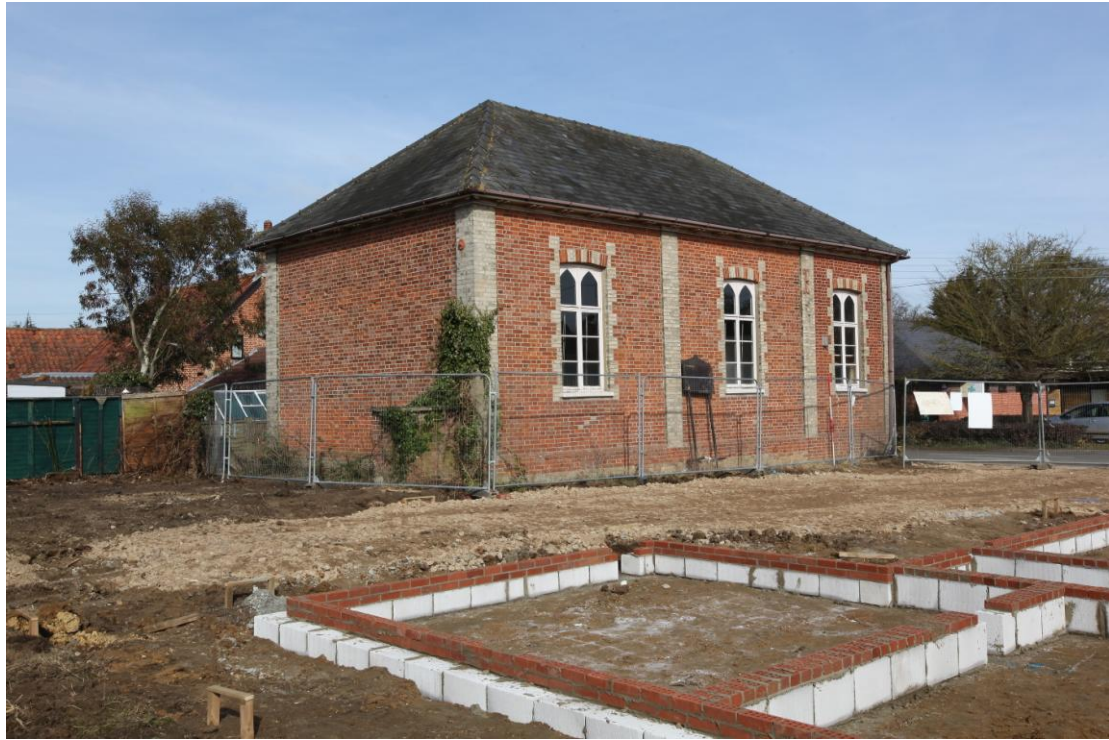
Illus. 3. The exterior from the south-west, showing the small brick shed added to the southern end of the western gable in the 20th century (and the foundations of a new dwelling on the associated plot of land).

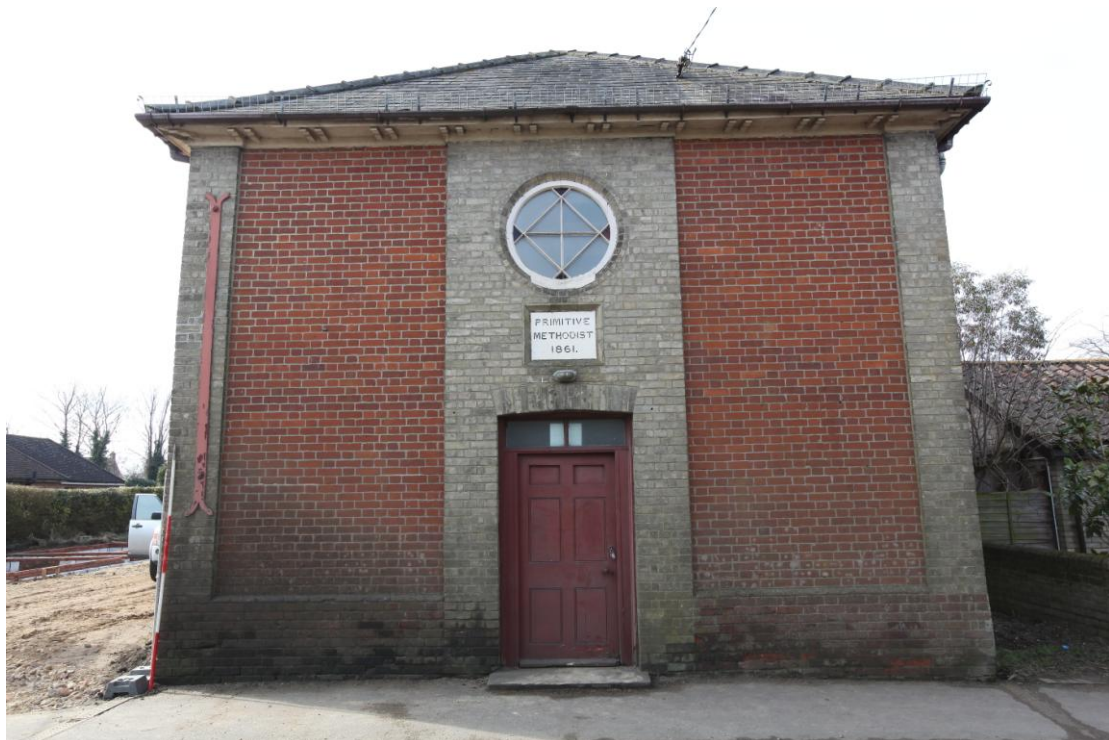
Illus. 4. The eastern external gable showing the six-panel 19th century central entrance door a stained glass roundel and foundation plaque above. The plaque appears to consist of painted cement and reads 'PRIMITIVE MEHODIST 1861.' It may have been salvaged from the original eastern gable, which was set back from the road behind a small garden.

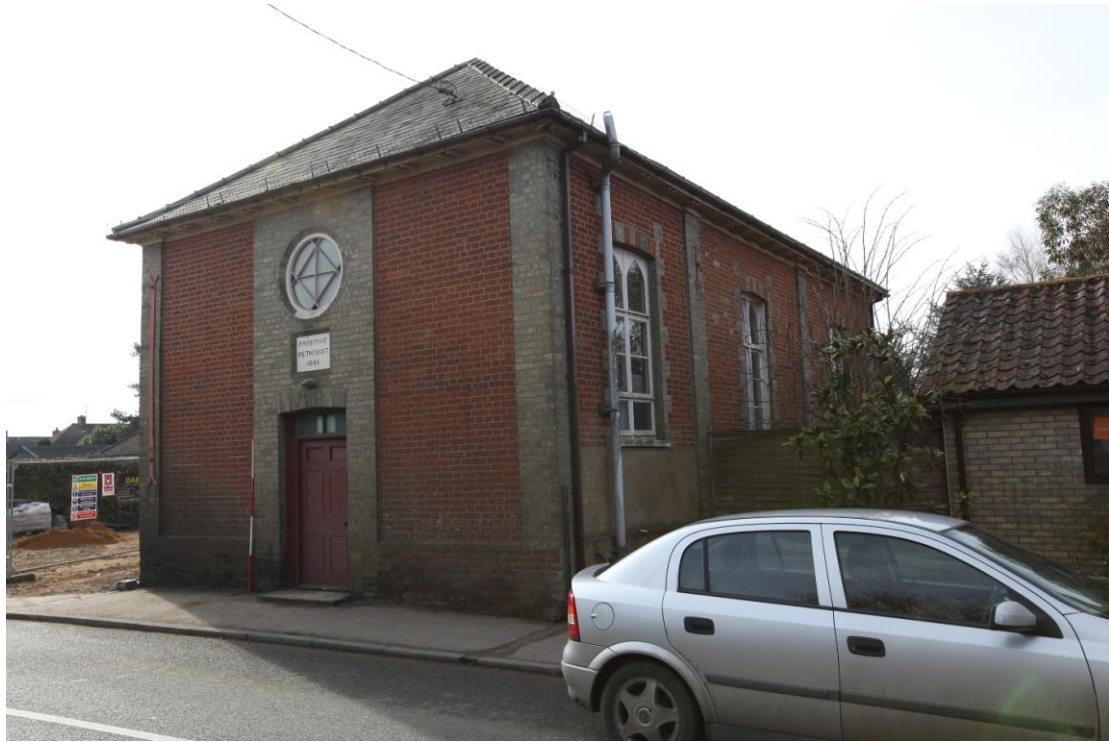
Illus. 5. The chapel from the north-east showing the northern elevation matching the southern elevation.

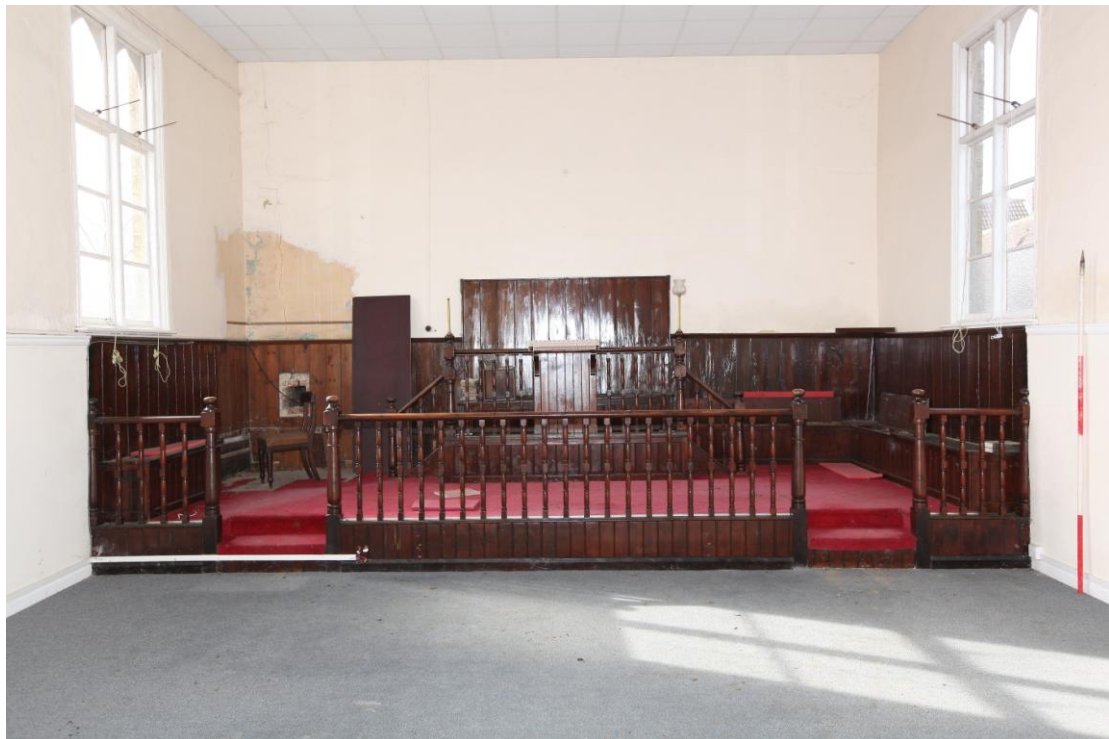
Illus. 6. The stained pine dais (1a) at the western end of the main hall (1). This is probably contemporary with the extension of the chapel at the end of the 19th century.

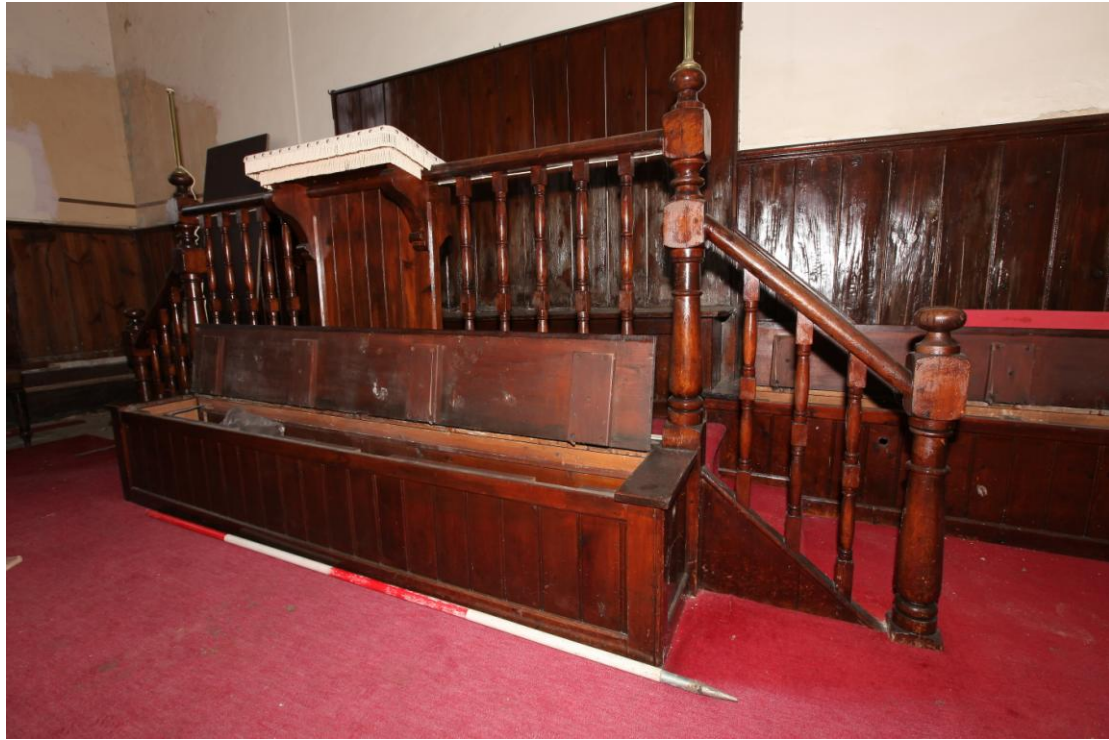
Illus. 7. The stained pine balustrade and steps of the dais (1a) to the west of the main hall (1), showing a storage bench in the foreground. The seats of the wall benches lift in the same manner.

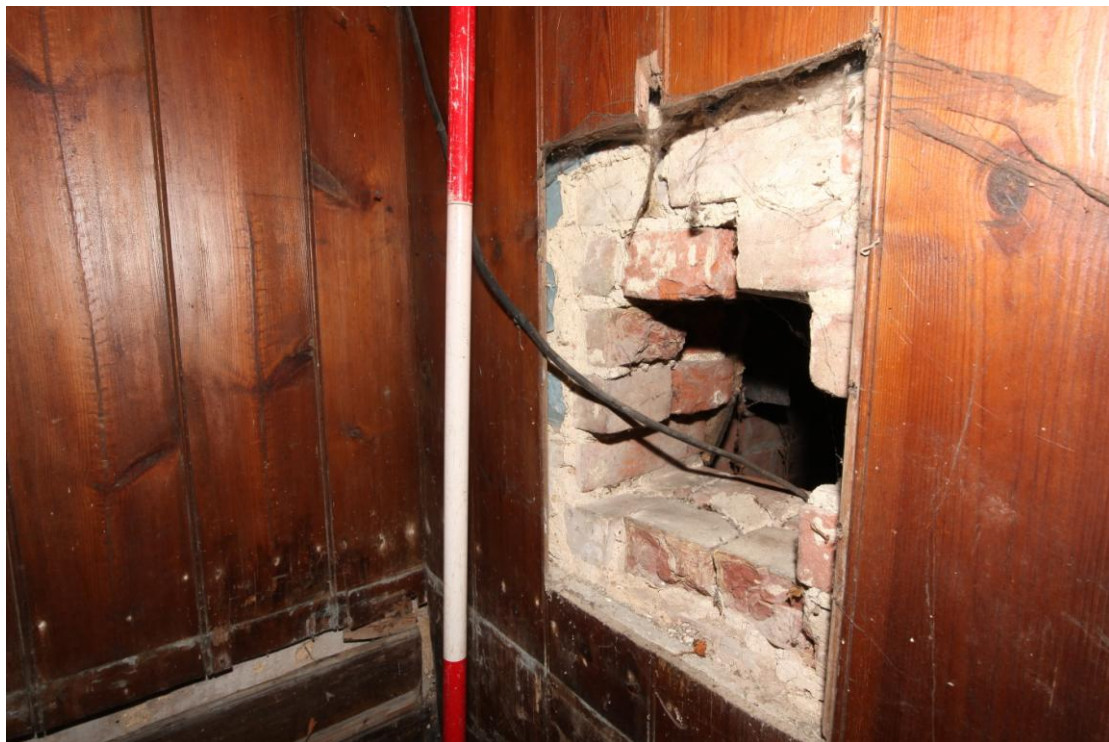
Illus. 8. A detail of the south-western internal corner of the wainscot panelling which surrounds the dais (1a). The aperture on the right connects with the small shed shown in illus. 3 and reveals the original painted plaster beneath the later panelling. The shed may have housed a generator.

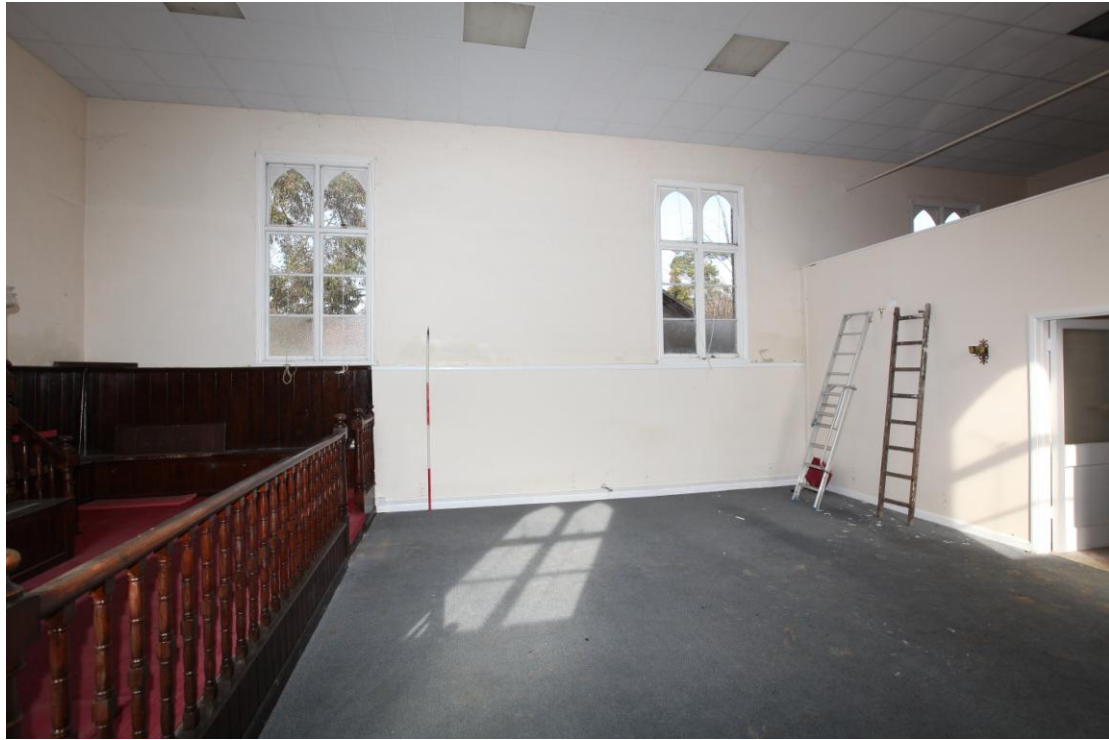
Illus. 9. The northern interior of the main hall (1) showing the dais to the left and the *circa* 1970s partitions forming a balcony above a kitchen and ‘committee room’ on the right. These partitions interrupt the eastern windows and the interior appears to have contained only a single large hall initially (perhaps with an internal porch of which no trace remains).

ladder in the passage. The ceiling and partitions interrupt the easternmost windows and the interior appears to have formed a single space prior to their insertion (possibly with an internal entrance lobby of which no trace remains).

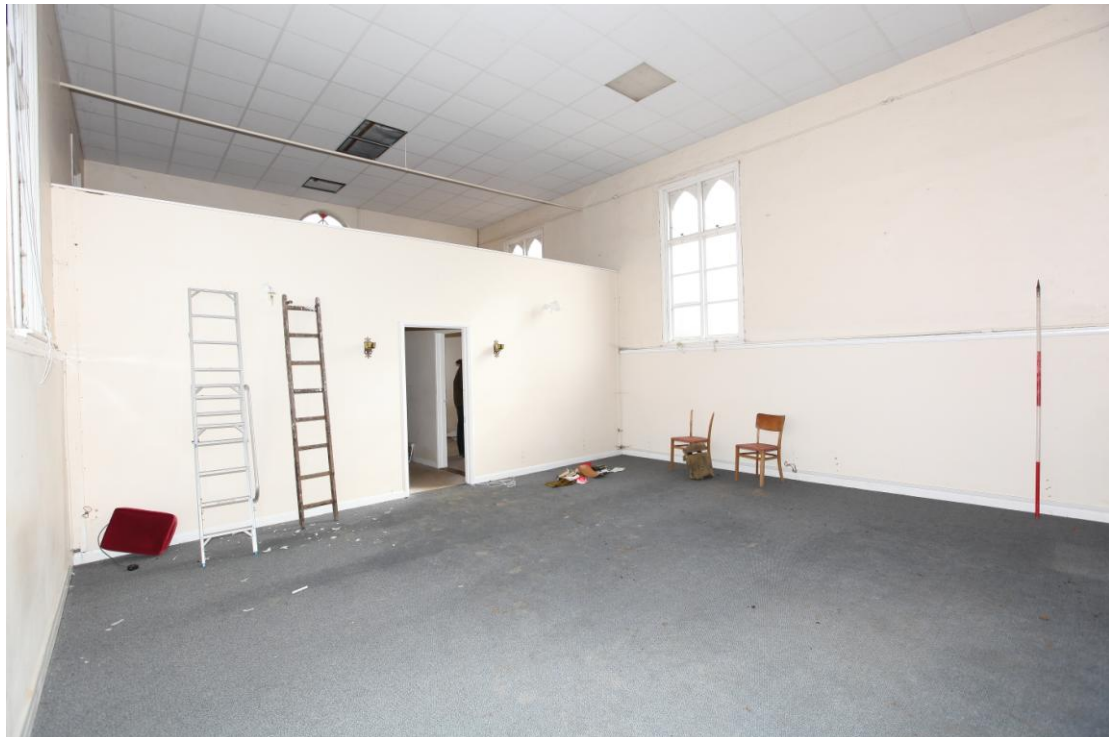
Illus. 10. The main hall (1) from the west showing the *circa* 1970s partitions and ceiling tiles. Wooden wainscot may survive behind modern boarding under the dado rail.

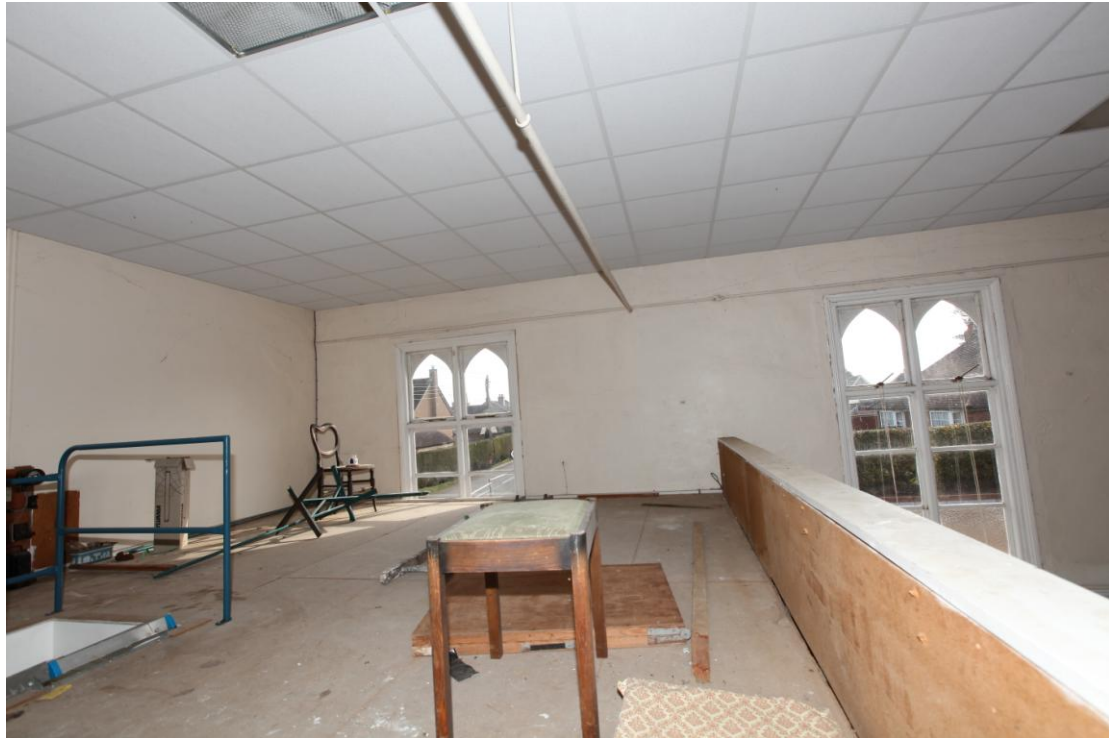
Illus. 11. The balcony above the modern partitions at the eastern end of the hall (1), viewed from the north. This area was reached by a retractable steel loft ladder from the entrance passage (as shown to the left). Note the iron tie-rod that replaced the original eastern gable when the building was extended.

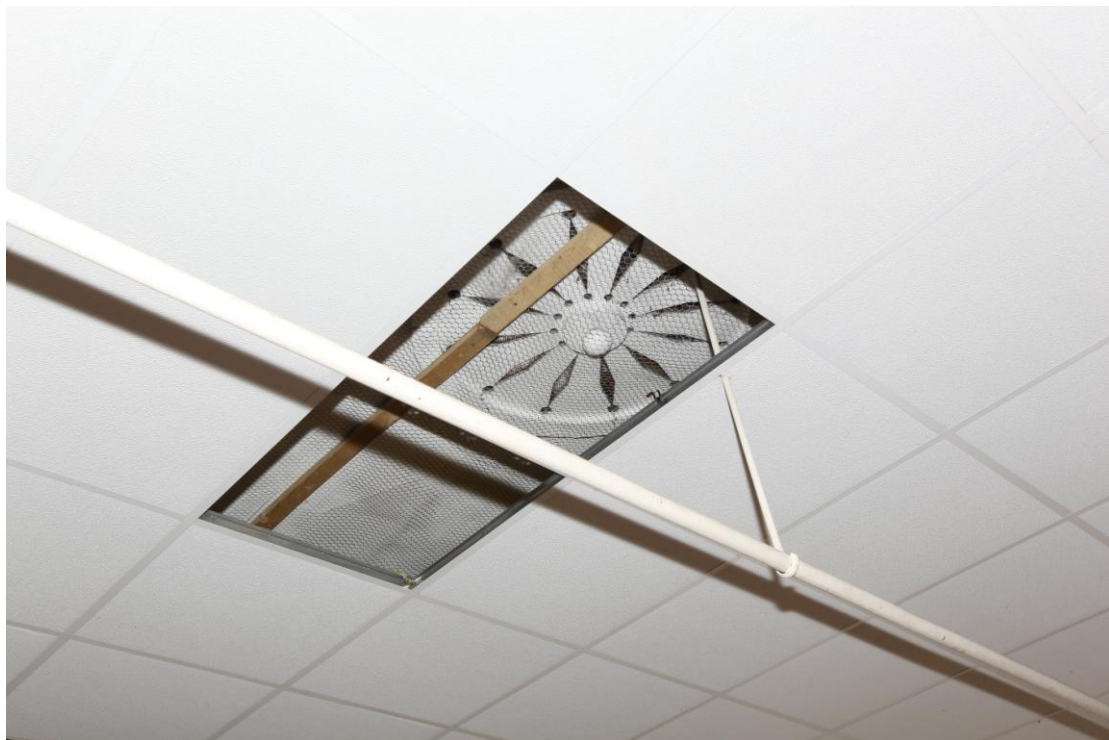
Illus. 12. A detail of the ventilation rose or chandelier support visible beneath the 20th century ceiling tiles above the eastern balcony, with the tie-rod shown in illus. 11. Other Victorian decorative features may be hidden behind modern cladding elsewhere.

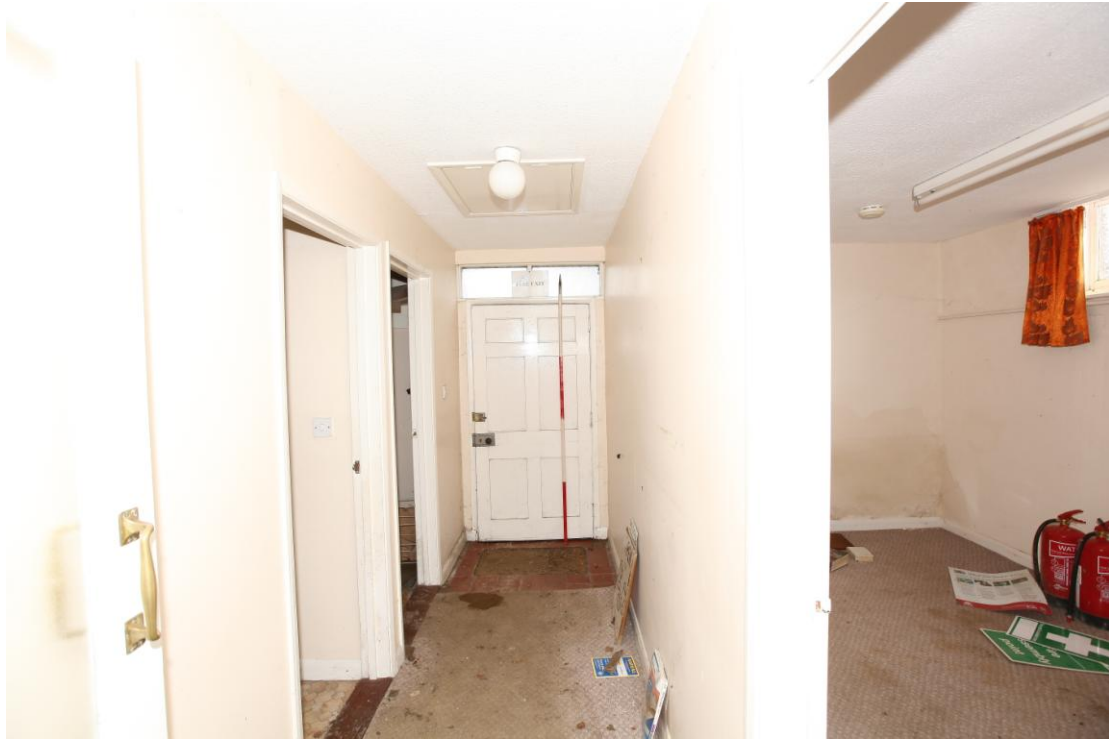
Illus. 13. The entrance passage (5) from the west, showing the external door with the loft hatch to the balcony in the ceiling above, the ‘committee room’ (6) on the right and doors to the kitchen, WC and cloakroom (2, 3 & 4) on the left.

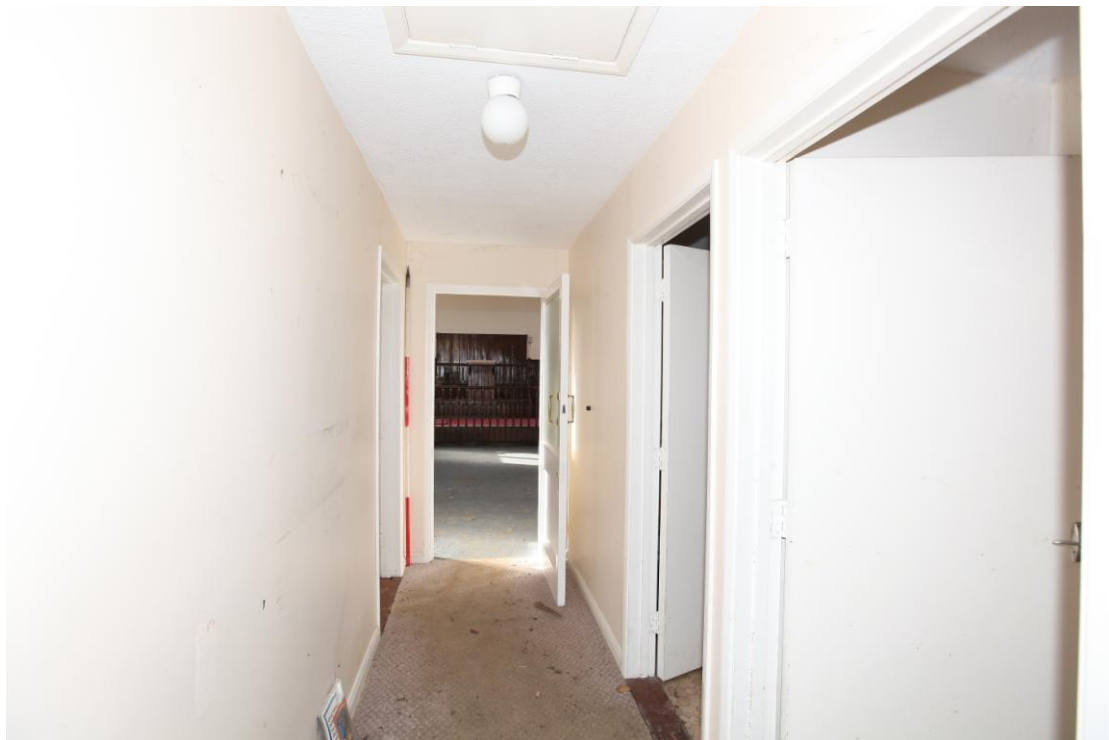
Illus. 14. The entrance passage (5) from the east showing the access to the main hall (1) with the doors to the cloakroom and W C (3 & 4) and kitchen (2) on the right and the ‘committee room’ (6) on the left.
