Martello Tower P, Langer Road, Felixstowe FEX 294

Archaeological Monitoring Report

SCCAS Report No. 2013/034

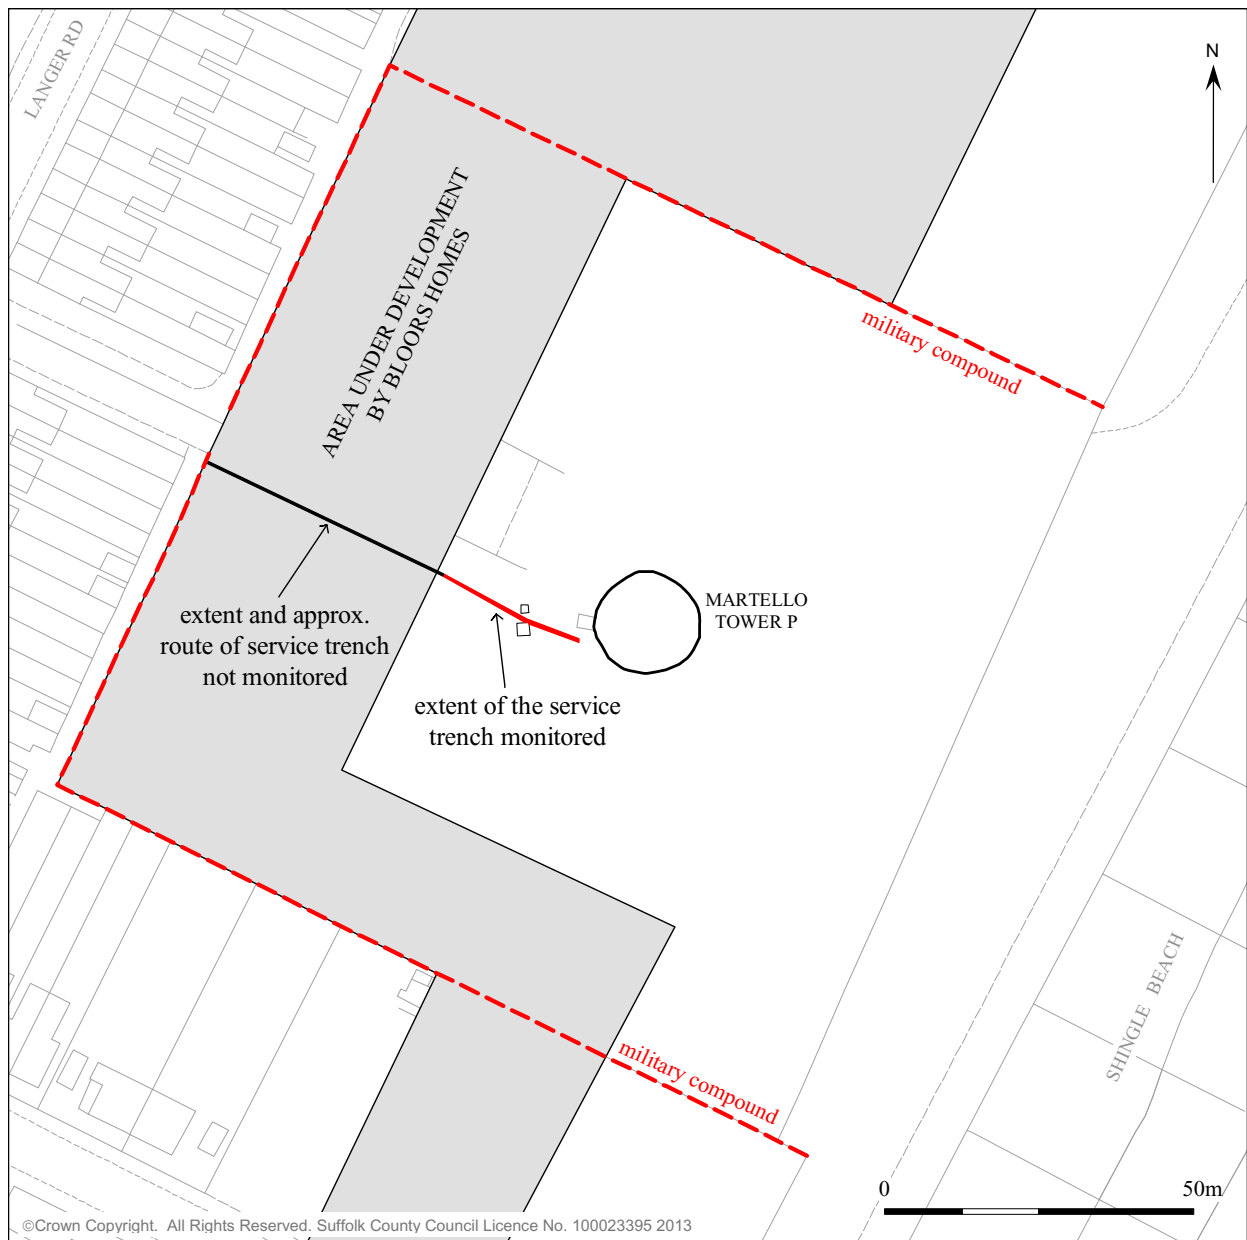
Figure 2. Trench location

A 25m length of the service trench, excavated for the installation of a cable duct, was archaeological monitored. It was located in the area adjacent the Martello Tower (fig. 2). It was cut in a straight line but with a slight kink to avoid a mast tether and a small, modern brick structure.

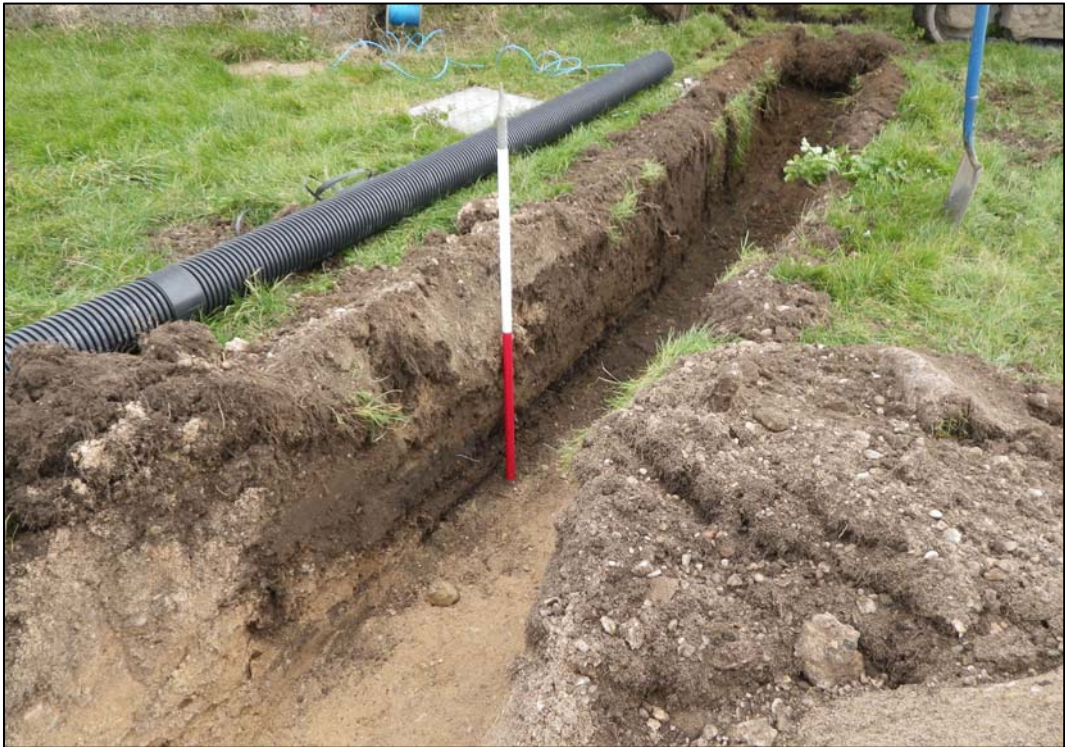
Plate 1. Tower ditch, camera facing east (ref. HTA 07)

1. Adjacent the tower the tower a large cut was present, the base of which was below the bottom of the service trench. It was predominately filled with topsoil with a lens of dark grey-brown sand gravel towards the base of the service trench (plate 1). The north-west edge of the cut sloped up gently; the opposite edge was not seen as it lay beyond the end of the service trench. This was interpreted as a ditch which is known to circle the tower. It was recorded in series of evaluation trenches excavated recently where it found to be 7.8m wide 0.85m deep (Sommers, 2012).

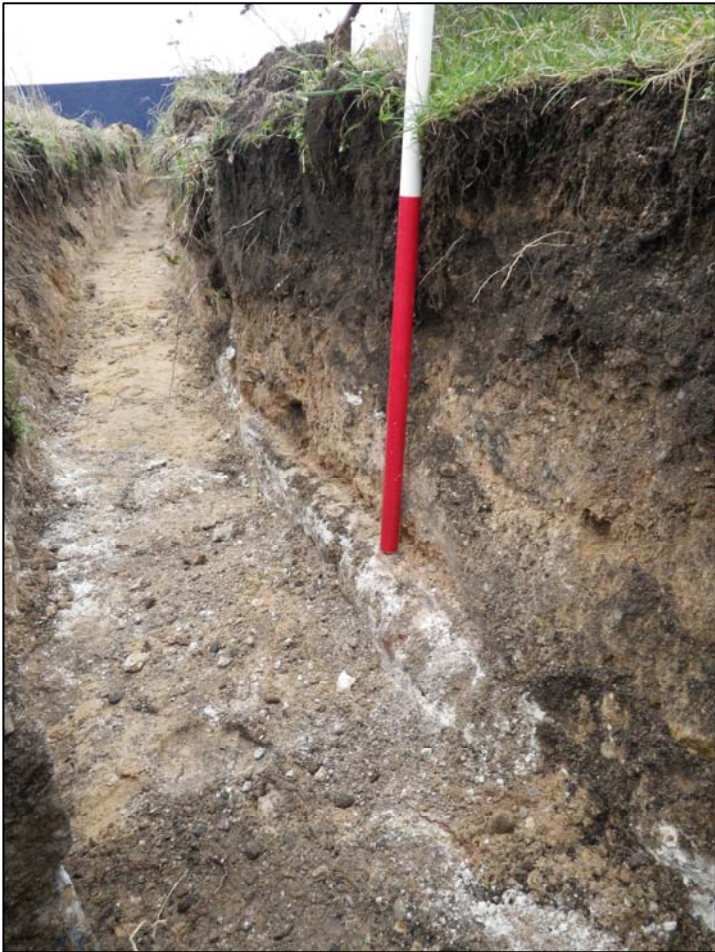
Plate 2. surface, camera facing northwest (ref. HTA 08)

2. A hard surface was noted at a distance of c. 8m from the tower. It comprised a layer of a fine white cemented material, possibly chalk mixed with lime, which formed a possible floor surface (plate 2). Inclusions within the material comprised occasional small fragments of dark red brick and infrequent pebbles, some quite large (plate 3). This surface lay at a depth of 0.6m below the present ground level, at c. 2.95m OD, and varied in thickness between 0.10m and 0.07m. It extended for a distance of 2.9m along the service trench and was clearly cut by the large concrete block that formed part of the radio mast tether.

The hard surface and the possible wall line contain similar materials and lie at identical depths below suggesting they are contemporary and are probably associated, being components of a single structure. The fact that the surface is cut by the tether mounting indicates it is pre c.1900 in date.

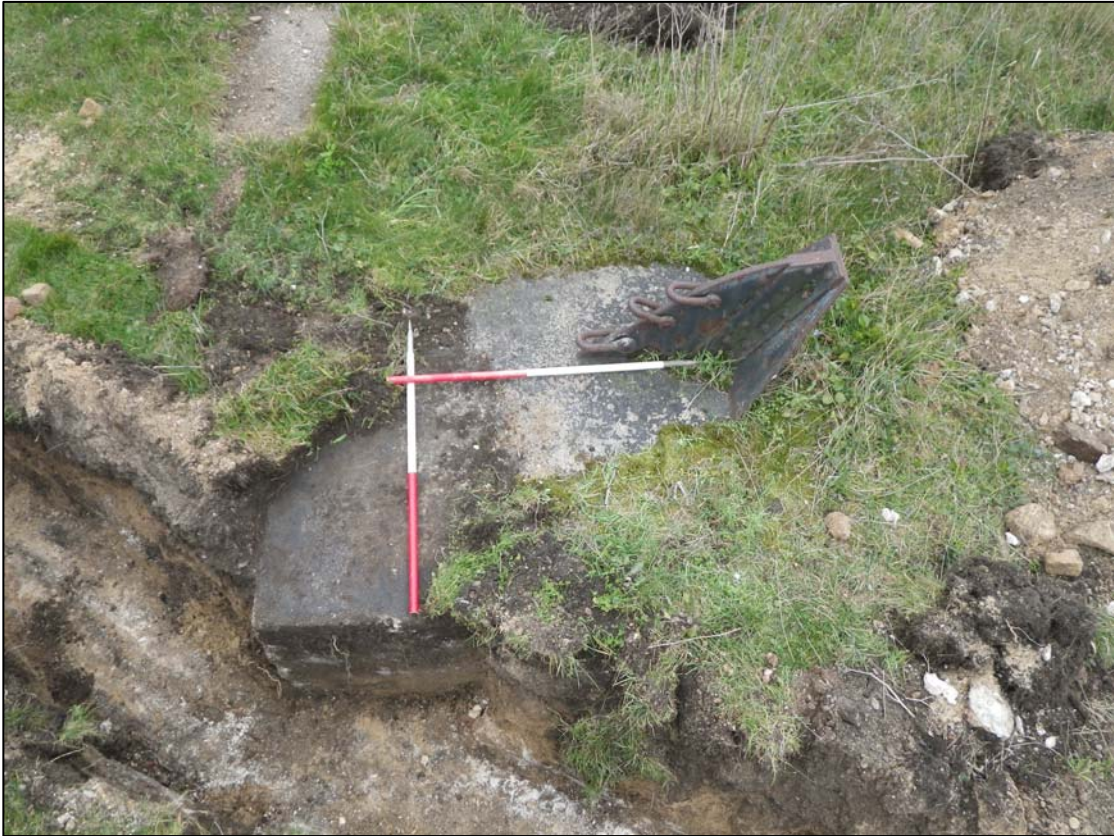
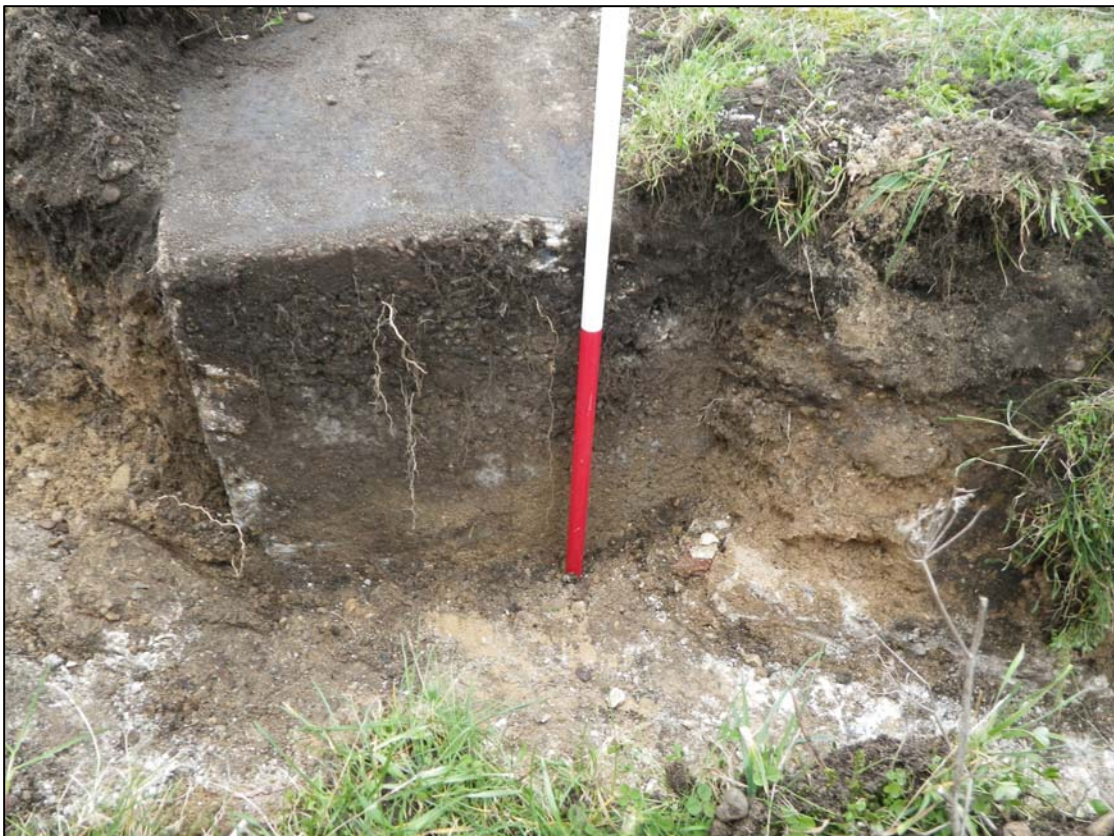
Plate 5. radio mast tether (ref. HTA 11)

4. The service trench cut alongside a large concrete block into which a substantial steel bracket is set. It is one of four identical blocks that are regularly spaced around the tower. They have been interpreted as tether for hawsers that originally supported a radio mast that was mounted on the top of the tower in the late 19th/early 20th century (plate 5). The trench exposed the side of the block which revealed the edges to be regular and smooth, suggesting the concrete was poured *in-situ* against timber shuttering (plate 6). The full depth of the block was not ascertained as it continued beyond the base of the service trench. It clearly cut through the surface identified in the service trench.

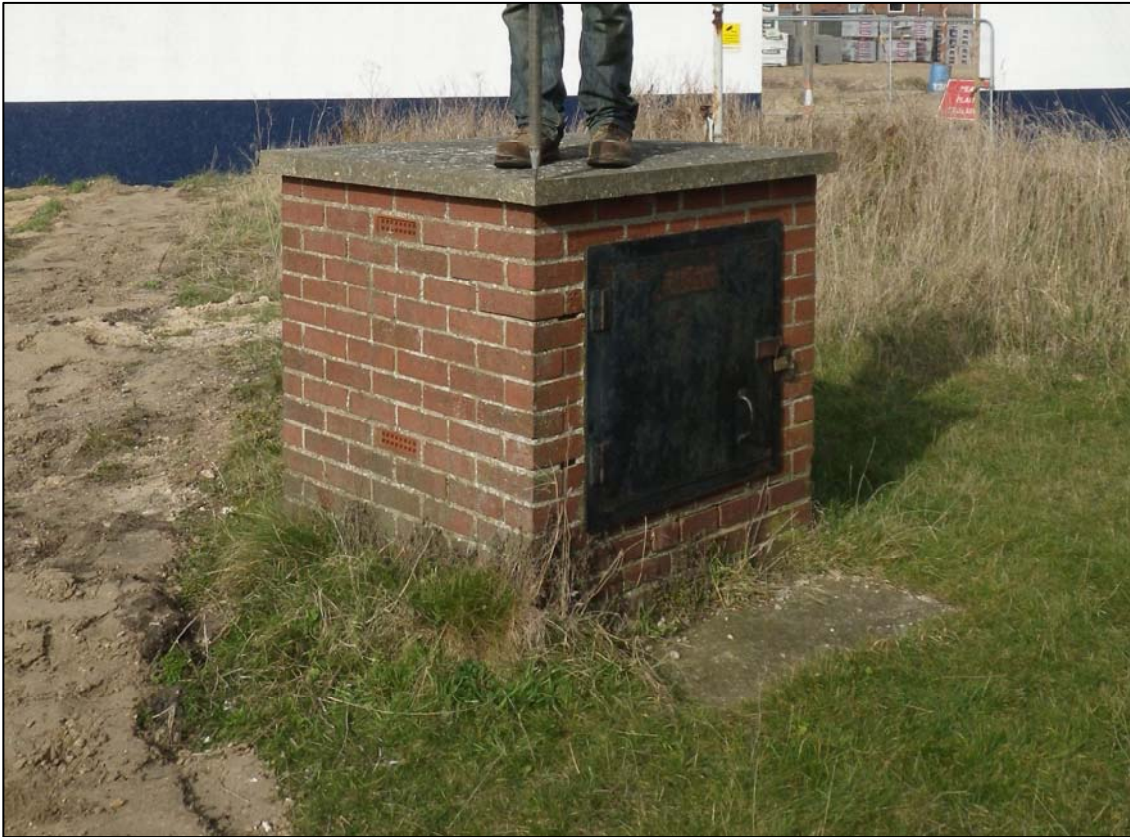
Plate 7. brick structure, camera facing northwest (ref. HTA 13)

5. A small brick built structure was situated immediately to the north of the service trench (plate 7). It is rectangular in plan with vertical, featureless walls and a concrete slab roof which overhangs the wall. A steel door is fixed on the eastern side, hinged and secured with a hasp and padlock. It is presumably related to services to the tower, the Coastguard Cottages that formerly stood on this site, or possibly the Royal Observer Corps bunker that lies to the northeast of the tower.
