**Tank Training Site, Fritton Lake  
Somerleyton, Ashby & Herringfleet  
HER ref. SOL 029**

**Archaeological Survey Report**

**SCCAS Report No. 2013/052**

**Site Name:** World War 2 Tank Training Site, Fritton Lake

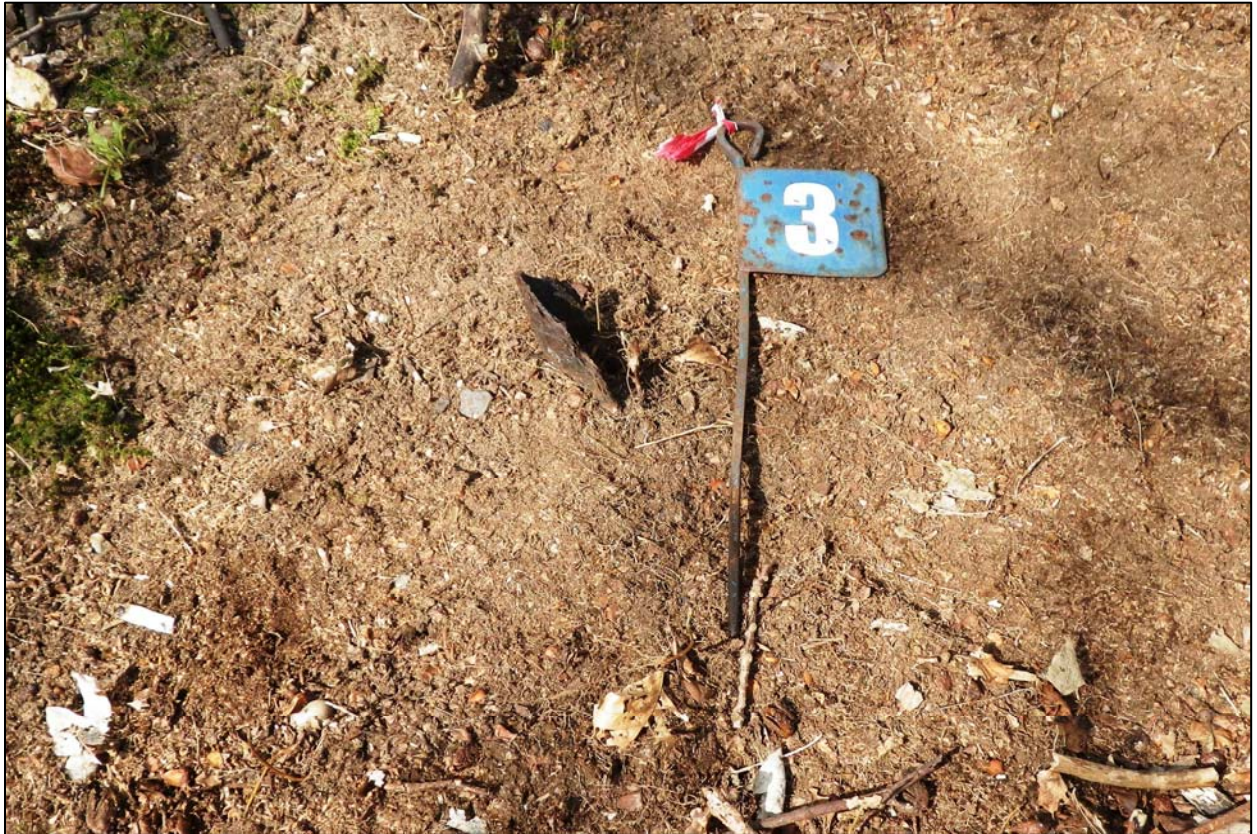
Plate 3. Feature No. 3, possible Dannert fence post

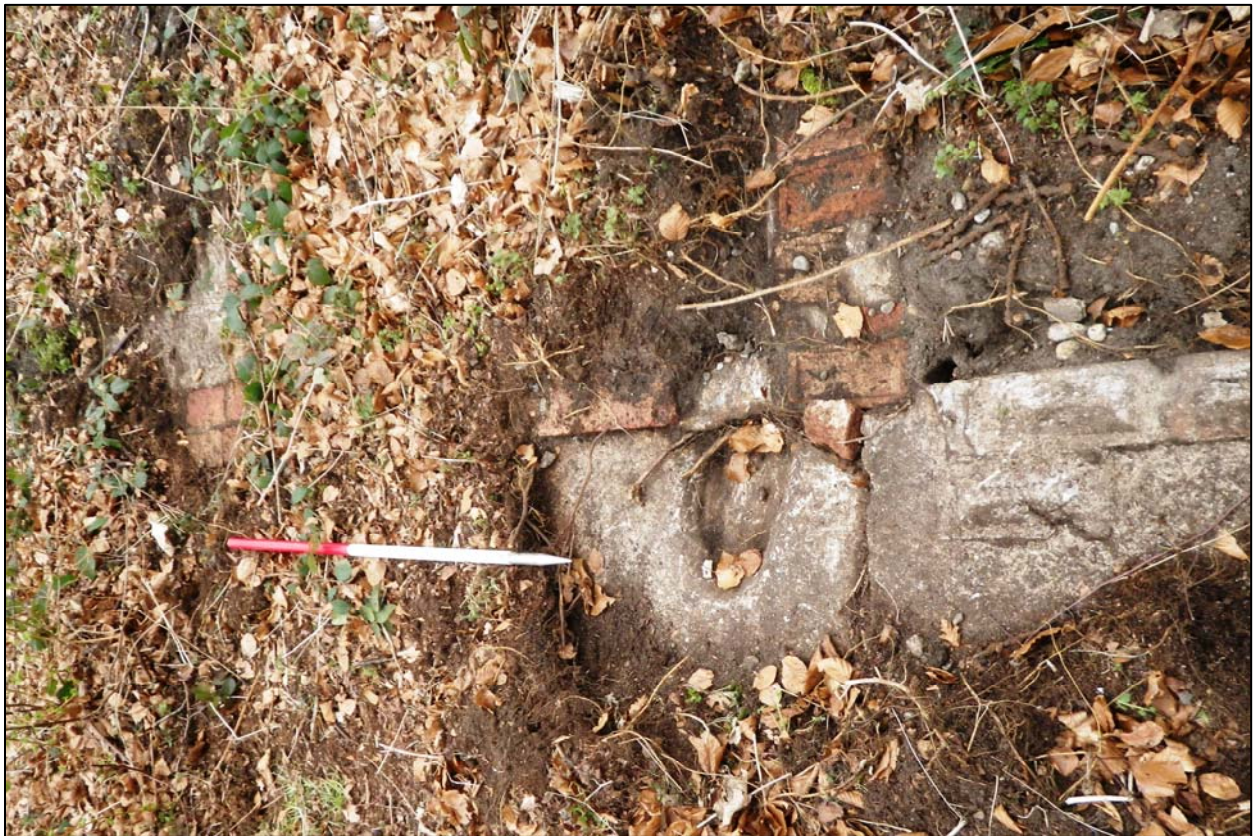
Plate 14. Building 15, showing an internal division and channel in floor, camera facing west

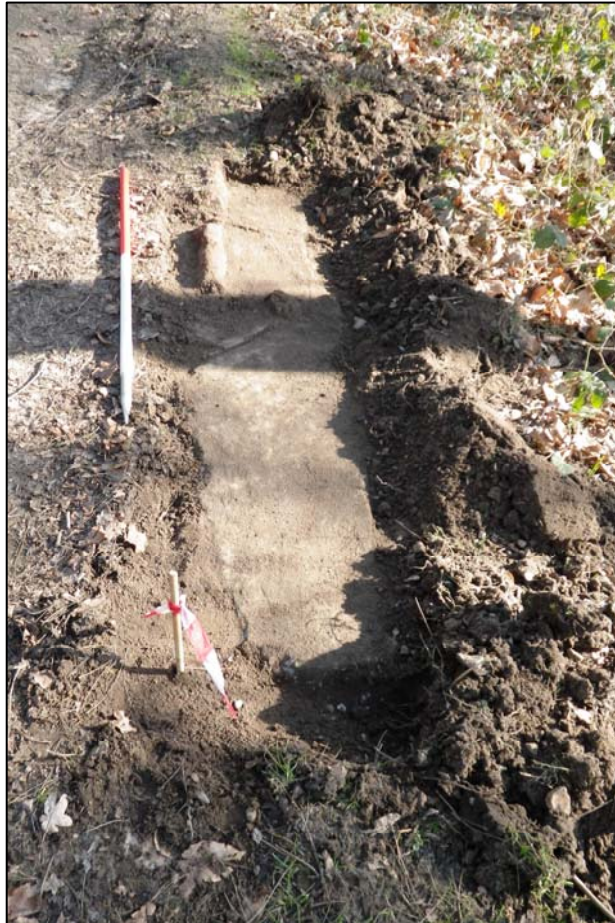
Plate 32. Amphibious Escape Training Facility - wall line (I)

- I - A strip of concrete revealed through limited hand excavation. Smooth on the upper surface although edges appear a little irregular (plate 32). Some brickwork visible, particularly towards the north west end. Thought to be the north-east wall, i.e. the rear wall, of the water tower that stood on the north east side of the main building.

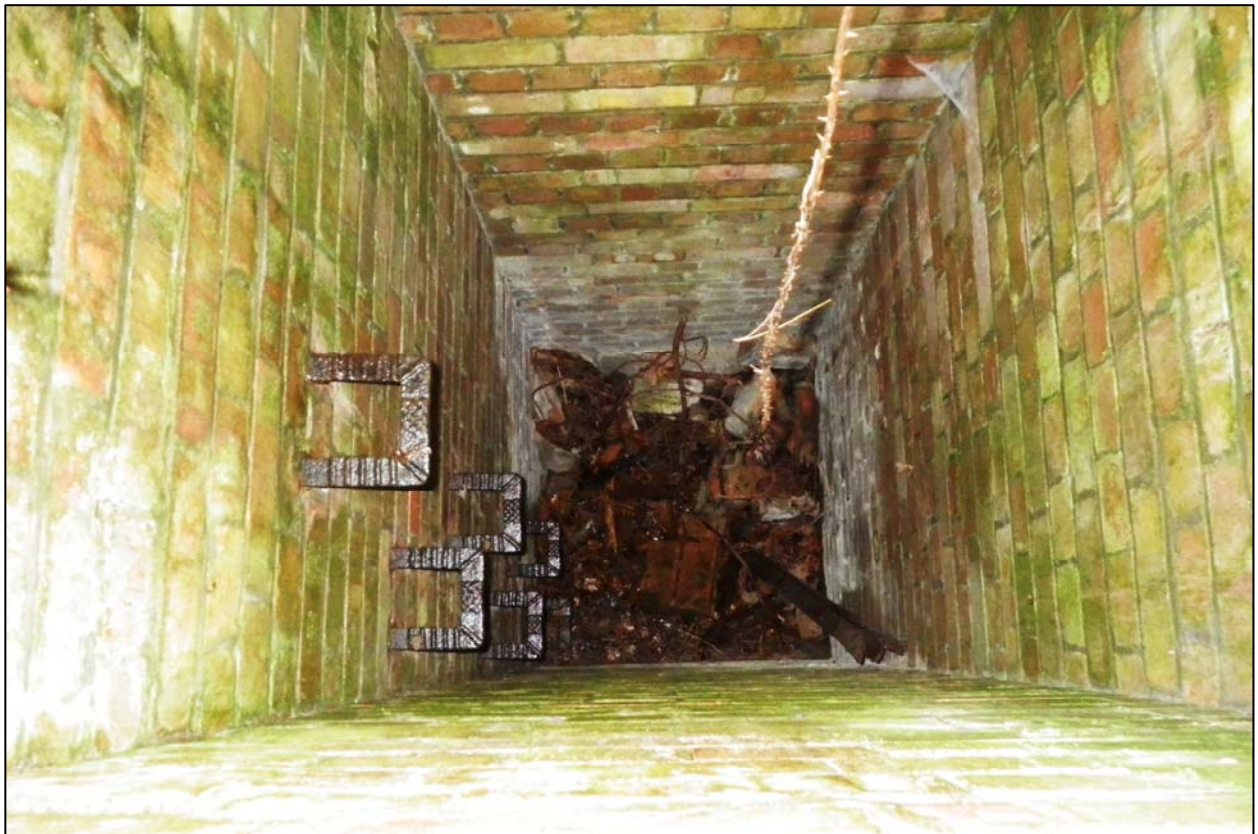
VIII - Vertical brick lined shaft. Rectangular in profile with iron steps set in one side (plate 33). A large diameter pipe visible in one corner at the base. The shaft extends above the present ground level by c. 1m (plate 34). Its purpose is unknown but it is believed to be associated with water management in the training chambers within the main building.

Plate 33. Amphibious Escape Training Facility - view down brick lined shaft (VIII)

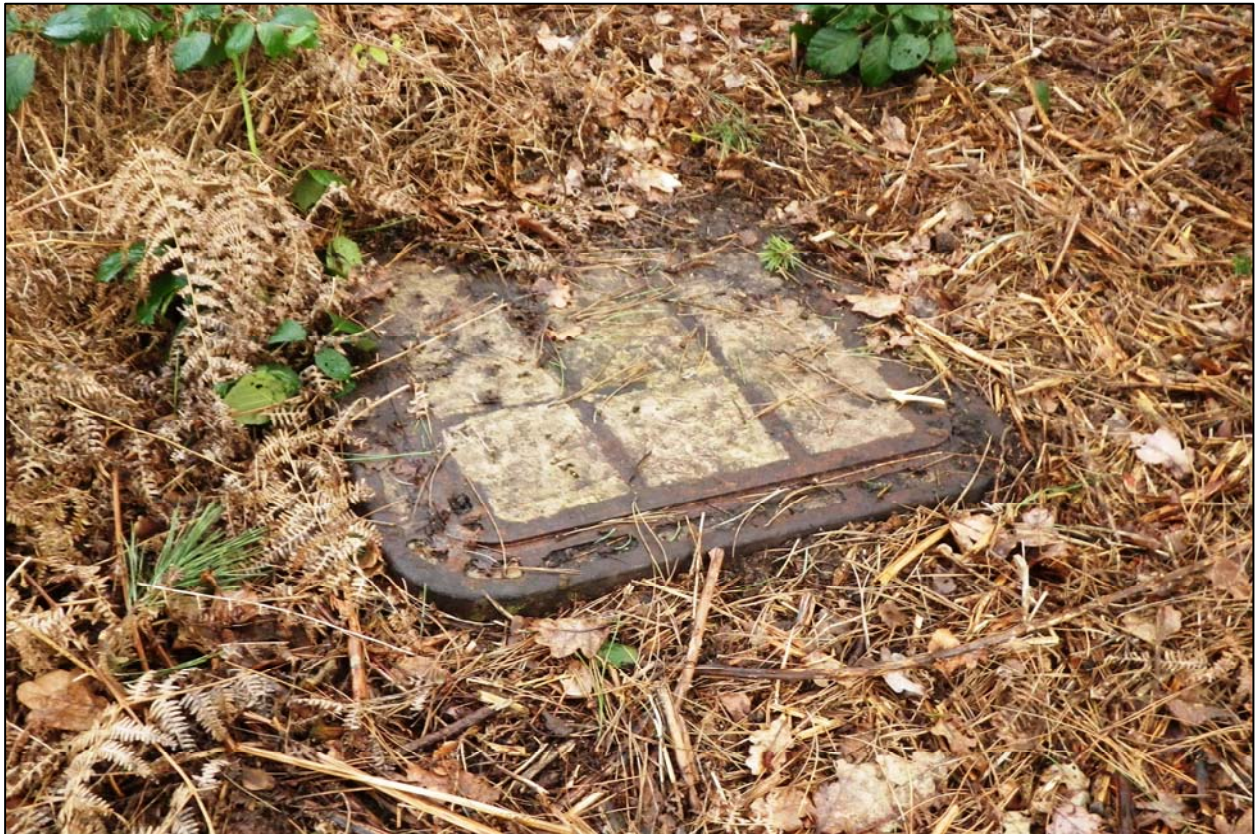
Plate 35. Amphibious Escape Training Facility - manhole cover (IX)

IX - Manhole cover at present ground level adjacent the brick shaft (VIII). Constructed of a cast iron with concrete (plate 35).

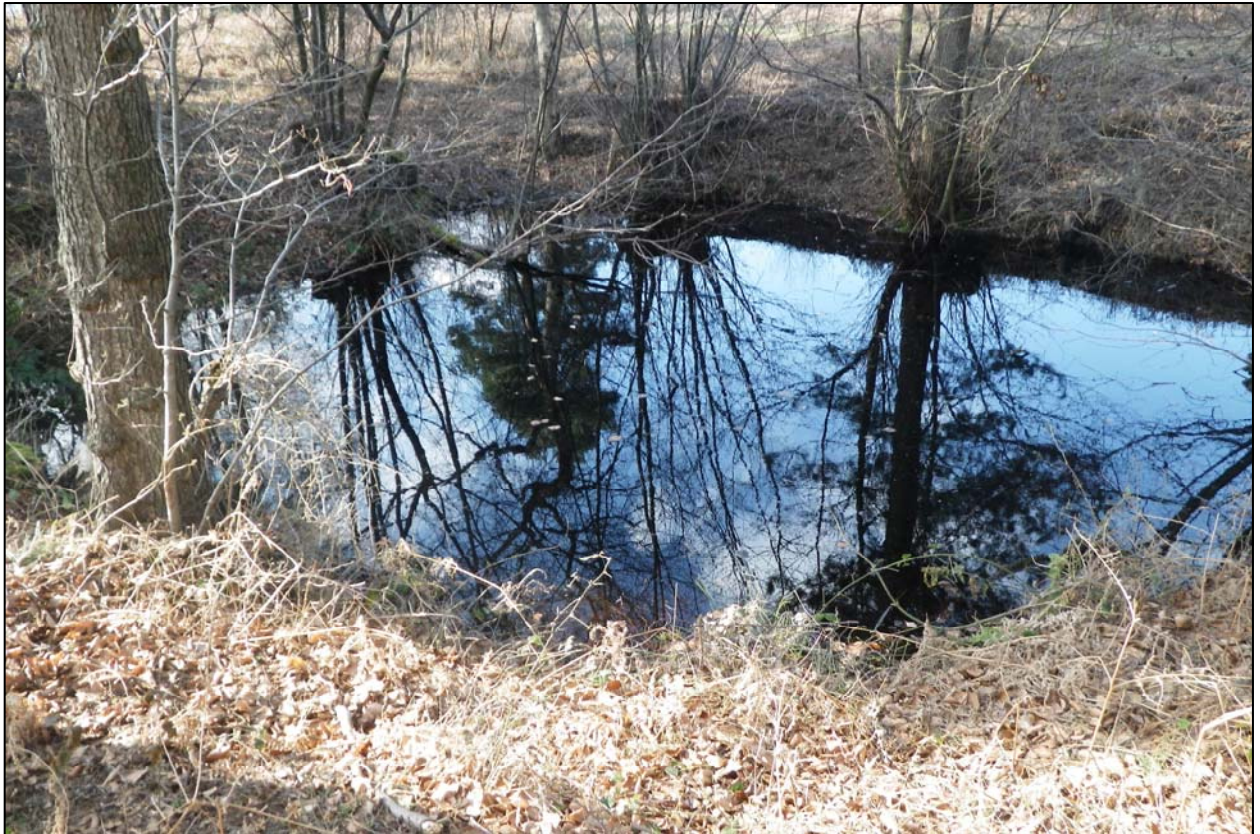
Plate 36. Immersion pool, camera facing north west

The immersion pool consisted of a roughly rectangular pool of water, measuring c. 9.5m by 7.75m, with sloping banks on all sides (plate 36). It was used to test the water-proofing of the tanks prior to swimming in the lake

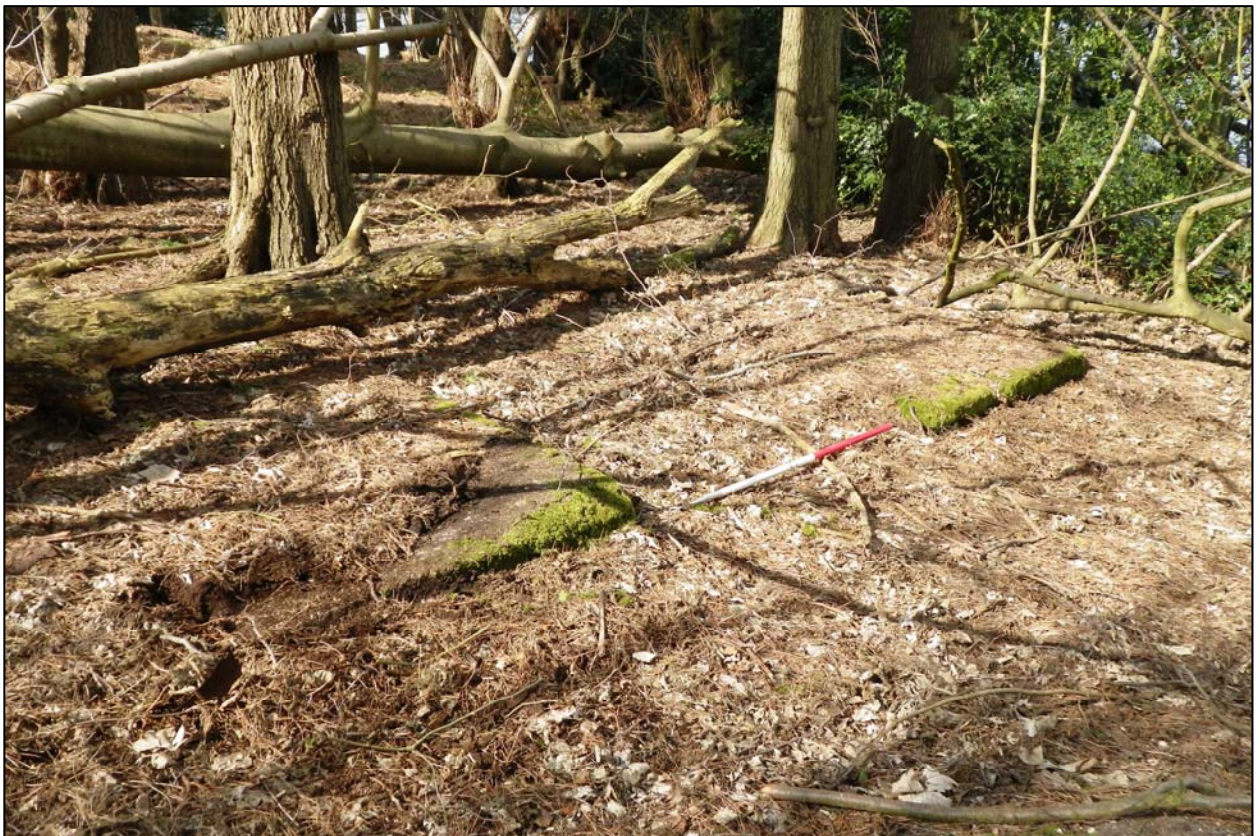
West of the tank park a series of four launching ramps for the tanks were present (marked in red in Figure 7). These consisted of short lengths of Bailey bridge ending with ramps into the water and were designed to simulate the launching of a tank from a landing craft. All of the Bailey bridge structures have been removed but a series of concrete slabs and beams remain *in-situ*. Each consisted of a single slab of concrete, measuring c. 10m by 6.3m with two further narrow slabs or beams, measuring 7.1m by 1.4m, set between the slab and the water (plate 37).

Plate 37. Landing craft ramp supports (L2), camera facing north west

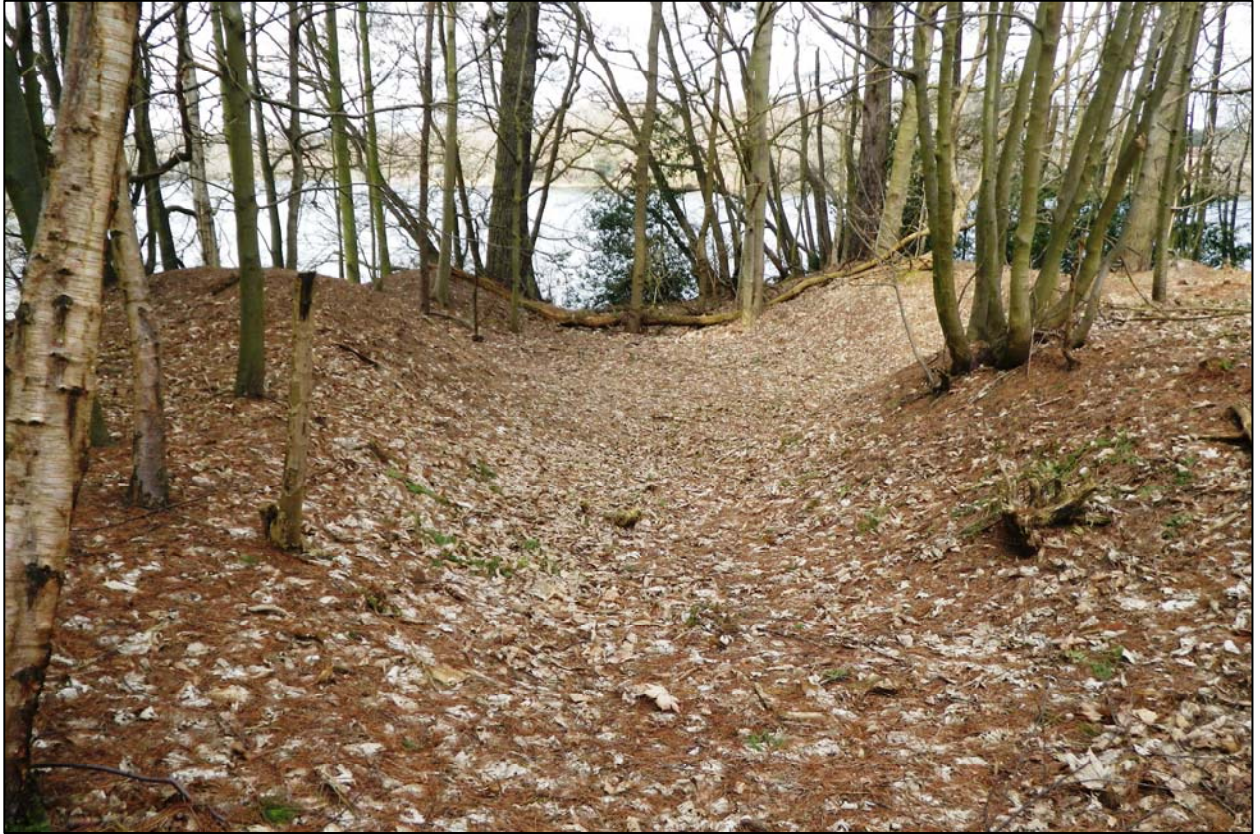
Plate 38. trackway leading down to L1 visible as an earthwork, camera facing north west

The launching ramps were connected to each other and the rest of the site by a series of tracks, some of which were visible as earthworks (plate 38). A complex of trackways is visible on 1944 aerial photographs and those in the launching area have been transcribed in Figure 7 (marked in black dashed lines). Many of these tracks converge on a junction to the south east of the launching area where a second concrete turning area was recorded (visible Figure 8).

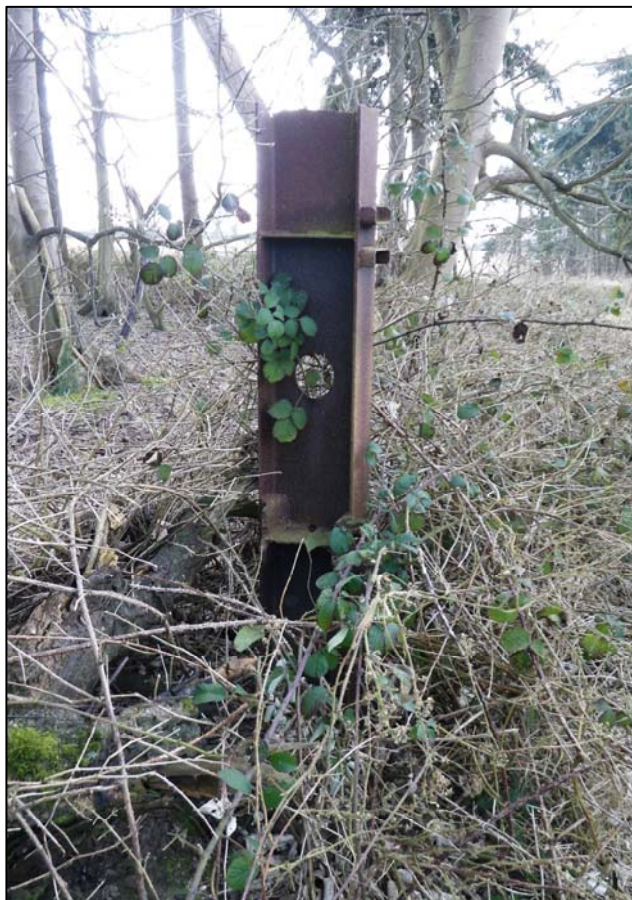
A number of artefacts have been recovered across the site as casual finds ranging from everyday household items used by the men living on the site to tank parts, including a makers ID plate from one of the tanks that served here, which in itself has provided significant evidence about the manufacture of the Valentine DD (see Appendix 2), and remnants of the Bailey bridges used on site (plate 39). The artefacts that have been

Plate 39. Bailey bridge component reused as a fence post

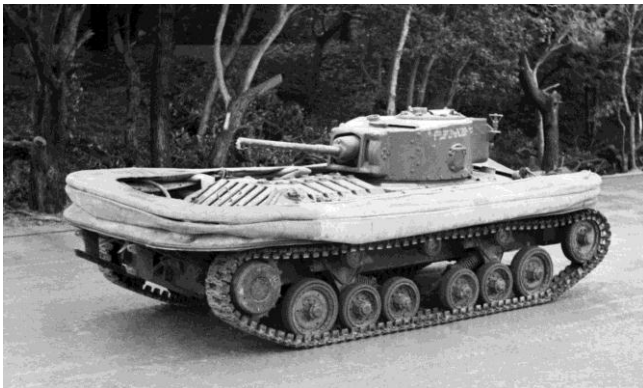
Fig 1 Valentine DD at Gosport 14<sup>th</sup> January 1944 with screens down. Note the turret is 180 degrees to the rear, so as not to foul the screens

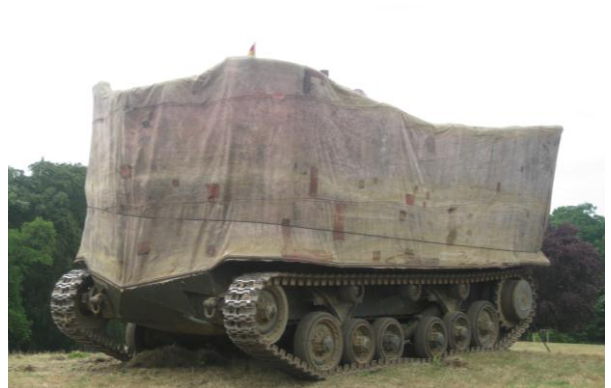
Fig 2 Valentine IX DD with Screens inflated. This tank is the only surviving example of a Duplex Drive Valentine

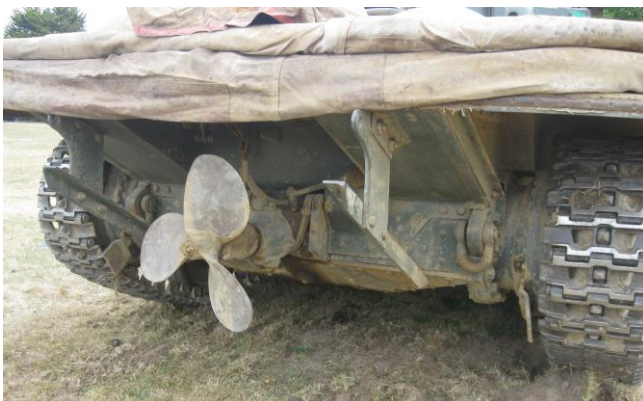
Fig 3 Close up of rear propeller on a Valentine DD – power is taken direct of the gear box

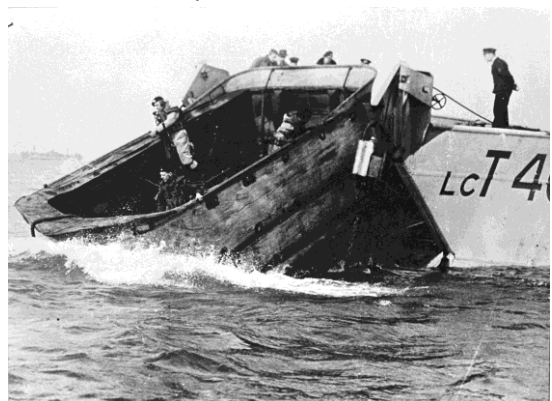
Fig 4 Sherman DD descending Landing Craft (Tank) during trials in the Solent.

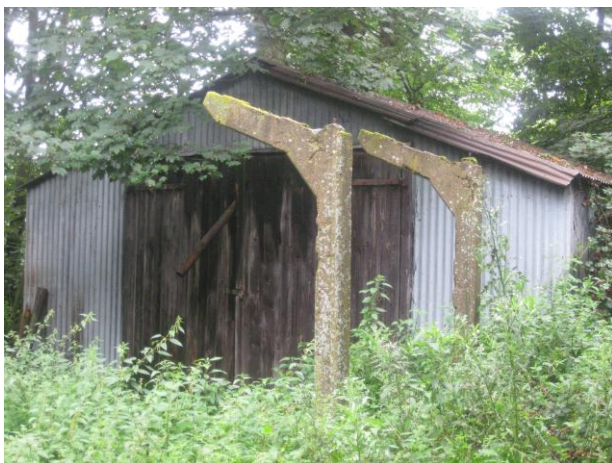
Fig 7 Remains of the Cook House. Some of the original supports have been re used to make the present day corrugated iron shed

The Cook House occupies a central area on the camp, and is constructed of concrete pillars set in the ground, and a screed concrete floor on two levels within. The walls were built from light weight blocks, and rendered. Evidence of tiles, drainage gullies and a raised area suggest the presence of preparation areas and ovens for cooking. The mess hut was located at right angles to it, and was made of timber.

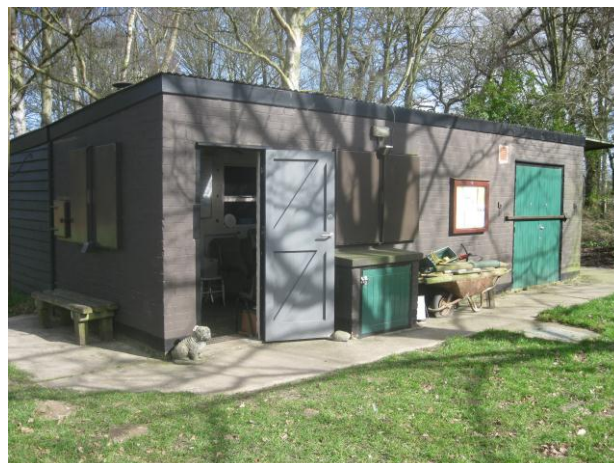
Fig 8 Re-used Military Structure, used to formerly house a machine, assumed to be the site of the Generator

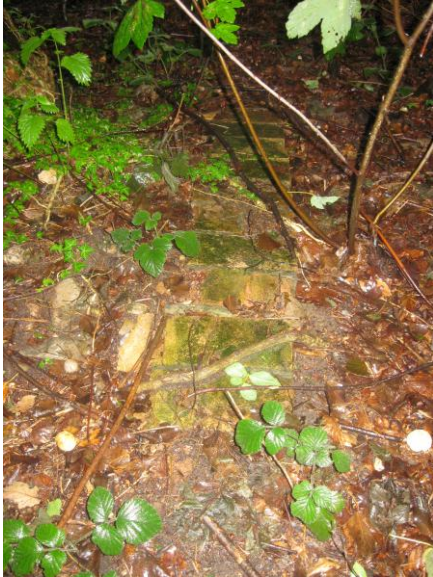
Fig 9 remains of brick footings

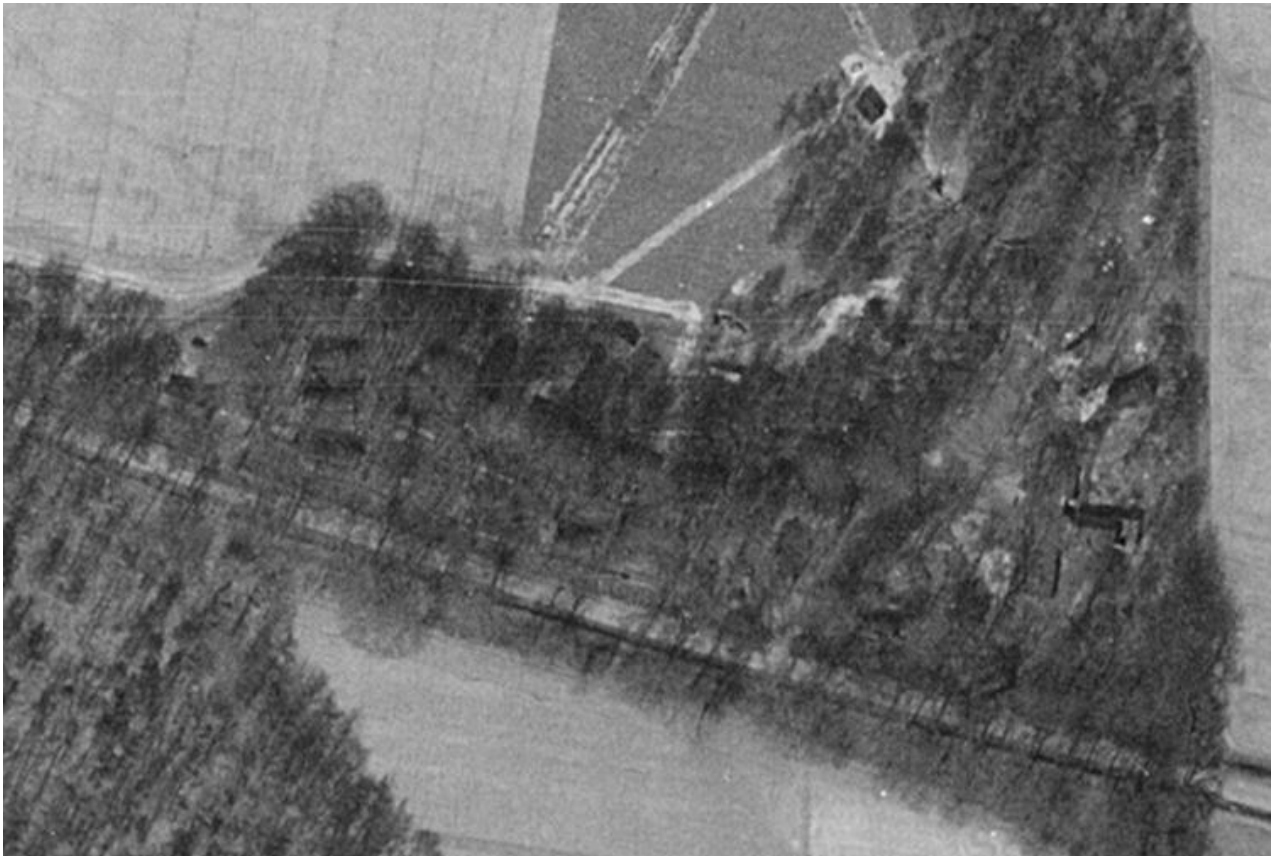
Fig 11 Aerial View of Camp showing temporary buildings. The central run of huts were used for accommodation, whilst those to the east may relate to officers mess and support buildings. The Generator Hut can be seen near the top of the image. [RCHME HLA/694 / 4112 26<sup>th</sup> March 1944].

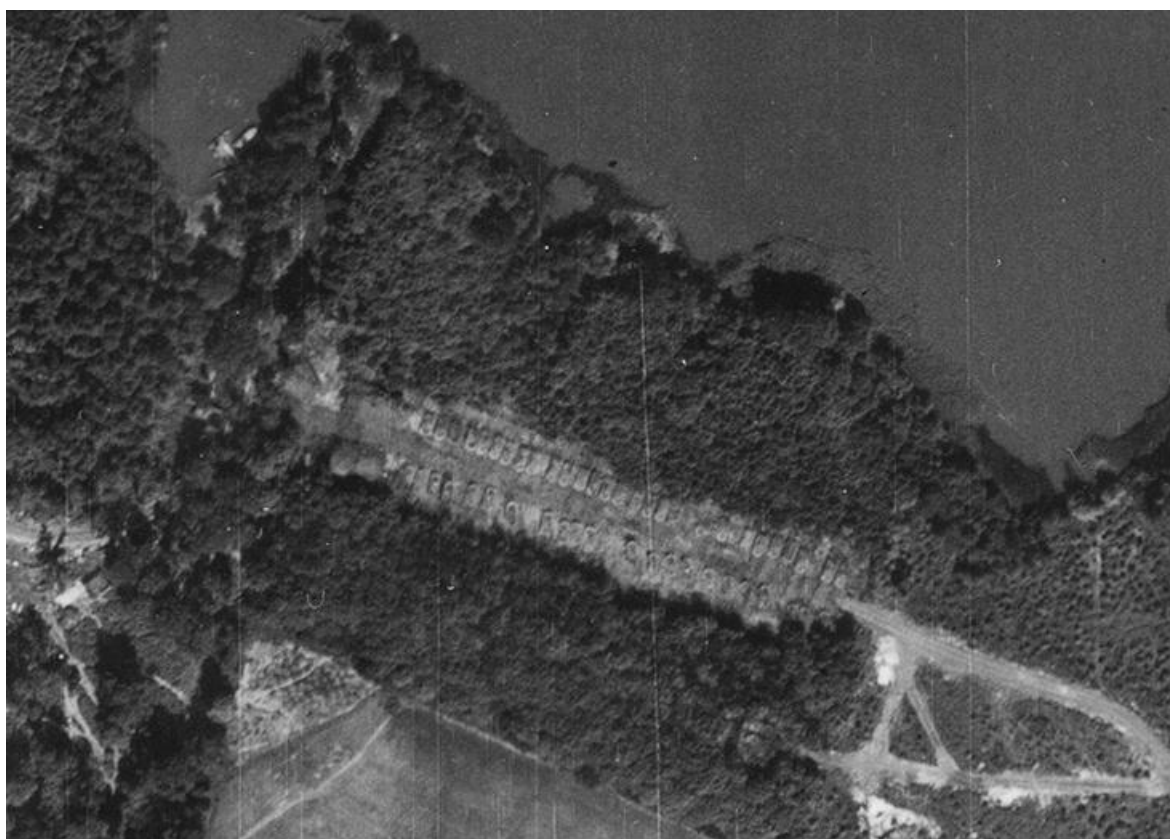
Fig 17 Aerial view of Tank Park. 36 DD Valentines can be seen parked. To their west are two Romney Huts, as well as a number of other sheds and structures. The camouflage netting appears to be ineffective in concealing the site at this time. [RCHME HLA/694 / 4112 26<sup>th</sup> March 1944]

Running parallel with the Lake was constructed a broad concrete hard standing, measuring approximately 150m long by 15m wide. It was capable of providing standings for 50 tanks. The tanks would park side by side lined up either side of the main through route, 25 tanks each side. This area was used by the crews to learn and perfect the drills associated with waterproofing, screen inflation, repairs and maintenance. The whole area was covered in a camouflage net, supported by scaffold towers and wires attached to trees. Remains of the wire, as well as scars in the trees can still be seen today.

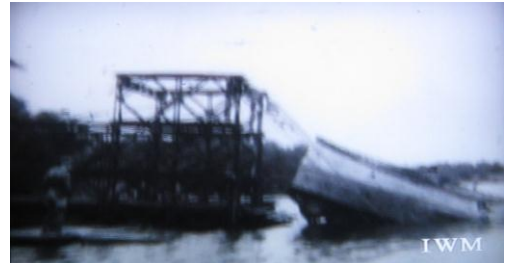
Fig 19 Image of DD Valentine descending LC(T) Ramp 1943 Imperial War Museum Film WOY 530.

Where the DDs approached the LC(T) structure, a concrete surface was laid to facilitate the slewing of the tank. Sappers were employed to maintain the Bailey Bridge, make adjustments and bail the pontoons following submersion or more likely rain.

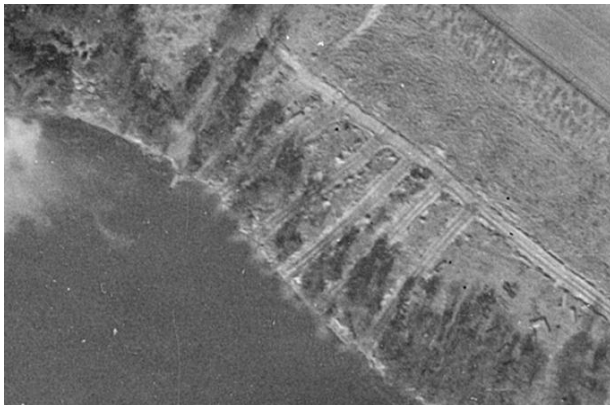
Fig 21 Aerial image of Exit Beach. This area has since been planted with trees

The DDs would exit the lake at a prepared area on the north side of Fritton Lake, near to Lake Cottage. This site was chosen because it facilitated landing tanks side by side - simulating an assault on a defended beach. Two sets of 5 exits were established, reflecting the number of DDs able to be carried on LC(T)s. Key to the training here was the quick transition from swimming tank to fighting tank. Crews had to perfect the drill to drop the screens, rotate the turret and disengage propeller prior to ascending the shore.

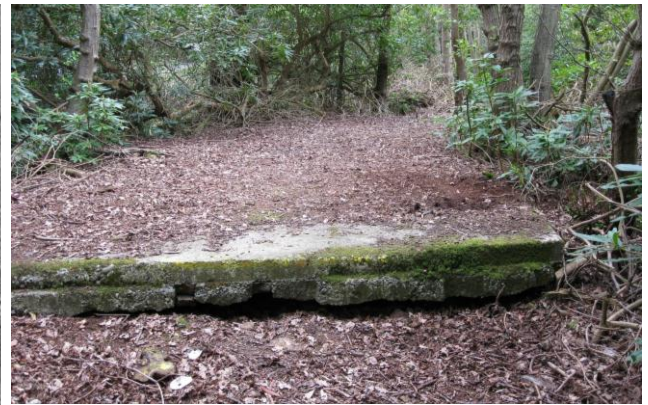
Fig 22 Surviving concrete raft formerly supporting Bailey Bridge at Lound Run

For those tanks unable to swim back into the lake, a corduroy road extended from the beach round via the Lound Run then back to the Tank Park (a distance of some 2 km). To cross the boggy ground at Lound Run a Bailey Bridge was constructed, mounted on two concrete rafts<sup>17</sup>.

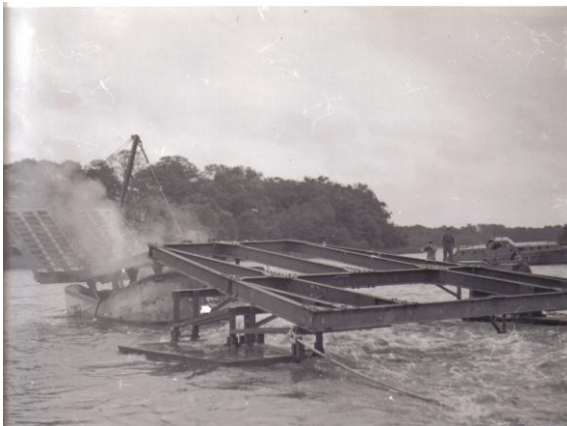
Fig 23 Trails associated with the Swimming Ark or Hopper in 1945, enabled other DDs to climb over it, out of steep sided canals. SEP 6680/31

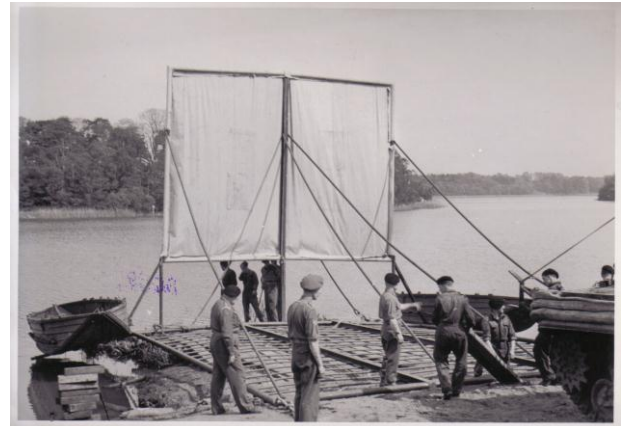
Fig 24 "Ginandit Mk II" was a device used to push in front of the tank whilst swimming and deployed over soft mud. SEP 6681/04/09

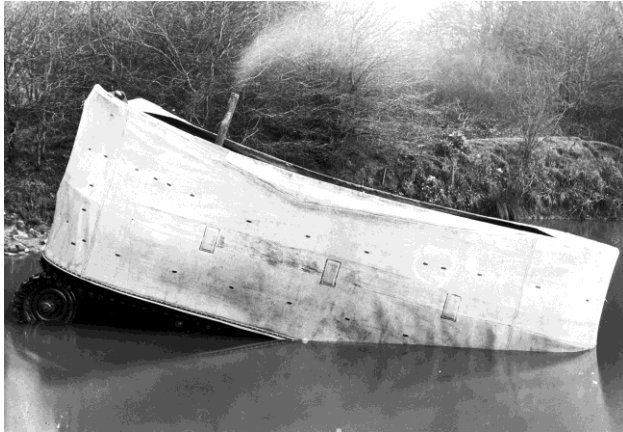
Fig 32 Valentine DD being tested for waterproofness in Fritton Immersion Pool  
[Bovington 2191-E1 ]

Prior to crews taking their tanks in the water, it was necessary to ensure they were waterproofed correctly. Crews would drive their tank into a shallow water filled pit, dug near to the lake, where the tank would be submerged up as far as the track guard. Inside the tank, crews could inspect for leakages, and set about remedial work prior to entering the Lake<sup>14</sup>.

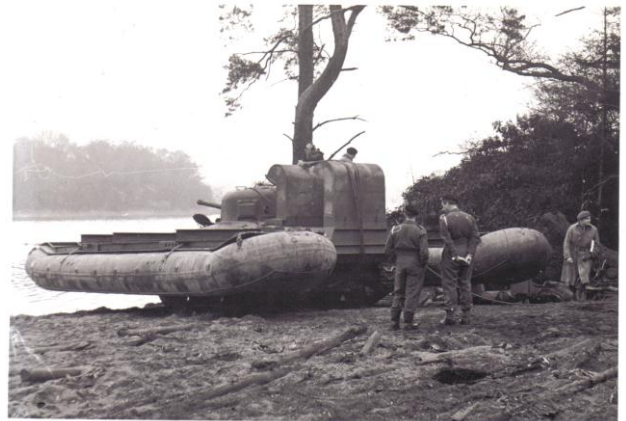
Fig 35 M12 Floatation Device – Trails at Fritton 1946  
[SEPA 6681/04/09]

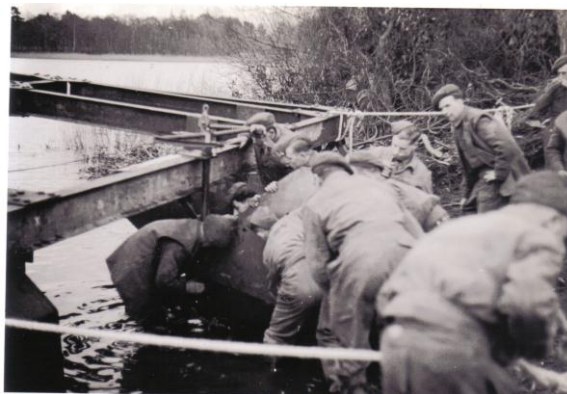
Fig 36 Crews from SADE fitting rudder to Swimming Ark [SEPA 6589/03/12]

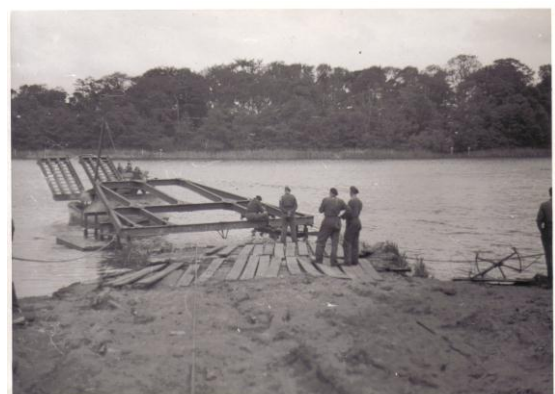
Fig 37 View of slipway N of Tank Park [SEPA 6690/25]

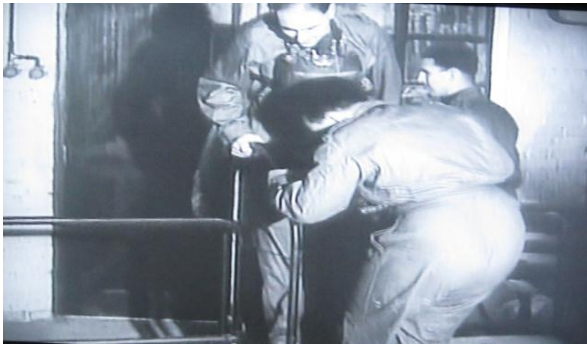
#### 1 Entering the Chamber

The crews would descend a ladder in to the chamber containing the cut down hull of a tank

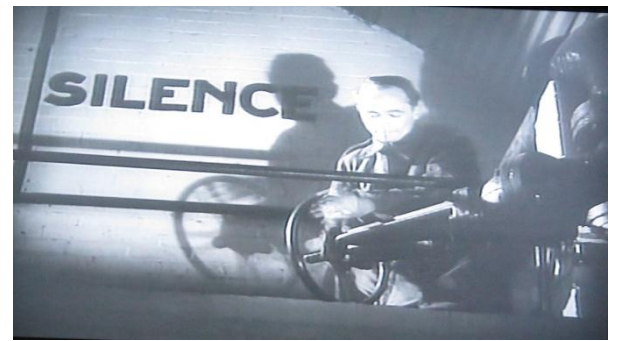
#### 4 Turning on the main Valve.

The pipes were about 18 inch diameter, and would bring in water from the Braithwaite Water Tower. The water was kept at a moderate temperature

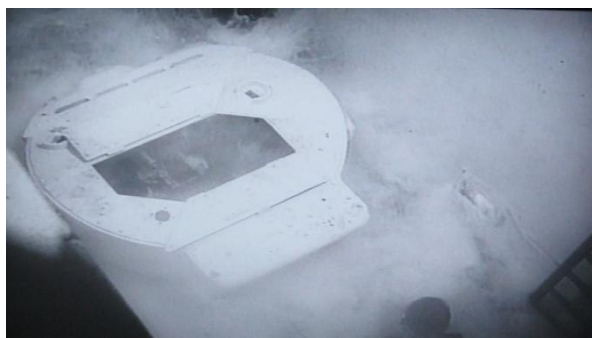
#### 5 Flooding the Chamber.

The filling of the chamber would take less than 3 minutes. During this time the men would put on their ATEA, and begin breathing into it

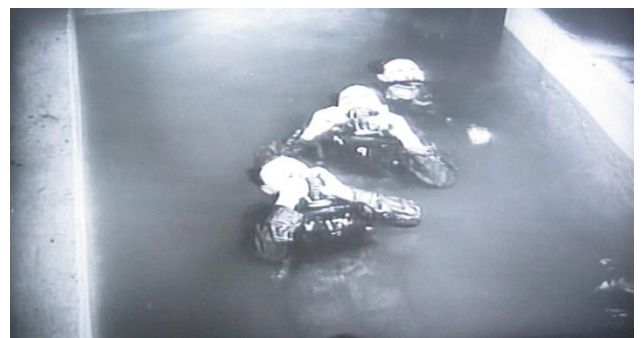
#### 6 Exiting to the surface.

Crews would exit in a strict order, according to rank. This would prevent congestion of crews through the restrictive escape hatches

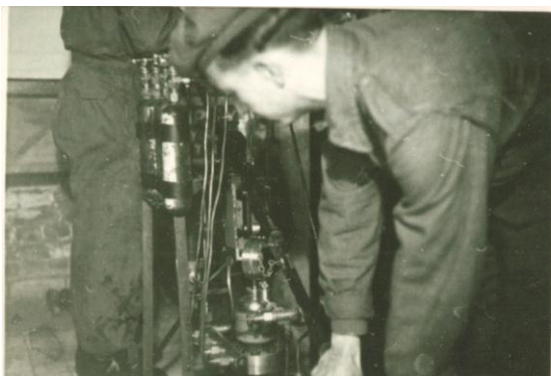
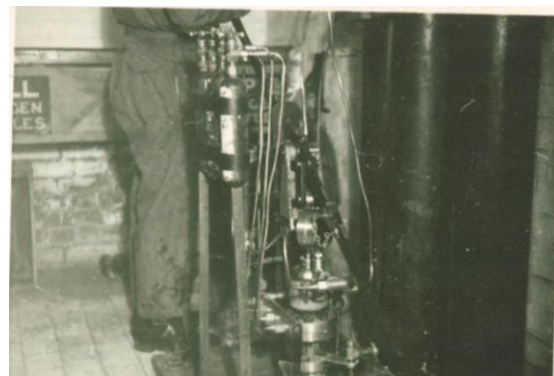
#### **Refilling of the Oxygen Cylinders in the ATW**

Empty Oxygen cylinders from the ATEA were refilled in the building. Each cylinder held enough Oxygen for 7 minutes. The obscured sign is likely to read "FULL OXYGEN VESSLES". [SEPA 11 & 1]  
It is assumed these 2 images are at the ATW, but may equally be the store near the Tank Park.

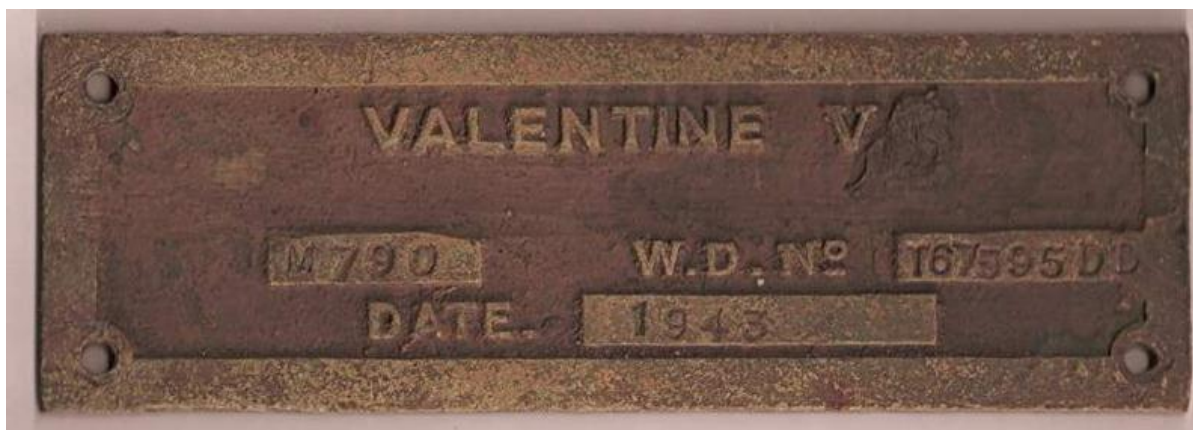
*A manufacturer's identification plate, originally fitted to one of the Fritton training tanks, was recovered from the undergrowth at the site. The following brief report details the known history of this individual tank, T67595*

T67595 was one of a batch of Valentine tanks ordered from Metropolitan Cammell on order number T2454. The War Department numbers allocated ran from T67221 to T67865, made up by:

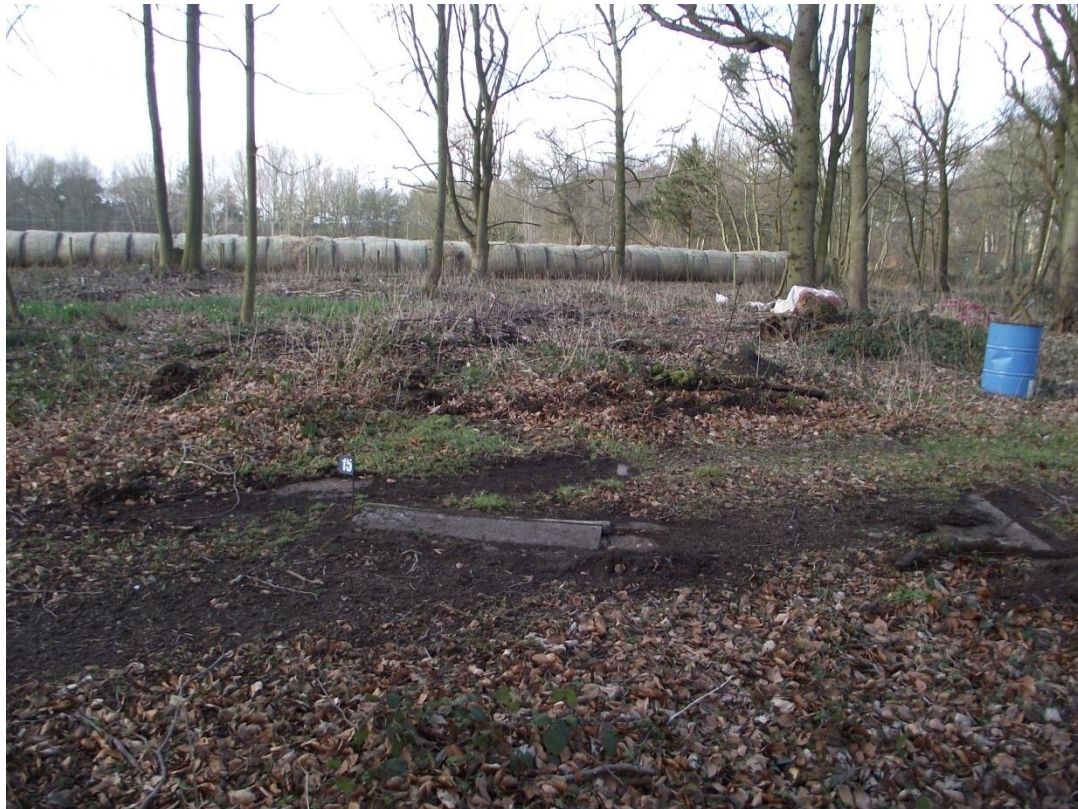
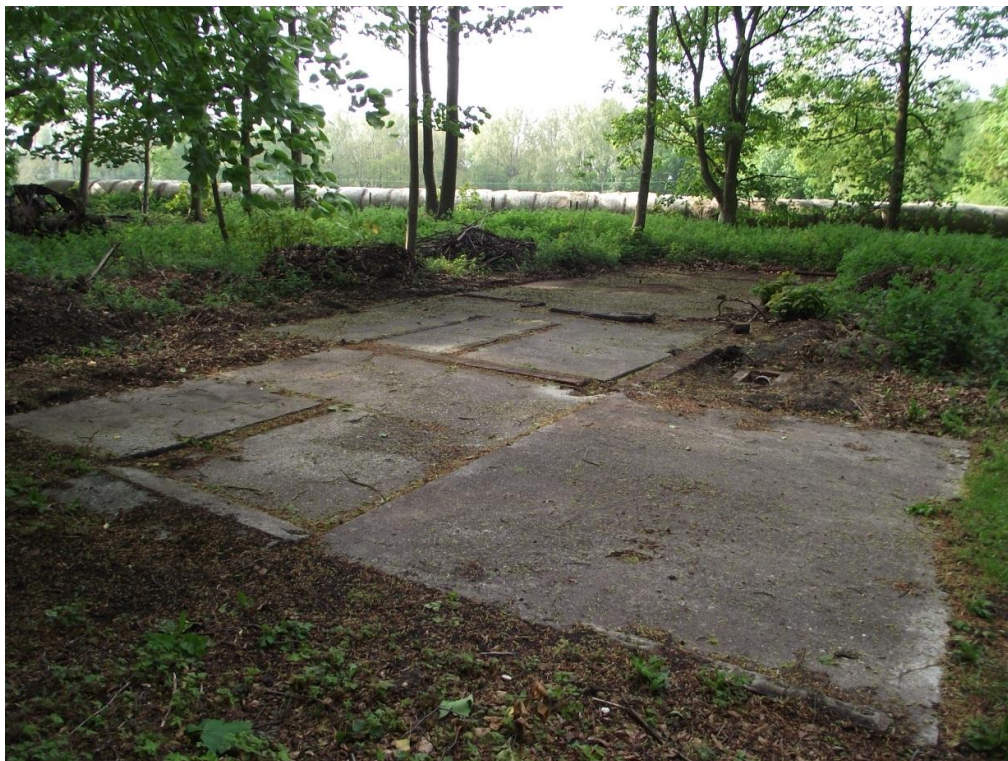
Fig 11 and 12. Views NE (March 2013) and N (May 2013) showing the site before and after clearing the overburden. The exterior walls were identified first, and care was taken uncovering internal areas, due to the irregular numbers of walls and other features.

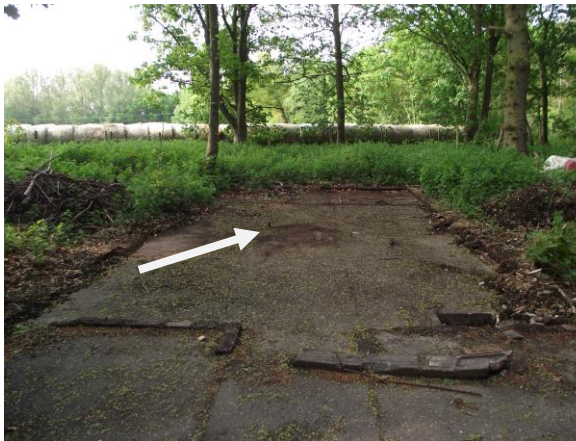
Fig 14 View of Northern section, showing section of vertical support, and internal wall lines. A small vertical pin was discovered (arrowed)

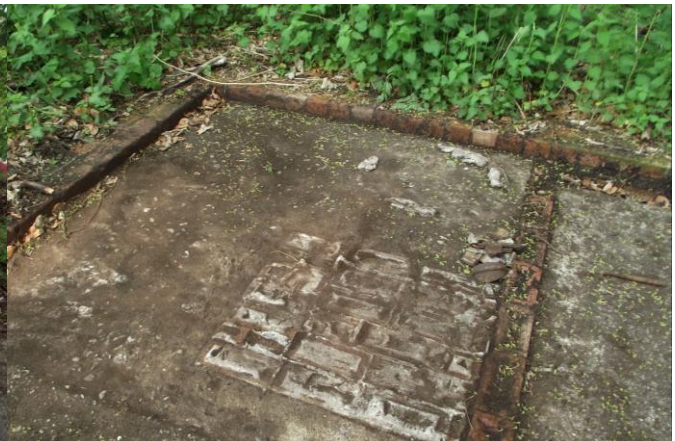
Fig 15 View of Foundations for Water tank (far side – circular) and 78cm square base for an additional structure.

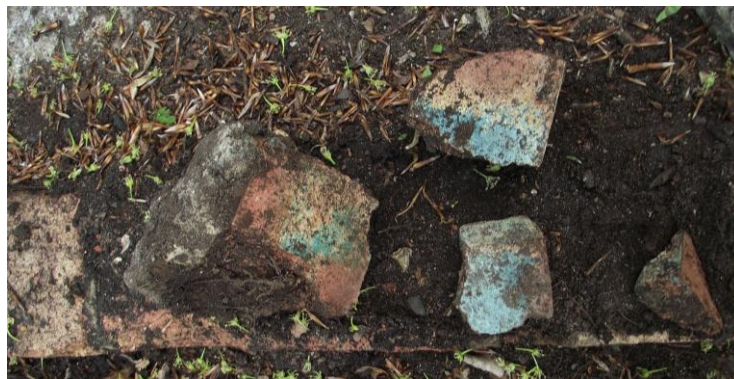
The rear (north side) wall was double width, and no entrance was seen. Limited excavation occurred in the northwest corner due to tree stumps and roots. Brick fragments found in association with the building contained traces of paint on one side, suggesting that some of the internal walls were turquoise in colour.

Fig 2: Fragments of turquoise coloured brickwork from the Areas C and D
