1 Bulmer Road, Sudbury
SUY 133

Archaeological Monitoring Report

SCCAS Report No. 2013/056

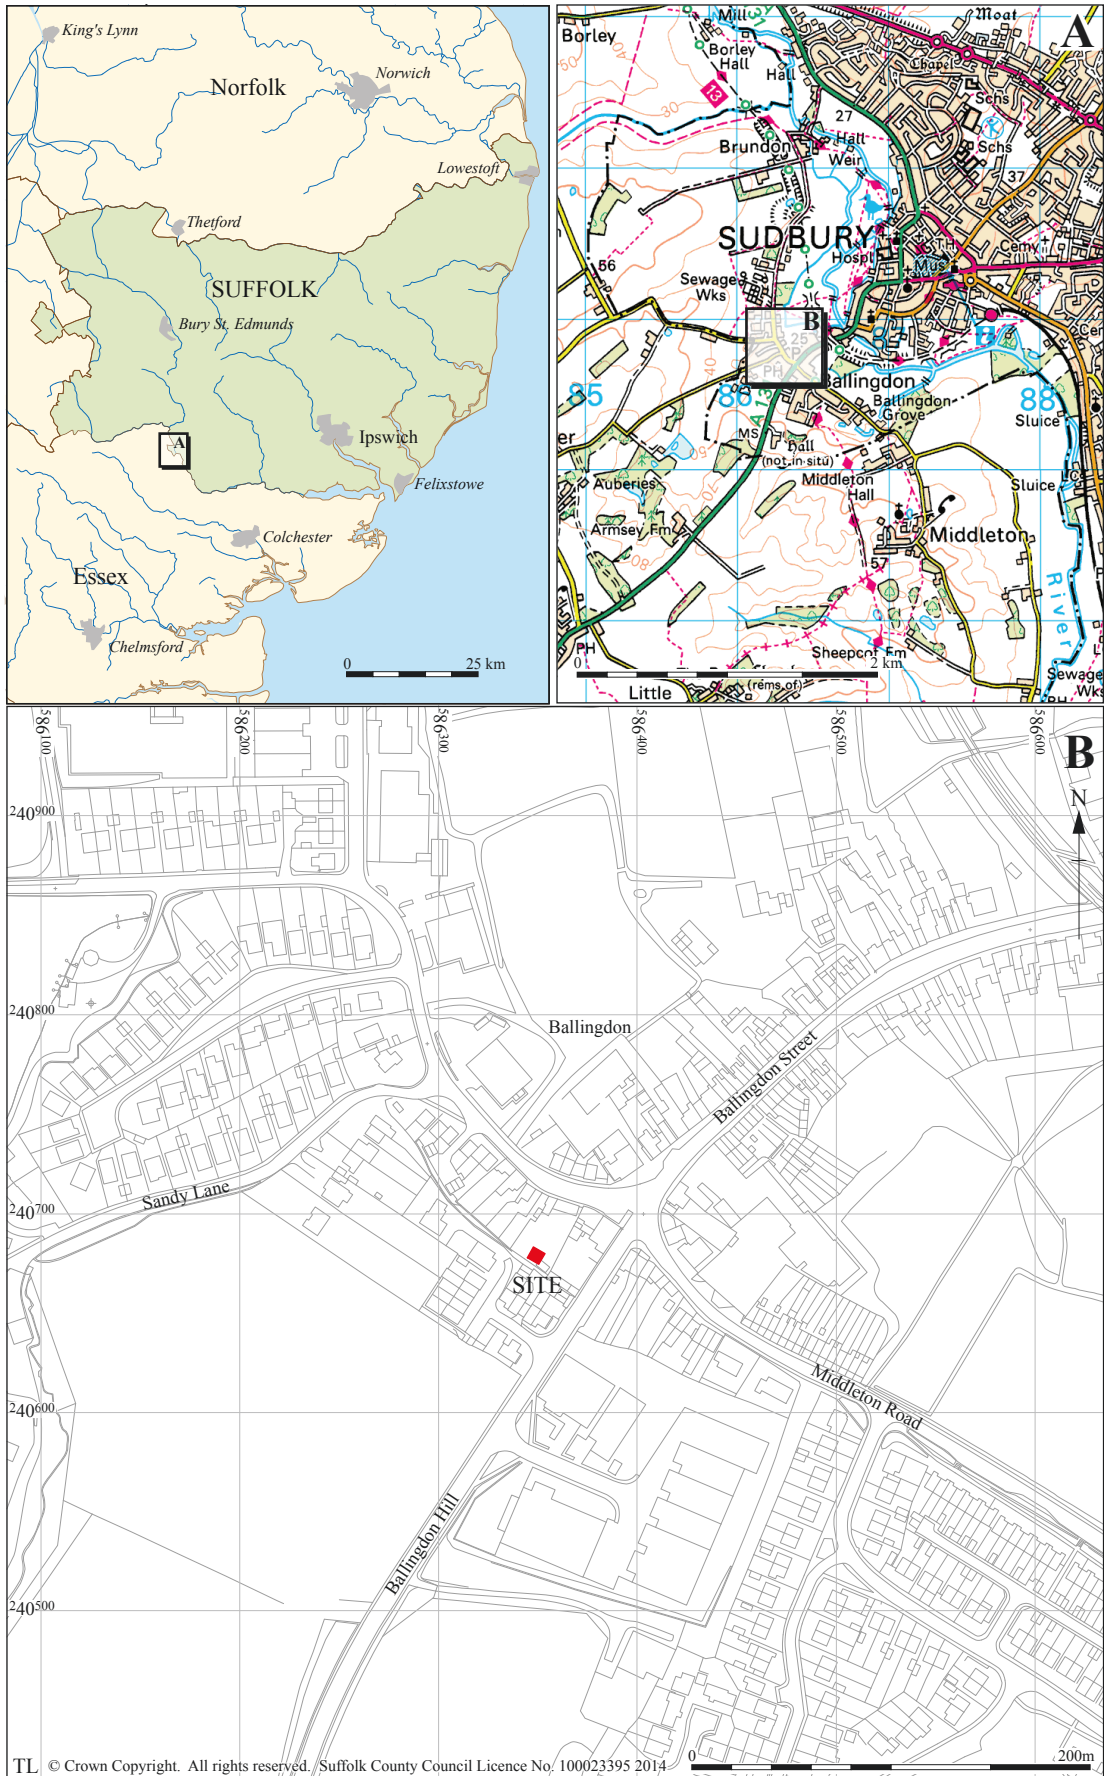
Figure 1. Location of site, showing development area (red)

Two visits were made to 1 Bulmer Road, Sudbury (Fig. 1) on the 23rd and 24th April 2013 to monitor the excavation of footings for a new two storey garage to be built in the rear garden of the property. The work was carried out in accordance with a Brief and Specification provided by Rachael Monk (Suffolk County Council Archaeological Service, Conservation Team - Appendix 1).

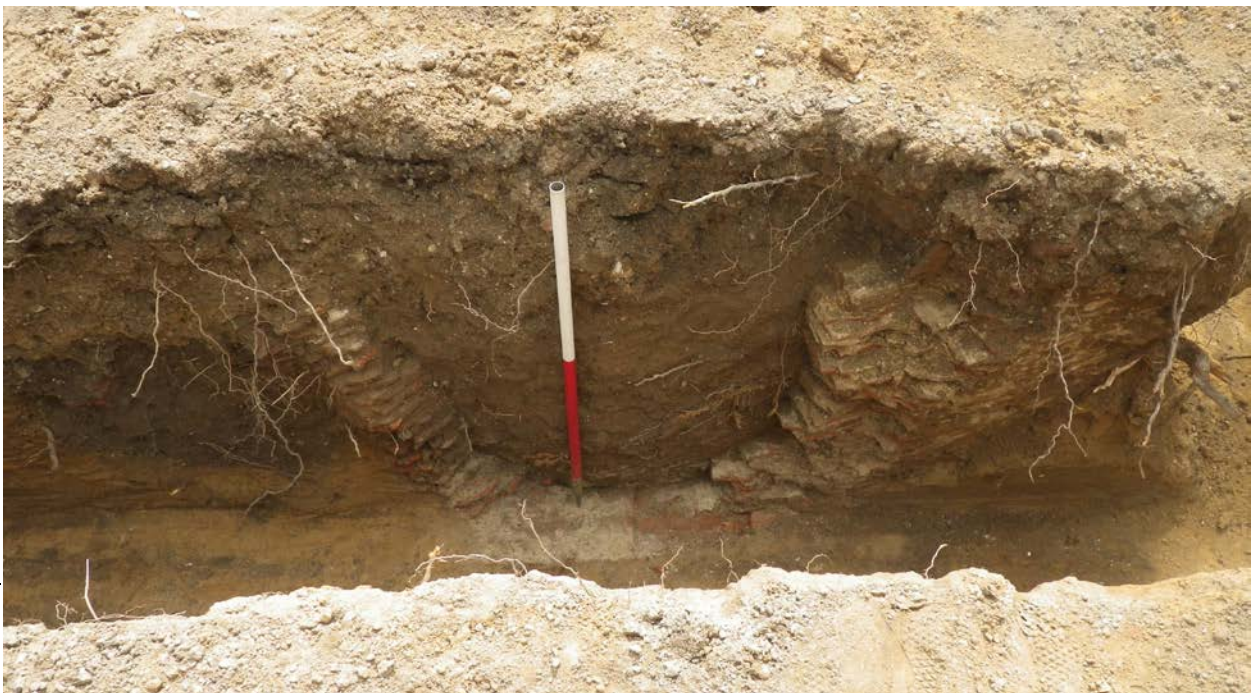
Plate 1. Section of well 0018 showing tile construction, 1m scale with section facing northwest

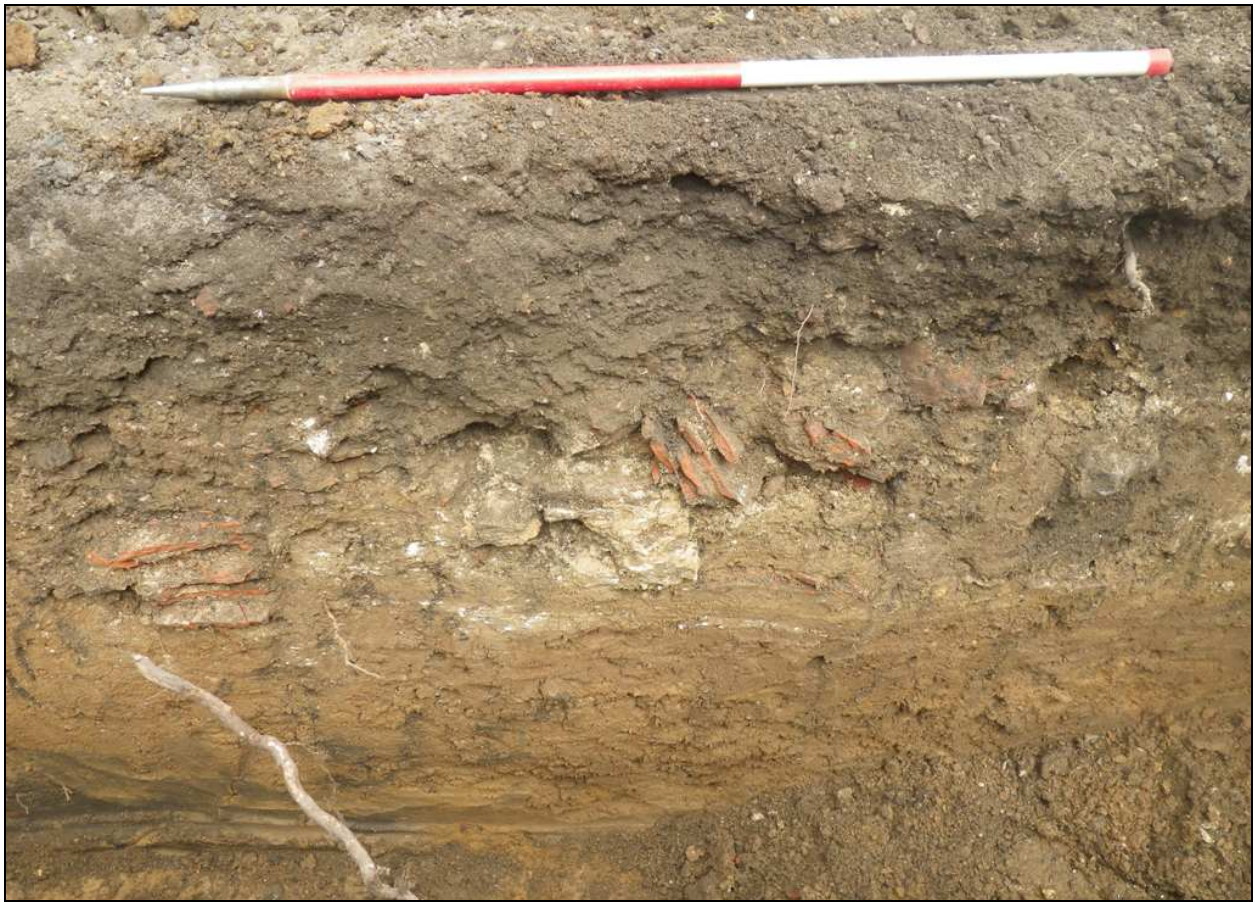
Plate 2. Section 4 showing tile foundation 00024 to the left and mortar foundation 0022. 1m scale with section facing southeast

Beneath layers 0001 and 0002 were two wall foundations 0024 and 0022. 0022 was constructed from bonded tile and was similar to foundation 0007 in section 1. It was 0.32m wide and 0.18m tall and was built on a flint and mixed pale yellow and cream sandy mortar foundation. The tile wall turned to be north-west south-east aligned approximately 0.3m into the trench. Here it was 0.2m in height and 0.45m wide and was faced with soft creamy coloured plaster on its north-west facing edge but was not built on the flint and mortar. Foundation 0024 was built of lime mortar with some limestone rubble. Layer 0023 on the south east side may have been related; it was composed of mid brownish grey firm chalky clay with occasional CBM flecks. This layer was cut by feature 0021, which was filled with dark greyish brown firm clayey silt 0021. These features all overlay a large pit 0026, which was at least 6m wide and was approximately 2m deep from the modern ground surface. It had a similar profile to pit 0012 with relatively steep concave sides and a generally concave base. Its fill, 0025, was also similar, mid brown silty sand with occasional CBM.
