**Suddon Hall,  
Kenton,  
Suffolk.  
KNN 020**

**Archaeological Evaluation Report**

**SCCAS Report No. 2012/201**

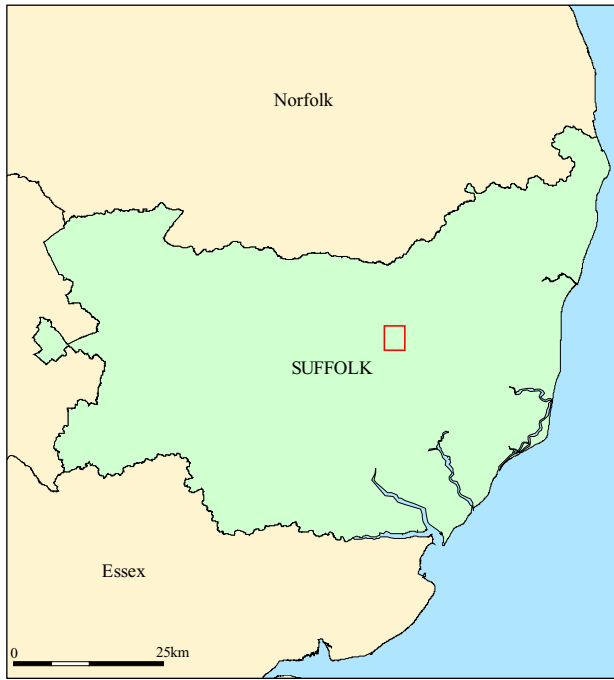
Figure 1. Site location showing Historic Environment Record entries

Planning permission for an extension to Suddon Hall, Kenton, required a programme of archaeological works as a condition of the consent. The site lies at TM 2010 6581 (Figure 1), at a height of approximately 54m OD, within a medieval moated manor complex (KNN 005) recorded in the County Historic Environment Record (HER). Suddon Hall itself is a grade II listed farmhouse located towards the north eastern corner of a roughly square moated platform, and described in the English Heritage Schedule as a timber framed building with a late 16th century core, considerably rebuilt in the late 17th or early 18th century. A scatter of medieval pottery and oyster shell was found near ponds to the north west of the site (KNN 014).

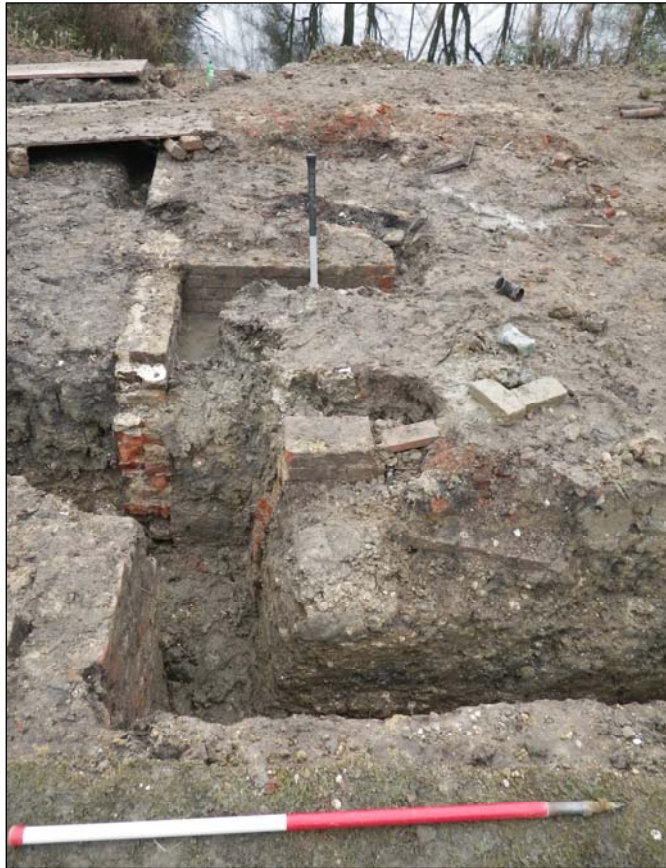
Plate 1. Brick footings exposed in the stripped footprint. Looking east.

Demolition of a former extension and removal of floors etc. to the rear of the hall had been carried out to create a new formation level, revealing remains of red brick footings exposed in the stripped surface (Plate 1). Footings measuring 0.5m wide and up to 2m deep were excavated from the new formation level.

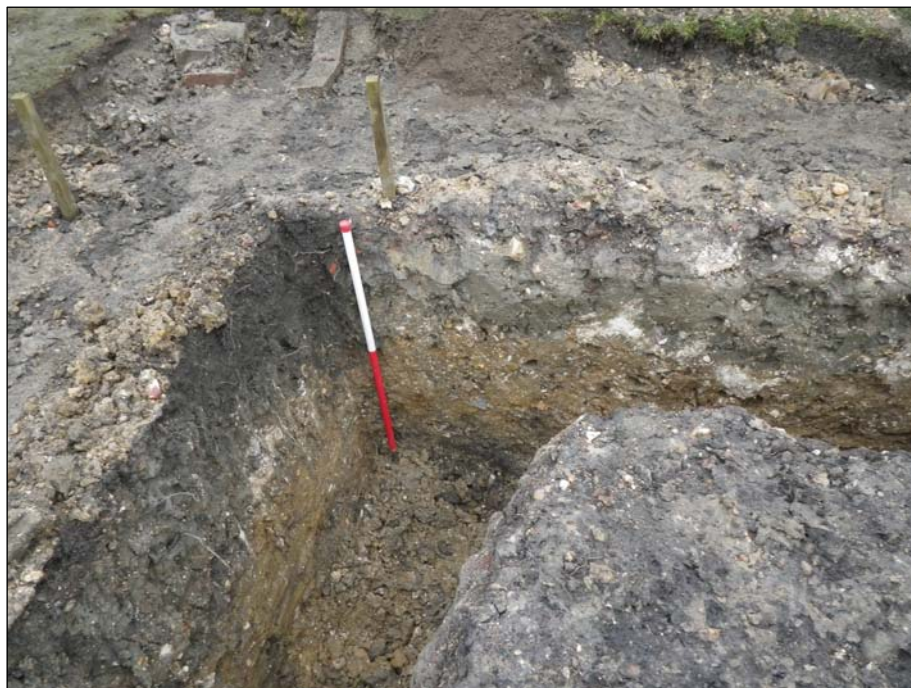
Plate 2. Soil profile in the northern extension footings

In the footings of the northern part of the extension, c.0.3m of dark brown clay loam topsoil had been stripped off a mixed dark grey brown layer of chalky clay subsoil some 0.4m thick and containing occasional tile, bone and CBM fragments. This layer sealed the pale yellowish brown chalky boulder clay natural subsoil (Plate 2). The footings in this area had been excavated to a depth of 1m.

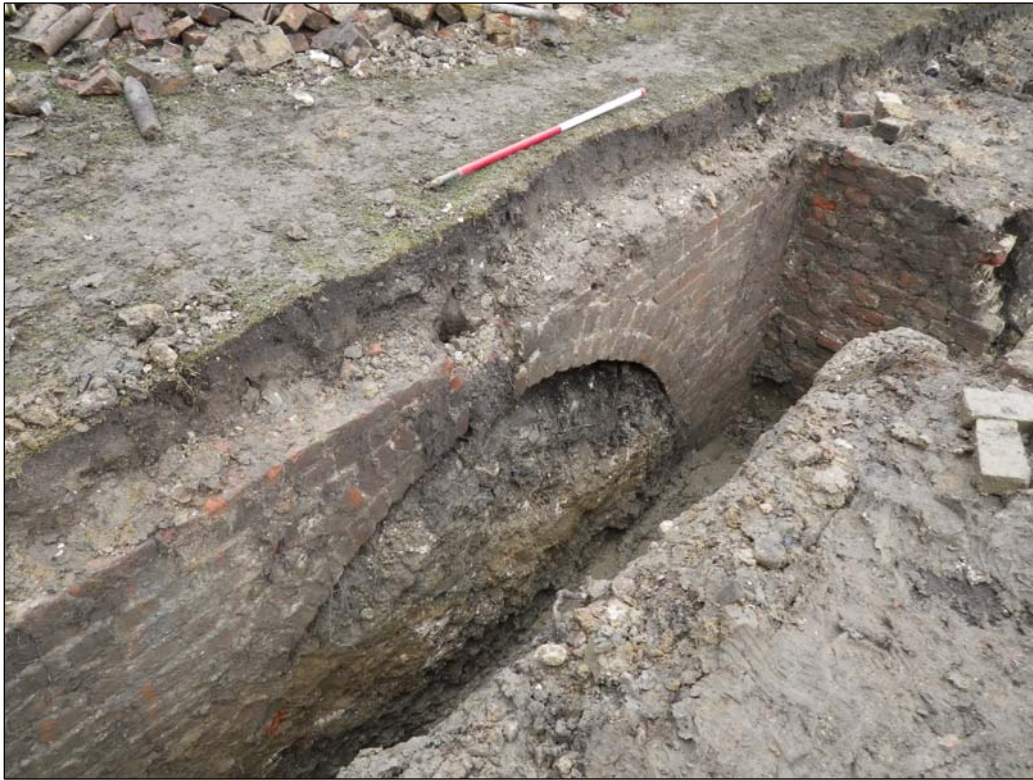
Plate 3. East facing brick wall with a rounded arch, with the 'rougher' finish to the eastern return visible in the top right of the photo.

The western footing trench exposed a red brick structure all along its western section. This consisted of a well finished wall extending the full depth of the trench (up to 2m at its deepest point) with a rounded arch towards the north (Plates 3 & 4). The eastern return of the structure consisted of the same brick but had a rough finish, suggesting it was not intended to be seen, unlike the wall and arch. The fill inside the arch comprised a loose, dark grey loamy clay at the top, c.0.5m thick, sealing a layer of pale yellowish brown

The wall and arch noted in the west footing seem likely to have originally formed part of a bridge spanning a northern arm of the moat. The bricks used suggest a late medieval or more likely early post-medieval date. When this part of the moat was backfilled is unclear, but the extension built over the line of the moat was in place by the 1880's, as shown on the 1880's-1920's Ordnance Survey maps (Figure 3), and may have reused some of the earlier brick structures noted during the monitoring in its construction.

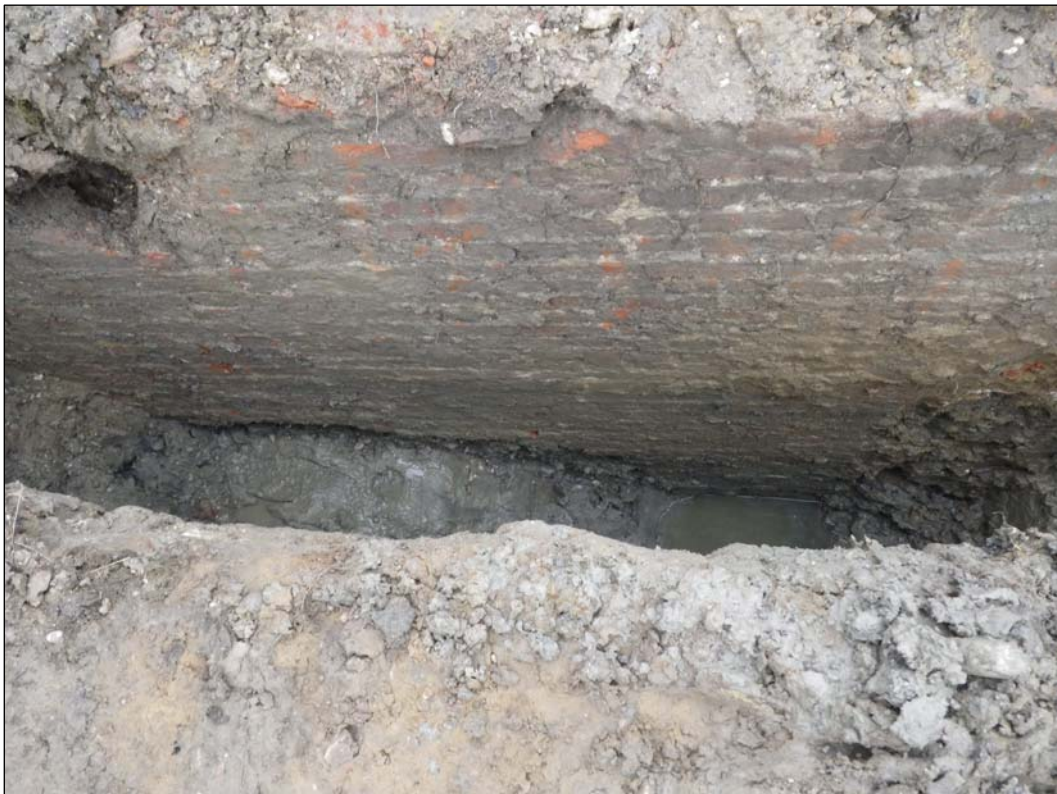
Plate 4. Full depth of the brick wall, immediately south of the arch, showing waterlogged clay through the base.

natural chalky boulder clay (c.0.5m thick) which in turn sealed a dark bluish grey clay, also present through the base of the trench and waterlogged. It appeared to be a natural clay layer, and the point at which the water table was hit.

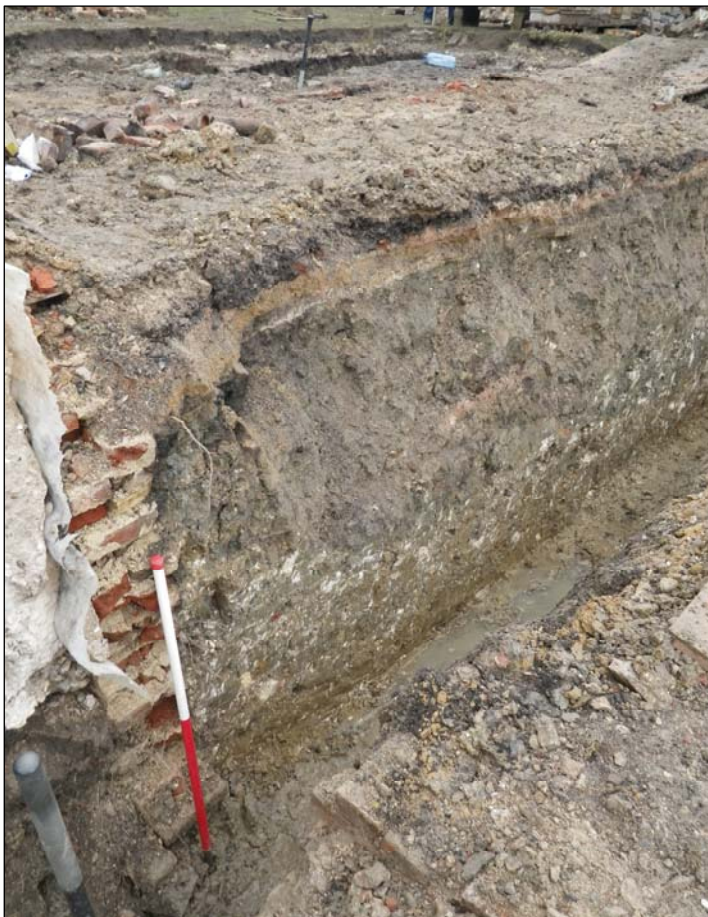
Plate 5. Likely backfilled moat in the eastern footing, sealed by former floor surfaces. Looking north west.

The eastern arm of Suddon Hall's moat survives, widening out to the west at its northern end. The soil profile in the adjacent footing were not immediately suggestive of a backfilled moat but a wide, albeit quite shallow feature with gently sloping sides and a flattish base. It is thought likely that this represents the northern return of the moat (Plate 5). Its fill was a loose, fairly homogenous greyish brown silty clay, similar to the fill immediately below the arch in the opposite footing.

The soil profile in the eastern footing may not have been identified as a backfilled moat had the potential bridge not been exposed, despite its location on the line of the presumed northern arm. The cut was relatively shallow and noticeably higher than the adjacent pond. In addition, the fill was pale, loose and relatively dry, without any of the dark, wet, humic fills normally characteristic of redundant moats. This may indicate that the northern arm of the moat was a dry ditch, or that it was well cleaned of silts soon before it was quickly and deliberately backfilled.
