**Coach House & Stables,  
Beyton House,  
Beyton, Suffolk  
BEY 016**

**Heritage Asset Assessment**

**May 2013**

## **Heritage Asset Assessment**

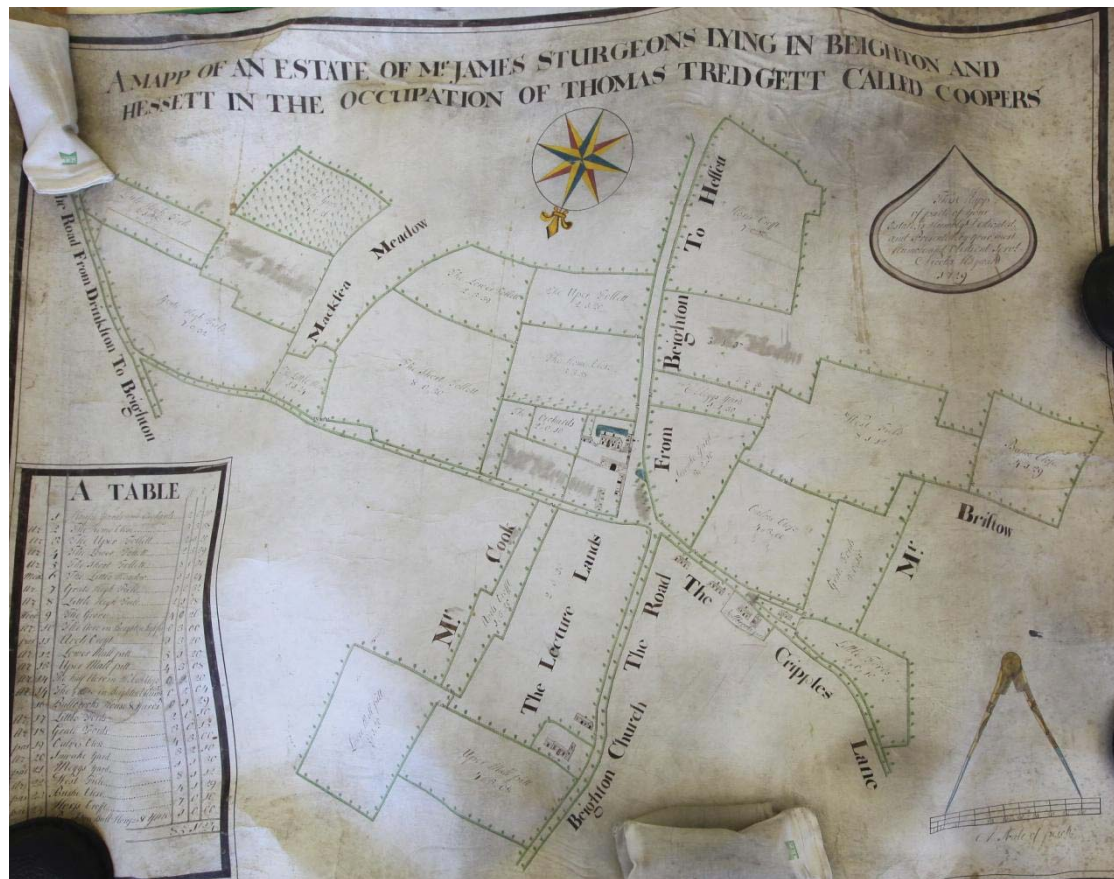
**Figure 2. The manuscript plan of the 85-acre estate in 1729 when it belonged to Mr James Sturgeon and was called ‘Coopers’. (Suffolk Record Office 85/1/24). The arrow indicates the direction of north towards the bottom of the map; the site of Beyton House lies at the road junction in the centre with the parish church beneath.**

A pictorial manuscript map of the estate drawn in 1729 is preserved in the Suffolk Record Office (figure 2). The property was then known as Coopers and belonged to Mr James Sturgeon but was occupied by Thomas Tredgett. The land extended to a modest 85 acres (less than the 100-acre threshold for Yeoman status) but is said to represent only part of Sturgeon's total estate, and the principal house is depicted as a substantial two-storied dwelling with two chimney stacks. This house faced north towards Beyton church (unlike the present house which faces a park to the south), and lay to the north of a large L-shaped pond. The yard in front of the building was enclosed by a wall and hedge with a large barn to the north and another dwelling on the site of Beyton Lodge. The latter is shown as a smaller, single-storied structure with a single chimney and is more typical of the other farmhouses on the map. A single-storied building without a chimney lay on the approximate site of the present stable and coach house and may well have formed an earlier stable range.

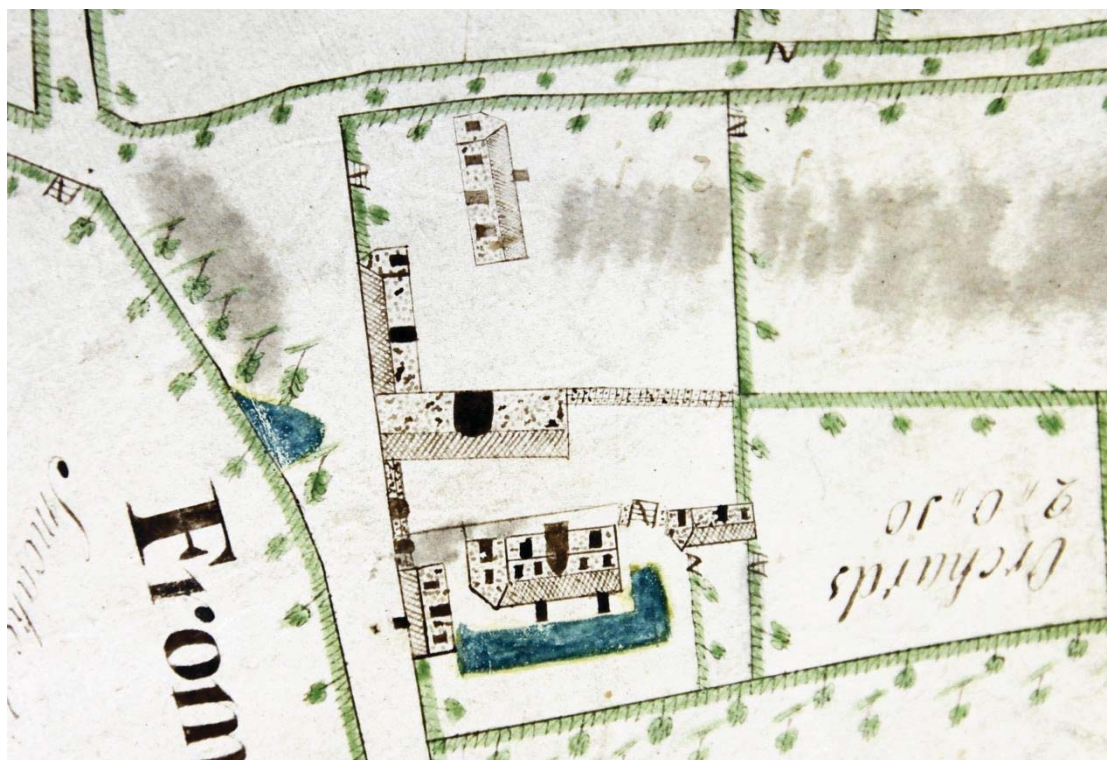
**Figure 2a.** A detail of the 1729 estate plan, re-oriented to show north at the top. A substantial two-storied dwelling house with twin chimneys faces north towards an enclosed yard containing a large barn with a linear pond to the rear. A smaller single-storied domestic house with a single chimney occupies the site of Beyton Lodge to the north, and a small building without a chimney that may well represent a stable lies in the approximate position of the existing coach house and stables to the east.

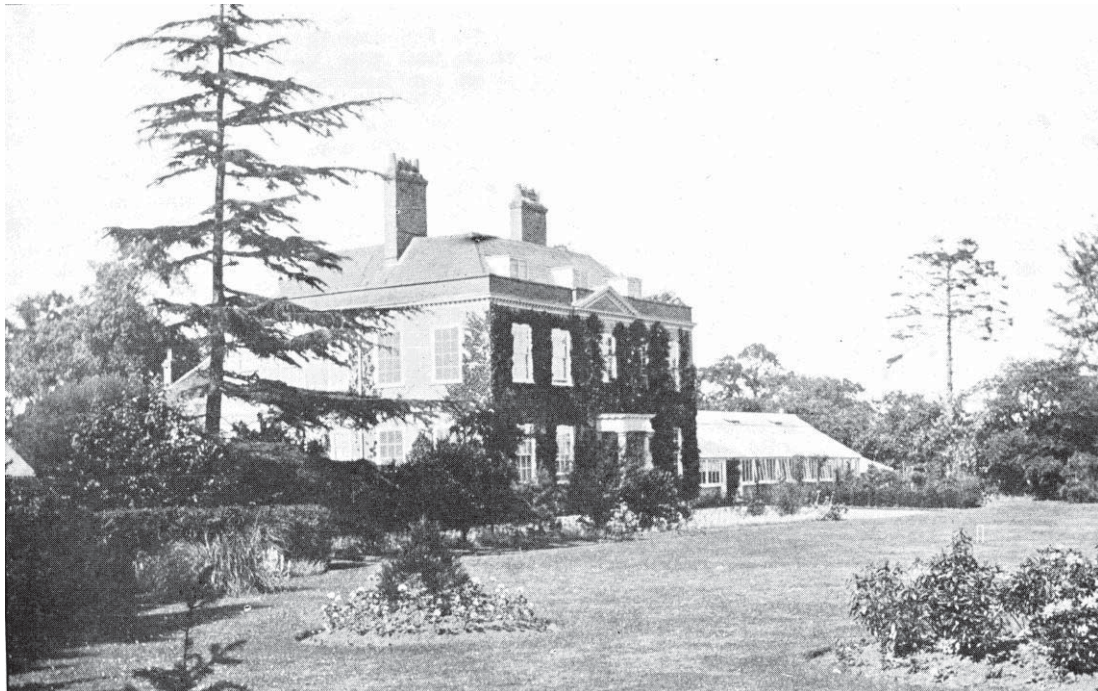
Figure 7

Beyton House from the south-west before its destruction by fire in the 1930s, as published in 'West Suffolk Illustrated' in 1907. This late-Georgian country house was probably built at the beginning of the 19<sup>th</sup> century at much the same period as the surviving Beyton Lodge.

**Figure 3. The Beyton tithe map of 1838 (Suffolk Record Office). The rectangular pond is still recognisable, although its eastern arm had been filled since 1729, but the old house had been demolished and replaced by a walled garden (now a lawn). The new ‘mansion’ shown in figure 7 had been built further to the east. The L-shaped range of outbuildings between the two appears too far north to represent the present coach house and stables.**

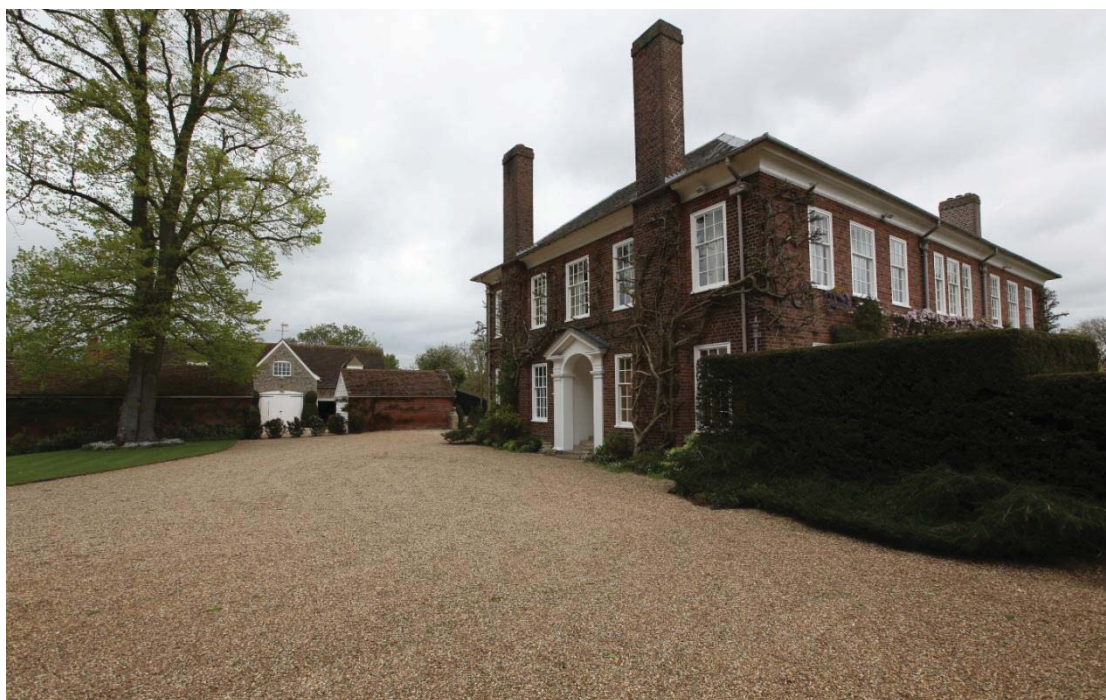
**Illus. 1. A general view of the site from the south showing Beyton House as rebuilt in 1936 after its predecessor was destroyed by fire with the coach house and stables to the left.**

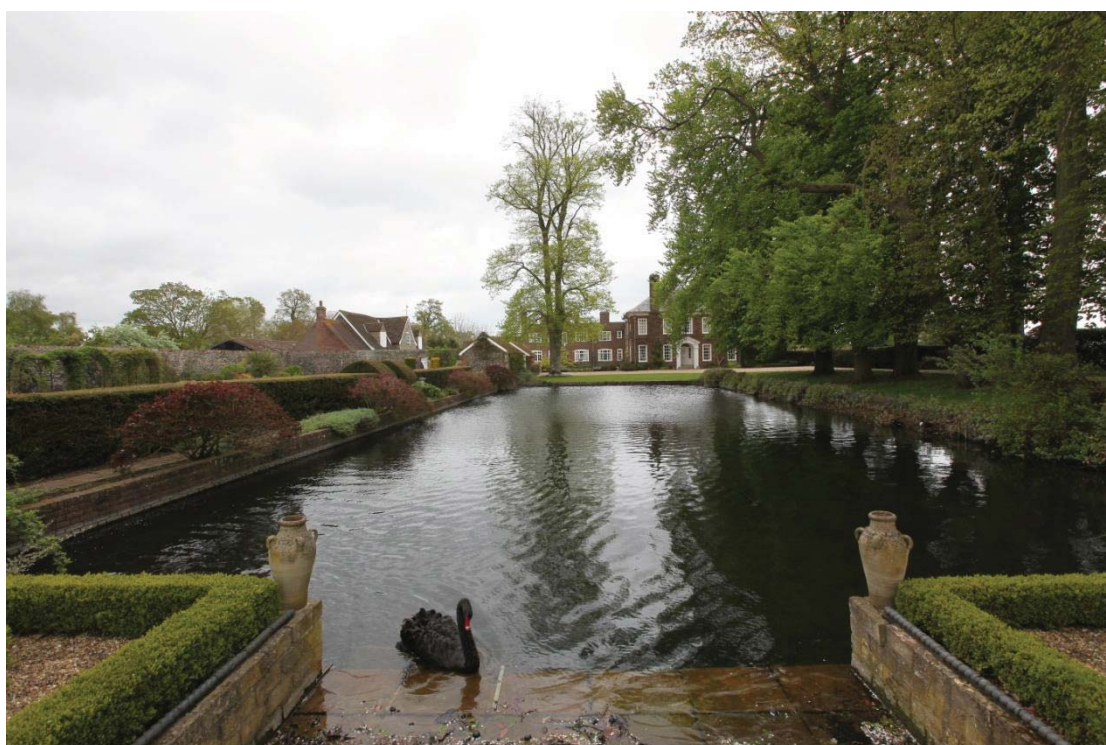
**Illus. 2. The linear pond from the west showing Beyton House in the rear with its coach house and stables to the left. This pond is depicted on the estate map of 1729 which shows the principal house on the site now occupied by the hedge and lawn to the extreme left. The pond is likely to represent either a part of a moat or a garden 'canal' of the late-16<sup>th</sup> or 17<sup>th</sup> century.**

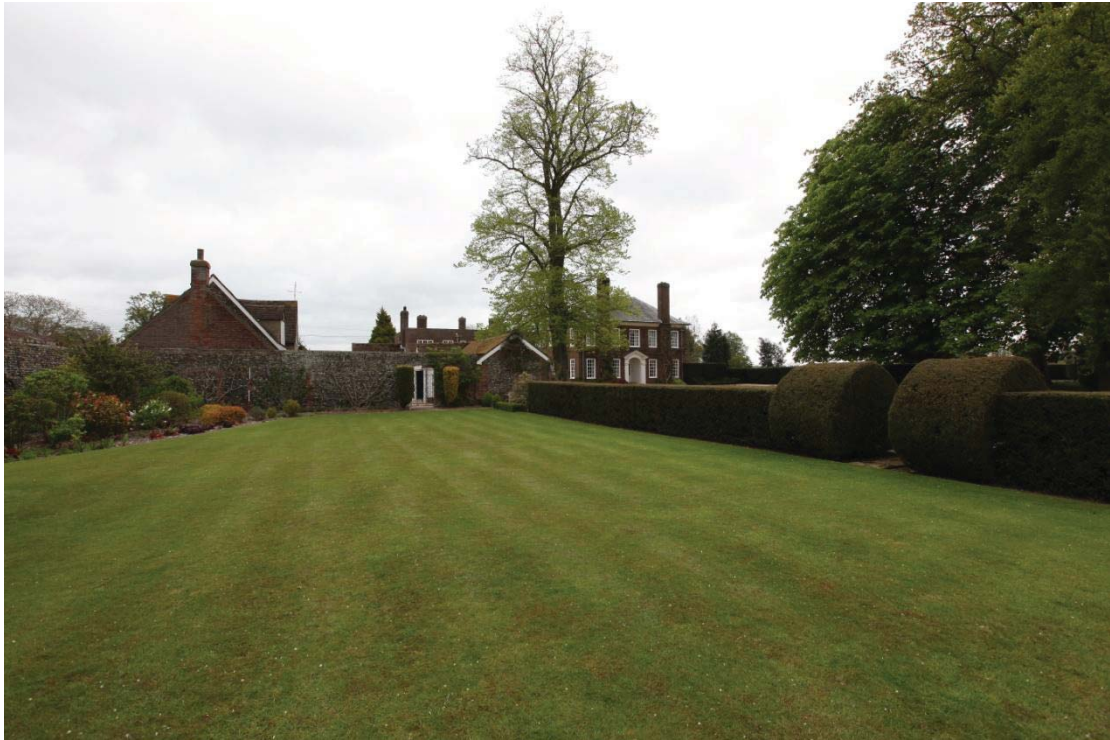
**Illus. 3. The lawn on the site of the house depicted in 1729 showing its close proximity to the coach house and stables on the left. The brick gable of the tack room extension incorporates an earlier flint-rubble garden wall with a blocked door.**

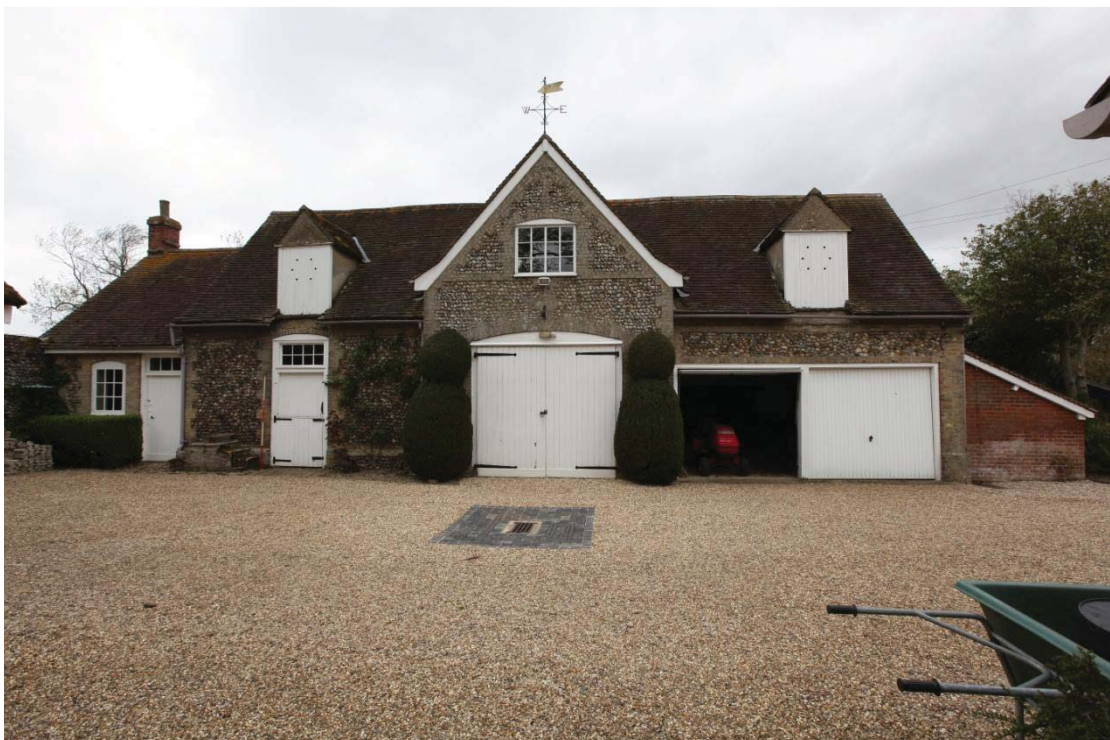
**Illus. 4. The southern facade of the coach house and stables showing the lower roof of the tack room extension to the left and the lean-to brick log store on the right. The original building was symmetrical with two stables and lofts flanking the central gable of the coach house. The eastern stable on the right was converted into a garage during the 20<sup>th</sup> century but evidence of its original central door can still be seen.**

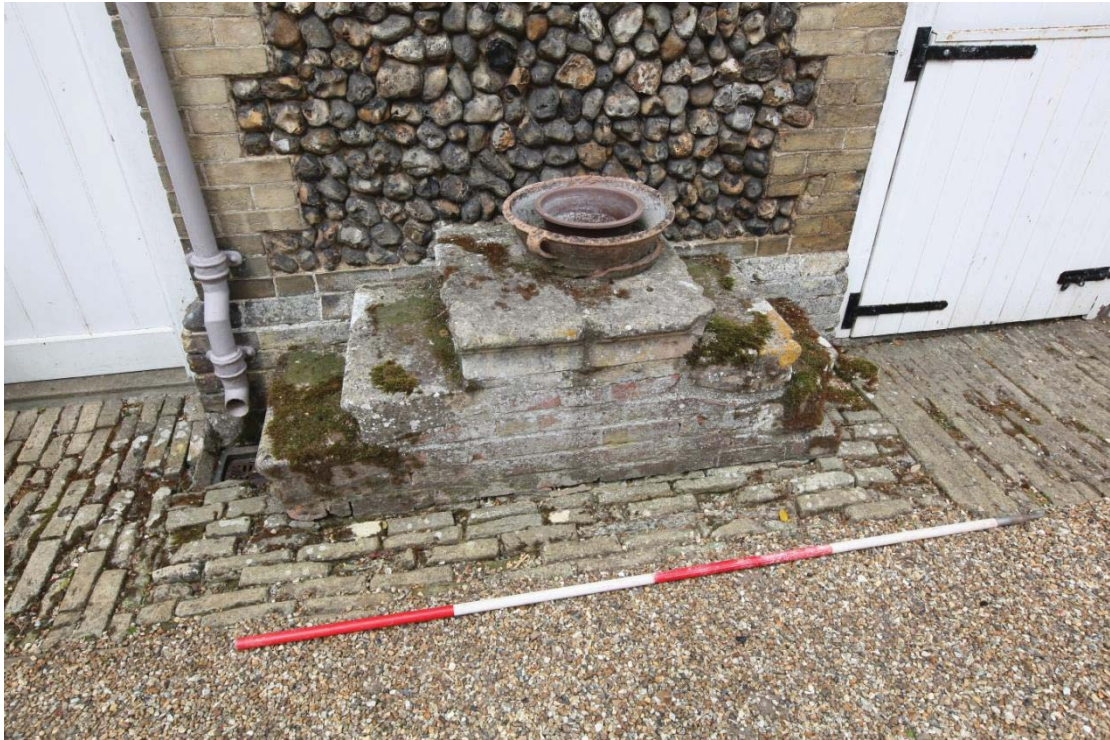
**Illus. 5. The brick mounting block with moulded stone steps to the left of the entrance to the western stable. The gault-brick dressing behind the drain pipe marks the south-western corner of the original building.**

The original building contained identical stables flanking the coach house. The facade of the western stable remains unaltered with a central door and a rare mounting block of brick with moulded stone steps (illus. 5), and the double doors of the coach house also occupy their original positions. The facade of the eastern stable was destroyed in the 20<sup>th</sup> century when it was converted into a garage with overhead doors of pressed steel, but an area of new brickwork beneath the eaves disguises the position of its former central door. A pair of loose boxes with corner troughs and well-made doors and partitions of chamfered and pegged timber with iron bars survives to the west, but only the troughs and wainscot boarding of identical boxes remain to the east. The gault-brick floor of the southern passage also survives in the eastern stable but has been replaced by concrete to the west, with later tiled floors to the boxes. These loose boxes probably pre-date the turn of the 20<sup>th</sup> century but are not original to the building as the internal plaster of both rear walls preserves the scars of two earlier vertical partitions that formed three stalls in each stable. The replacement of traditional narrow stalls with more spacious loose boxes was a normal development during the 19<sup>th</sup> century. A series of wooden harness hooks attached to the southern interior of the western stable is probably contemporary with the new boxes but may be original. A number of original floor drains pierce the rear walls and the exposed eastern gable.

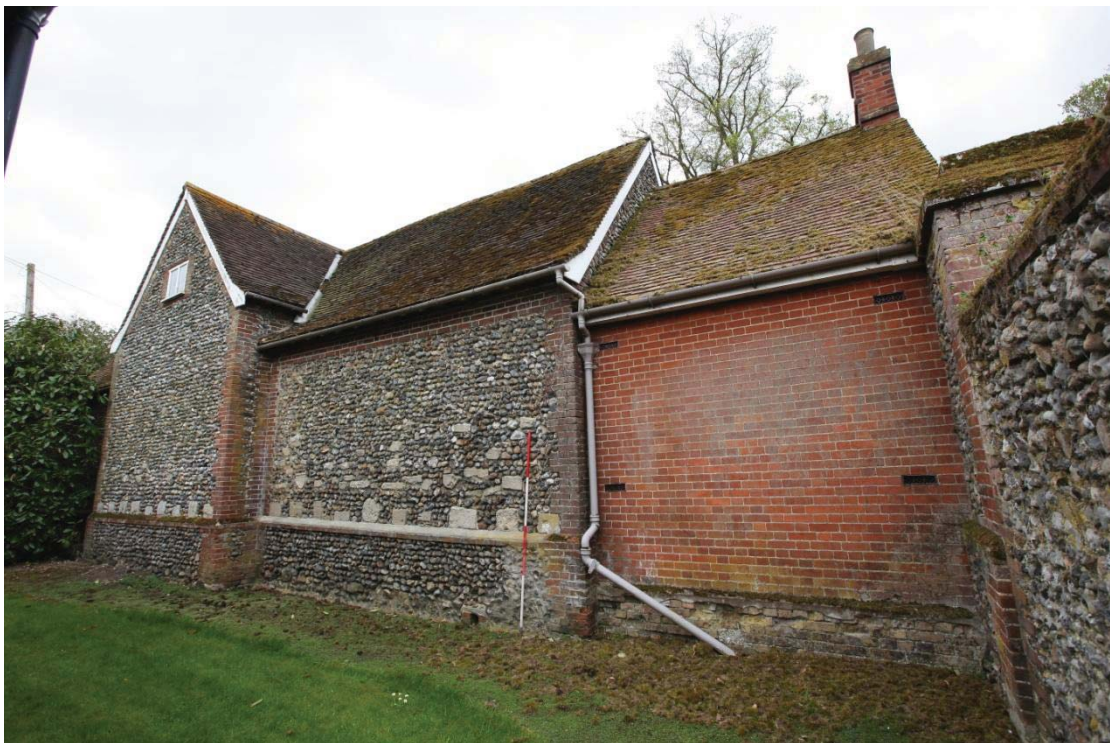
**Illus. 6. The rear elevation of the building from the north-west, showing the later brick tack room on the right. The flint-rubble walls of the original structure are dressed in red brick to the rear (as opposed to gault brick to the south) and contain re-used blocks of dressed medieval stone that may have been salvaged when the parish church was rebuilt in 1854.**

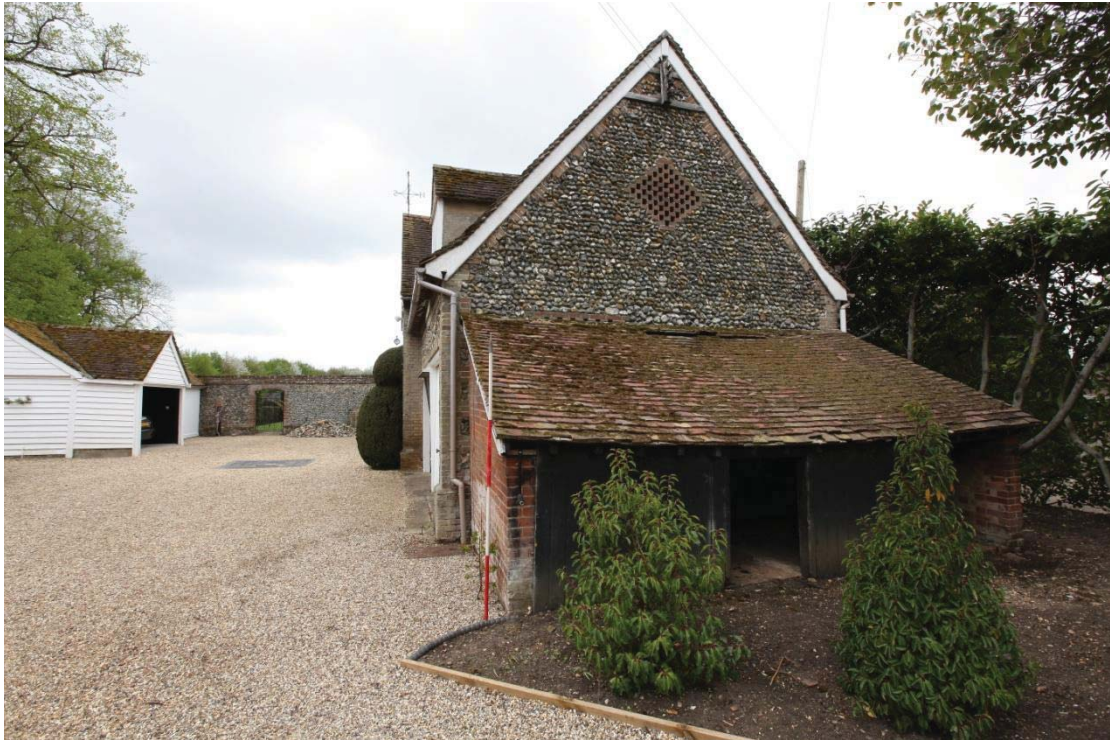
**Illus. 7.** The eastern external gable with a diamond-shaped pattern of ventilation bricks to the loft and a rectangular pattern to the former eastern stable (the latter just visible above the roof of the later lean-to log store which bears the incised date 1901).

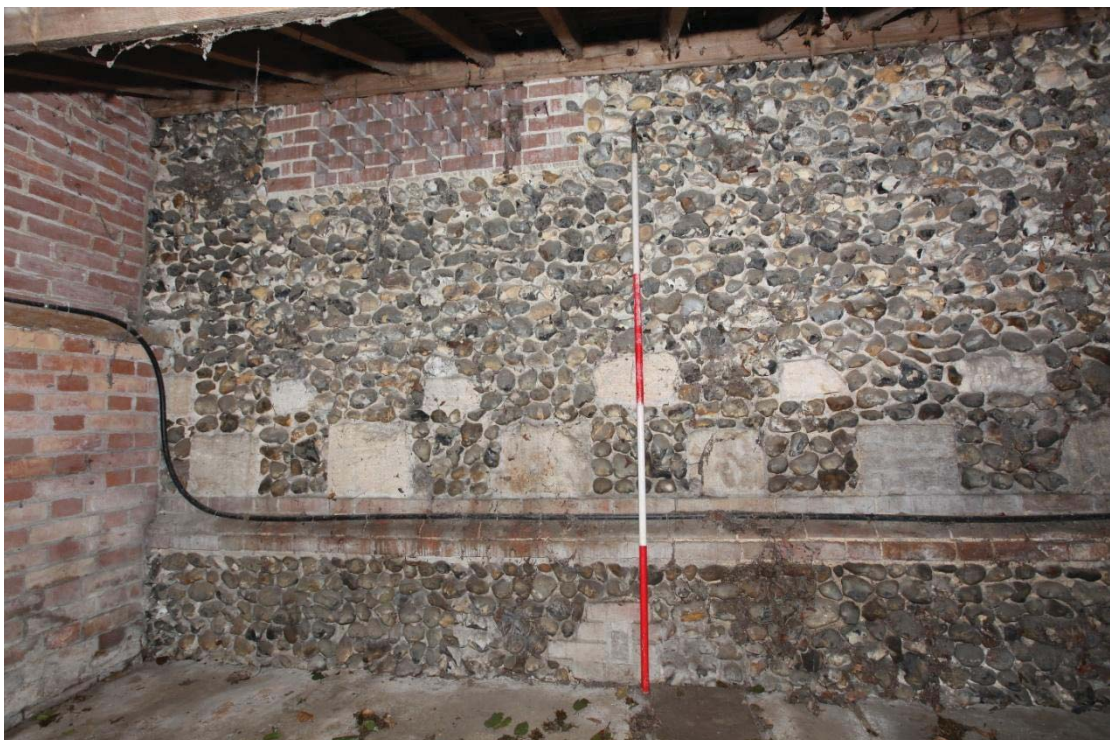
**Illus. 8.** The lower part of the eastern external gable seen from the later log store. The rectangular-shaped pattern of ventilation bricks is visible top right, with a blocked drain serving the former eastern stable below. The irregular chequer-board pattern above the plinth consists of large re-used blocks of masonry that may have been salvaged from the parish church in 1854 and suggest a possible date for the building.

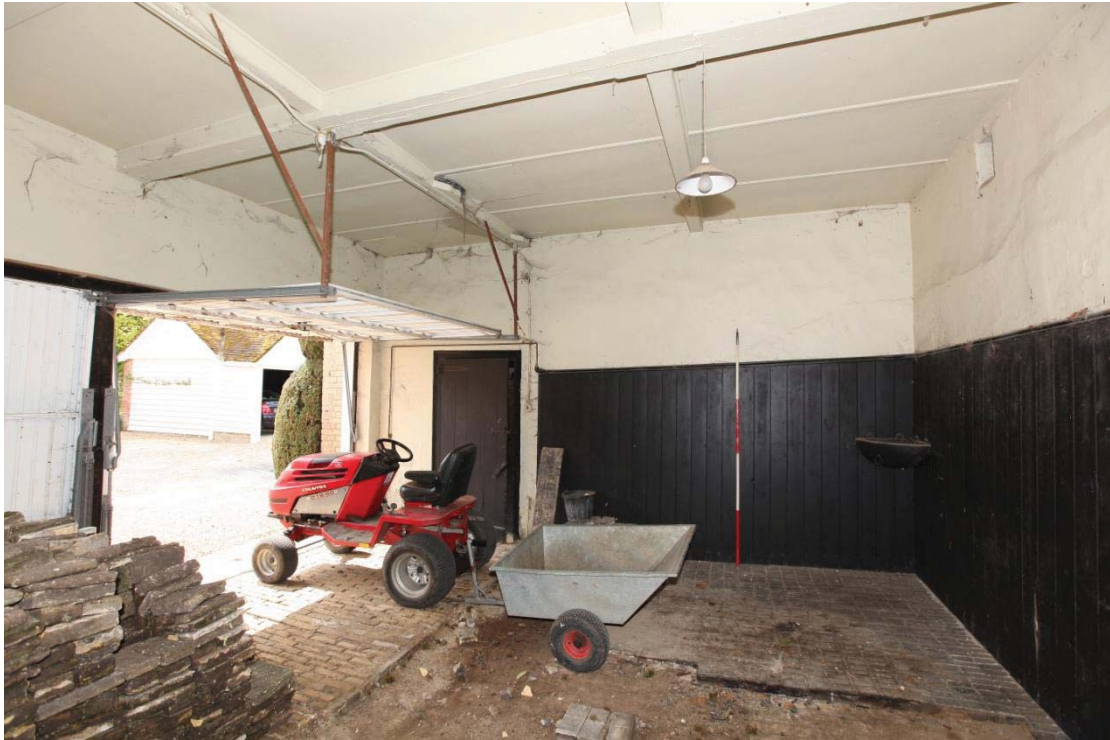
**Illus. 9. The interior of the garage from the east showing the remaining wainscot boarding and corner manger of two loose boxes matching those of the western stable, with the floor bricks of its southern passage to the left. The scars of two earlier stall partitions can be seen in the plaster of the rear wall to the right.**

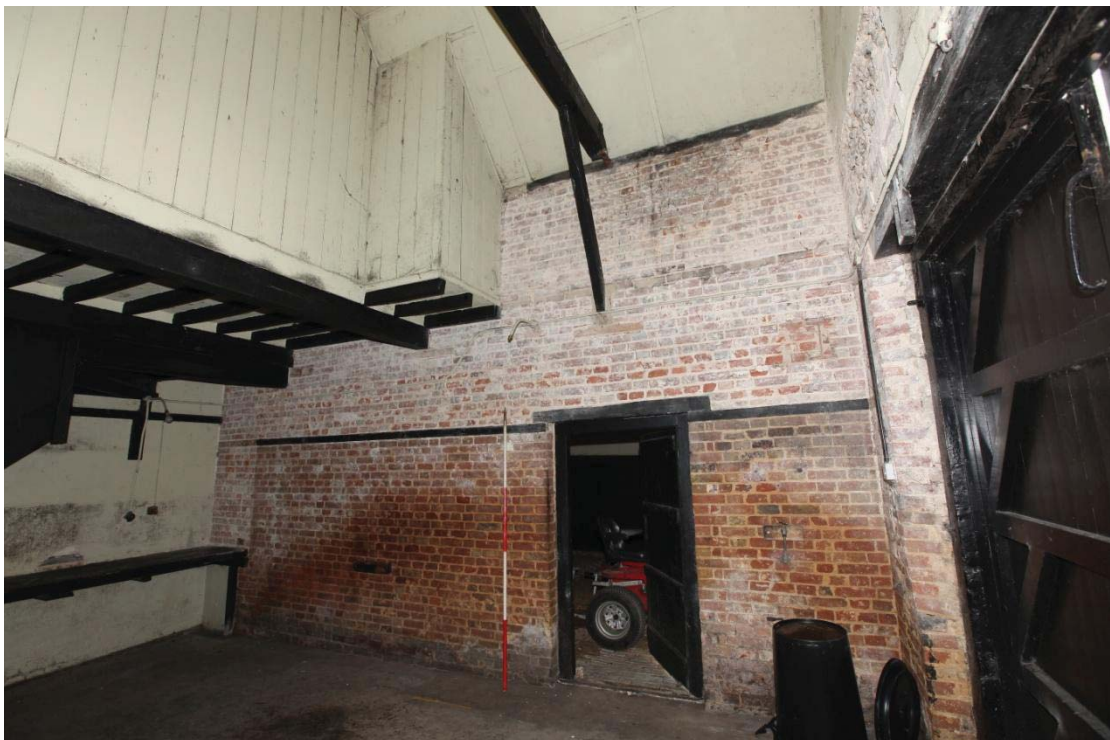
**Illus. 10. The interior of the central coach house from the west showing the door to the garage and the remains of the ceiling. This ceiling originally continued to the southern gable on the right but was later removed to increase headroom. The scar and wooden support of the missing principal joist is visible above the door and beneath the later brace to the tie-beam.**

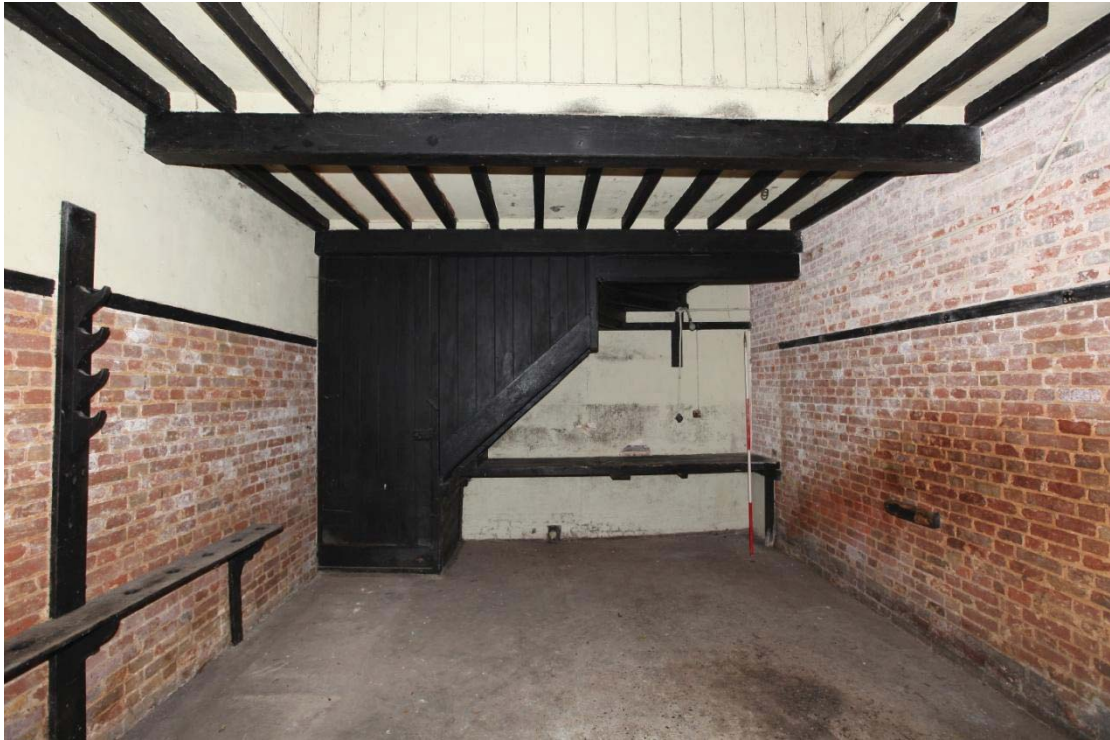
**Illus. 11. The loft stair against the rear (northern) wall of the central coach house with its tack hooks and holes to the left. The projections of the ceiling at top-right and top-left provided access to the secondary doors between the attic over the coach house and the lofts of the two stables.**

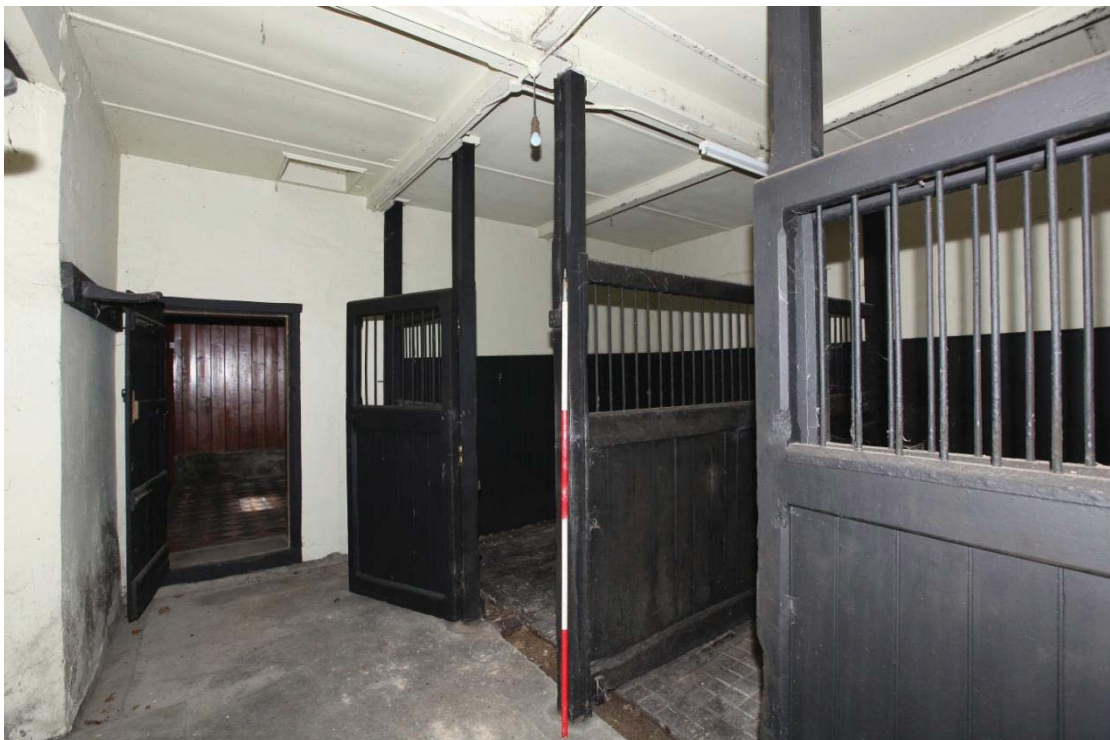
**Illus. 12. The western stable seen from the east showing the well-made doors and partitions of its two loose boxes, all with neatly chamfered timber and pegged joints. The boxes probably date from the end of the 19<sup>th</sup> century and are impressive survivals, but replaced three earlier stalls as indicated by the scars of their partitions on the back wall. The door on the left open into the tack room extension.**

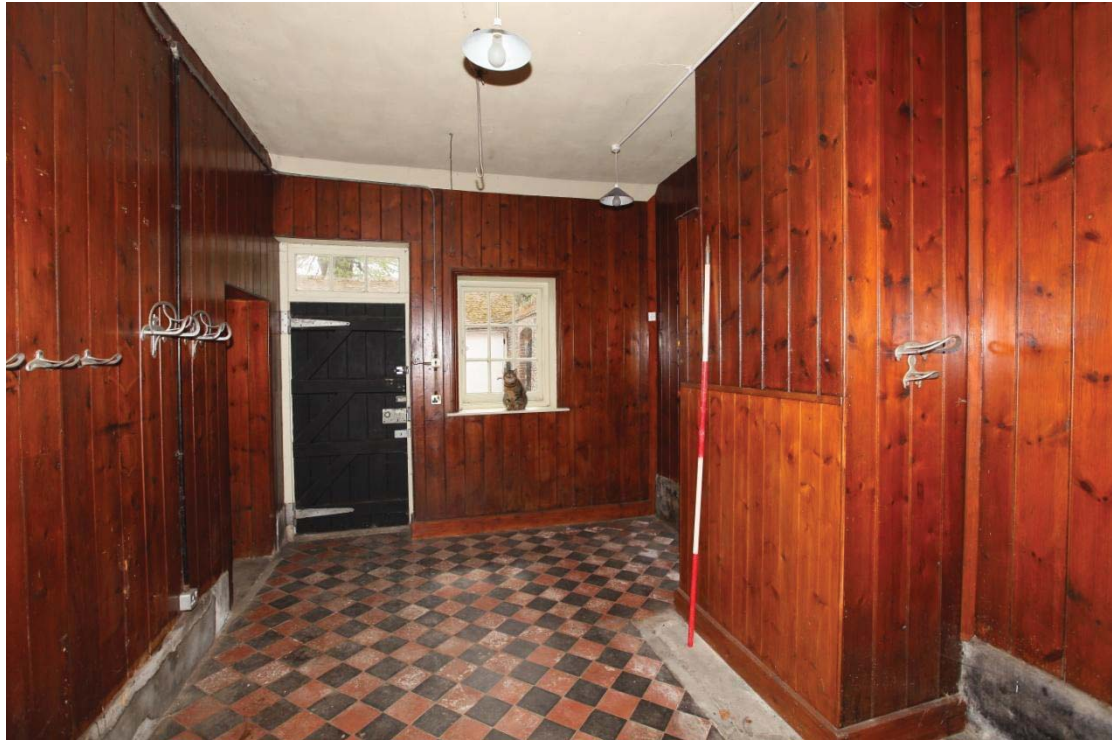
**Illus. 13.** The interior of the tack room extension from the north showing its boarded walls with modern tack hooks and a blocked gable fireplace to the right.

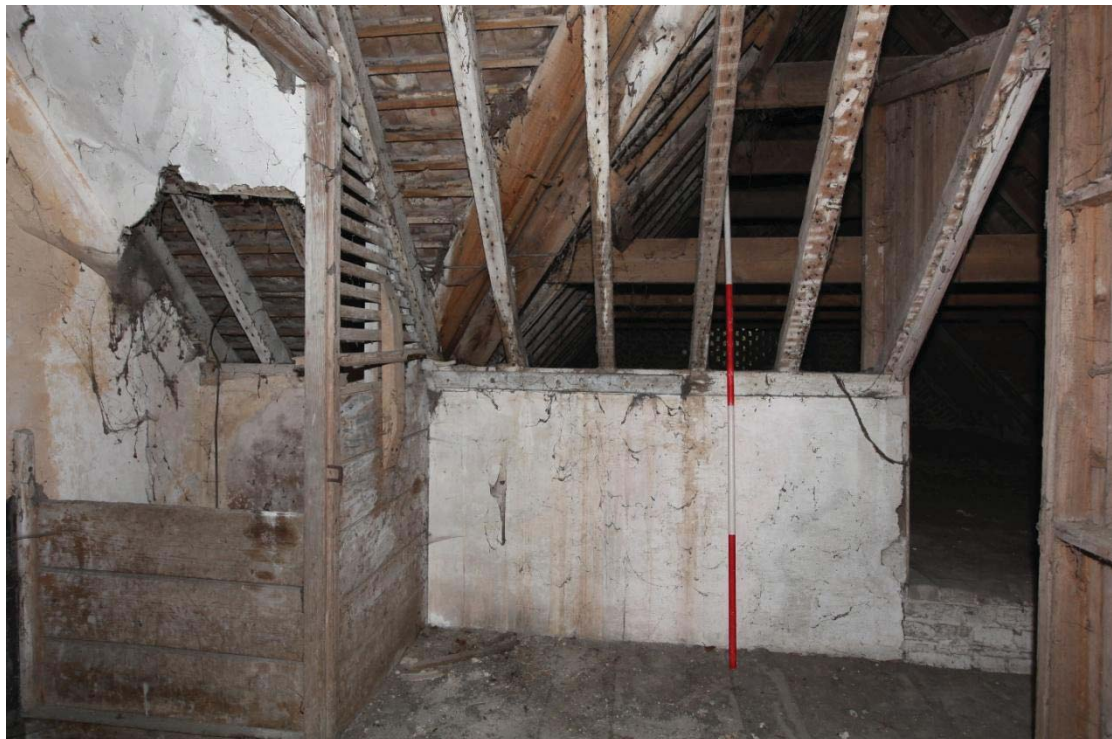
**Illus. 14.** The interior of the attic above the coach house seen from the west, with the boarded chaff box at the head of the stair to the left and the secondary doorway to the loft over the eastern stable (now the garage) on the right. The attic was originally fully plaster with a ceiling at collar height and extended from the stair to the front (southern) gable.

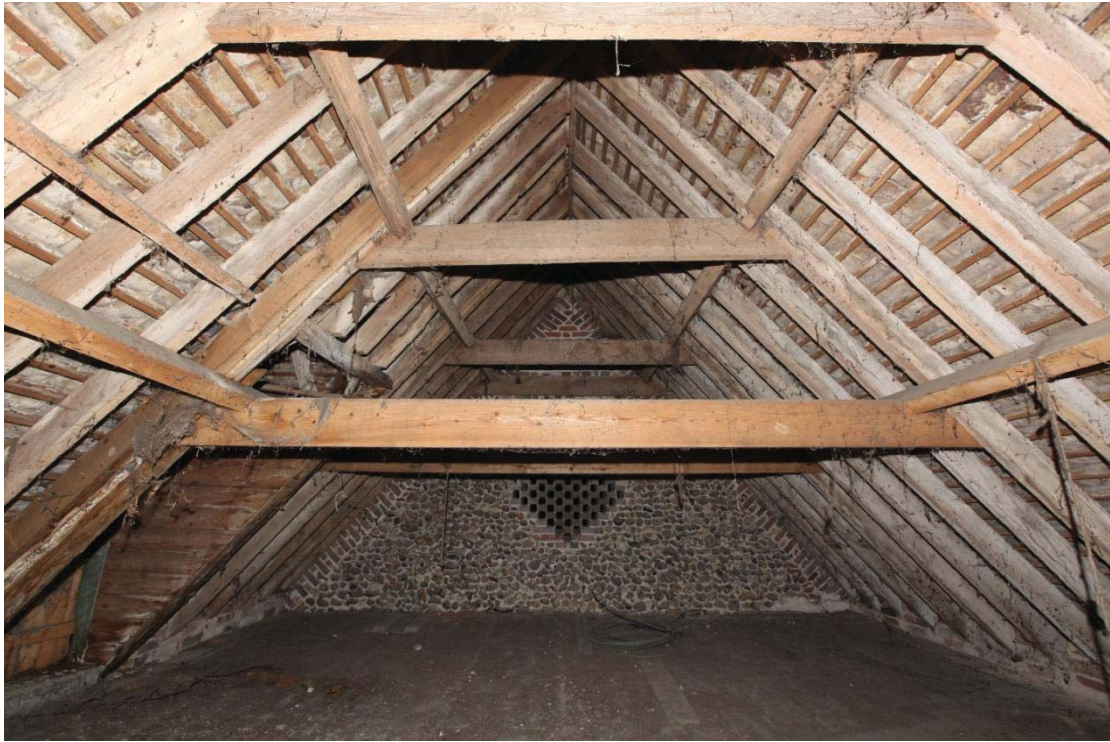
**Illus. 15.** The interior from the east of the loft above the western stable showing the ventilation diamond in the original western gable (now blocked by the tack room extension). The higher collars and purlins are original to the roof structure but the lower tier of light-coloured pine is a secondary insertion; the original collars are tenoned and pegged to the rafters while the secondary collars are nailed.

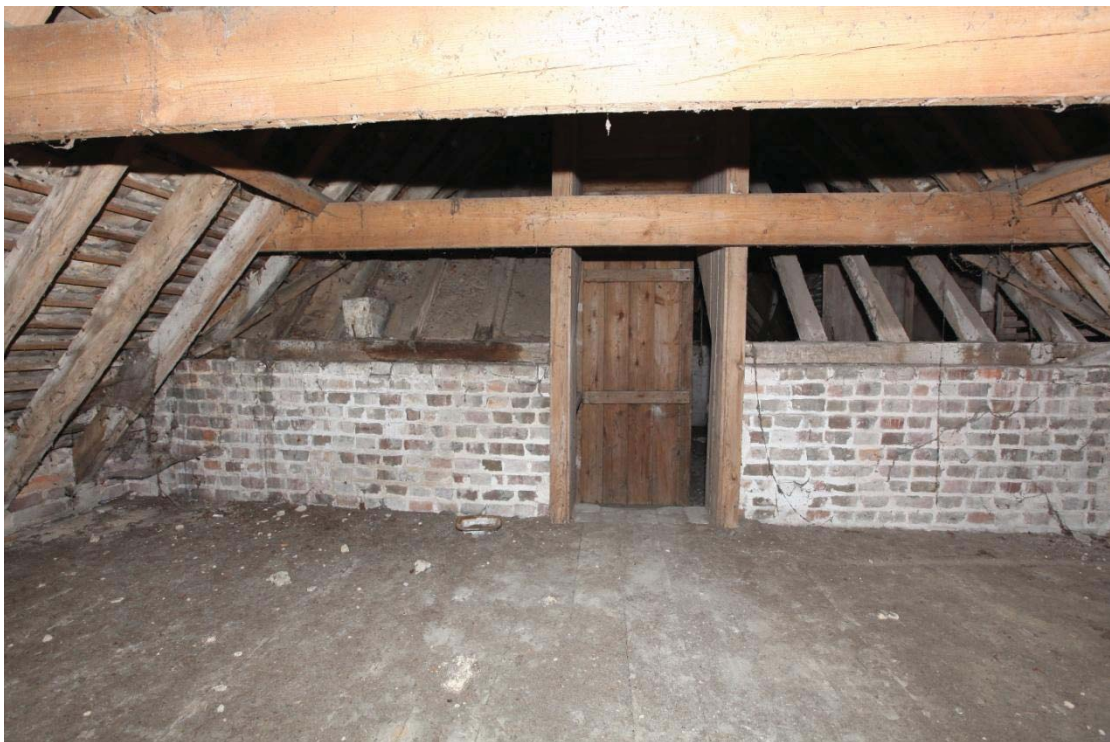
**Illus. 16.** The eastern loft above the garage, viewed from the east and showing the inserted doorway to the attic of the coach house; the door's pine jambs interrupt the original brickwork.
