**59 College Street, Bury St Edmunds  
BSE 419**

**Archaeological Monitoring Report**

**SCCAS Report No. 2013/068**

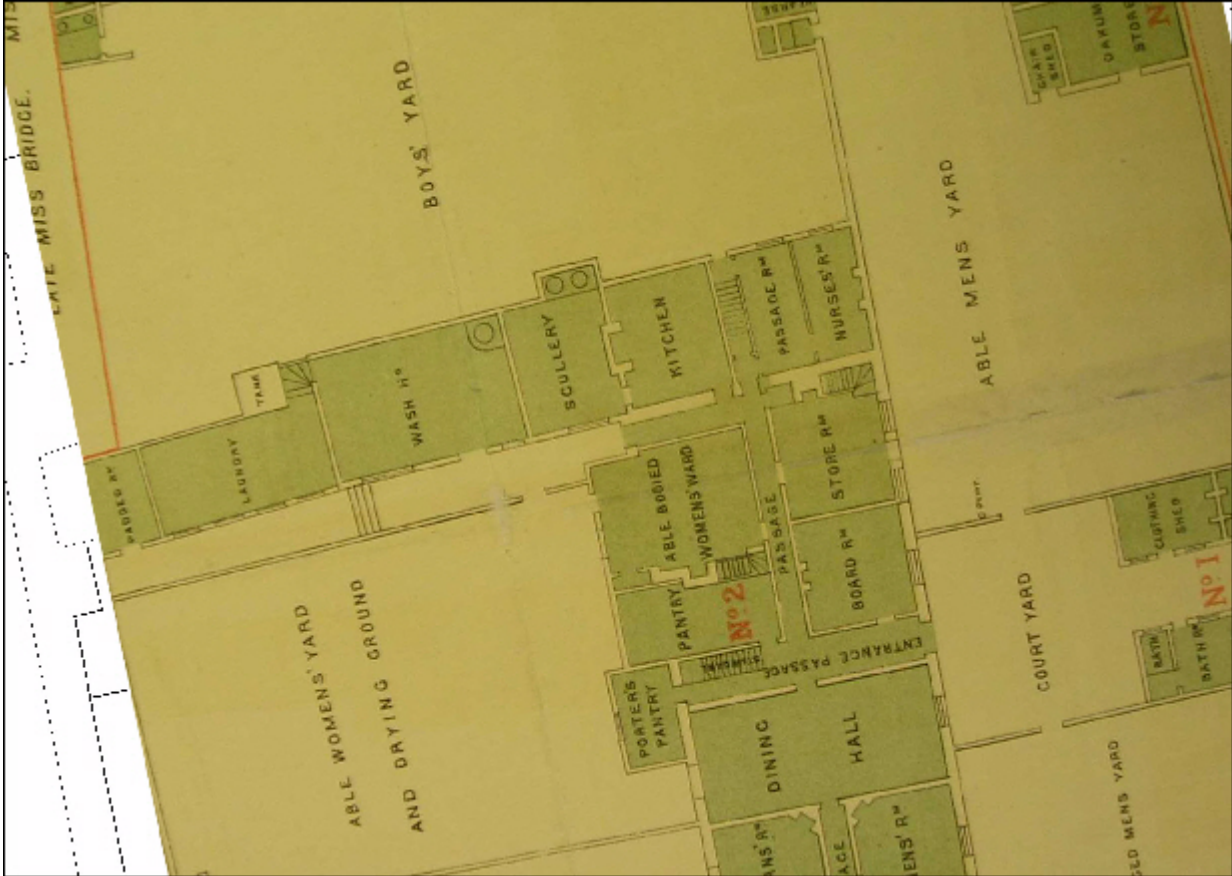
Plate 1. 1884 map of the workhouse, 59 College Street is the range at the top, north end, of the plan

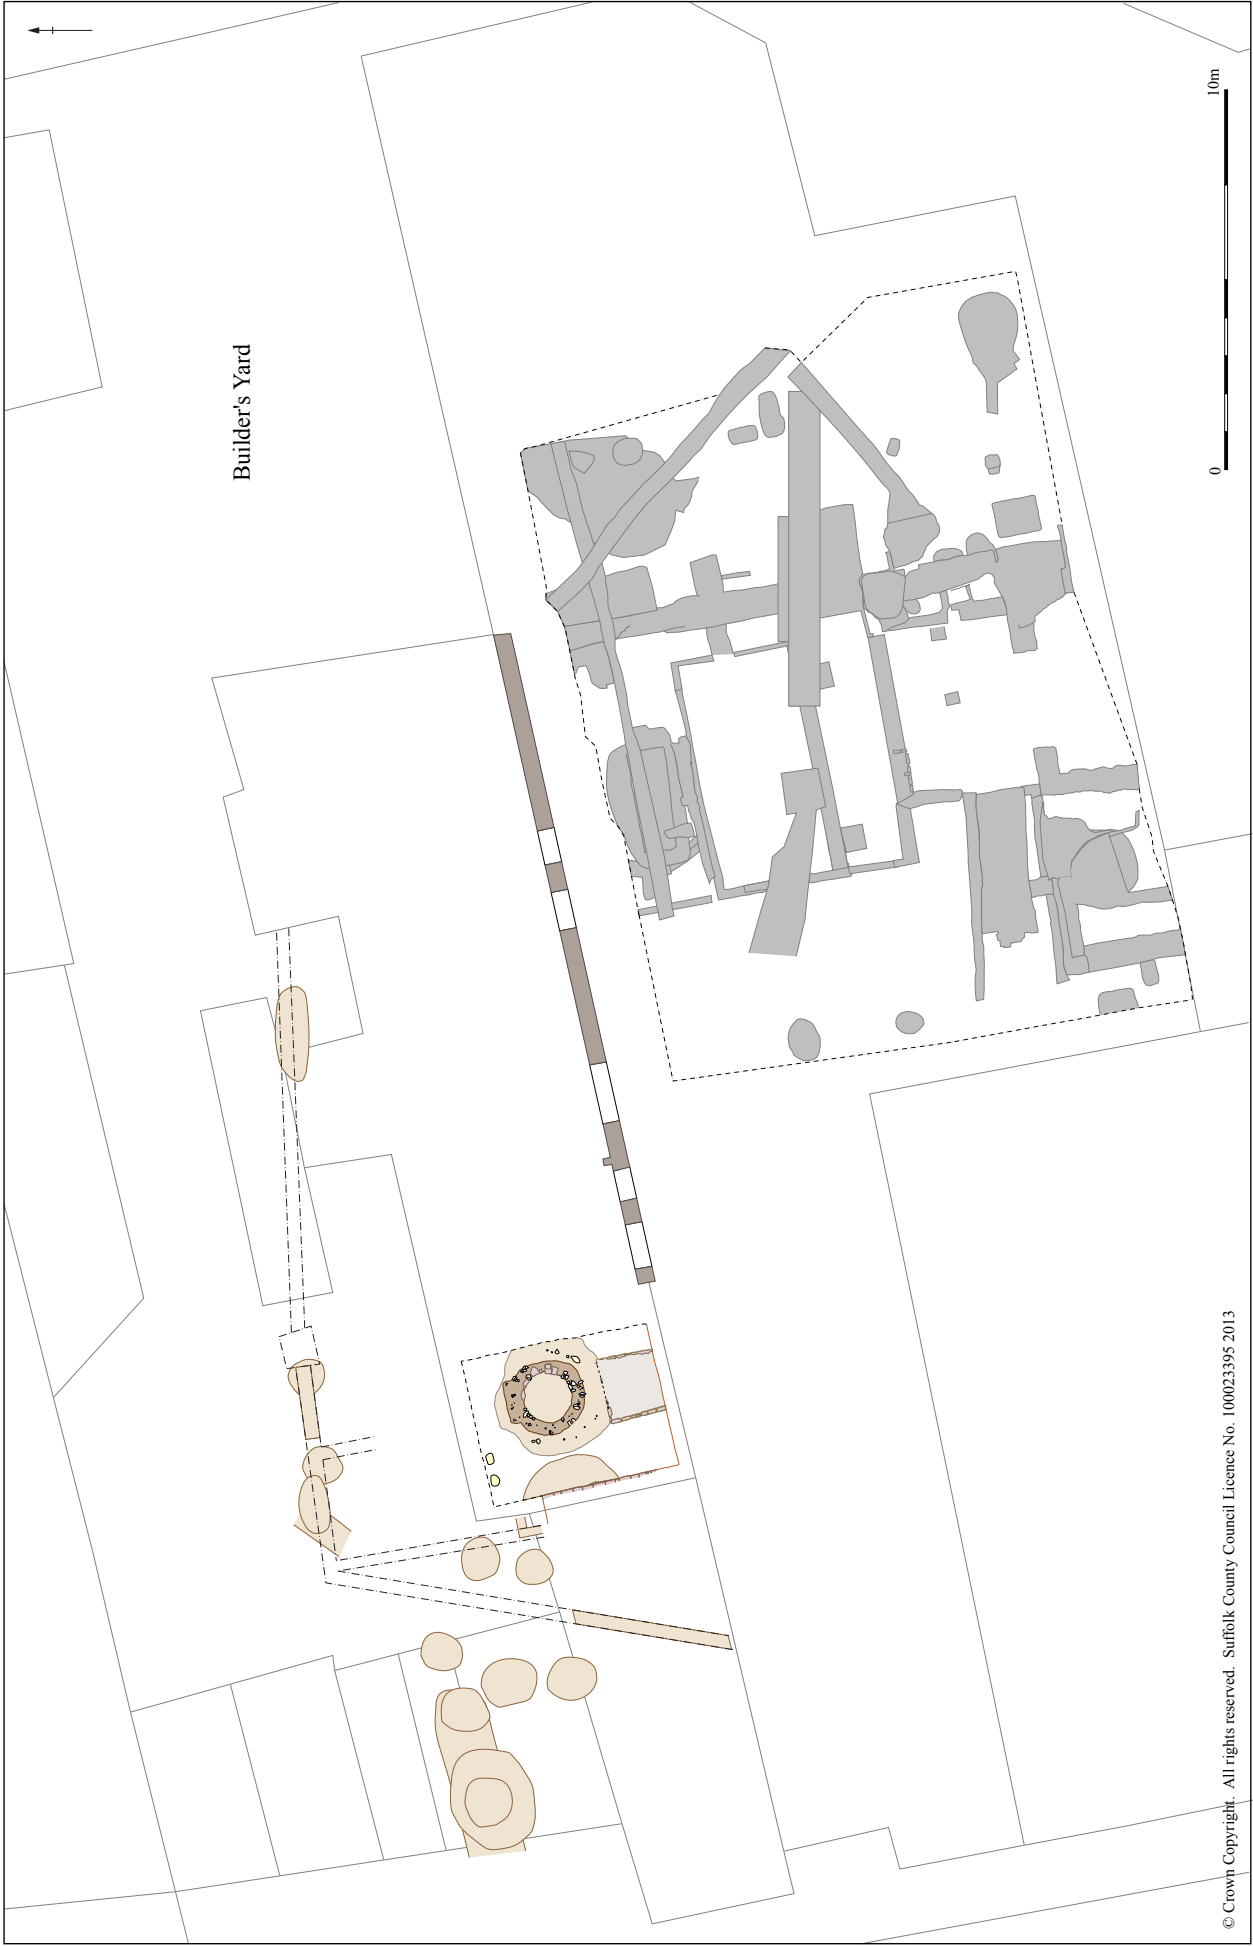
Figure 2. Plan of the areas investigated alongside the excavations carried out on the suggested site of the medieval college to the south

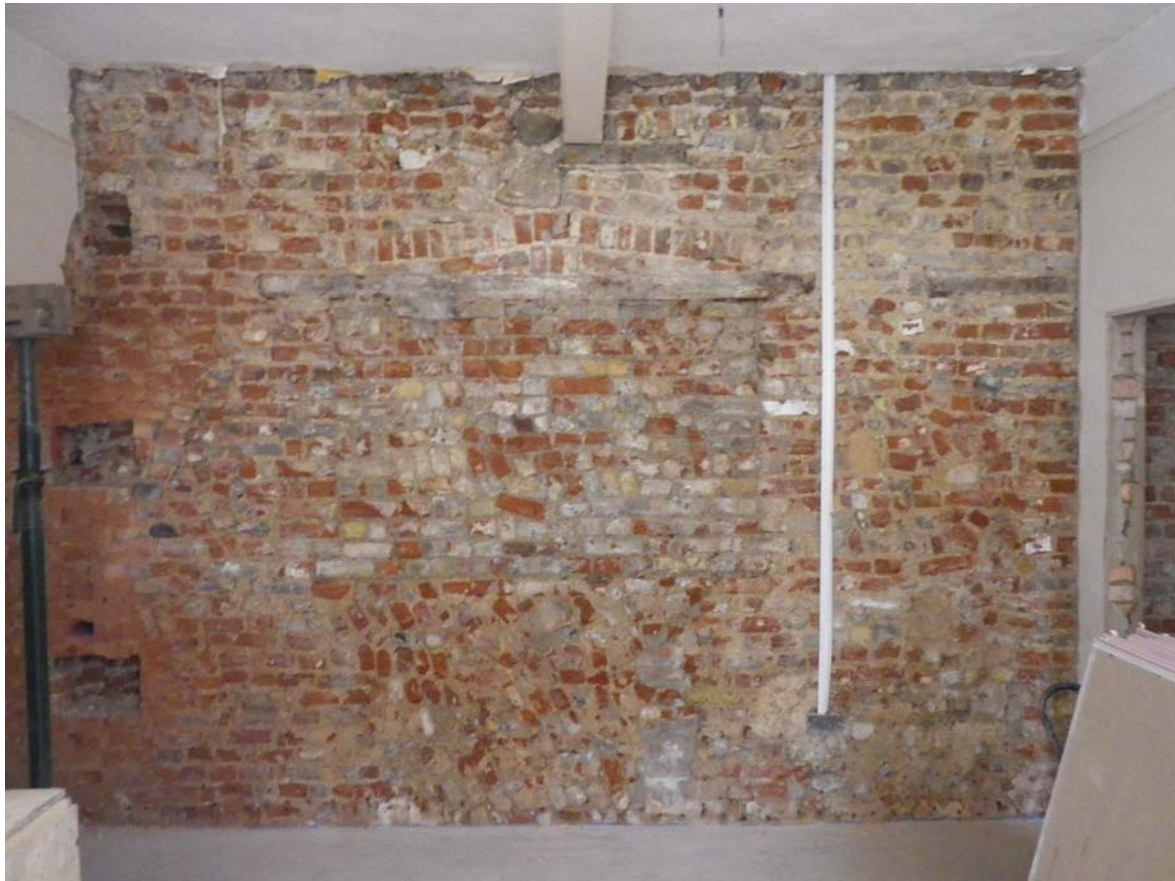
Plate 2. Wall 0010 showing blocked up double window with softwood lintel, facing north

The plaster was removed from a 15m length of the south wall which forms the southern property boundary exposing the bricks beneath, the wall, which was allocated context number 0010, was a randomly coursed rubble wall, bonded with lime mortar, made up of a mixture of 16th and 18th century bricks and limestone blocks with the College

Street end being all built of 16th century bricks to a height of 1.5m. Within the wall were a series of openings forming three doors, a single window and a larger double window (Pl. 1). These had softwood lintels and sills and had been blocked with 19th-20th century bricks. The windows and doors can be seen on a plan of the workhouse (Pl. 1) with the large double window having been in the scullery (Pl. 2). A plan of the exposed wall can be seen on figure 4.

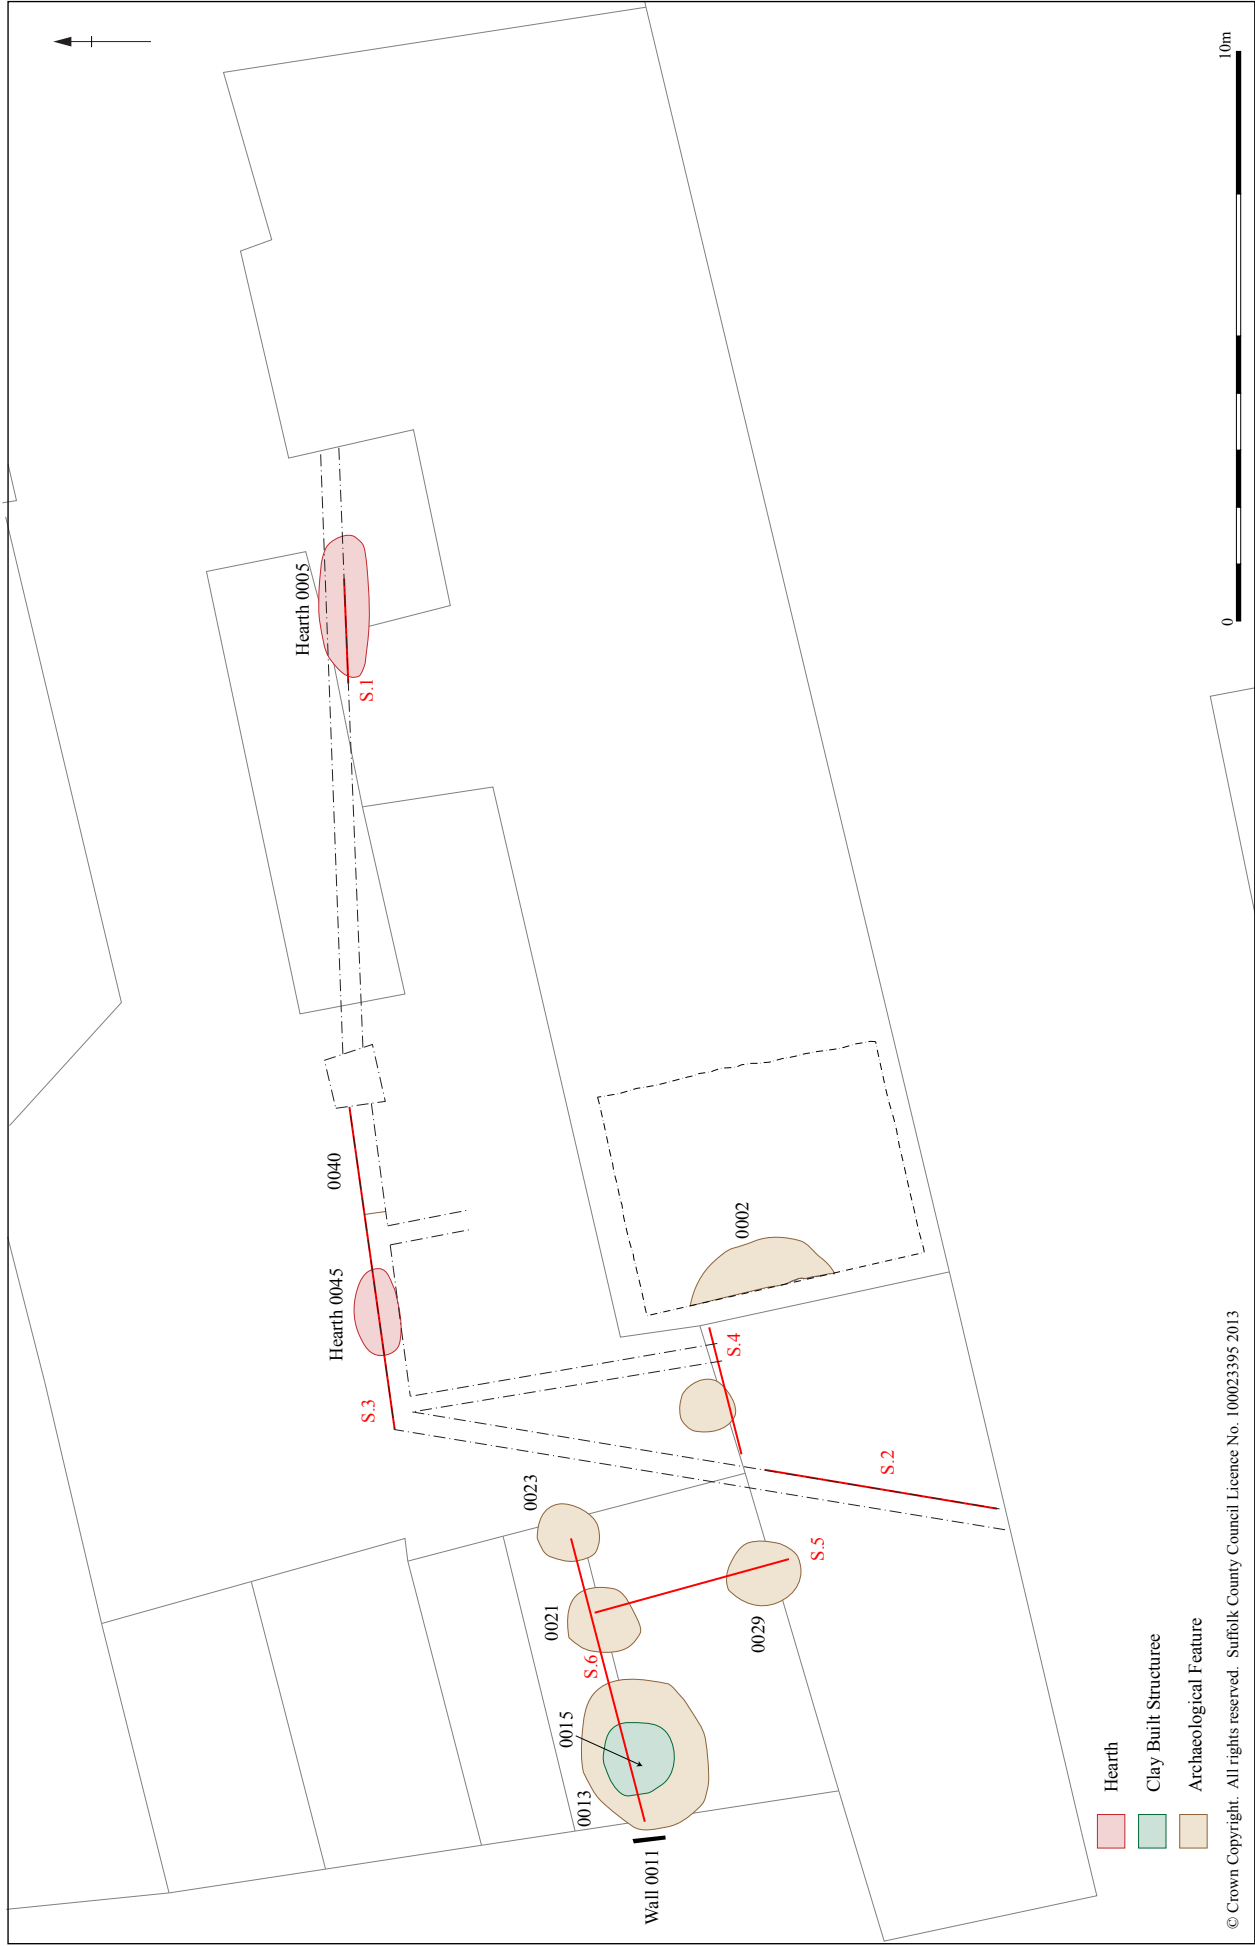
Figure 3. medieval Phase

Whilst the post-medieval features here seem to relate to the construction and possible demolition of buildings, the earlier medieval features (Fig. 4) show more the domestic occupation of the site with food waste, pottery and evidence of hearths. Section 1 shows 0005 being sealed by deposit 0007, which was one of two possible hearths

identified during the monitoring. It was at least 1.8m long and 0.26m deep and was made up of bands of charcoal and red heat-altered clay rubble with occasional patches of unburnt clay and produced two sherds of late 12th to 14th century pottery. Although 0045 was cut by both 0011 to the west and 0035 to the east, as shown in section 3, enough remained of its charcoal and heat-altered red clay for it to be interpreted as a second hearth. To the east of 0045 and also in section 3 was deposit 0040. This was clearly a feature fill of some kind but its edges were undefined due to being cut to the west by 0035 and to the east by 0038 and its base was not seen due to it being deeper than the service trench. It consisted of mid to dark brown loam and contained small amounts of animal bone. A concentration of six pits was identified to the west of the site, which were bounded to the west by a medieval flint wall and these are shown in sections 5 and 6. At the southern end of section 5 was pit 0029. This had a steep slightly concave side, was cut by pit 0025 and was seen to continue below the standing wall of the current building. It was filled with two deposits, 0028 and 0030, both of which were flecked with shell and charcoal. At the north end of section 5 and the east end of section 6, where it is shown being cut by pit 0021, was pit 0023. This was steep sided with a concave base which was at least 2m deep and it was filled with brown silt with shell and charcoal flecks. Pit 0021 was shallow at only 0.34m deep but had been truncated by pit 0019. With concave sides and a flat base it was filled with bands of mid brown silt and gravel (0022) and also cut pit 0013. A clay built structure, 0015, was also recorded in the centre of pit, 0013, which was filled with a mid brown clay silt with pale yellow clay or degraded lime mortar with chalk flecks. The underlying pit, 0013, was nearly 2.5m wide with steep sides and clearly deeper than the 1m deep limit of excavation. It contained a mid brown soft silt with charcoal and shell (0014) and produced four sherds of pottery dated again to the late 12th to 14th century. In addition two fragments of roof tile came from this deposit, which have been dated to the 13th to 15th century. At the west end of this section pit 0013 was cut by 0046. This was a clay silt which was thought to be the foundation for the flint wall 0016 above. The wall was a single course high and consisted of large flints bonded with distinctively medieval coarse pale brown mortar. It is shown in section 6 disappearing below the building to the west and terminated within the service trench.
