**Glemsford Silk Mills,
Chequers Lane,
Glemsford, Suffolk
GFD 021**

Heritage Asset Assessment

Glemsford Silk Mills, Chequers Lane, Glemsford, Suffolk

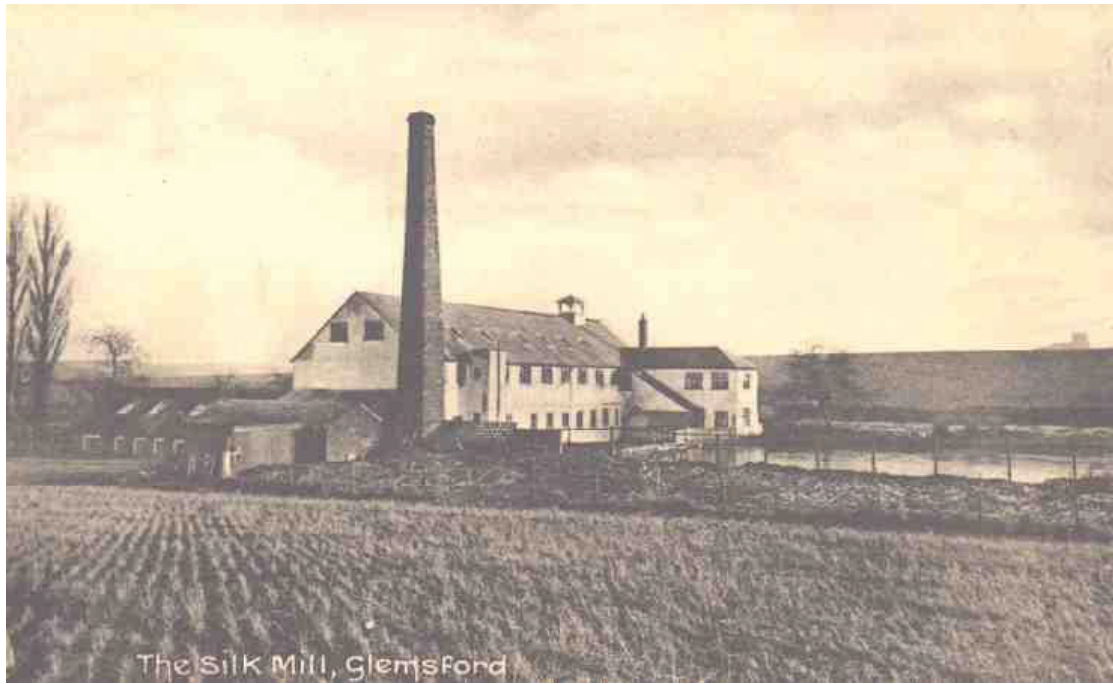
Figure 6
The mill from the north-west in *circa* 1910. From an old postcard. Note the multiple windows of the surviving single-storied red brick shed in the rear to the left (the dye and yarn store in figure 11).

Duff's mill was an imposing three-storied building which continued the existing roof of the southern dwelling house northwards, as shown in figures 6-9. This building was almost entirely demolished in 1960, shortly before the present dye-house was built, retaining only the heavily mutilated remains of the original basement storey in its new walls. Where the 19th century brickwork remains exposed it contains evidence of a continuous series of windows reflecting those of the missing upper storeys. This floor of this basement storey lay approximately 2.5 m (8 ft) below ground level and the internal floors of the manager's house, in order to maximise the head of water supplied to the water wheel from the large spring-fed pond on the site of the present car park. There is no longer any evidence of this wheel or its pit, but a fast-flowing stream which probably represents the by-pass channel still runs in a 19th century brick culvert beneath the dye house floor (illus. 7). The present space of 22.5 m in length (74 ft) is open to its steel-framed roof and formerly contained ten large dye vats of which only the outlines remained in the concrete floor at the time of inspection. Steps rise in the southern gable to the office floor, and the same gable preserves the scar of a former stair that would have linked the second and third floors of Duff's mill.

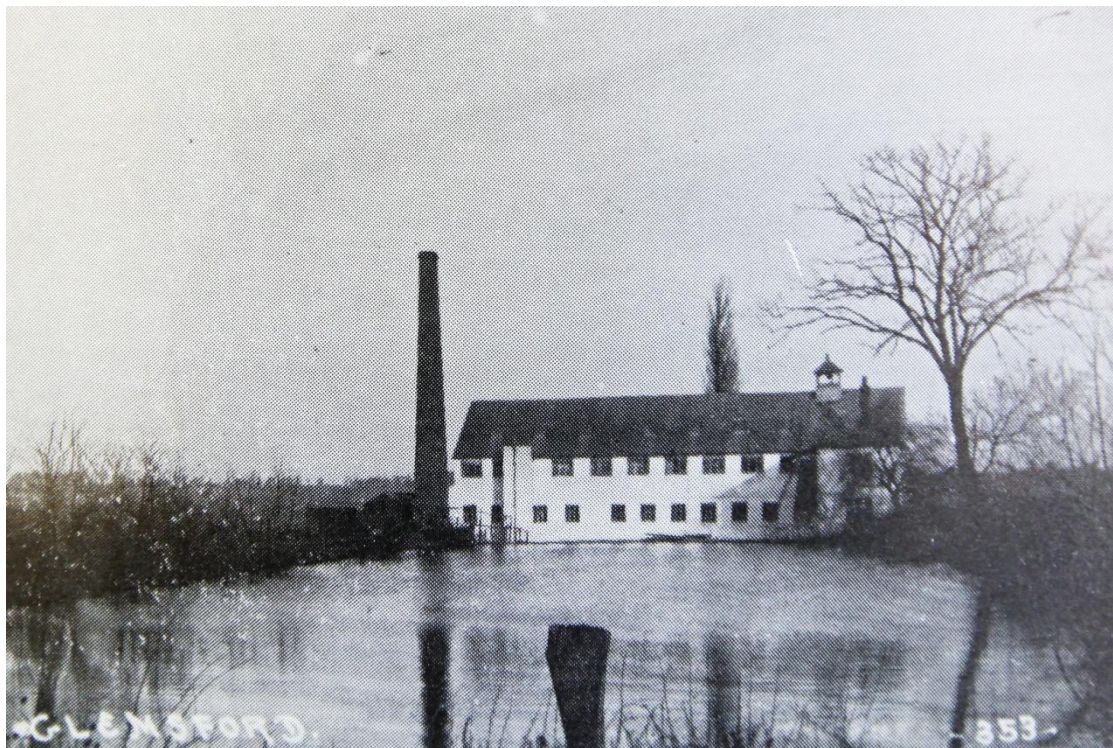
Figure 7
A view from the west of *circa* 1910 showing the large headwater pool in the foreground. (From a postcard published in 'Glorious Glemsford' by Richard Deeks, 1972). Only the basement storey of this imposing building, hidden from view here by the pond, survived the demolition of 1960 – along with the canteen wing on the right.

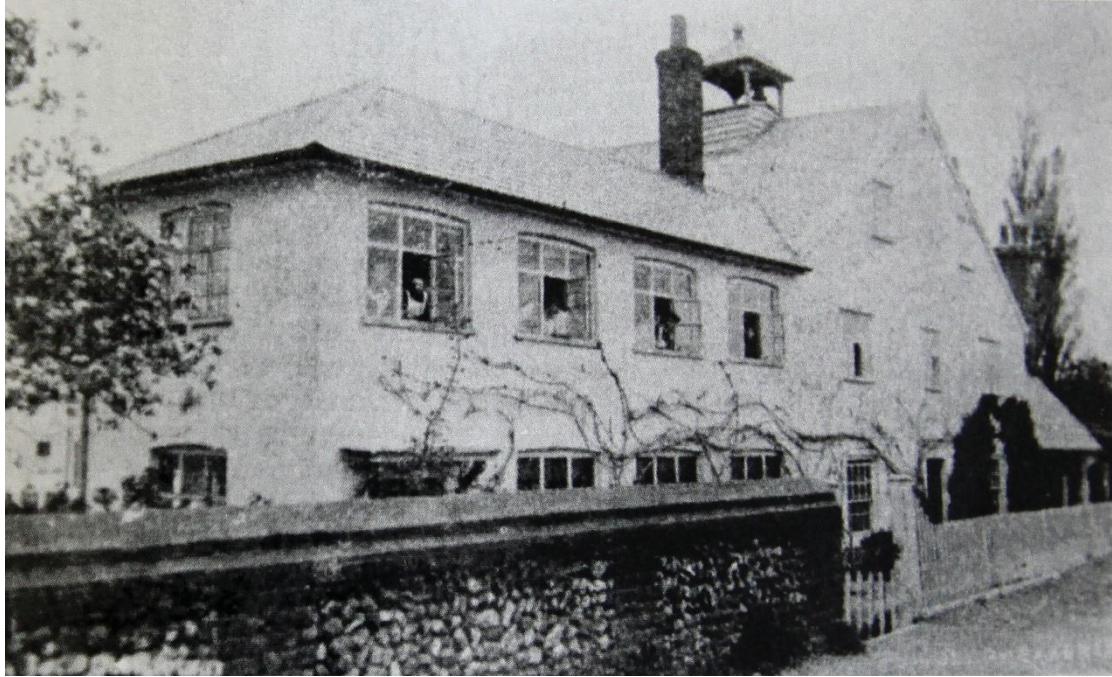
Figure 8

The southern facade from the south-west in *circa* 1910 showing the original appearance of the gabled dwelling house to the right and employees at the windows of the later 'canteen wing'. The factory bell can be seen on the roof. (From a postcard published in 'Glorious Glemsford').

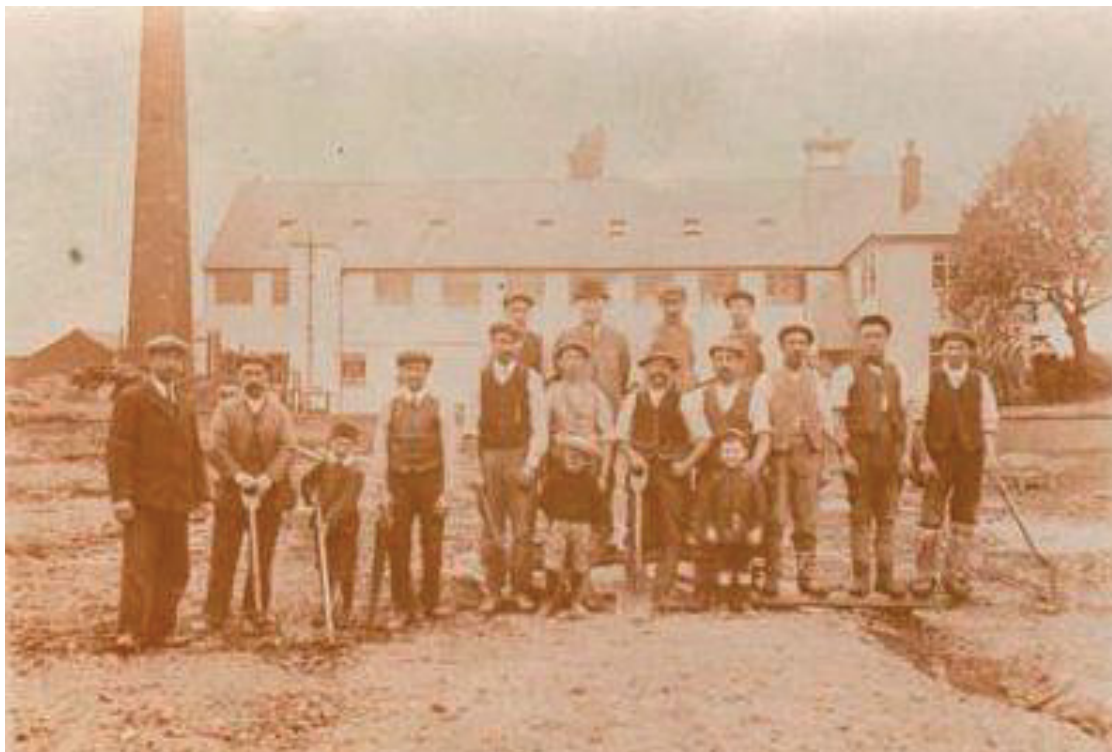
Figure 9

Workmen apparently compacting the drained bed of the headwater pool in *circa* 1910. From a postcard published online.

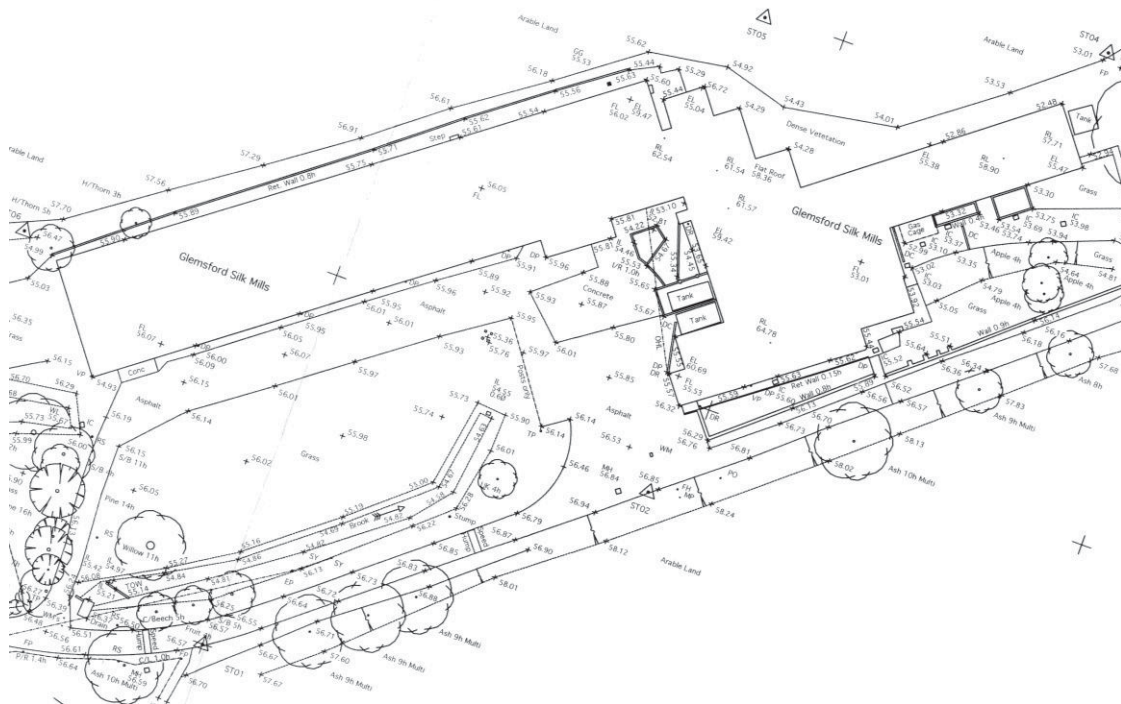
Figure 12
The current Ordnance Survey site plan showing the historic mill to the right and the large extension of circa 1960 to the left.

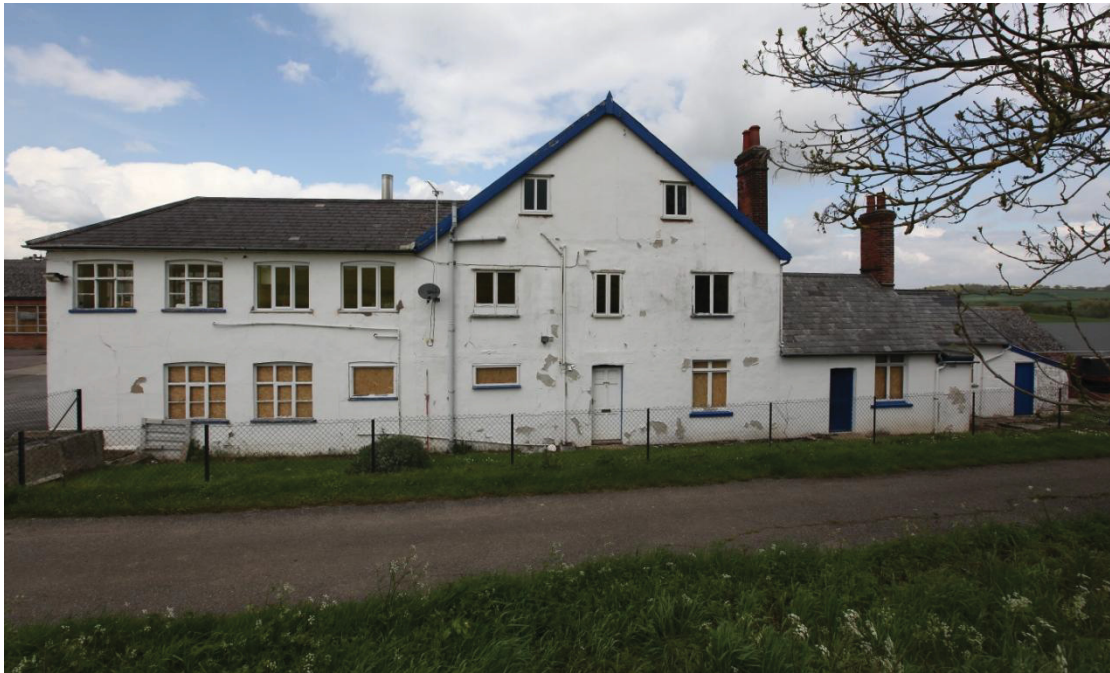
Illus. 1. The southern facade of the mill showing the wide gable of the original manager's house in the centre with its single-storied kitchen (most recently used as a lab) to the right and the later canteen wing to the left. The chimney to the right of the house was formerly matched by another to the left, and its fenestration was entirely renewed in the mid-20th century.

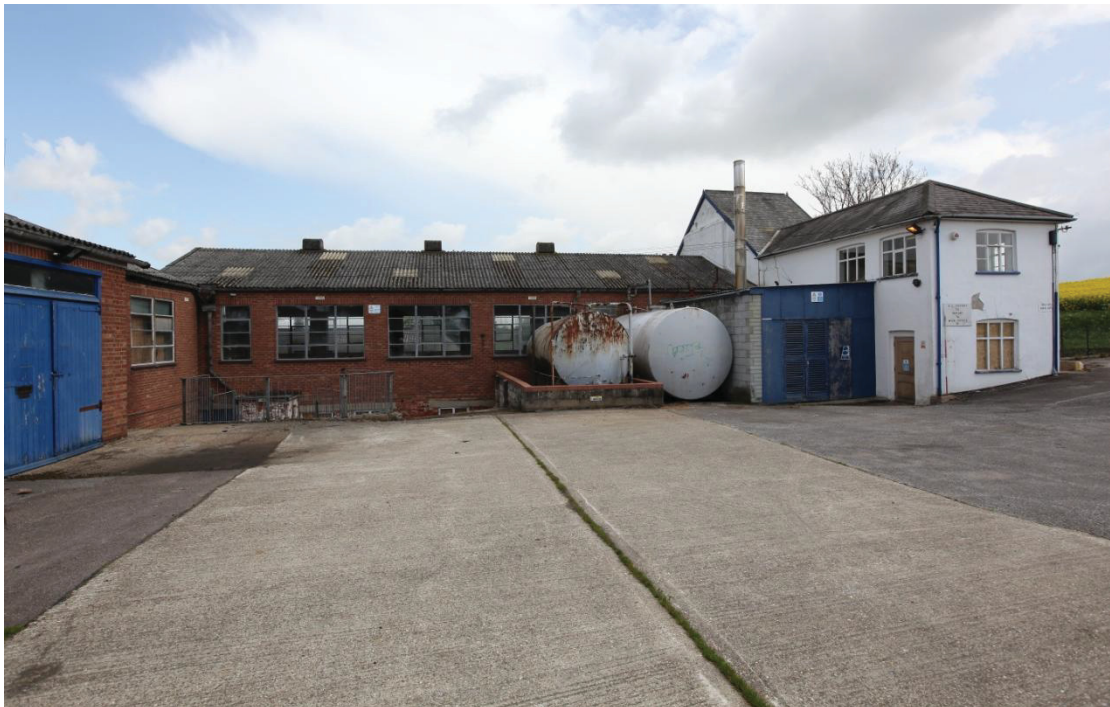
Illus. 2. The exterior of the red-brick dye house from the site of the 19th century headwater pond to the west (now a car park) showing the high gable of the manager's house on the right and the 1960s sheds to the left. The dye house retains only the basement storey of the three-storey 19th century mill, which continued the roof of the manager's house, and in its present form dates only from 1961.

The dwelling house forms the wide gabled structure in the centre of the southern range (illus. 2) and consists of cement-rendered red brick with a slate roof. The southern windows are mid-20th century replacements but the building's attractive original appearance with small-paned eight-over-eight sash windows is shown in figure 8. The internal layout was typical of its period, with a central lobby entrance opening onto a turned newel stair flanked by identically proportioned ground and first-floor rooms heated by 'gable' chimneys to east and west. Each room extended to a modest 3.6 m in length by 4 m in internal width (12 ft by 13 ft). The right-hand (eastern) room operated most recently as the factory office and remains intact, with a mid-20th century tiled fire surround, but the external western wall of the left-hand room has been lost and the space now accommodates part of a WC (the 'loos' in figure 11) and a passage to the dye house. The western bedroom immediately above preserves a late-19th century arched coal grate with an early-19th century reeded surround, but the chimney has been demolished and it is unclear whether a fireplace ever existed on the ground floor. The eastern bedroom retains a fine 'swan's nest' grate that is almost certainly an original feature of 1824 (illus. 16) and there are two narrow bedrooms in the roof space. These bedrooms formed a separate flat at the time of inspection, with a modern kitchen above the WCs in the later 'canteen wing'. The 19th century kitchen or bake-house lay in a single-storied slate-roof structure to the east of the facade (recently used as the 'lab'); this was present by 1841 and is probably original, although a vertical crack at its junction with the main house suggests it may be a slightly later addition. Steps descend from the north-western corner of the adjoining 'dye office' to a 19th century cellar beneath this single-storied kitchen; one of its two barrel vaults is intact on a north-south axis but the other to the east appears to have been blocked and is indicated only by a brick arch. The surviving vault contains wooden pallets and was used to store dye, as shown by modern writing on the whitewashed walls and colour stains on the floor. It is unclear whether these vaults are part of the initial phase of construction.

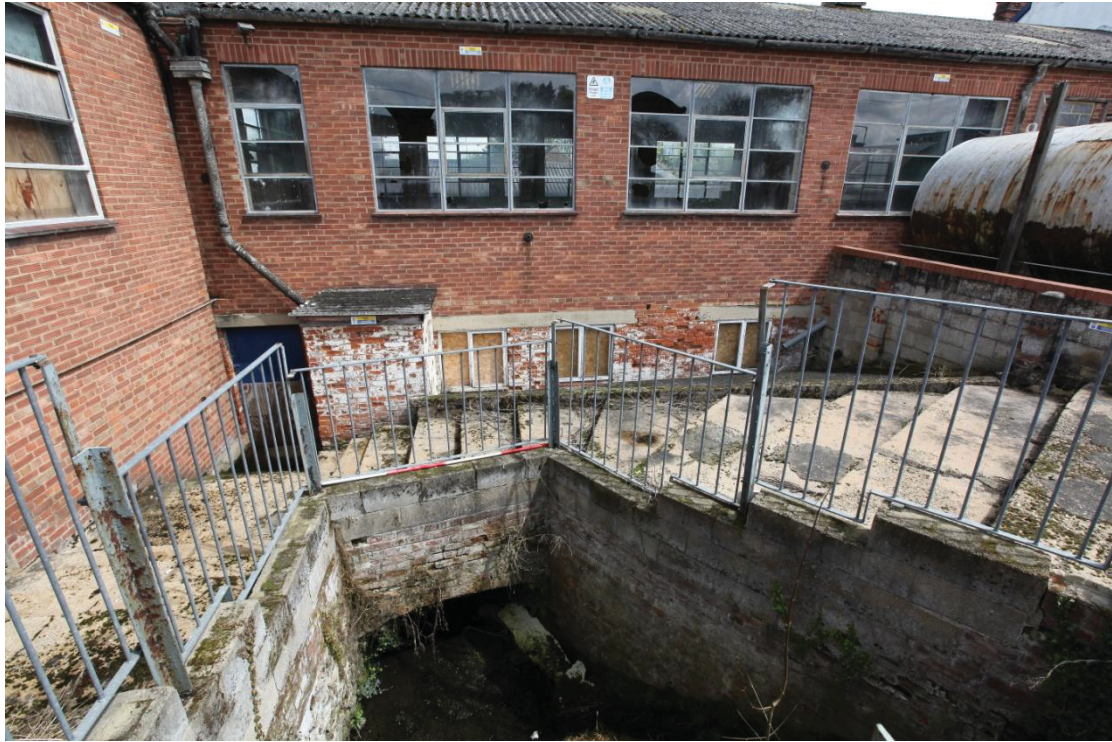
Illus. 3. The 19th century mill race flowing beneath the dye house, viewed from the site of the headwater pond to the west. The whitewashed red brick beneath the concrete widow lintels survives from the original mill but the rest is a reconstruction of the 1960s when the sheds on the left were added.

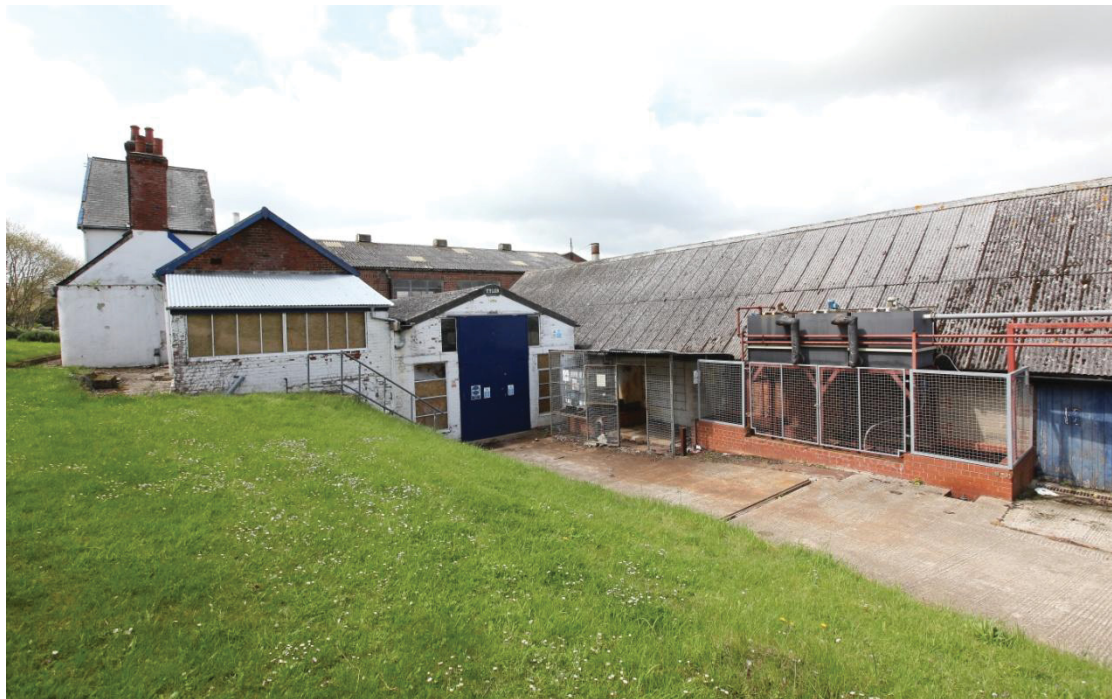
Illus. 4. The exterior of the complex from the east showing the corrugated asbestos roof of the yarn store to the right (a 19th century single-storied brick shed, the southern elevation of which was rebuilt in cement blocks during the 20th century). The roof of the dye house is visible in the rear with the narrow dwelling house on the left and the gables of the drying room (with blue doors) and the lab (with glazed lean-to) in the foreground.

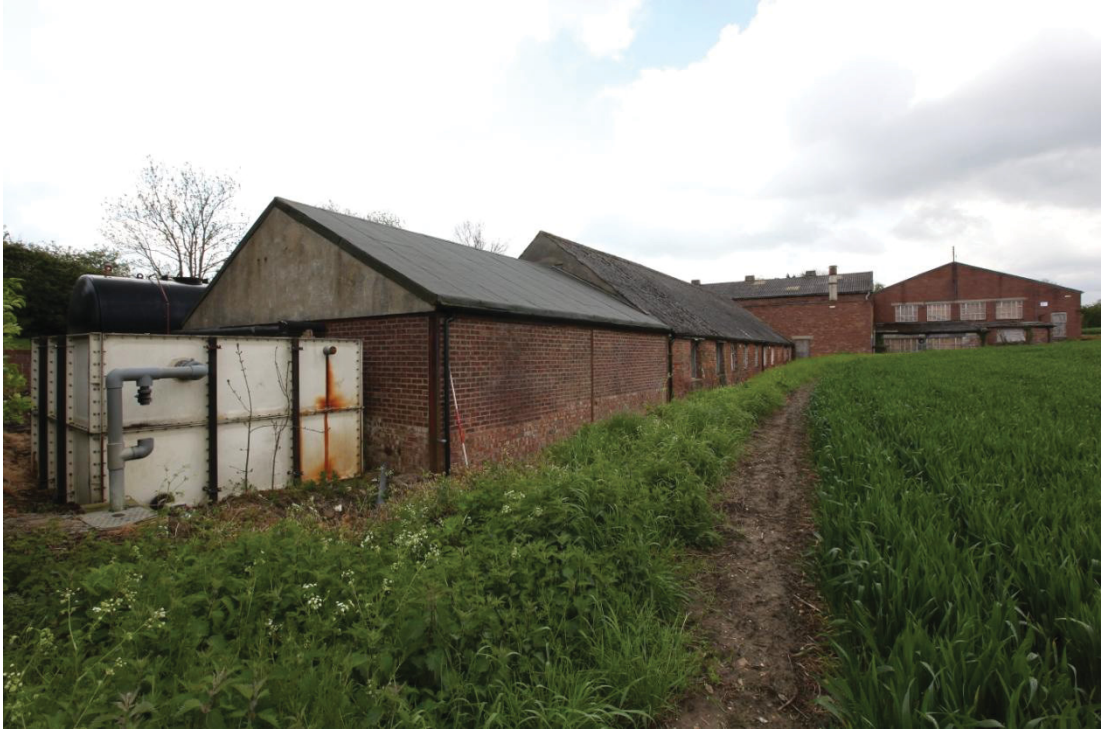
Illus. 5. The complex from the north-east. The long, single-storied 19th century red-brick shed that latterly operated as the dye and yarn store lies in the centre with its lower 20th century extension on the left, the mid-20th century ‘old boiler room’ with its chimney in the centre and the 1960s sheds on the right.

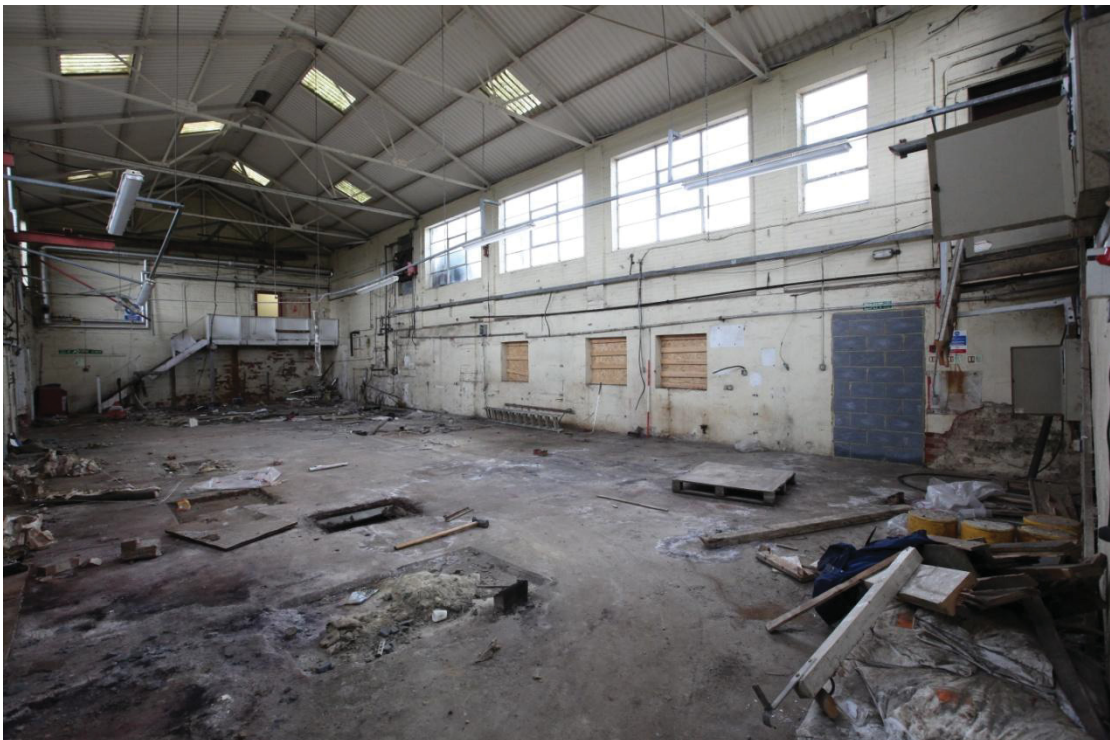
Illus. 6. The interior of the dye house from the north, showing the positions of the removed dye vats in the concrete floor. The stair and gallery projecting from the southern gable in the rear opens onto the office floor, with the scar of an earlier stair belonging to the demolished upper storeys of the mill to its left. The lower walls of this structure survive from the 19th century but the rest dates only from the 1961.

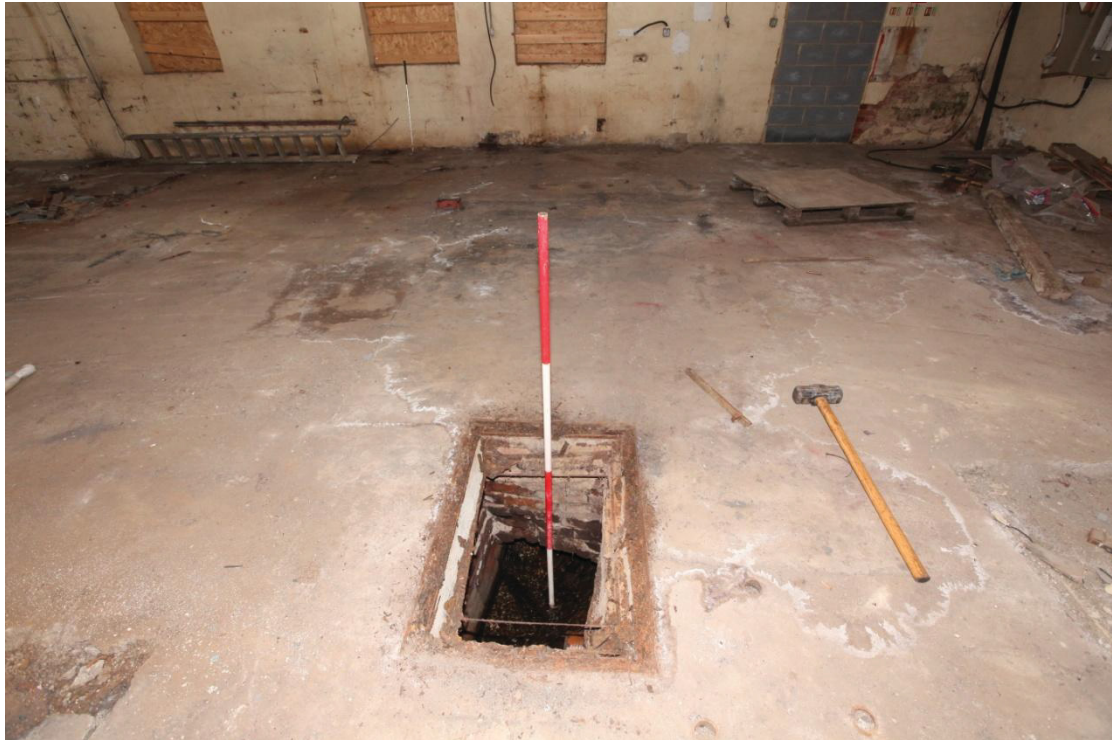
Illus. 7. The concrete floor of the dye house viewed from the east showing the man-hole opening onto the fast-flowing water of the 19th century mill stream which still flows beneath the building. There is no obvious evidence a wheel pit or any other original mechanism, and this probably represents the by-pass channel.

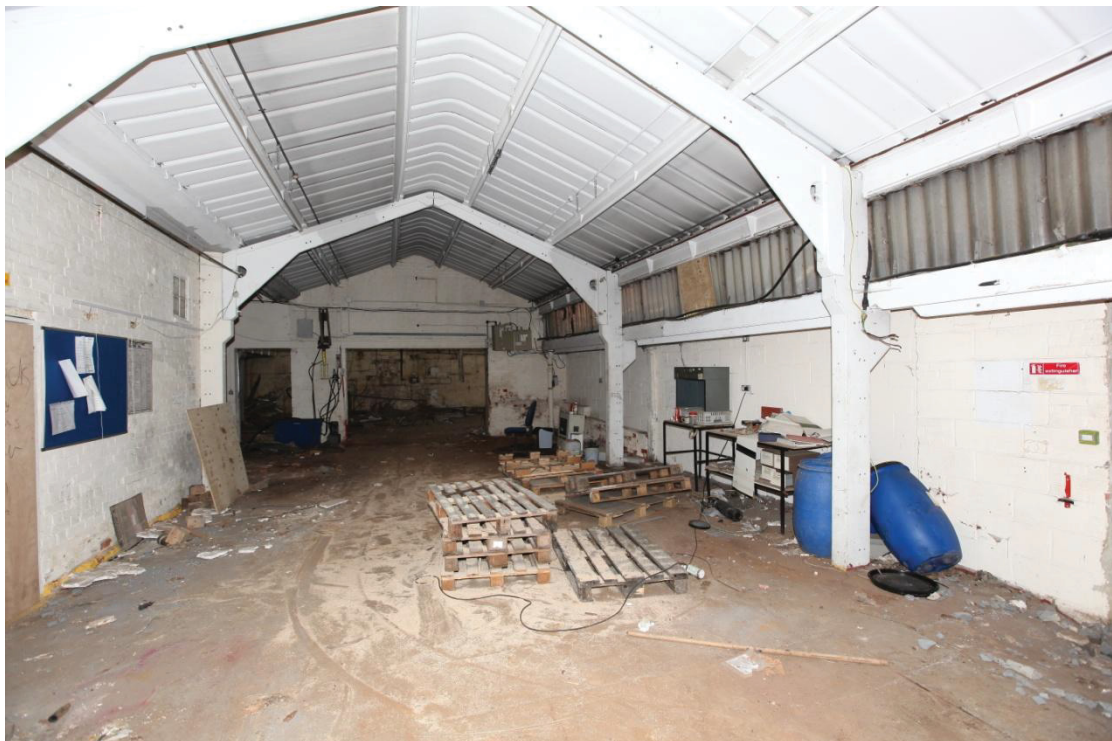
Illus. 8. The steel and concrete-framed 20th century shed which operated as a drying room, with the entrance to the dye house in the rear. The door on the left opens onto the cellars beneath the lab and the wall on the right (largely rebuilt in cement blocks) is part of the 19th century single-storied dye and yarn store.

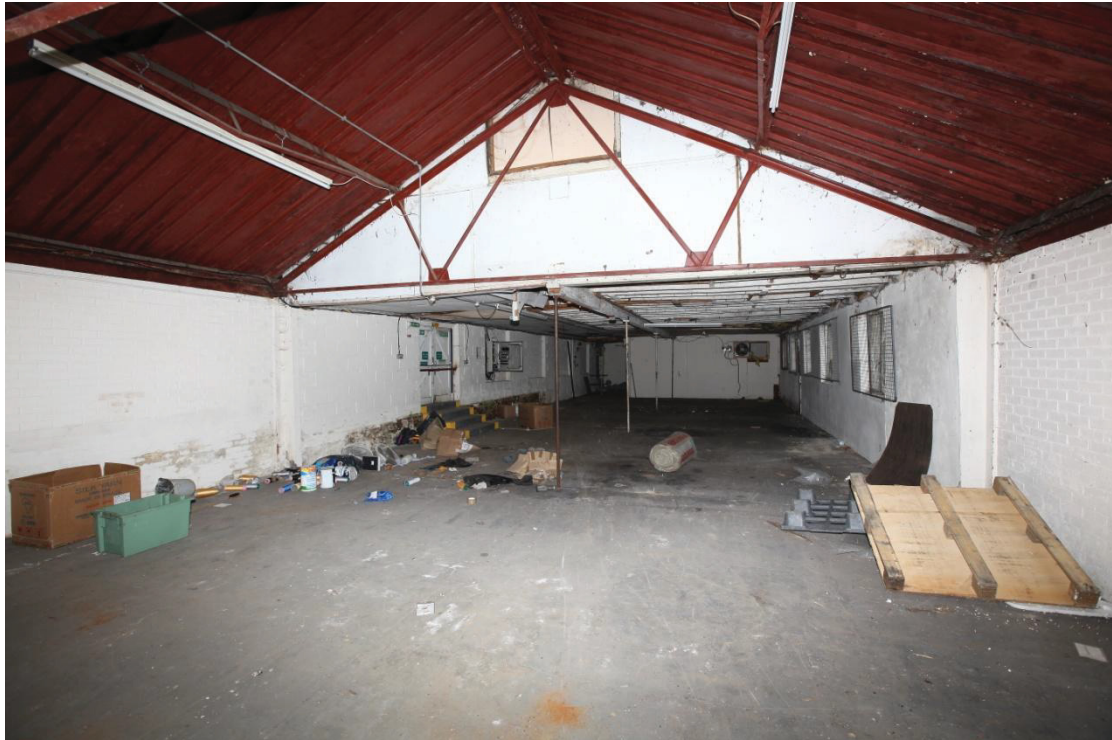
Illus. 9. The yard store from the eastern gable of its 20th century extension (to the left in illus. 5) showing the remains of the original 19th century gable supported by an iron post in the centre. There is evidence of a series of 19th century windows in the northern elevation on the right but the southern wall has been rebuilt above its red-brick plinth.

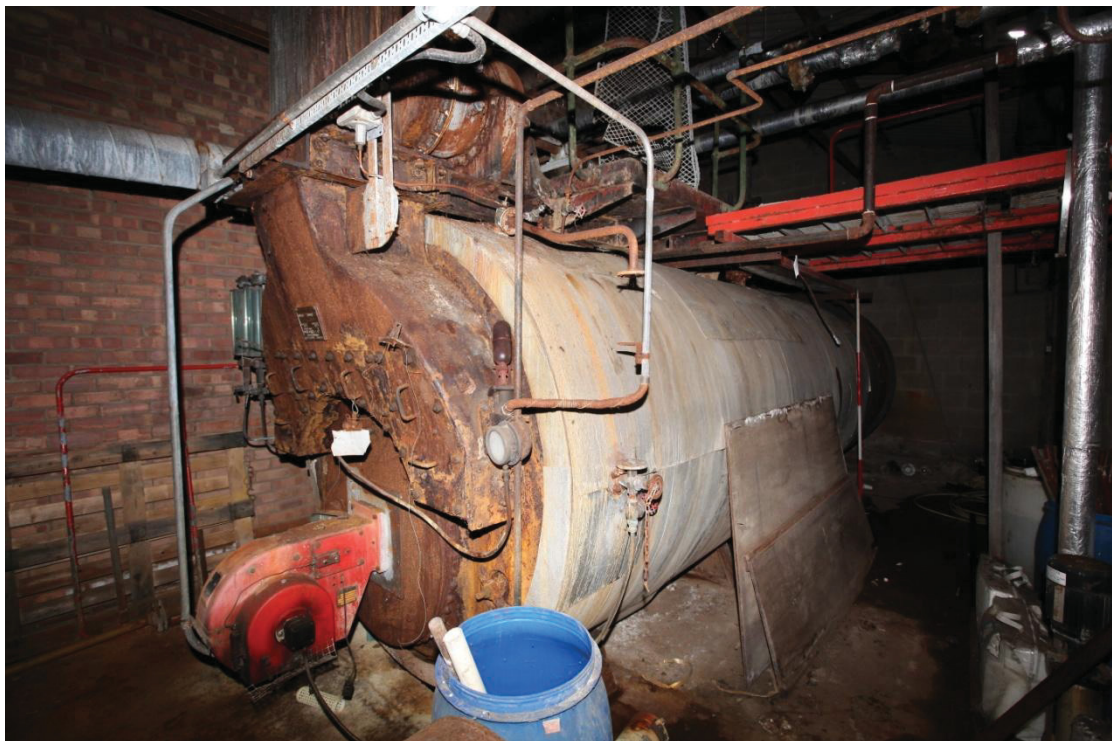
Illus. 10. The substantial mid-20th century boiler in the 'old boiler room' of Fletton brick seen from the north-west.

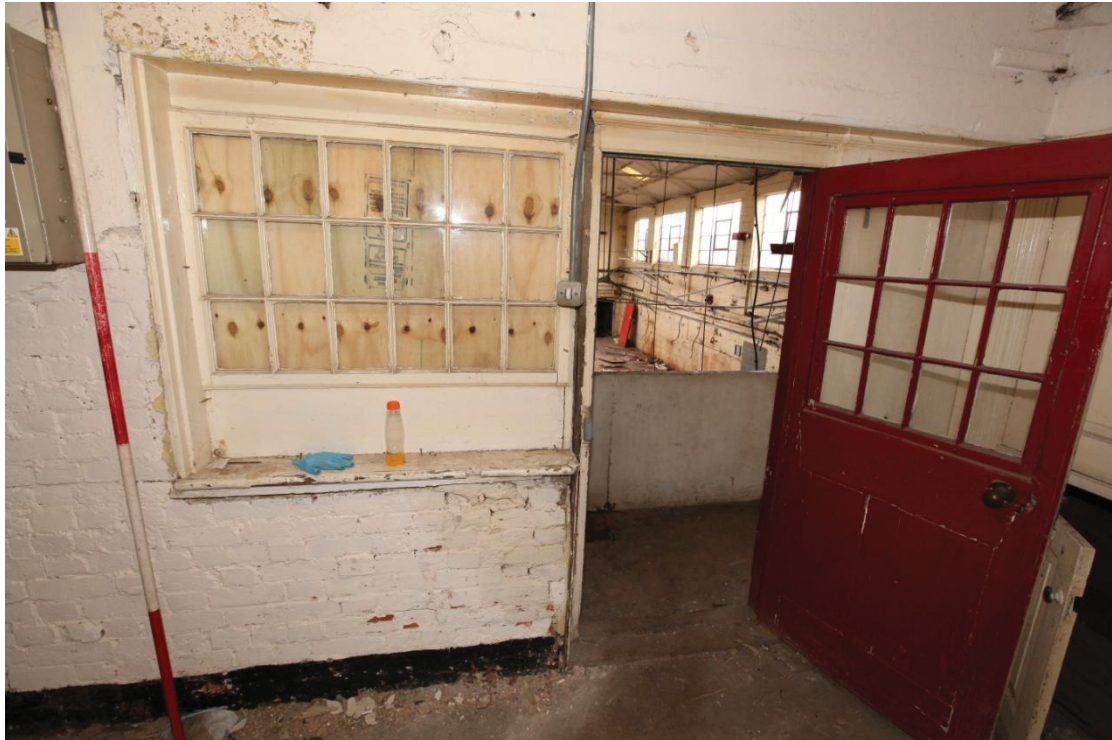
Illus. 11. The 19th century door and window opening from the office floor into the southern gable of the dye house at the eastern end of the passage behind the WCs. Both features appear to interrupt the brickwork and may be secondary.

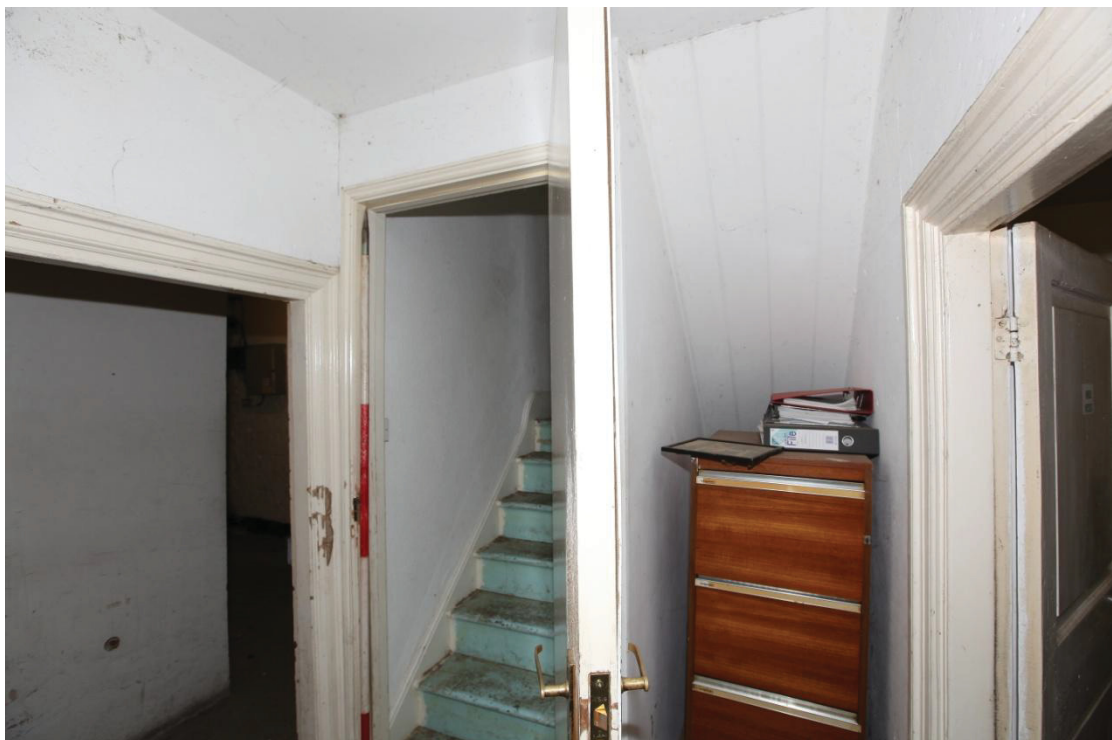
Illus. 12. The central stair lobby of the dwelling house seen from the south and showing the door of the office on the right and the passage to the dye house and canteen wing on the left.

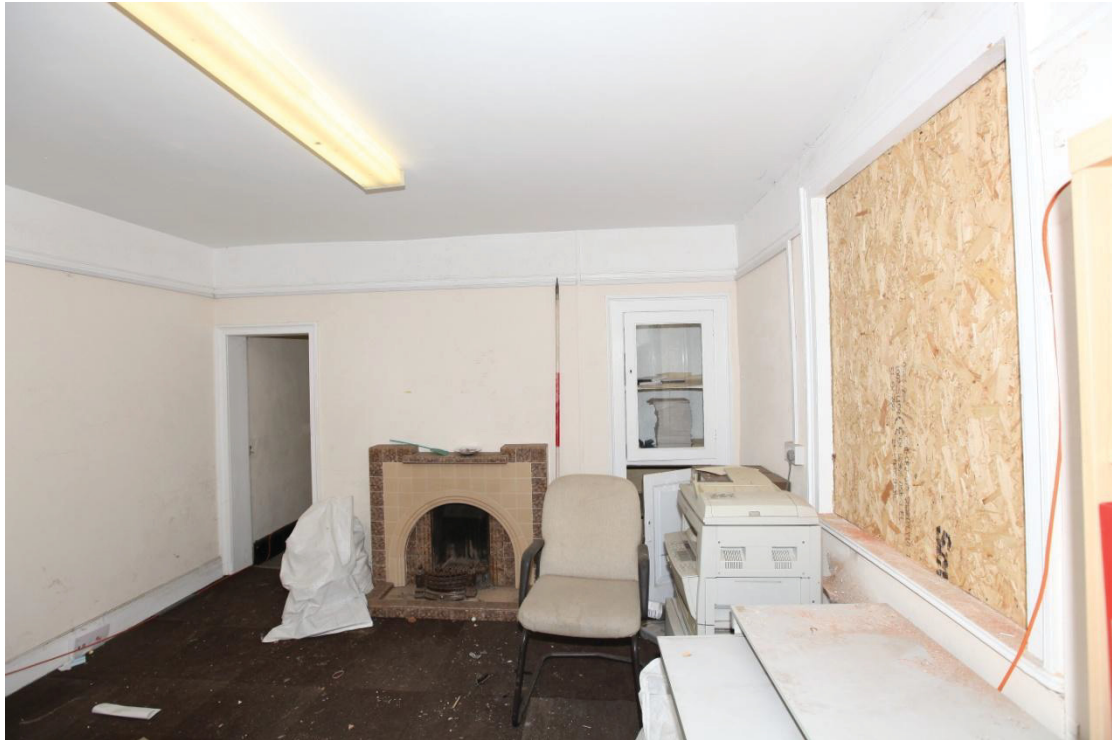
Illus. 13. The interior of the office from the stair lobby to the west, showing its tiled mid-20th century fireplace with the door to the lab on the left. This part of the mill was a domestic house for the manager and was occupied as such until its closure in 2009.

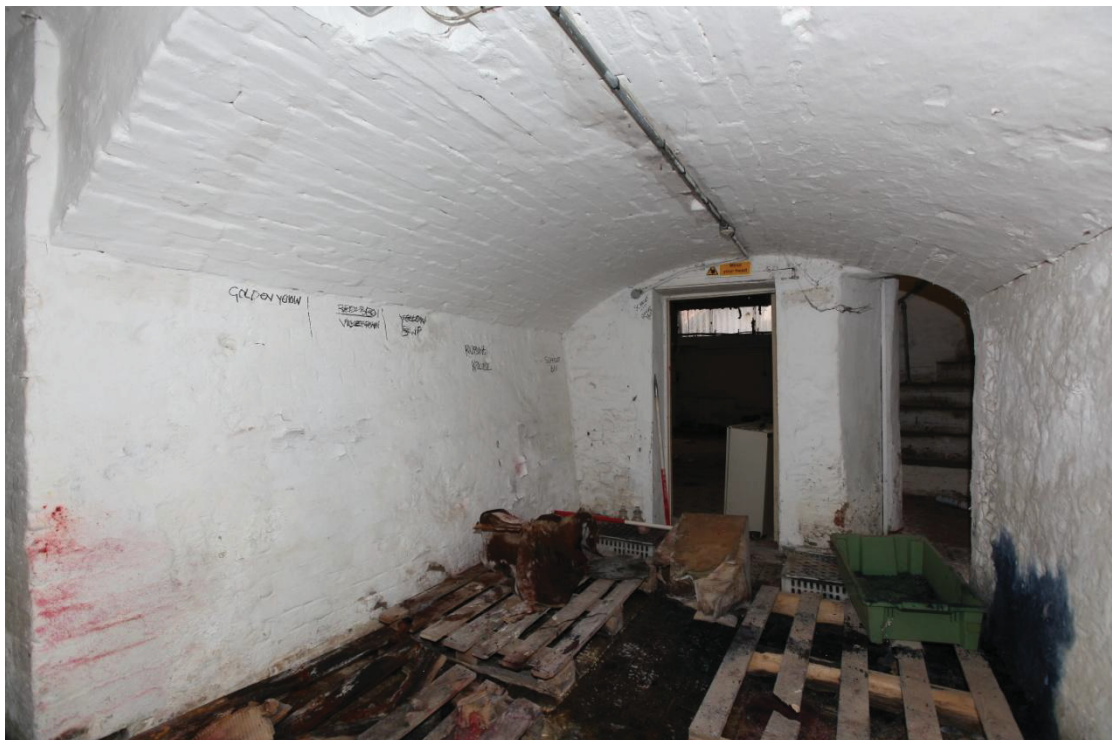
Illus. 14. The interior from the south of the barrel vault beneath the lab, showing the door to the drying room on the left and the stair rising to the dye office on the right. The pallets were evidently used to store dye, with the names of colours such as 'Golden Yellow' and 'Scarlet BN' inked in the whitewash to the left.

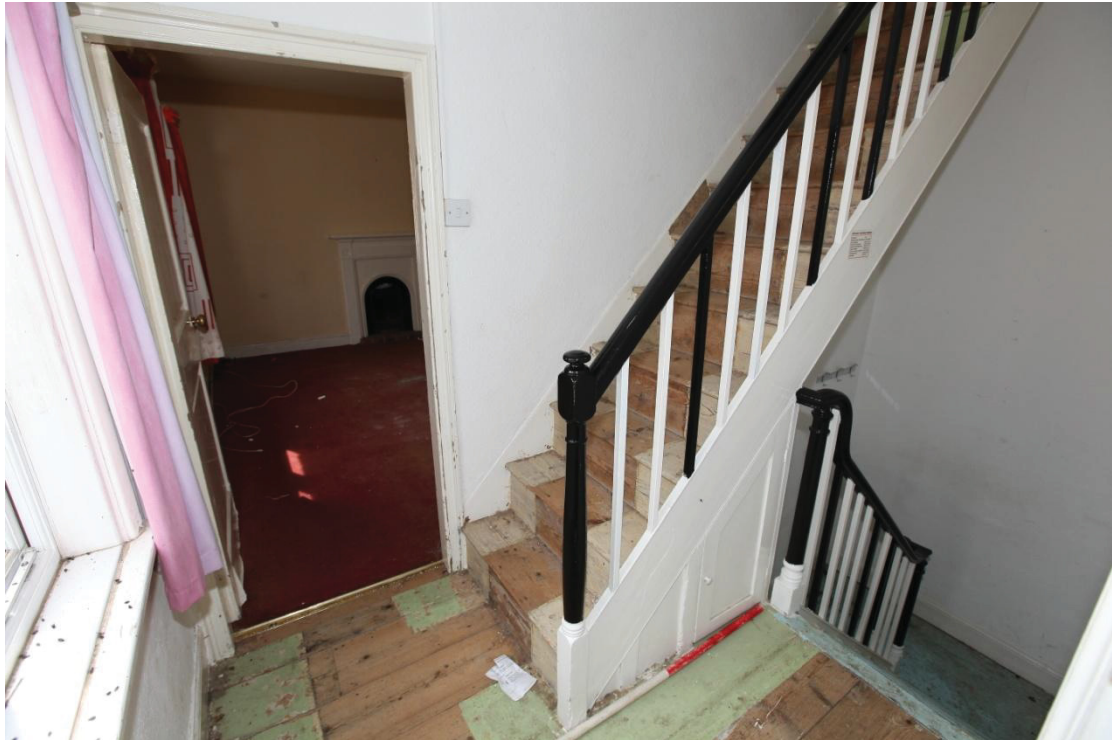
Illus. 15. The second landing of the original central stair in the dwelling house seen from the east. The stair descends to the entrance lobby on the right (illus. 12) and rises to the attic rooms. The bedroom to the west (left) contains an arched late Victorian coal grate and is linked to the kitchen of a modern flat, both of which lie above the ground-floor WC.

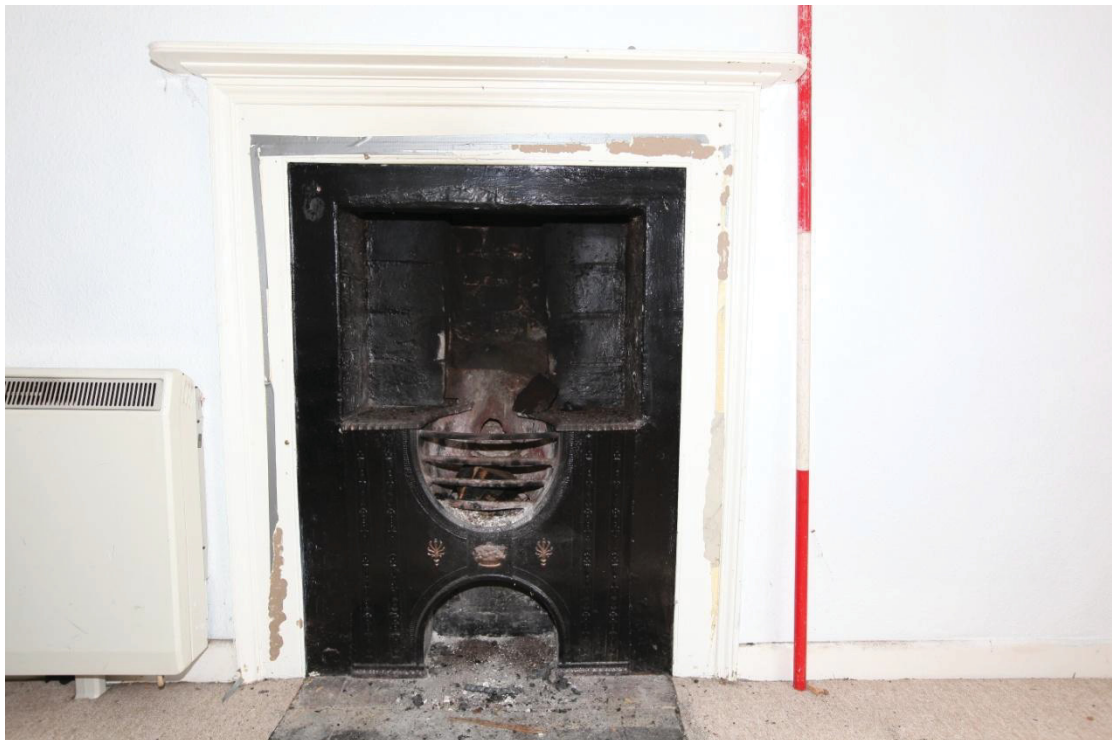
Illus. 16. A detail of the late Georgian swan's nest coal grate in the eastern gable of the first-floor bedroom above the office. This is typical of the 1820s and is likely to be original to the 1824 mill.
