12-14 Eden Road and 85-87 High Street,
Haverhill
HVH 081

Archaeological Evaluation Report

SCCAS Report No. 2013/080

Client: Havebury Housing Partnership

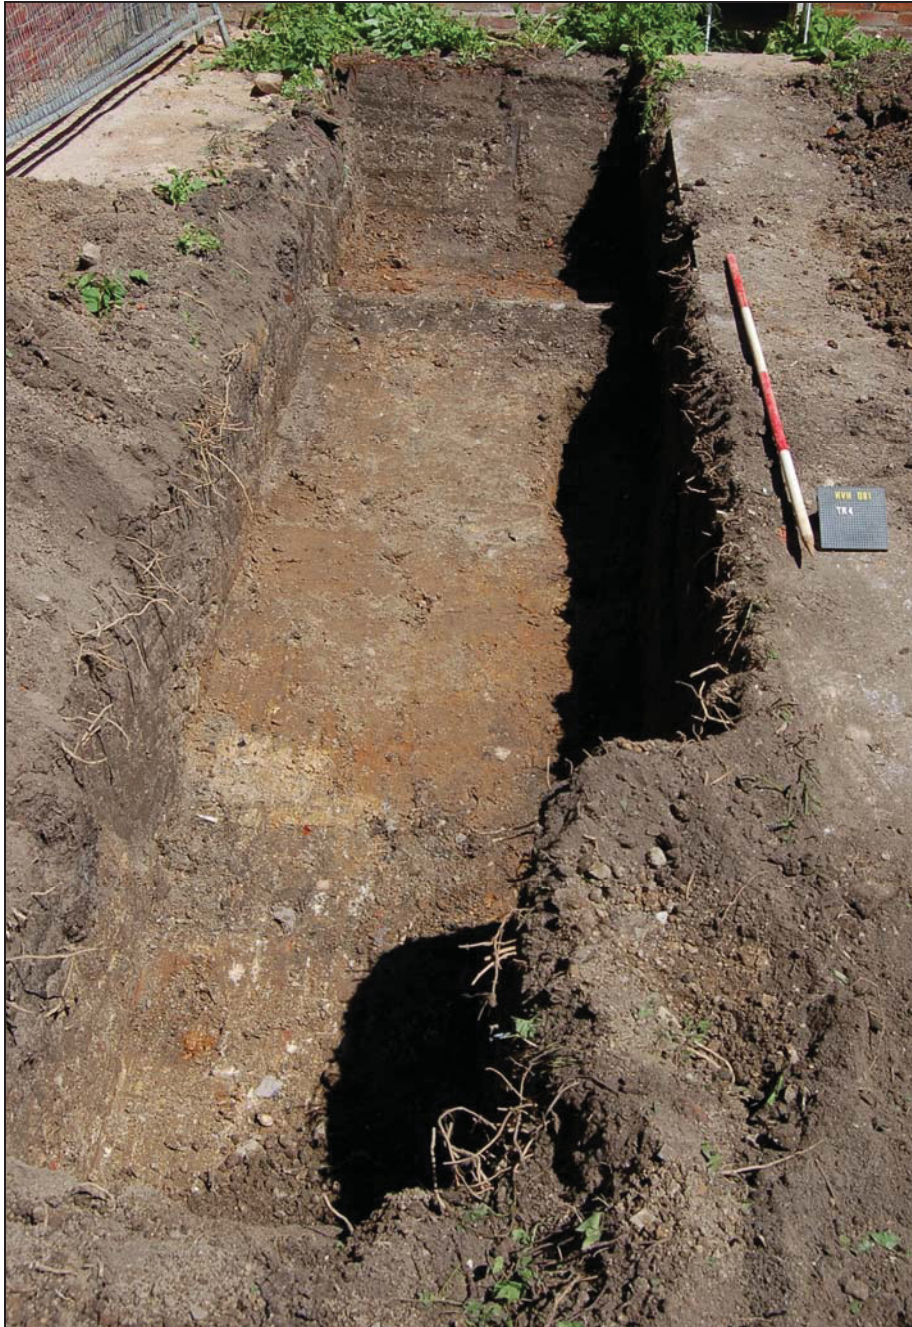
Plate 1. Trench 4, facing north-east (2m scale)

This trench was 6.5m long, 1.3m wide and up to 0.8m deep. The stratigraphy encountered consisted of 0.4m of dark brown humic-rich sandy silt topsoil/garden soil with occasional small ceramic building material (CBM), glass and crockery fragments above a similar deposit 0.35m thick of dark brown sandy silt with more frequent CBM, roof slate, bottle glass, roof tile and china fragments interpreted as a (?) Victorian/modern made/disturbed ground layer. The fragments and lumps of cultural material were noticeably larger in this layer than in the higher deposit – potentially due to garden maintenance/turnover having removed the larger pieces from the upper soil level (in a similar way to de-stoning agricultural land).

This made/disturbed soil sat directly above natural red/brown silty sand and gravels and chalky patches, with three large modern intrusive features noted as cutting into the natural geological layers. Finds from this trench included brick lumps with 'LBC' stamped into the frog, green bottle glass, roof slate, blue/white china, white glazed china, modern window glass and frequent roof tile fragments.

No deposits or artefacts of archaeological relevance were observed from this trench.

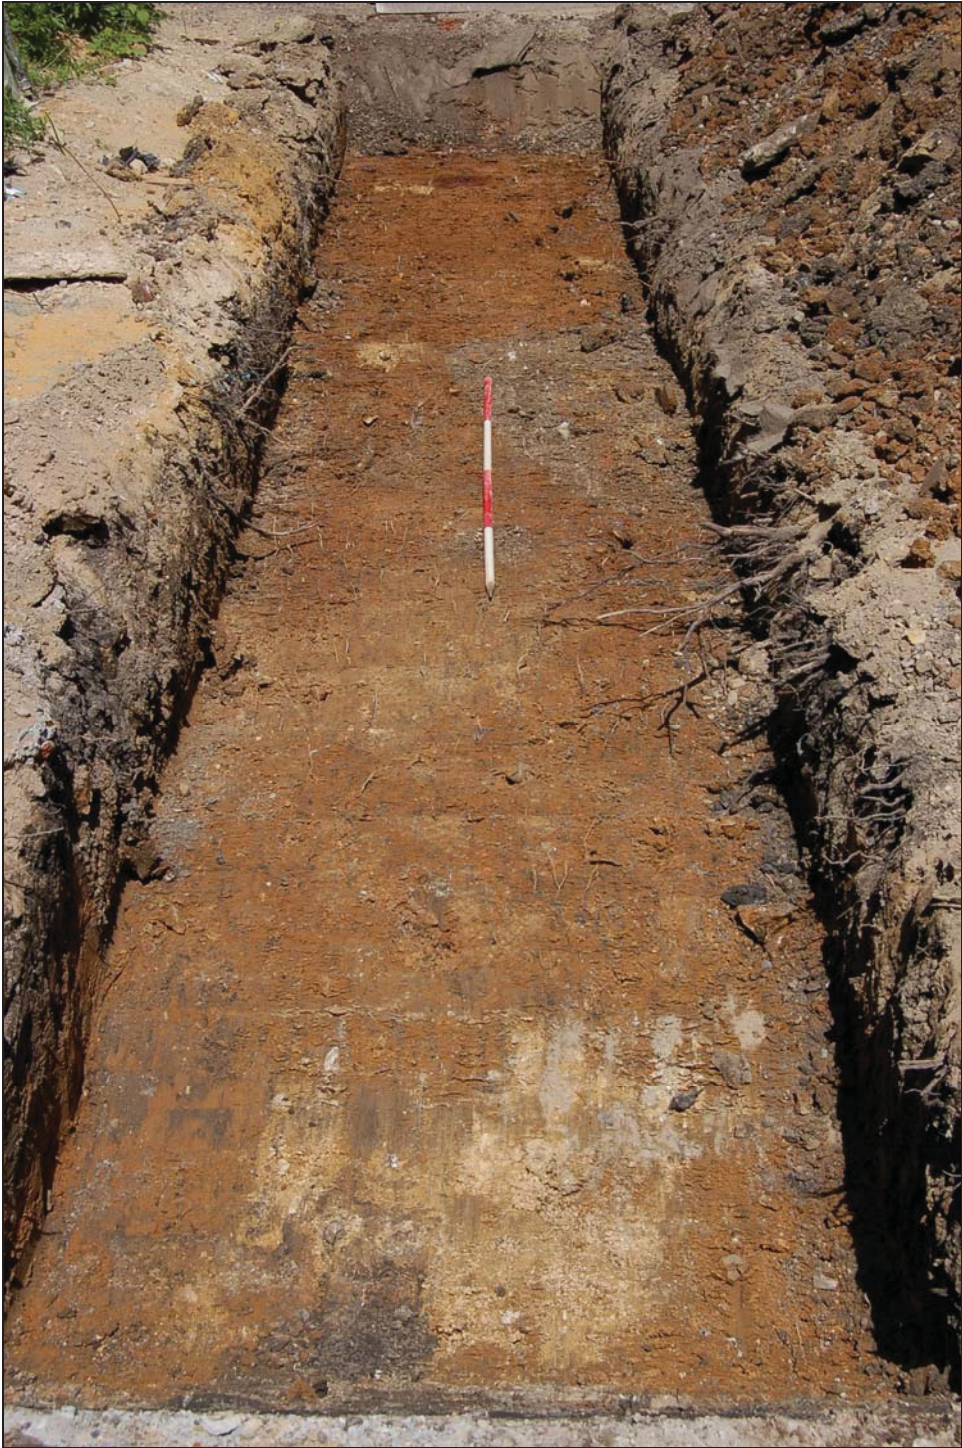
Plate 2. Trench 5 facing north (2m scale)

This trench was 10.5m long, 1.5m wide and up to 0.7m deep, orientated approximately north-south. The exposed stratigraphy consisted of c.0.35m of modern hardcore/ demolition rubble and gravel above sheets of geo textile (the made ground surface for the recent site compound used during development of 83 High Street) which lay on a layer approximately 0.25m thick of mixed orangey brown silty clay with very frequent rubble/building detritus inclusions. This sealed natural orangey brown silty clays and chalky patches. Two modern features were observed, a large pit and a small posthole,

both of which contained CBM fragments and lumps of modern brick and tile, glass and modern china.

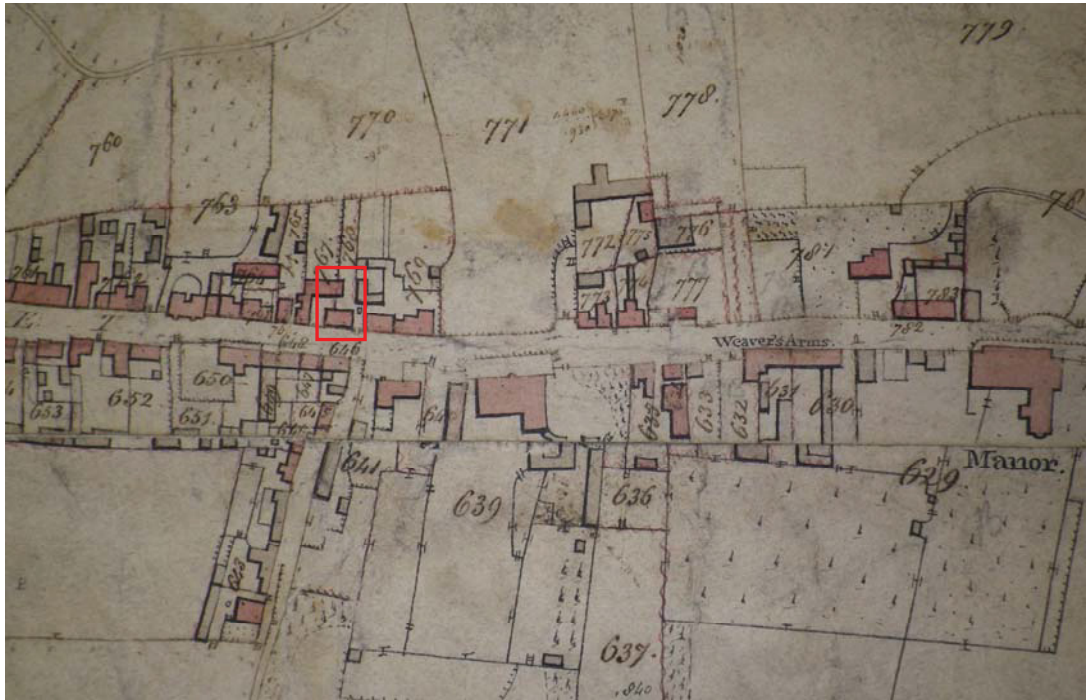
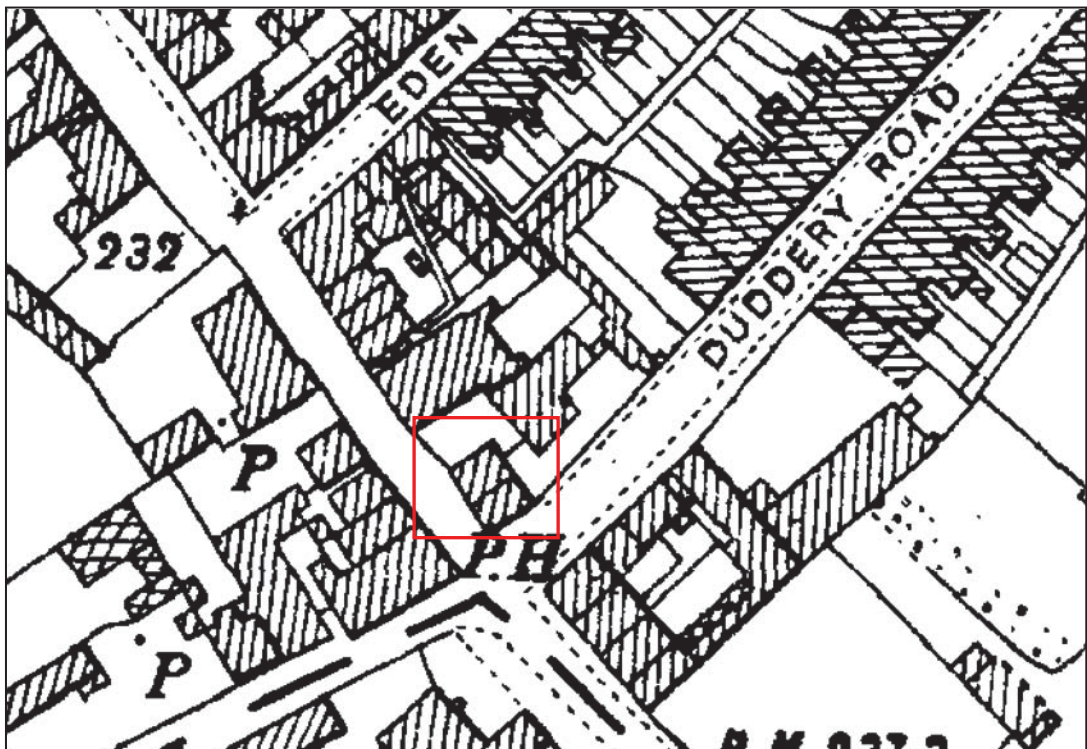
Figure 1. The surveyed building out lined in red on the Tithe and early Ordnance Survey maps

Duddery Road and Eden Road which flank the site are the result of a late 19th expansion of the town's street plan and are lined with brick-built terraced houses. The tithe map of 1840 (Fig.1) provides an illustration of the town prior to the creation of these new streets and shows the properties (numbers 769, 770 and 765) that were lost to the change. The surveyed building is shown on the map (no 768) as a single building and is depicted seemingly with the same footprint as it has today. The accompanying tithe apportionment records that the building was owned by Daniel Gurteen, the son of the founder of Daniel Gurteen & Sons who were manufacturers of woven cloth and, by the end of the C19th century, the largest employers and extensive property owners in the town¹. It was occupied by Edward Gurteen and Grace Auber. Edward also owned the property next door where the tenant was Stephen Webb. Webb is listed in the 1844 Suffolk Directory as a drabbet maker and therefore probably an employee of the Gurteen family firm.

The first edition OS map shows the new streets and surveyed building divided into two; both the tithe, and Ordinance Survey maps record the west boundary of the rear yard inside the line of the NW gable so that this end of the building appears to impinge on the neighbouring plot. The arrangement of the back doors however indicates that the two halves of the building shared the rear yard which was reduced in size, losing part of the north end and the street access to south-east of the building, when Duddery Road was created.

Tithe map and apportionment 1840 (MS47/16 a-c)

2nd Edition OS map 1904 the site is unchanged from the 1876 1st edition

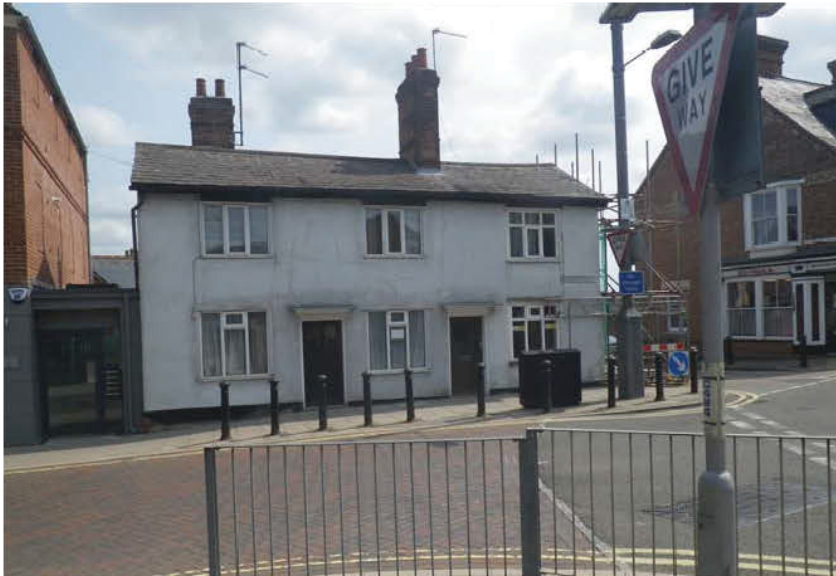
The front of Nos. 85 and 87 High Street viewed from the south. No 87 is to the left and the double fronted door cases are original and suggest an early 19th century date. The windows and slate roof are thought to be later replacements.

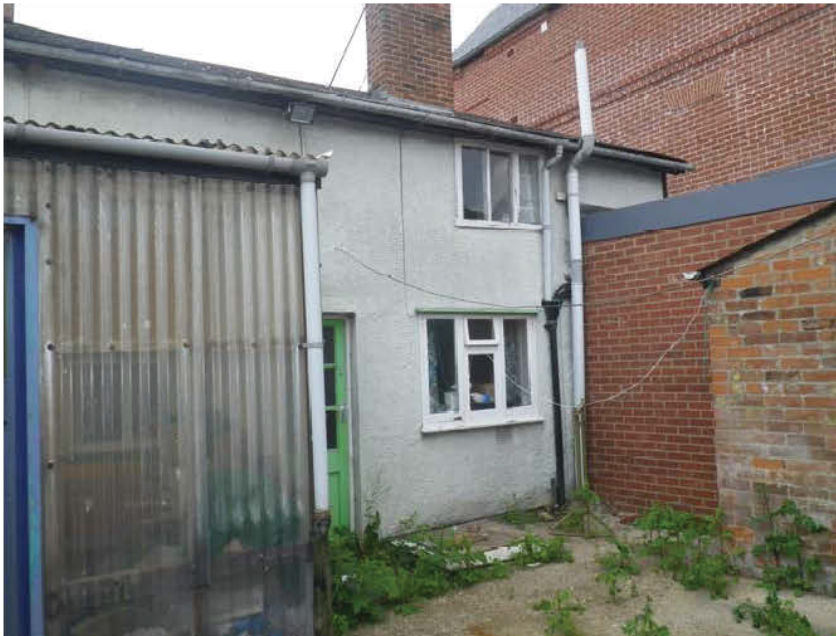
The rear of No 87 viewed from the north. The modern brickwork alongside the soil pipe follows the property boundary as shown on the tithe map of 1840 so that the north end of the building projects into the neighbouring plot in the manner of a flying freehold.

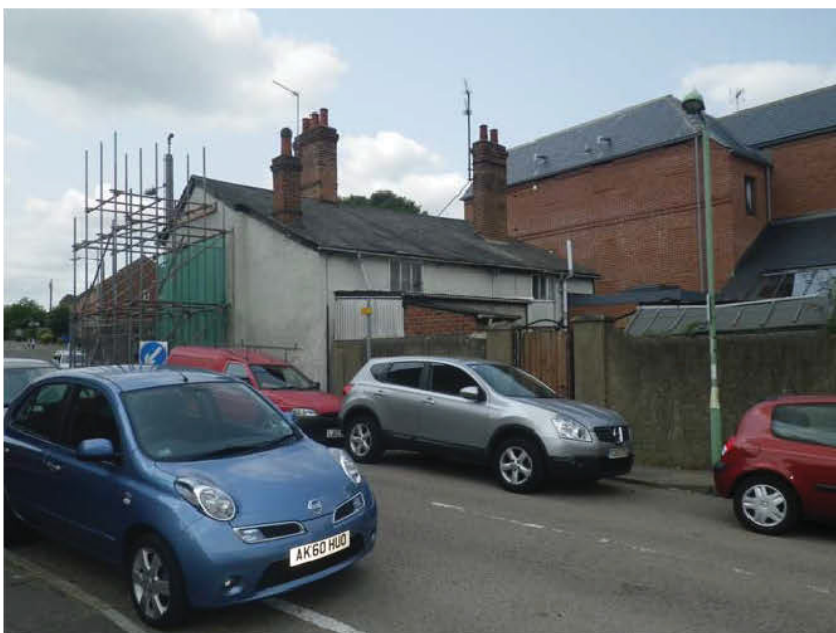
Rear of the building viewed from Duddery Road. The asymmetrical roof and the slight step in the gable wall suggest that the building is built in two bays, the rear being in effect a lean-to. The bays are contemporary.

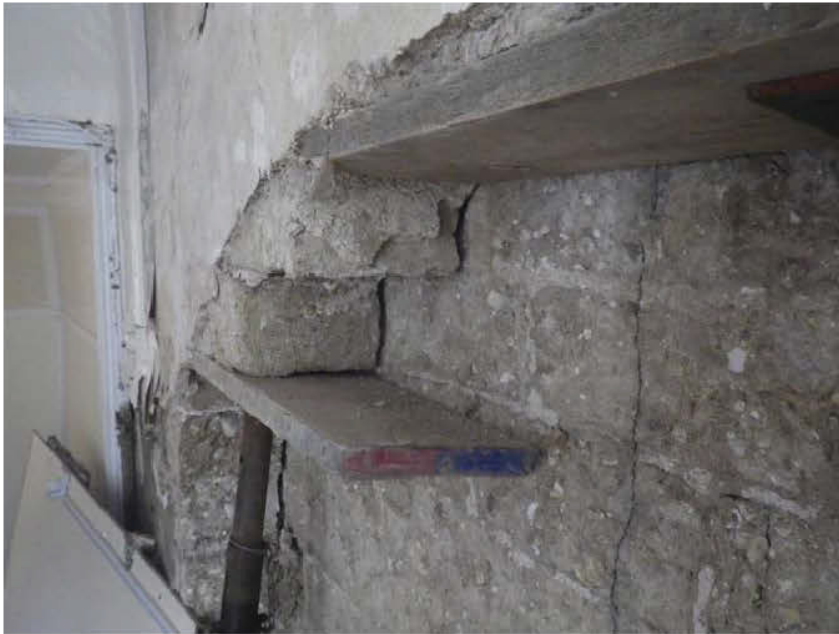
Double skin of clay lump block forming the south gable wall in room G1. The wall changes to timber-frame construction at first floor level. Note that the two faces that make up the wall do not appear to be bonded or keyed together.

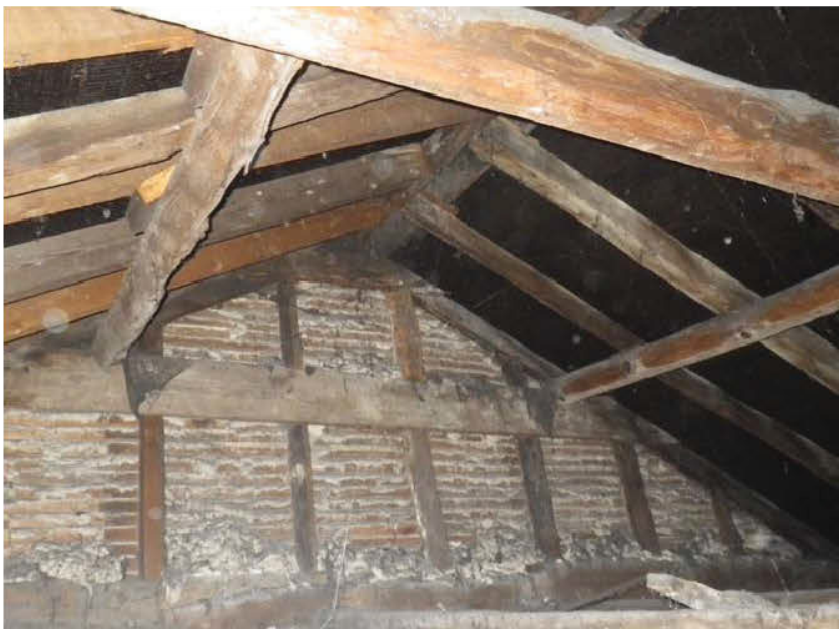
Roof structure over no 87 looking S. with clasped purlins. The purlins and the collar in the immediate foreground are made from timber left in the round; the plank-like collar at the far end is a replacement. Note the large tie beam which seems to have been made from two pieces of wood joined with a half-faced scarf joint. The well spaced studs suggest a late date.

The roof has a shallow pitch with paired rafters attached to a replacement ridge board; the rafters rest on clasped purlins held in place against the principle rafters by collars. The principal rafters rest on substantial tie-beams that run across the building and bind the front and central spine wall together. Where the original roof structure survives, the timbers are left as minimally worked baulks and left in the round or half-round and there are examples of tie beams, collars and rafters all dealt with in this homespun way. All of the timber is soft-wood. Much of the roof structure has been renewed (long ago) with sawn timber and it is quite likely that the slate covering was also added when the roof was refurbished and may have replaced more locally produced tiles; the roof pitch is original and far too shallow for thatch.

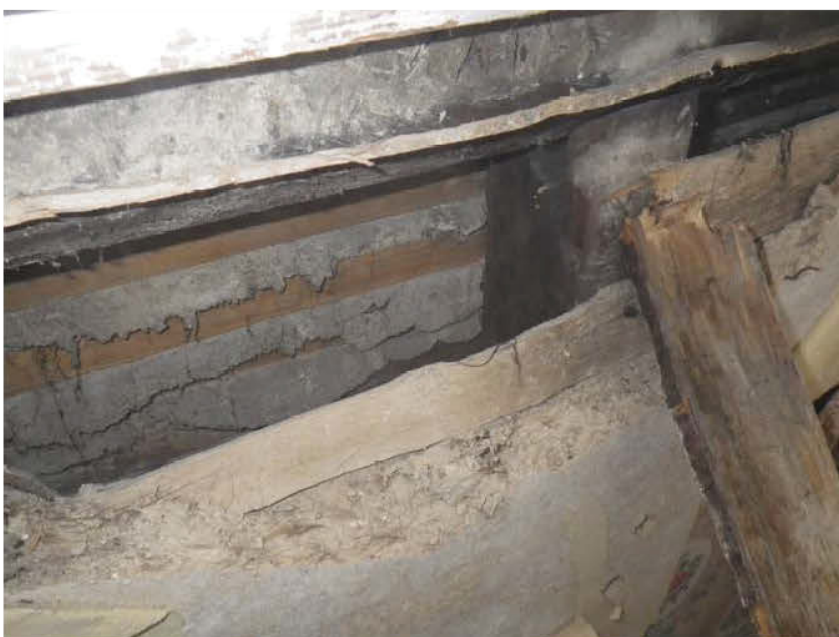
Inside of the front wall in Room F1 showing the timber framing. The vertical stud had been altered possibly to create a larger window opening and there was no indication of medieval carpentry joints. The photo shows the back of the external render which has been replaced in the recent past.

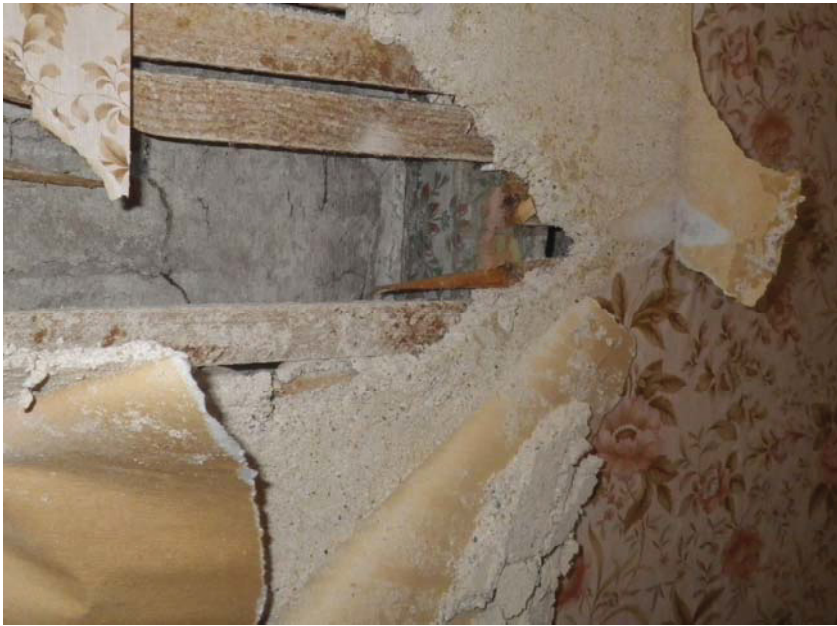
South gable wall in room in F1 showing the original plaster recessed back from the face of the studs behind later plaster work. The now hidden studs appear to have been individually wall-papered in a virtuos display of decorating.

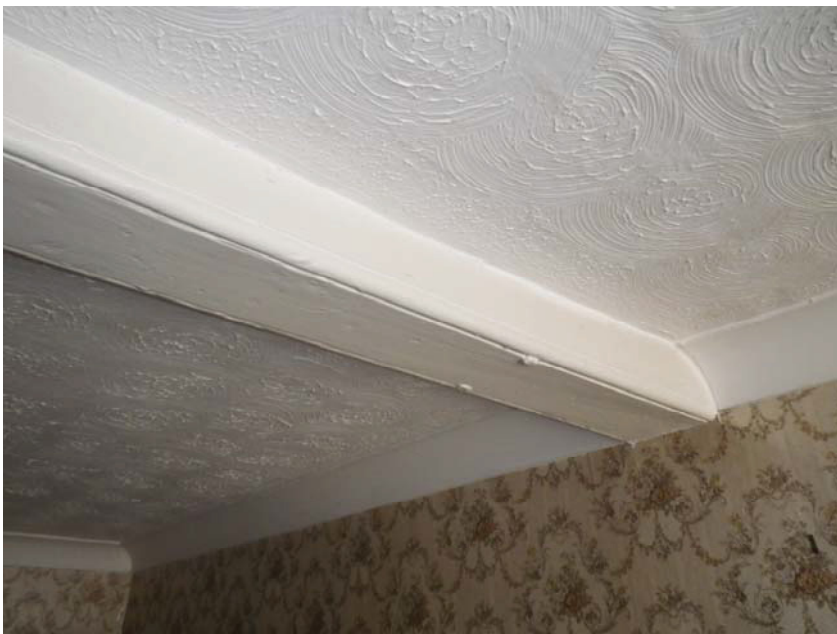
Bridging beam running across the centre of rooms G4 and 5. The moulded corners passed through the partition wall uninterrupted; this is not an indication that the partition is an insertion as there are no moulded stops on the beam ends.

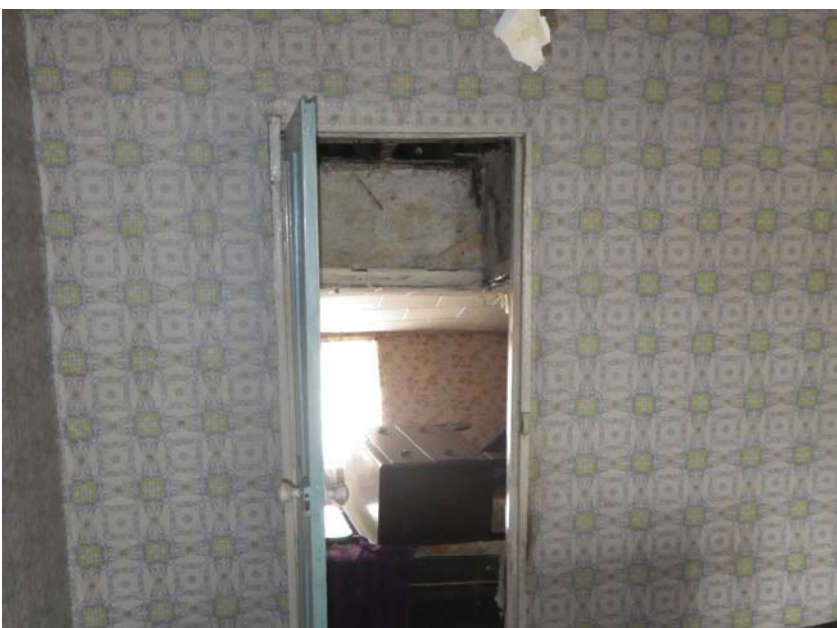
The door between Rooms F1 and F2 at the rear of the house. The floor and ceiling heights are much lower at the rear and a raised box-like section has been built into the rear ceiling to allow passage through the door.

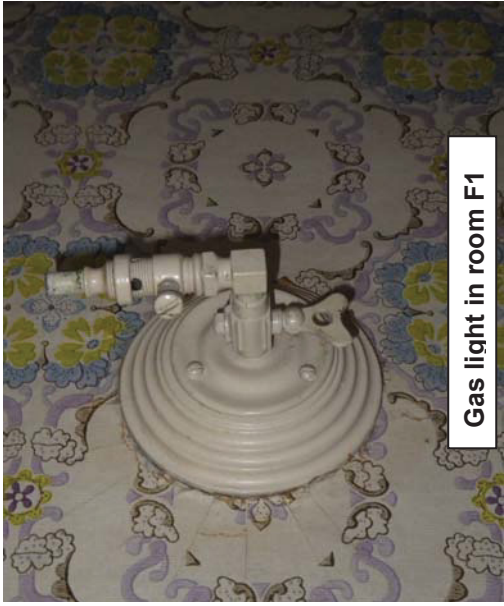
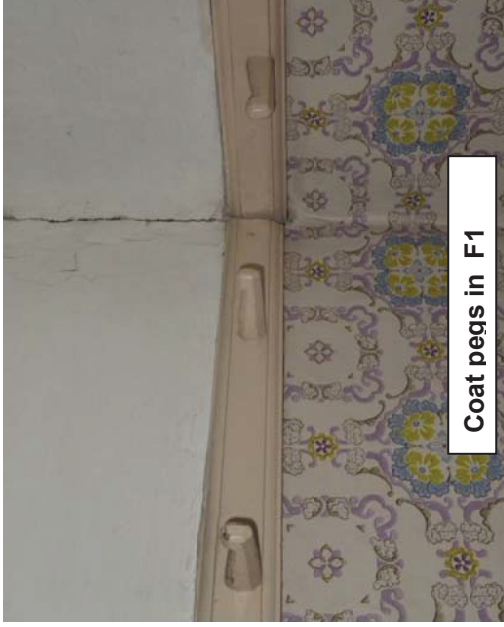
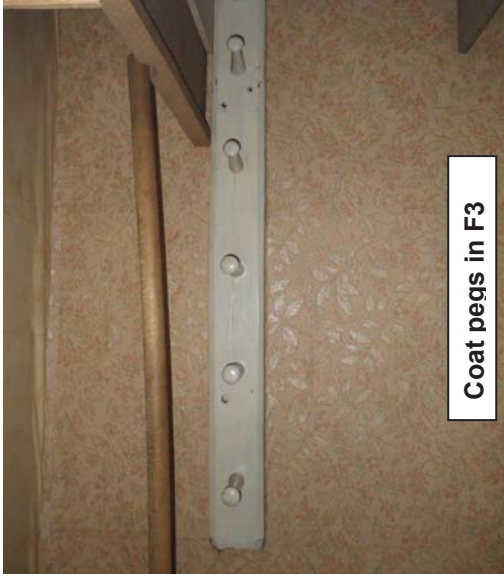
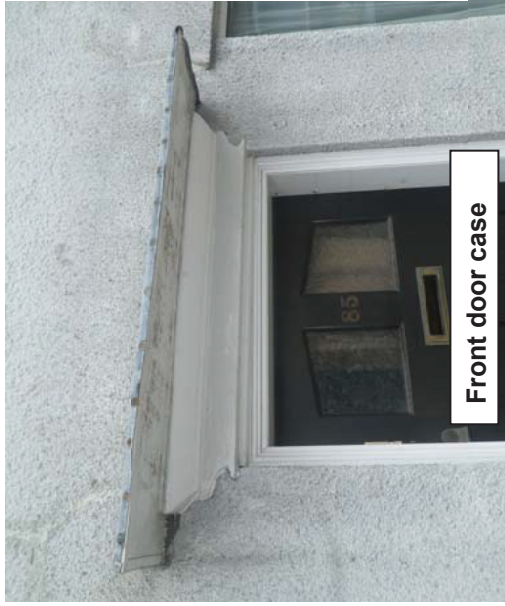
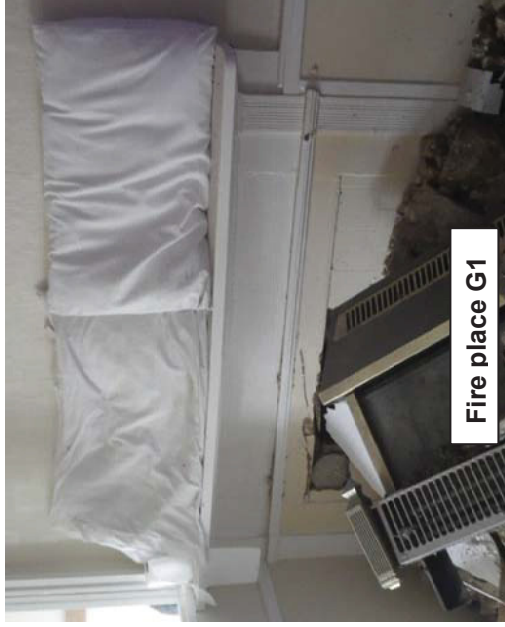
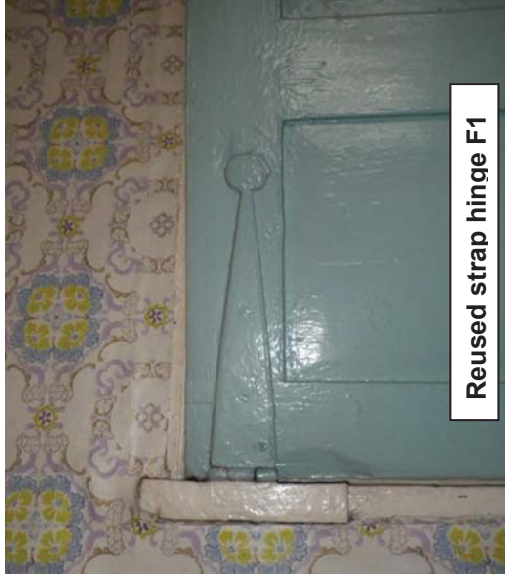
Selection of architectural features and fixtures retained within the cottages that date to the early and later 19th century
