# ARCHAEOLOGICAL EVALUATION REPORT

## Stanstead Hall, Stanstead STS 018

A REPORT ON THE ARCHAEOLOGICAL EVALUATION, 2006  
(Planning app. no. B/05/2168)

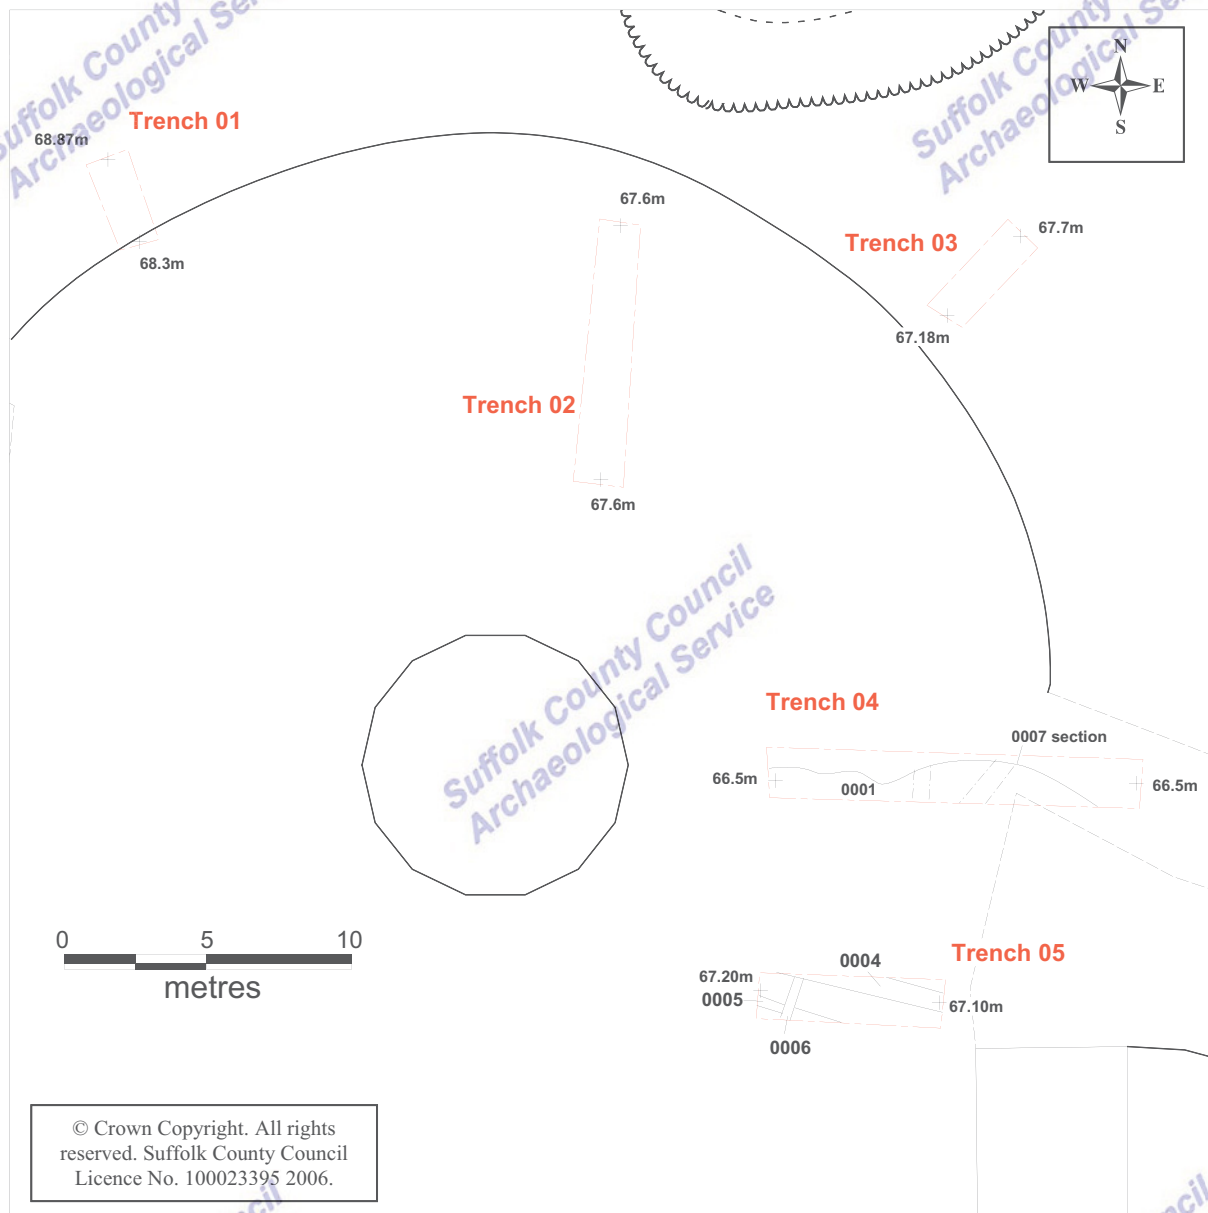
Figure 5. Trench plan

A series of five trenches were excavated in areas that were to be affected by the development. Three trenches were placed along the proposed course of the boundary wall, with two more on the footprint of the proposed extension. These trenches had two broad aims, the first of which was to see if any archaeological deposits existed relating to the medieval hall, particularly in trenches 01-03. Secondly trenches 04 and 05, being located immediately adjacent to the later hall, had the potential to identify a demolished range of buildings shown on the first edition OS, and help date the current structure.

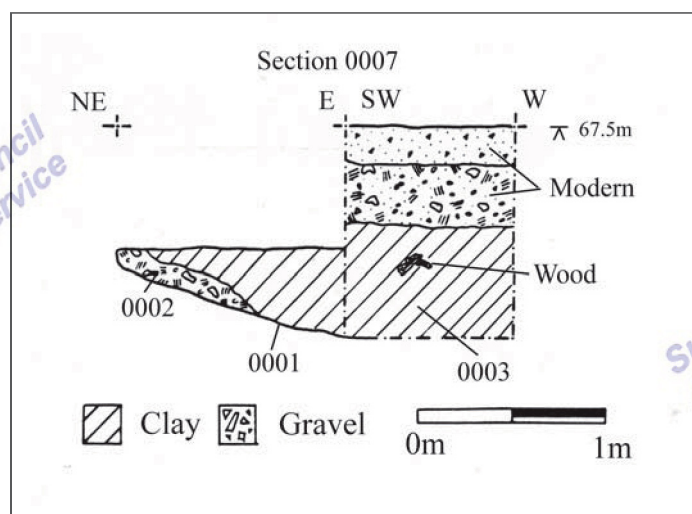
Figure 6. Sections

Trench 05, measuring 6.5m long and aligned east-west, was placed through the gravel driveway adjacent to the north wing of the hall where, on the first edition OS, a small range of buildings is shown. After the removal of 0.2m of gravel, two wall foundations and a brick lined drain were clearly visible. Machining was then halted and the trench cleaned by hand. The top of the three features were at the same level and corresponded with the base of the driveway, which lay upon a clay surface which was probably redeposited natural subsoil.

The southern wall, 0005, was on an east-west alignment and was constructed from red bricks set in a friable yellow mortar. Very few of the bricks were visible as the wall had been neatly demolished leaving an intact layer of mortar across the top.

To the west wall 0005 was cut by a north-south aligned drainage trench, 0006, which was lined with loose red bricks and contained a ceramic pipe. To the north this drain was cut by wall 0004, which consisted of a concrete foundation and the basal red brick course of a recently demolished garden wall.

The drain 0006 and wall 0004 in trench 05 were clearly relatively modern and of limited interest. The wall 0005 however is clearly the surviving foundation of the southern edge of the range of buildings shown on the first edition OS and demonstrates that the foundations for these outbuilding may survive intact under the driveway.

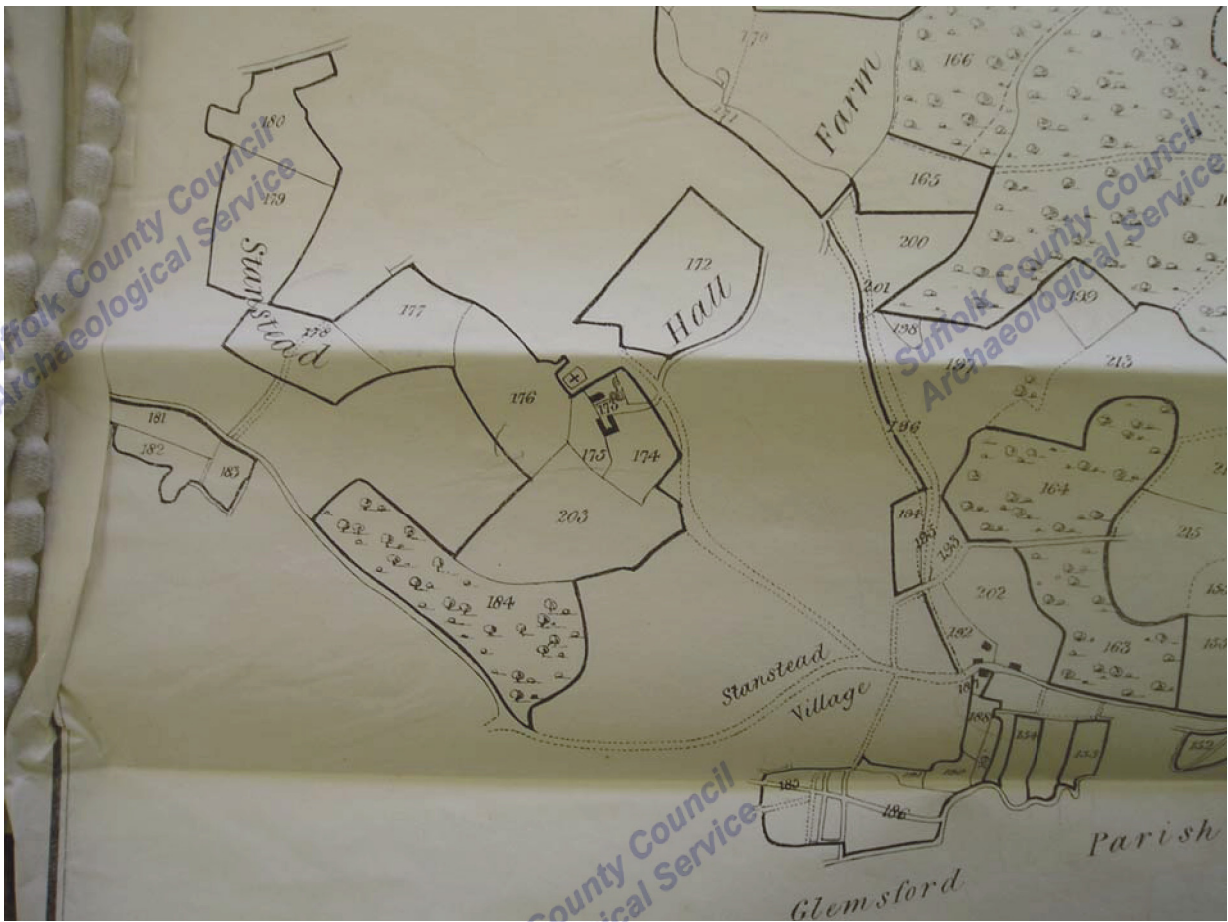
Figure 3a. Kentwell Hall Estate sale plan 1839 detail.

Attached to the sale particulars is a plan of the entire estate (Appendix 2, figs 3a & 3b). The plan shows the pond or possible moat and to the west a linear building, possibly the barn. The main entrance and driveway appears to the north of the present entrance to the hall.

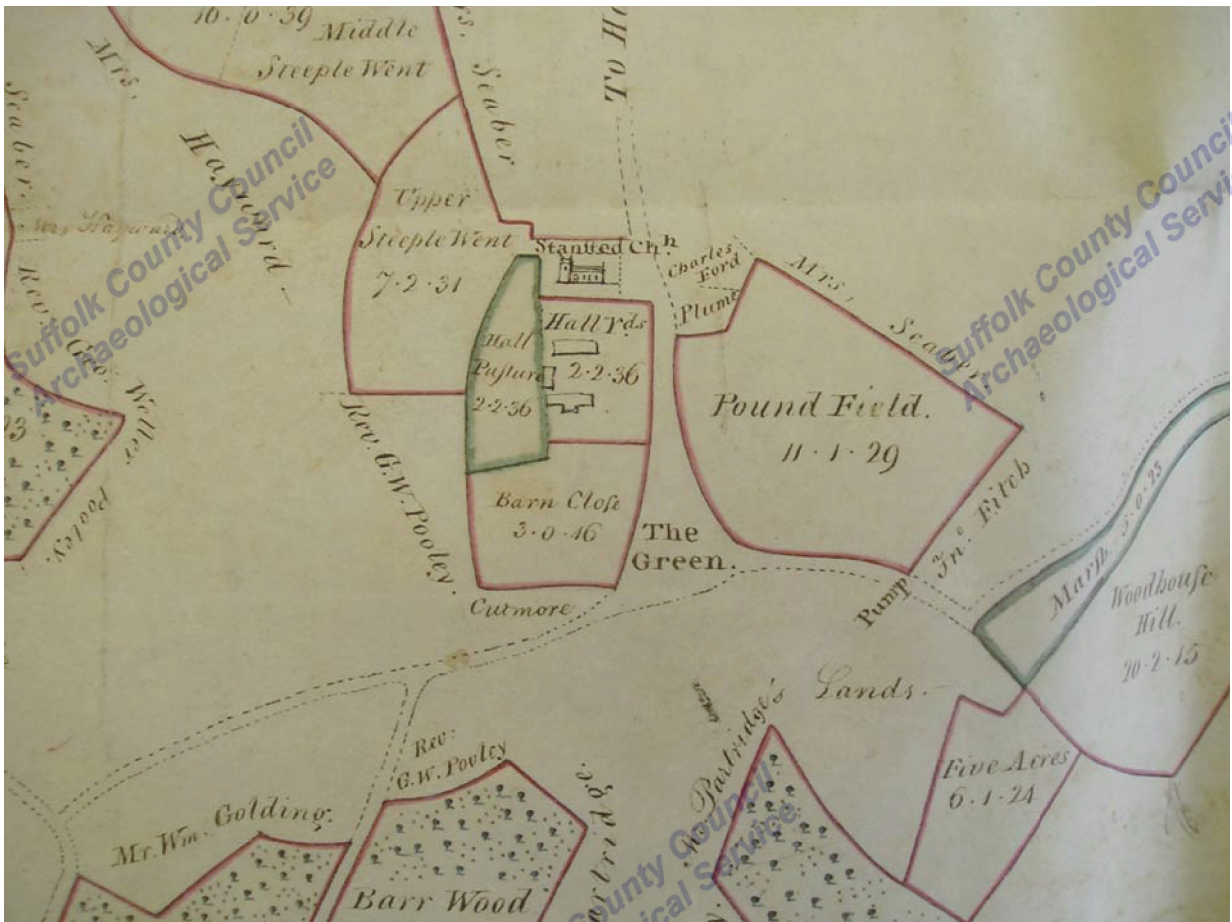
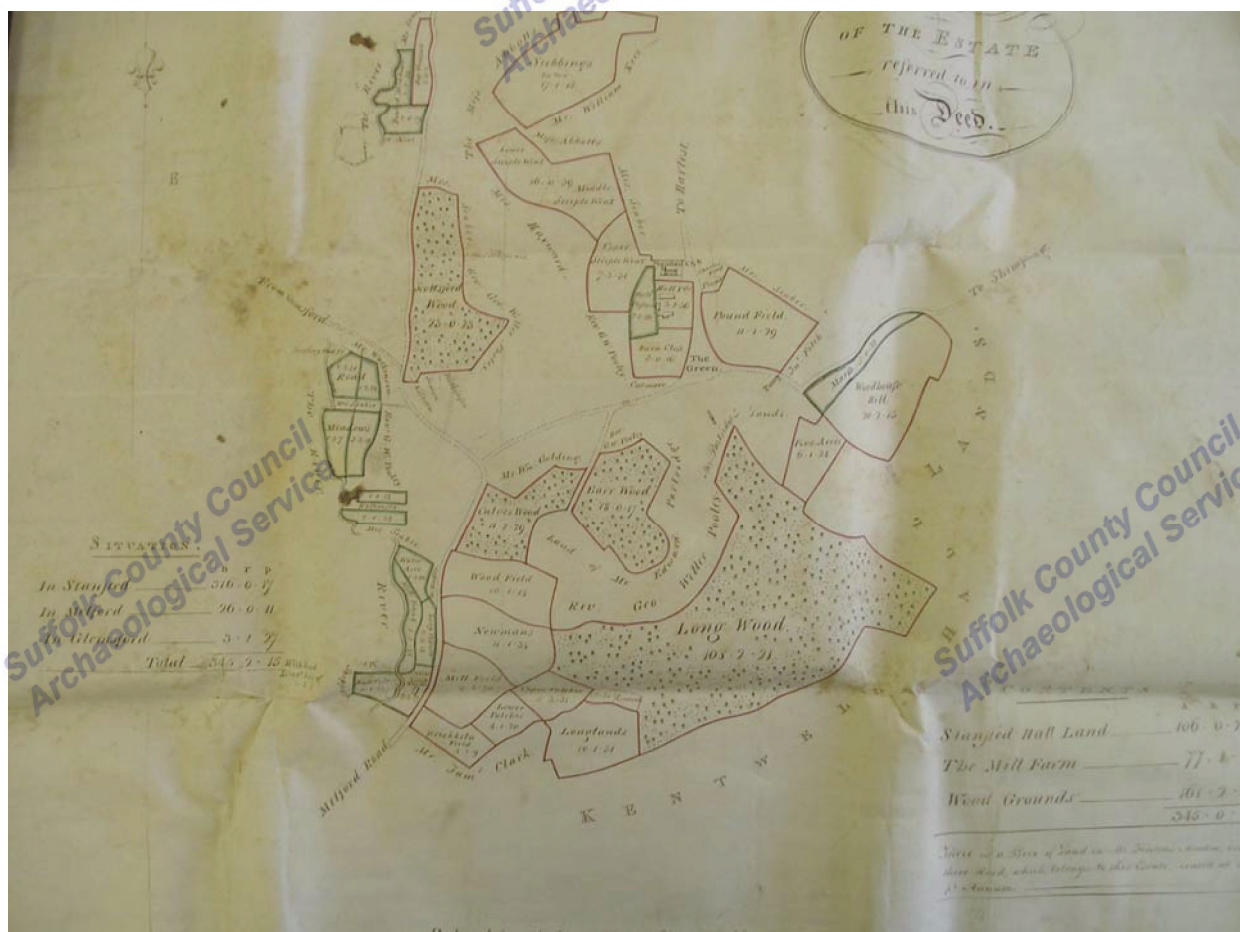
Figure 4a. Deed plan 1808 detail.

The earliest plan (Appendix 2, figs 4a & 4b) is attached to deeds of lease and release dated 3<sup>rd</sup> & 4<sup>th</sup> October 1808 between “*Sir Mordaunt Martin Bart and others to Richard Moore Esqr and his trustees*”. The release is endorsed “*Release of the Manor or Manors of Overhall and Netherhall &c in the County of Suffolk*”. The plan lists the contents as

At the foot of the plan there is the inscription “*Reduced from the Large Map of Sixteen Perches to one Inch, By Isaac Johnson Surveyor Woodbridge, Suffolk*”. The Isaac Johnson collection is held at the Suffolk Record Office in Ipswich though there are no maps of Stanstead within the collection.

The area around the hall is not shown in detail and the pond or possible moat is omitted. The formal property description is on the third sheet of parchment in the release.

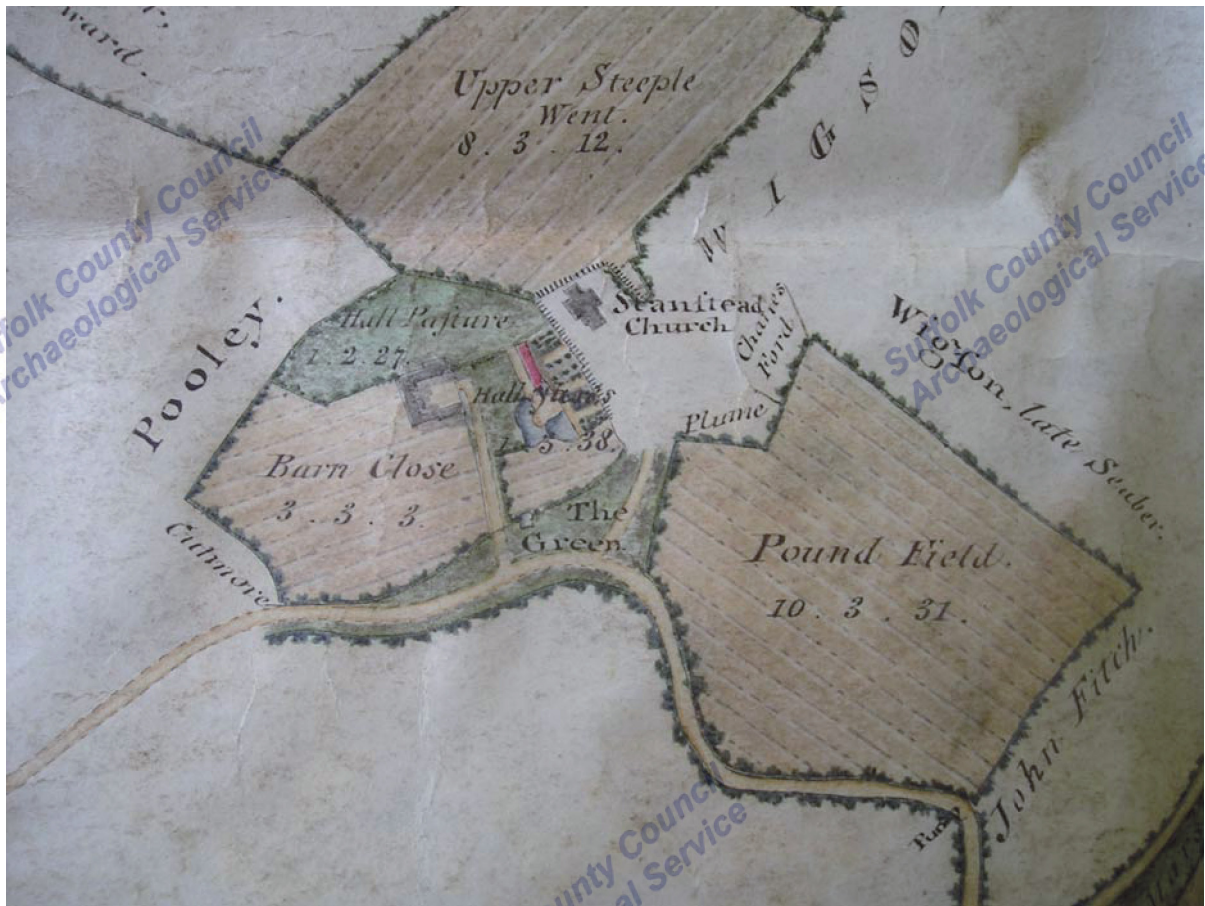
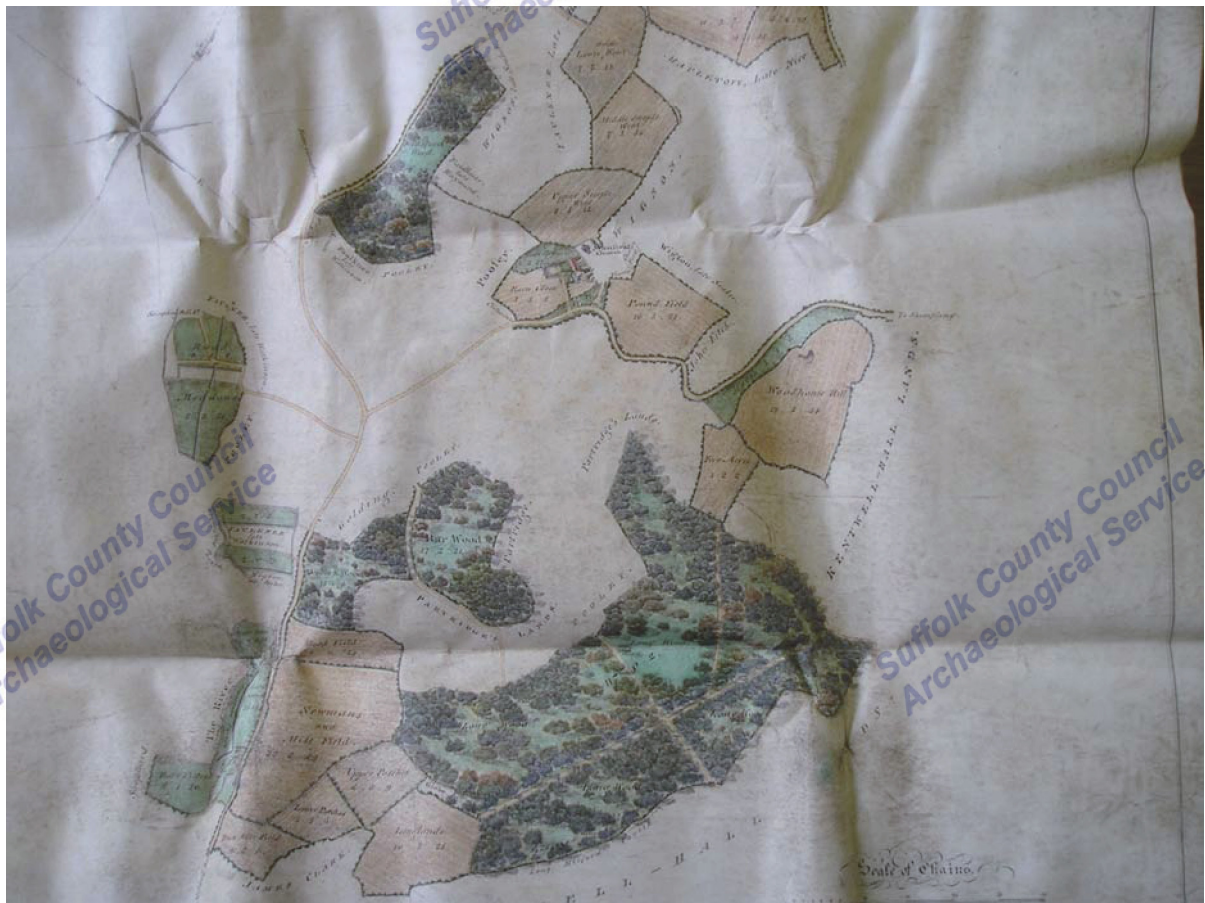
Figure 5a. Deed plan 1835 detail.

The later deed is again a lease and release dated 30<sup>th</sup> June and 1<sup>st</sup> July 1835. The parties were “*Mr William Moutrion and others to Hart Logan esquire, Conveyance by lease and release of the Stanstead Estate in the County of Suffolk*”. On the beautifully coloured plan (Appendix 2, figs 5a & 5b) the site of the hall is clearly shown not in its present position but to the west of the pond or moat and parallel with the church. The deed consists of twelve sheets of parchment and the property description appears on the ninth sheet. It includes a shorter description of the manor and then

The acreage of this site in the tithe apportionment is different to that given on the later Ordnance Survey maps. The plan on the 1835 deed shows an area of green that is common land to the east of the hall and along both sides of the road. Most areas of common land were enclosed through act of Parliament, though not all. In some areas if green was the property of the one manor it could be enclosed without resort to parliament. There was also a general enclosure act that gave powers to enclose such areas. The difference in the acreage might reflect that the plots included areas of the green that were not subject to tithes.
