# Church Field, Rede RDE 016

## **Archaeological Monitoring Report**

**SCCAS Report No. 2013/055**

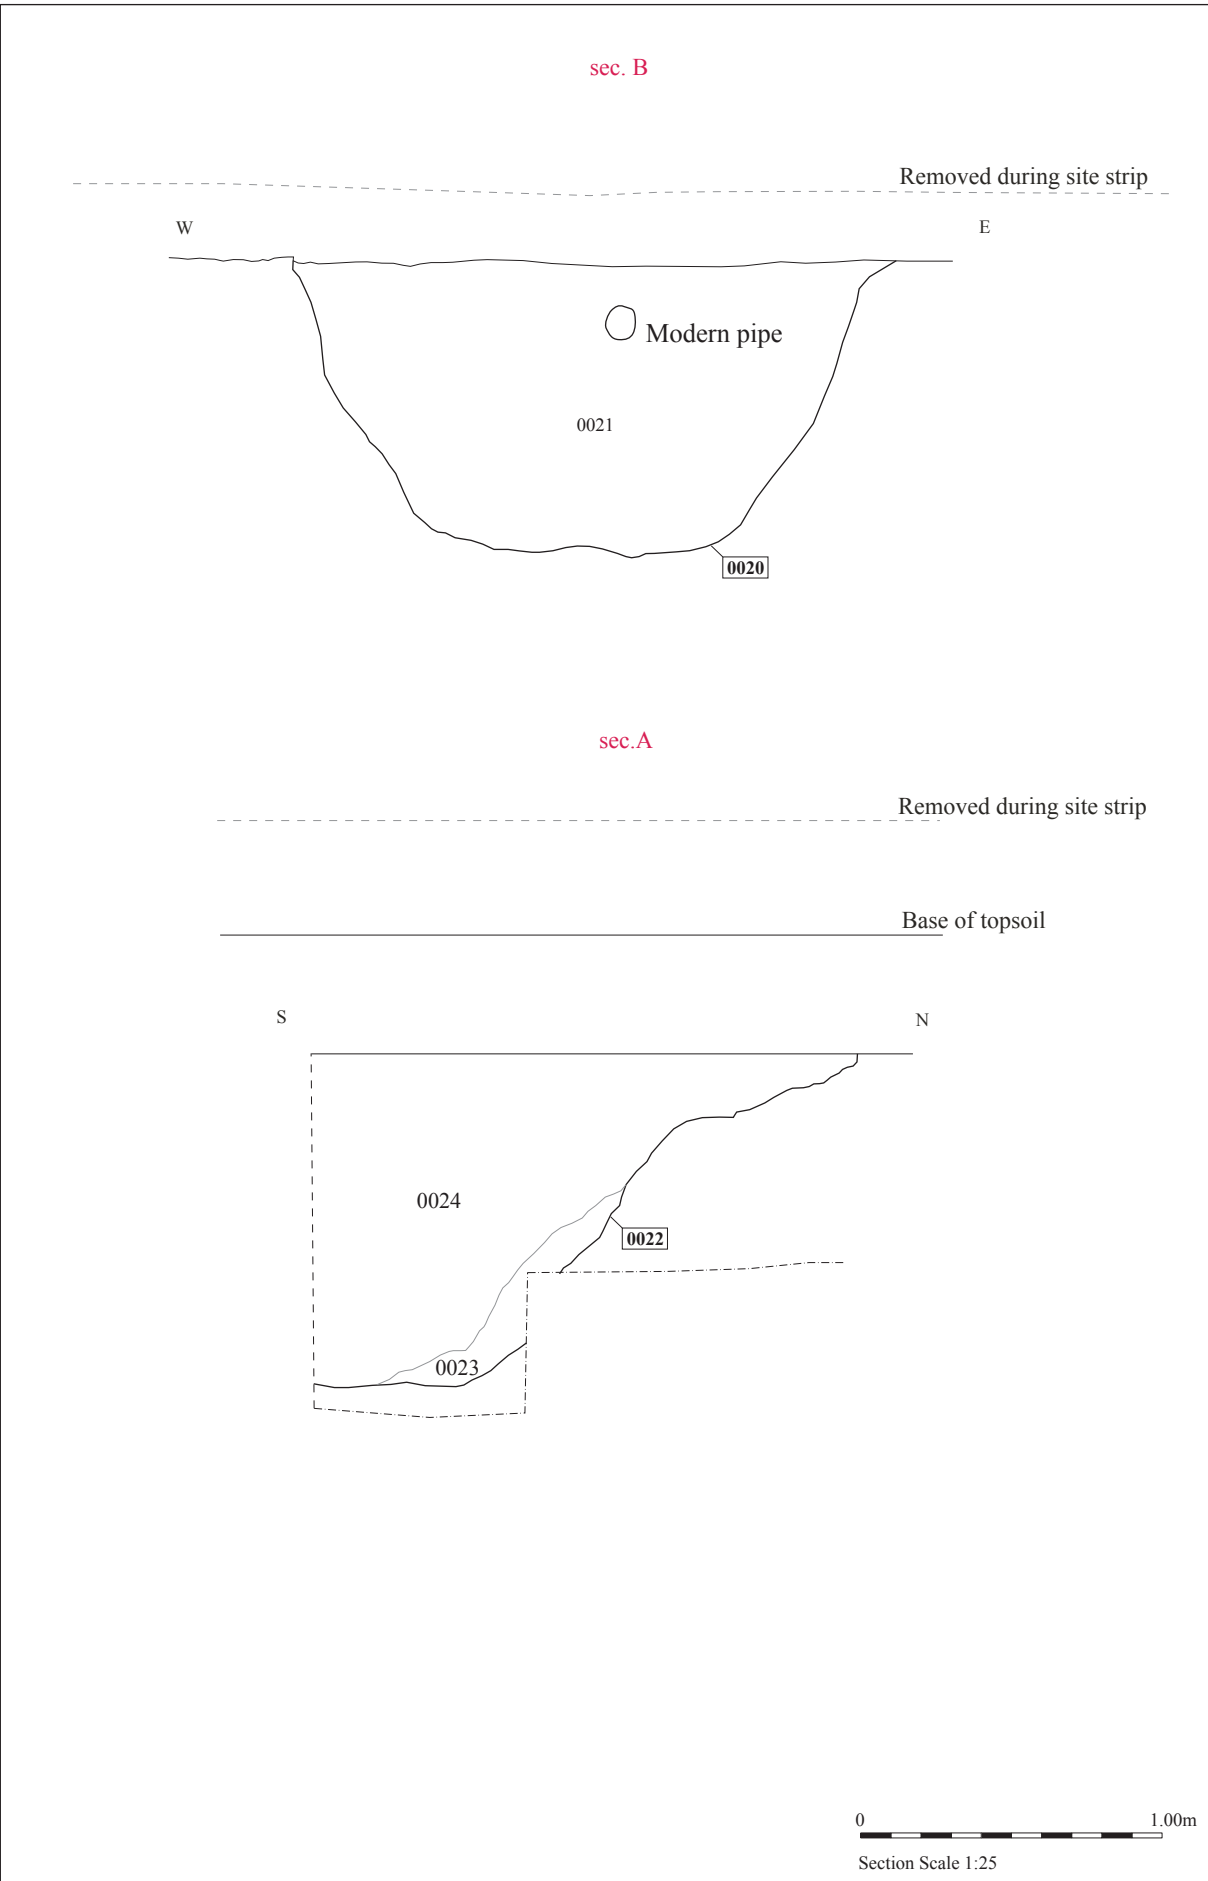
Figure X. Figure Caption

Several visits were made to the site during the excavation of footing trenches; the topsoil had been stripped from the site and some subsoil removed in order to create a level platform, up to 0.8m was removed from the south-west corner. Footings for the previous garage had not been grubbed out. Two sections were recorded and these were of ditch 0020 and pit 0022 (which produced finds). With the exception of the two ditches first recorded in the evaluation, the remaining features were pits of which representative sections were included in the evaluation report. A single context recording system was employed and digital photographs taken of the work. Approximately 80% of the footings were monitored during excavation and recorded photographically (Fig. 2). Footing trenches for the southern garage were not seen because the new build was to be on a similar footprint.

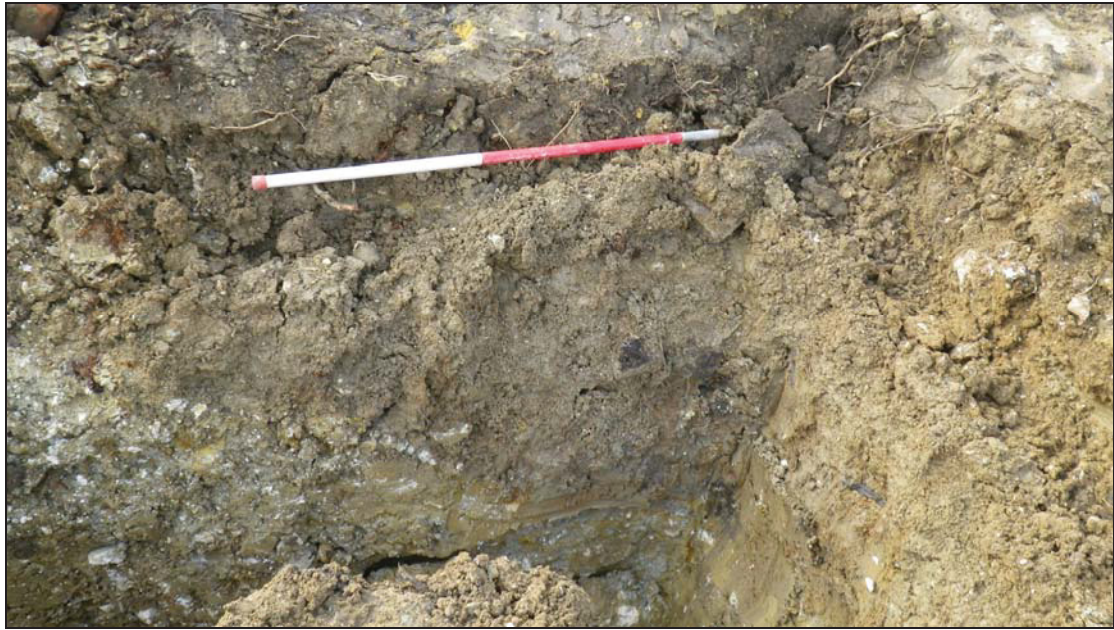
The footings varied between approximately 1m and 2m in depth below the already stripped topsoil (c. 0.3 – 4m). On site the ground was made of grey boulder clay with varying amounts of chalk nodules. A north – south ditch was recorded in several of the footings (0020, 0028 and 0020). It was fairly steep-sided and filled with clay/brown silt/clay (Section B). This ditch was traced across the site appearing in the western end of Building 2, (PLs.1-2)). A single sherd of pottery was recovered from the fill, 0021, which is dated to the Roman period.

Plate 1. Ditch 0020 facing south, 1m scale

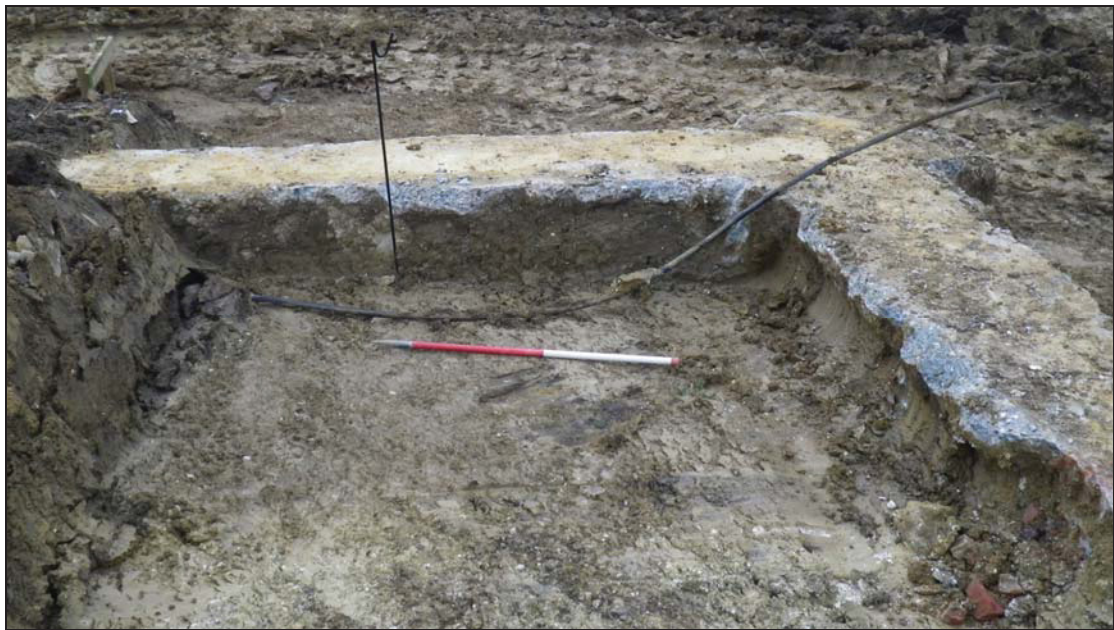
Along the eastern footing the base of two shallow ditches could be seen in section. These align with ditches 0009 and 0016 that were identified and hand excavated in the evaluation. A further small pit was located in the southern fire place extension to the site (0030). It was up to 0.7m deep (plate 3). Between Buildings 1 and 2 the course of ditch 0020 could be traced (PL. 3).

Plate 2 Brown clay fill of ditch 0020 visible in the area between Buildings 1 and 2 (the standing remains are part of the former garage) facing east. The scale is 1m.

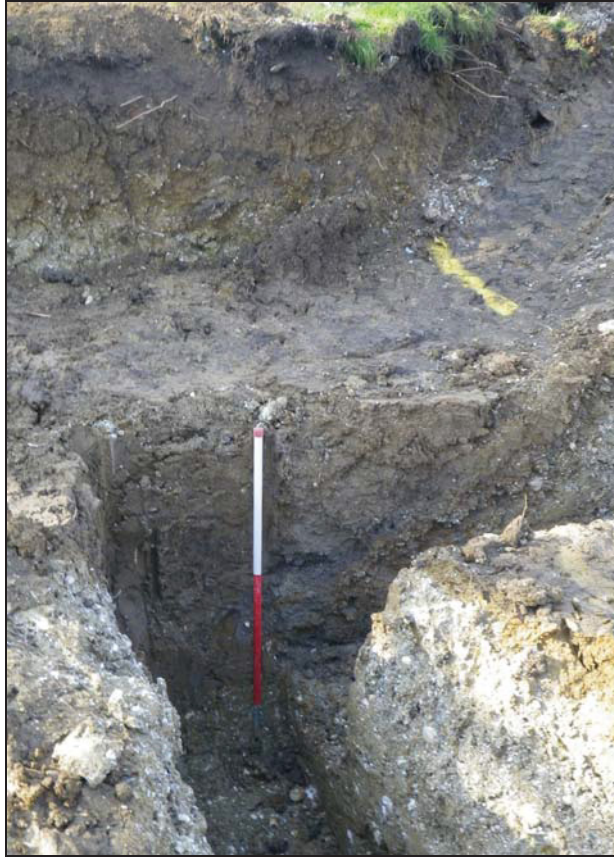
Ditch 0020 continued through the south-west corner of Building 2. A probable pit, 0022, was sampled with finds retrieved from dark grey clay fill, 0023, which was beneath an homogenous fill of mid brown silt 0024. From the stripped surface (which was c.0.8m below previous ground levels, it was c.1.1m deep and at least 2m wide and is illustrated as section A. The finds consisted of a fragment of roof tile, which is probably post-medieval and rib and vertebrae fragments from a lamb (these were found in the face of the pit section and it is suggested that they may have been from a complete burial).

Plate 3. Pit 0022 facing east, also showing site strip. Scale 1m

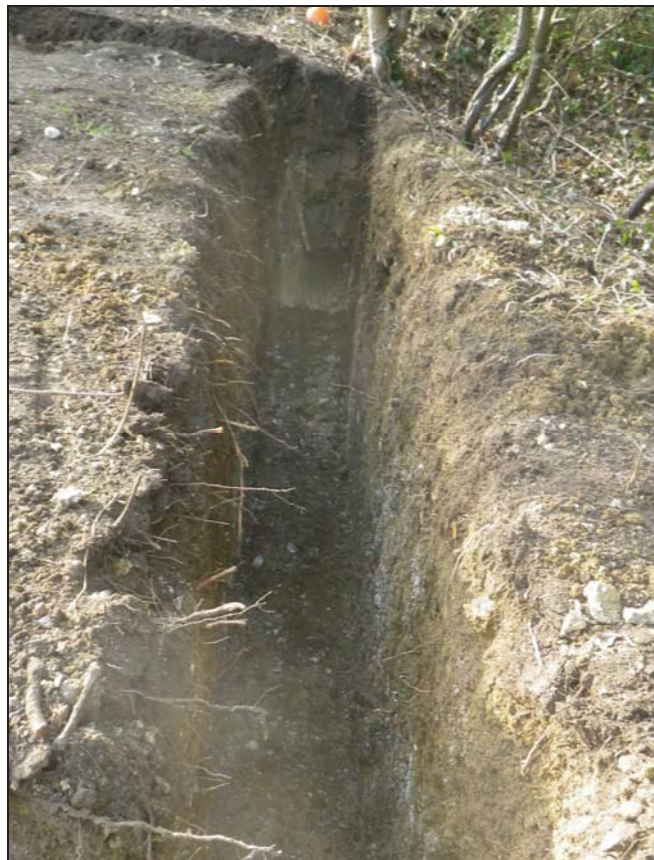
The north wall footing was c.2m deep (the depth of trench was mitigation for the hedge boundary immediately adjoining the trench. There was an irregular shaped disturbance at the north-east corner, 0029, .which is attributed to root penetration from the adjoining hedge. No features were observed in the remainder of the trench (PL 4).

Plate 4. Garage footing with hedge and ditch beyond to the right of the picture (north)
