**South Seafront and Martello Tower P
Felixstowe, Suffolk
FEX 294**

Archaeological Excavation Report

SCCAS Report No. 2013/083

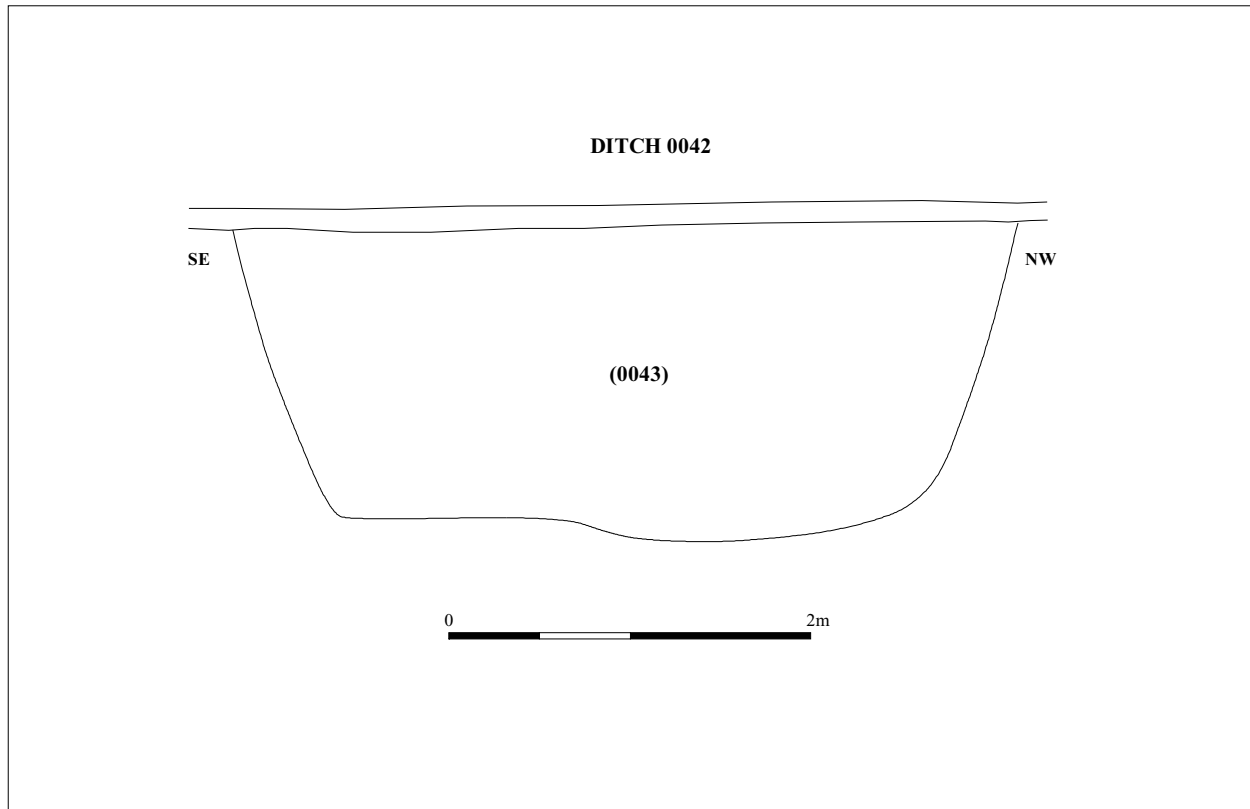
Figure 4. Ditch section (Area 6)

Two sections were excavated across the ditch, one in Area 3 and another in Area 6, both of which displayed similar profiles. The ditch cut the sand and shingle deposits to a depth of 1.75. The ditch had relatively steep sides and a flat base. The fill (0043) comprised a single homogenous mass of grey sand with no obvious layering. This

material was extremely unstable and readily collapsed during excavation of the ditch. Once fully excavated it was not possible to approach the feature due to the danger of further collapses and consequently the section was recorded photographically with scales in place (plate 3). The photographic data was then used to construct a scaled drawing of the exposed section (Fig. 4).

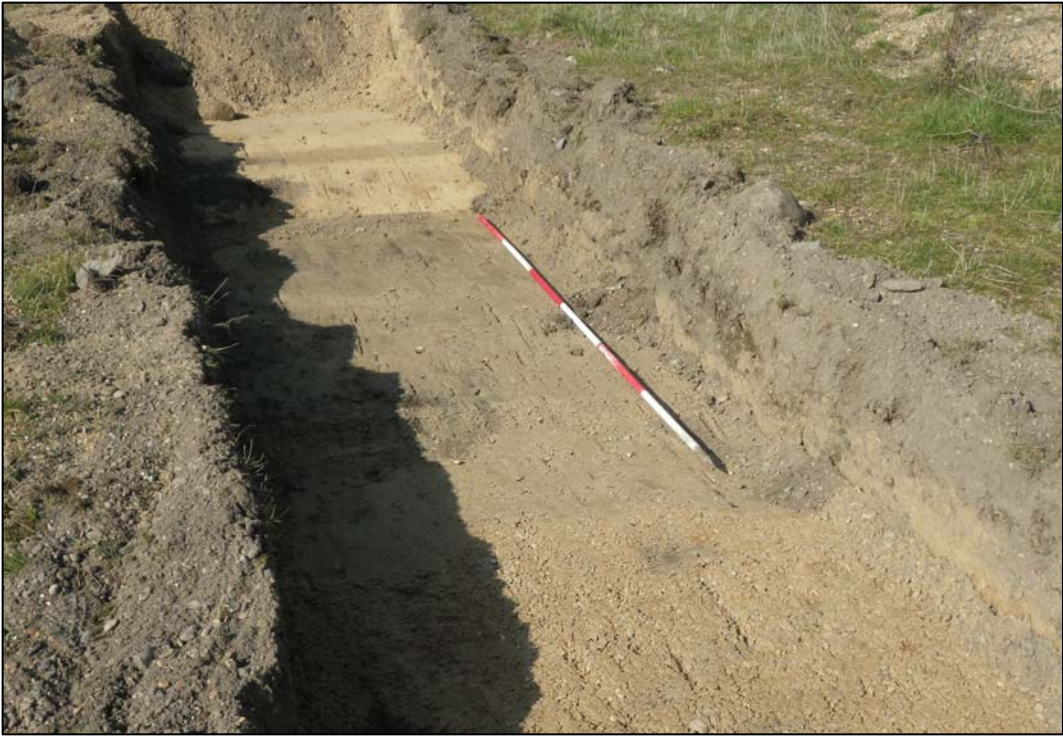
Plate 1. Surface appearance of ditch as see in Excavation Area 3

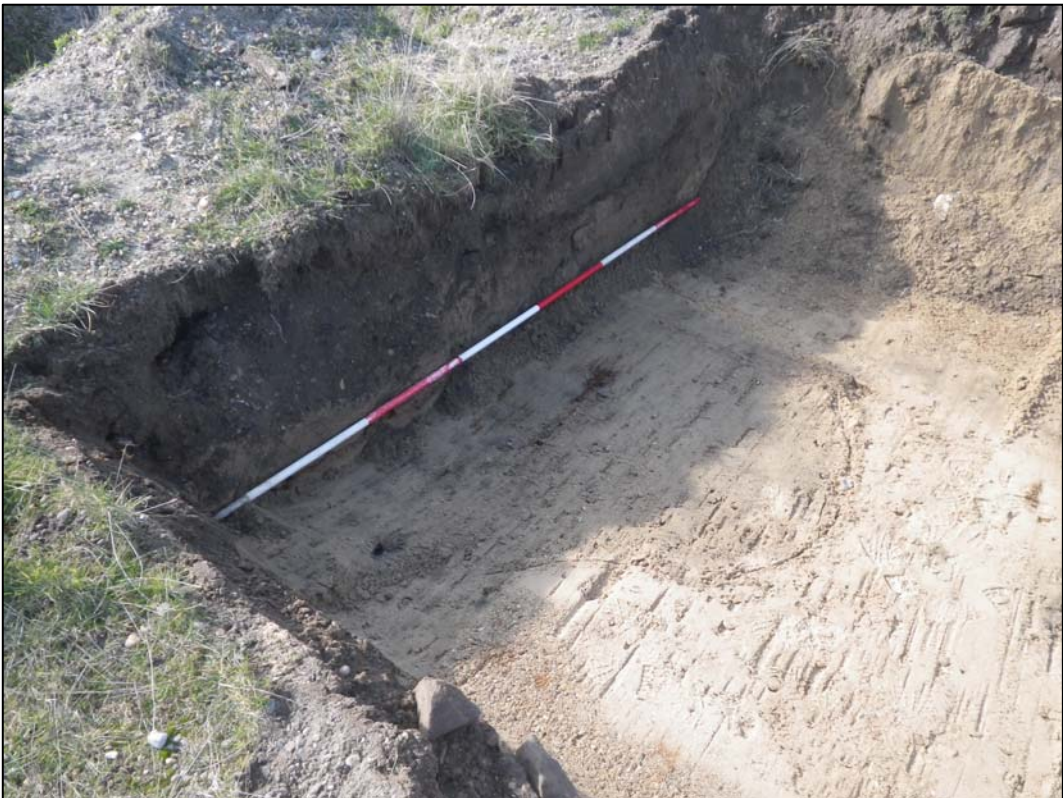
The ditch was not seen in A8 indicating a variation from the predicted route. A larger area was then opened in the car park area between A7 and A8 (numbered A9) in which a rounded terminal to the ditch was revealed (plate 2).

Plate 2. Ditch terminal, as seen in Excavation Area 8

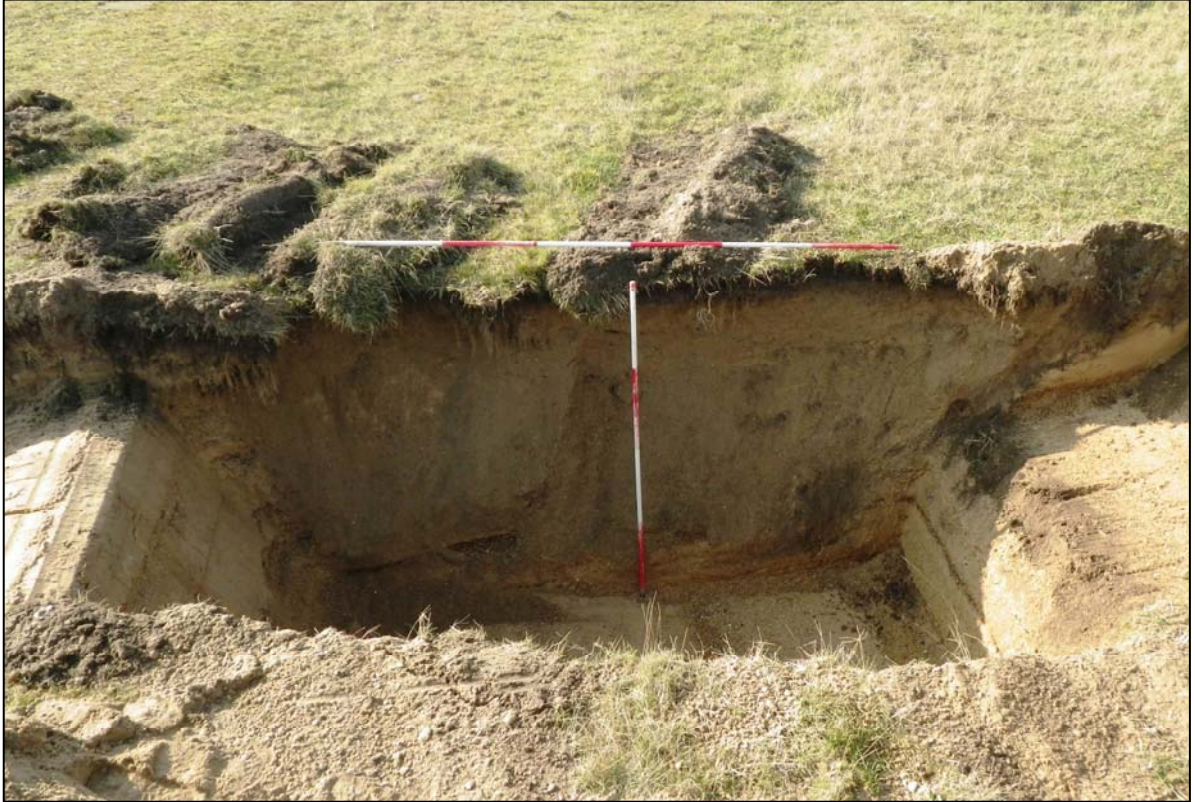
Plate 3. Ditch section, as seen in south west face of Excavation Area 6

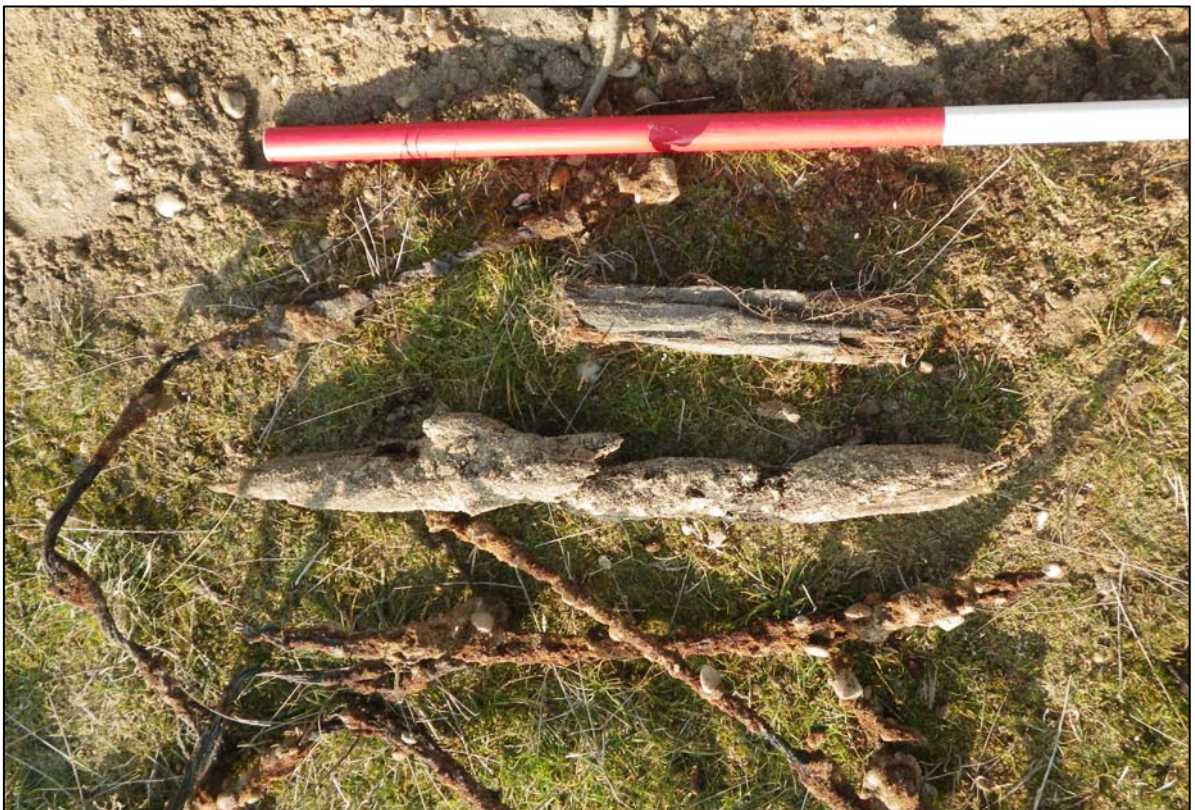
Very few finds were recovered during the excavation of the ditch sections. Those that were found consisted of occasional fragments of barbed wire, identical to fragments recovered during the preceding evaluation, and two fragments of timber posts. The section excavated through the ditch in Trench 39 revealed a group of three timber posts running along the base. These were not identified *in-situ* in the two sections excavated as part of this phase of the work although two fragments of identical timber posts were recovered from the fill (plate 4).

Plate 4. Samples of timber posts recovered from fill of ditch

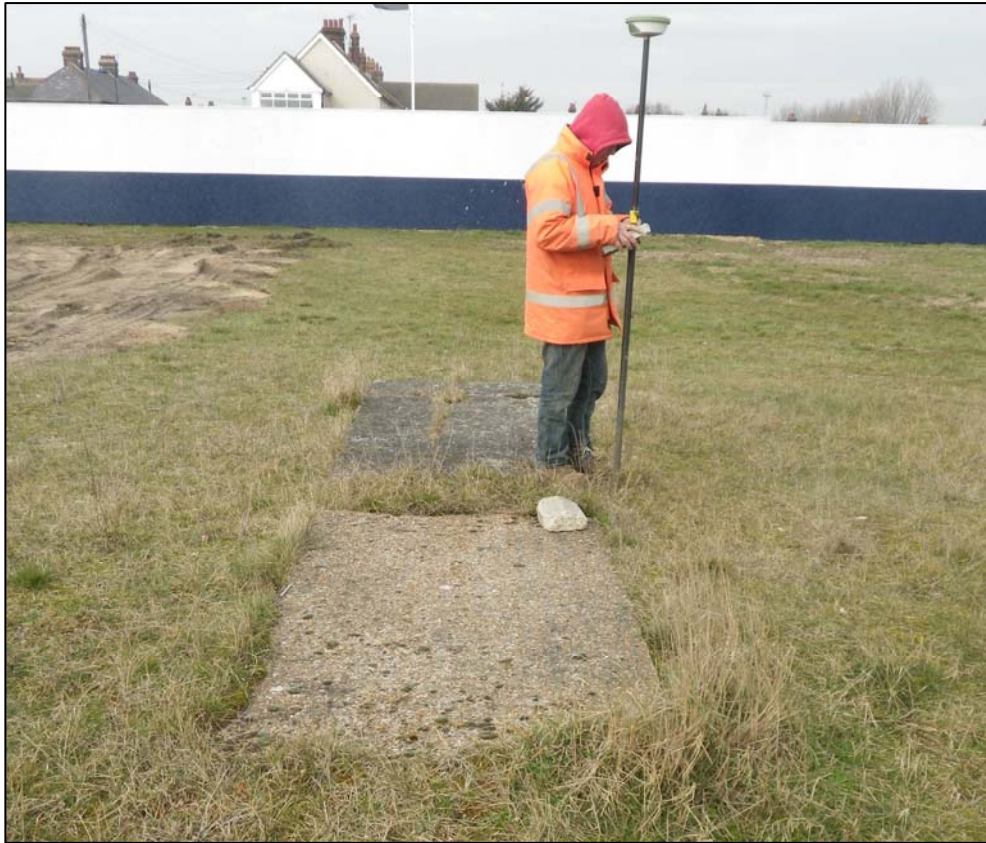
Context Nos.	Description	Plate
0050 & 0051	Two concrete pads of varying lengths but similar widths. Smooth, flat surface with no detail. Interpreted as two sections of a concrete path probably associated with a dense group of beach huts placed in this area shortly after the World War II (see plate 36).	5
0052	A length of concrete pathway, similar to above although in poorer condition suggesting a thinner slab. Probably associated with the post WWII beach huts.	6
0053, 0054, 0055 & 0056	A group of four similar concrete blocks, approximately square in plan, into which are set a substantial metal bracket formed of riveted steel plates. A series of four drilled holes are present in the leading	7, 8, 9, 10 & 11

Plate 5. Section of concrete pathway (0050 and 0051)

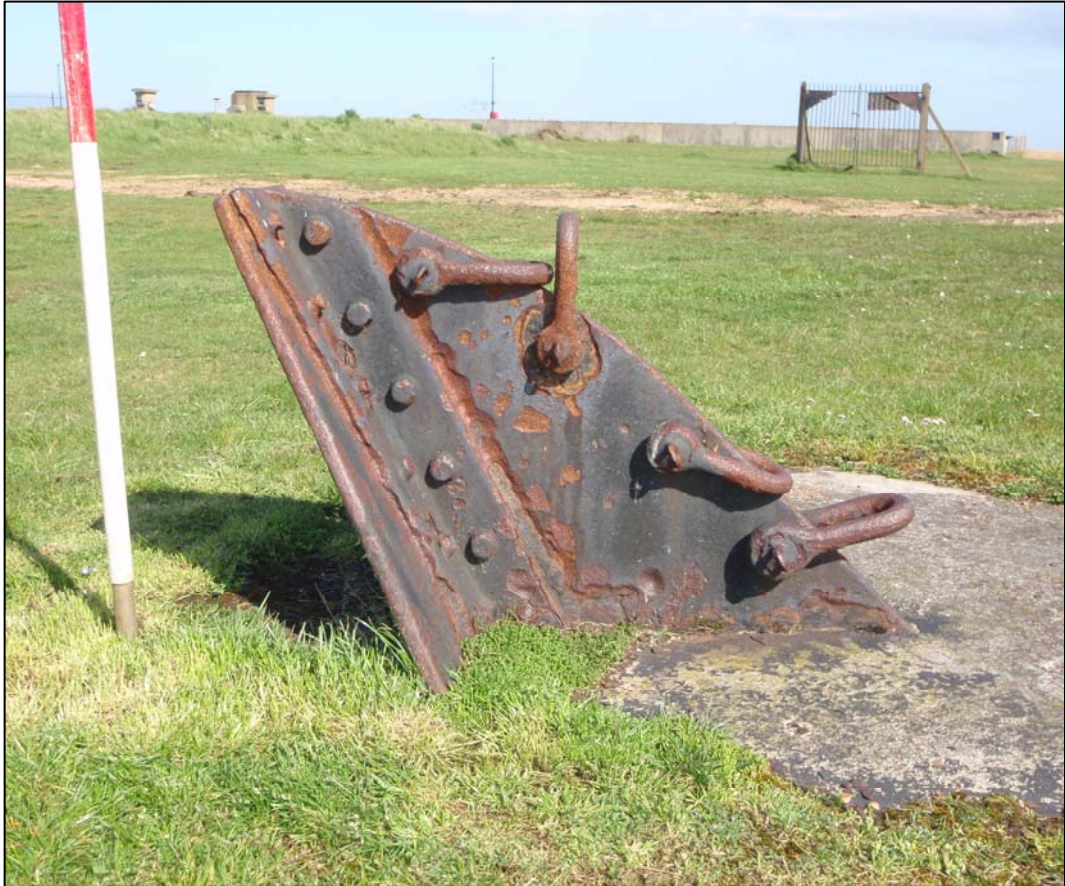
Plate 11. Anchor block (0053) showing steel plate bracket

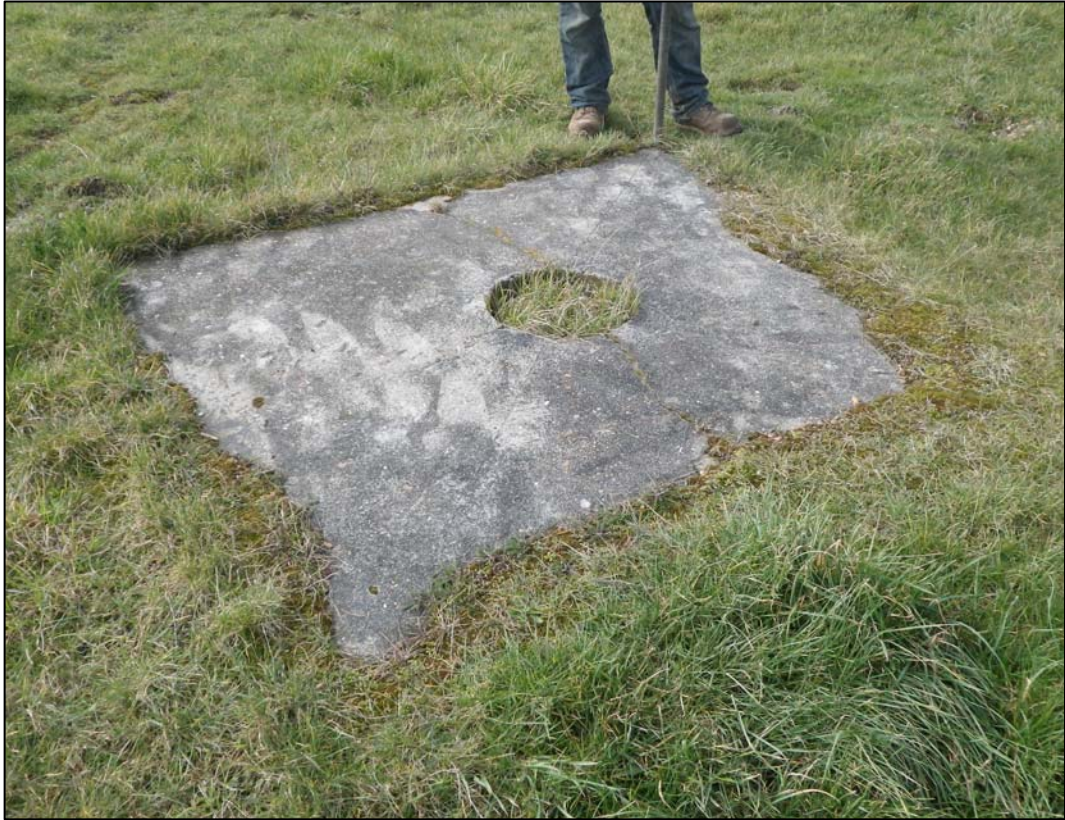
0061, 0062, 0063 & 0064	<p>Group of four blocks comprising a central support (0061) surrounded by three anchors for stays (0062, 0063 & 0064). The central support consists of a square block, the upper surface of which forms a near flat pyramid, with a central circular recess measuring 0.3m in diameter. This is surrounded by three equally spaced blocks at a distance of 7m (to centres). These are square in plan and are also near flat pyramids. A length of chain is set into the centre of these blocks. Three links of the chain are free from the concrete and each has a D or C shaped shackle at the end, secured by a nut and bolt;</p>	19, 20, 21, 22, 23 & 24

Plate 19. Block (0061)

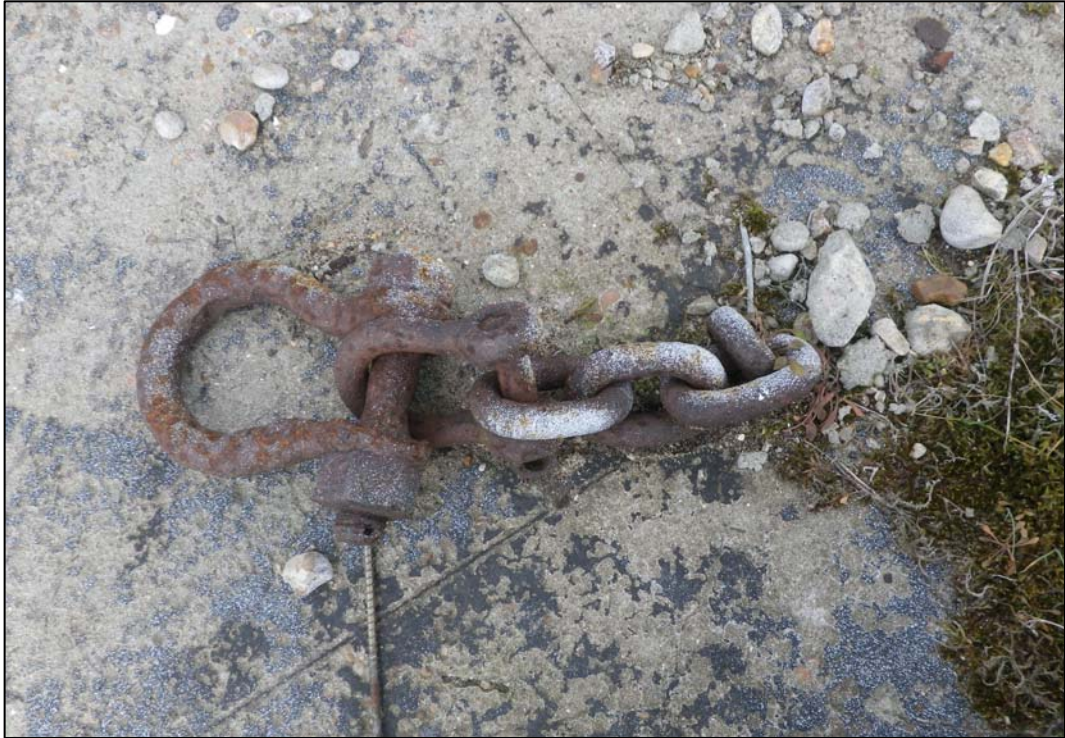
Context Nos.	Description	Plate
	the bolts are drilled to receive a safety/split pin (plates 23 and 24). This group features presumably supported either a flagpole or an alternative antenna and was independent of the Martello Tower.	
0065, 0066 & 0067	The remaining above ground components of the Royal Observer Corps (ROC) post, a monitoring station for use in the event of a nuclear war. 0065 is the main air vent from the monitoring room. The metal cover on the side is related to the radio aerial; 0066 is a mounting for a fixed survey probe; and 0067 comprises the entrance hatch and a further air vent. On top of the vent is a mount for equipment to record the direction of a bomb strike.	25, 26 & 27
68	A pair of iron railing gates on concrete posts. They are now free standing but were until recently associated with a chain-link fence. Presumably they were part of a now lost length of early iron railing fence, probably on the south east side of the military compound, and were to allow access out to the beach. An identical to a pair of gates, mounted on cast iron columns, were located at the main entrance prior to the start of the housing development (plate 30).	28 & 29

Plate 23. Anchor block (0062) showing central fixing

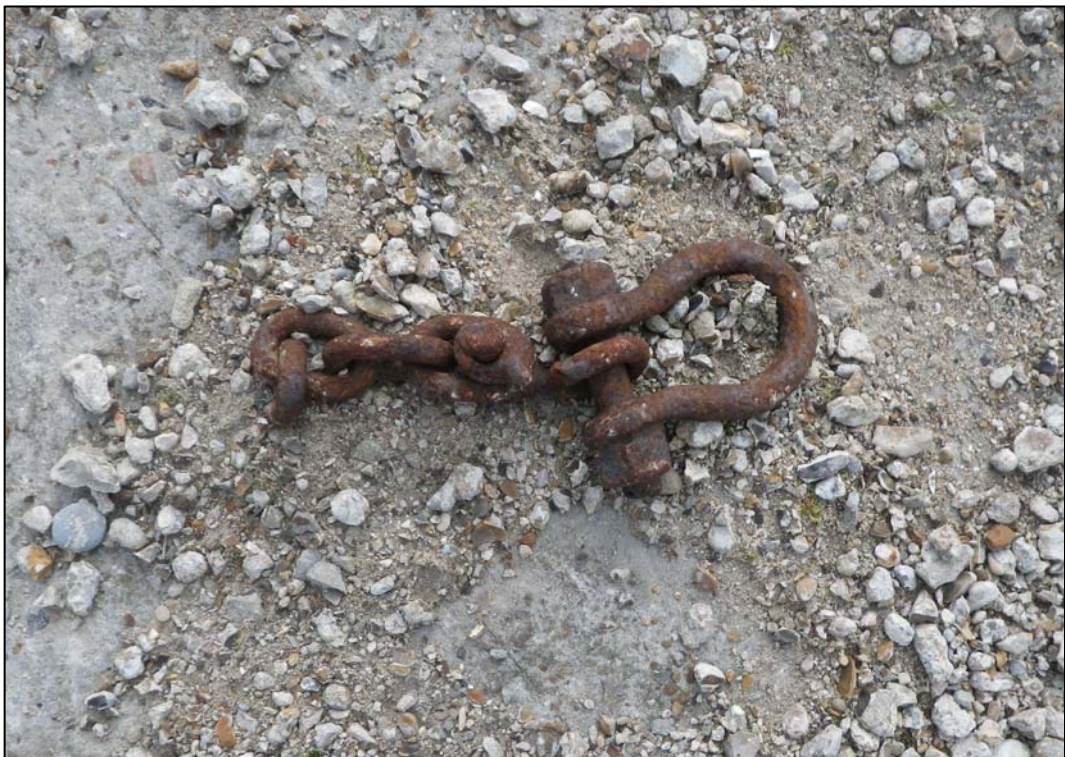
Plate 24. Anchor block (0063) showing central fixing

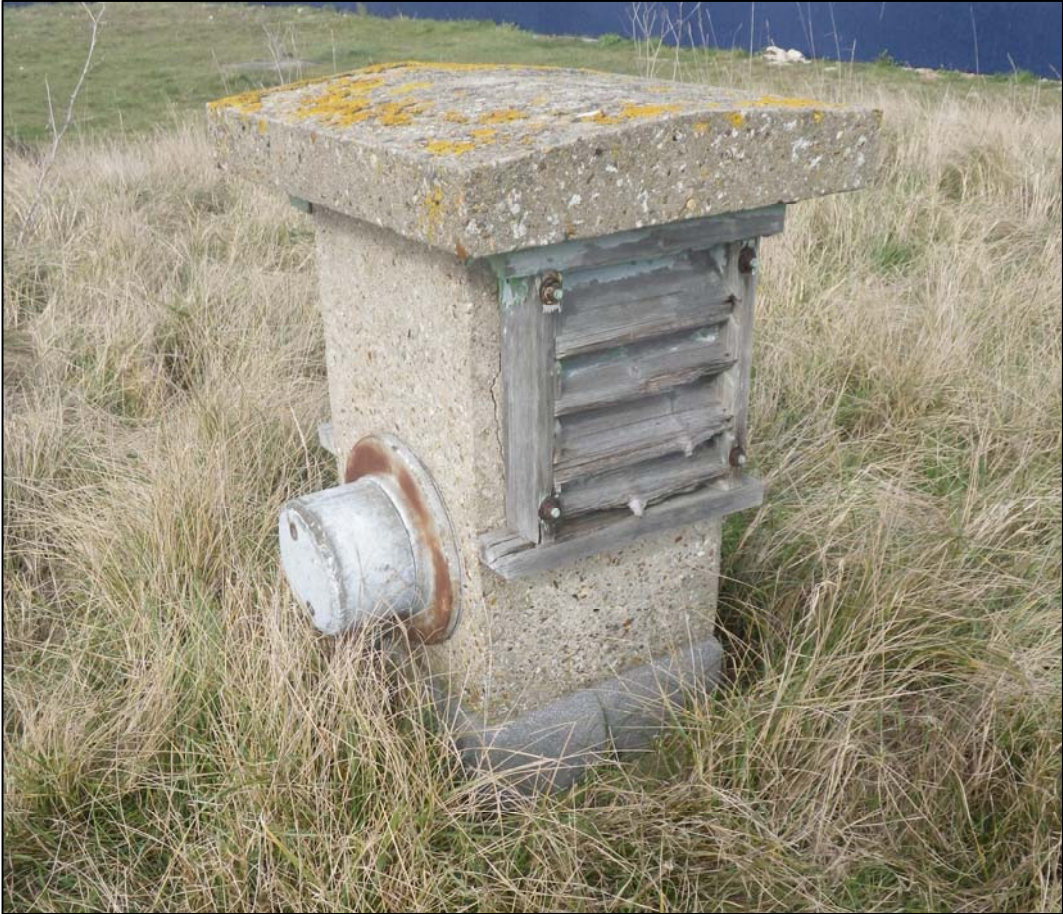
Plate 25. ROC post - main vent (0065)

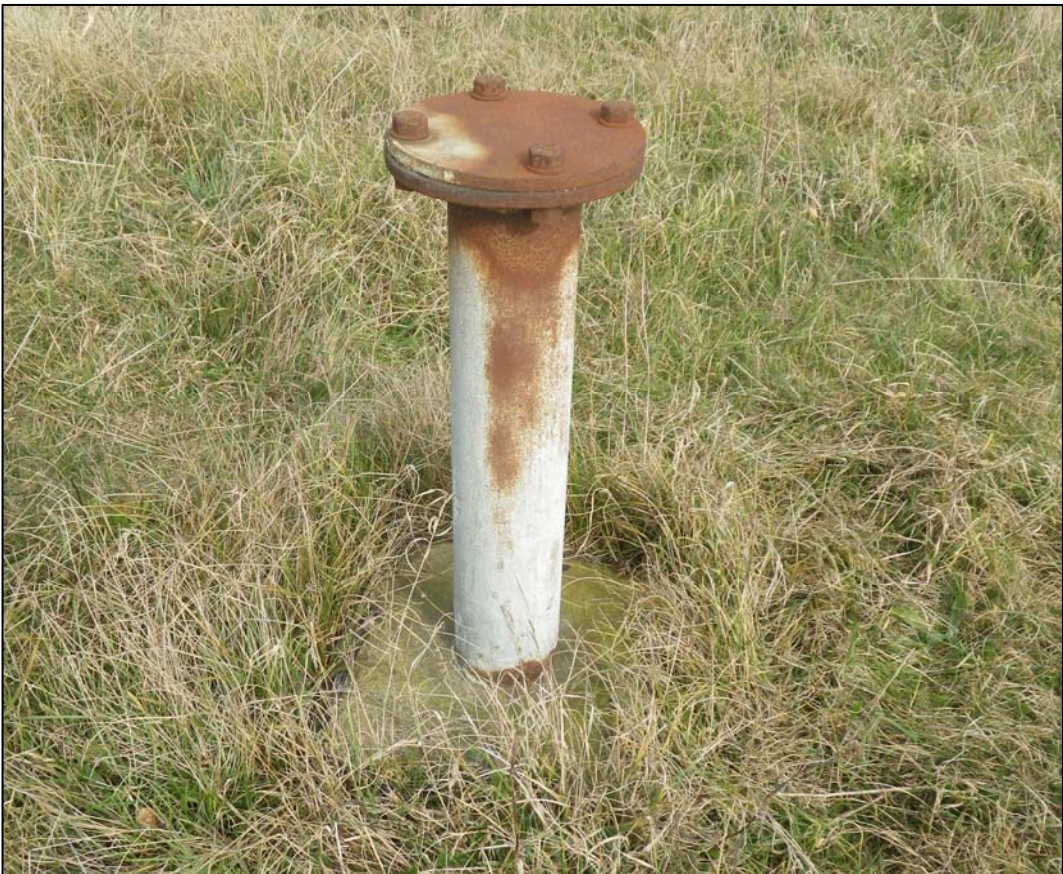
Plate 26. ROC post - mounting for a fixed survey probe (0066)

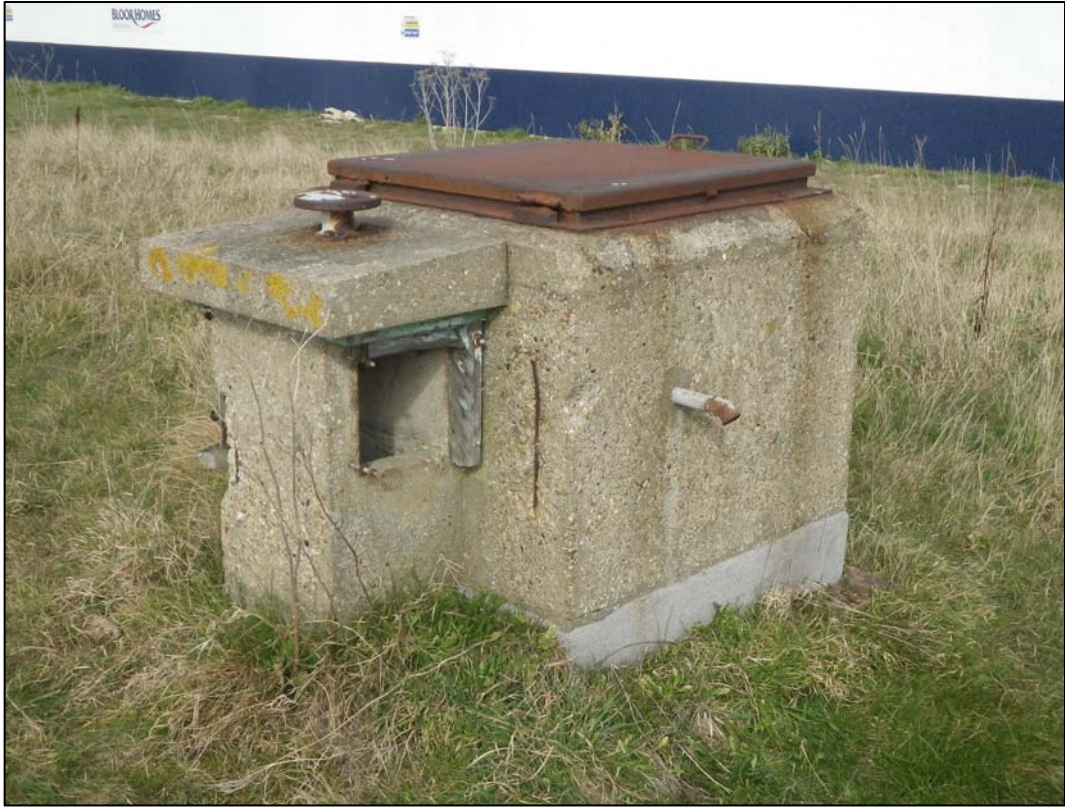
Plate 27. ROC post - entrance hatch and vent (0067)

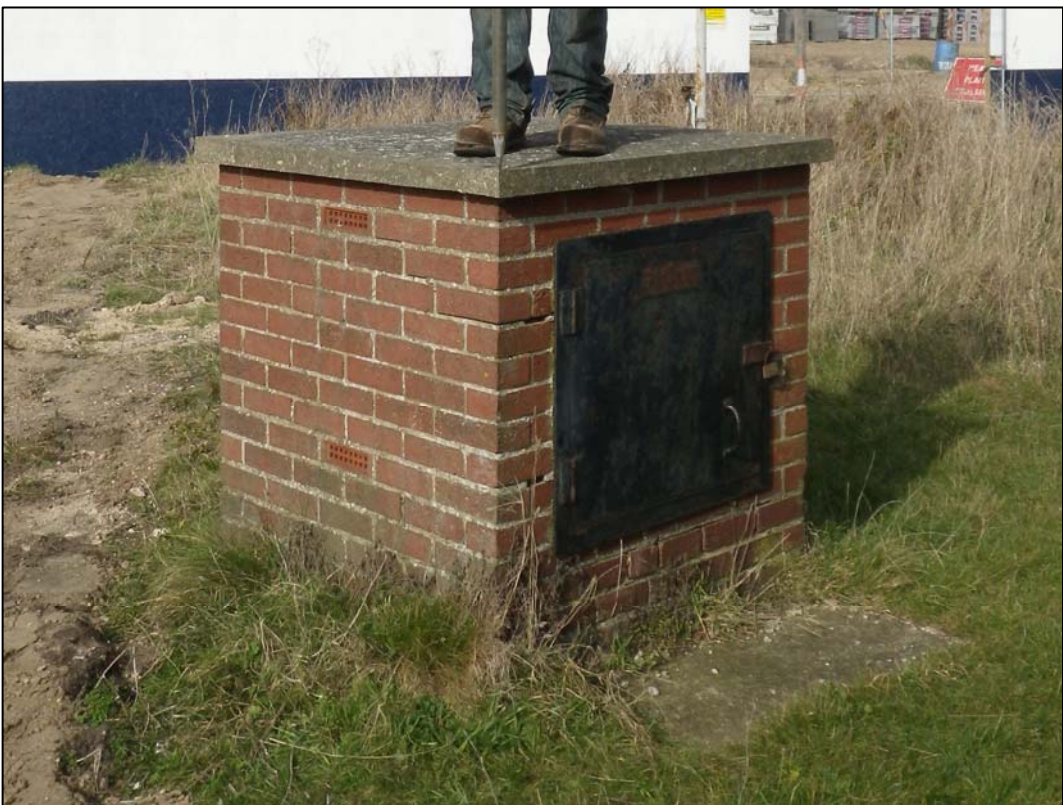
69	Concrete or possibly stone slab, rectangular in shape. Purpose unknown.	31
70	Brick built box or cabinet with concrete slab roof. Steel door, secured by a padlock, set into the eastern wall. Purpose unknown, possibly contains access to services, meters etc.	32
71	Circular concrete block with rectangular recess in centre. Appears to have been cast <i>in-situ</i> in a plastic drum. Purpose unknown but possible related to Coastguard Cottages, i.e. a support for a clothes line or similar.	33
72	Length of pipe or duct. Formed from galvanised metal. Purpose unknown but appears to runs towards the ROC post. Possibly a cable duct containing telephone connections etc.	34
73	Small area of a concrete slab exposed. Possibly a tethering block similar to blocks 0057 to 0060.	35

Plate 32. Brick built box or cabinet (0070)

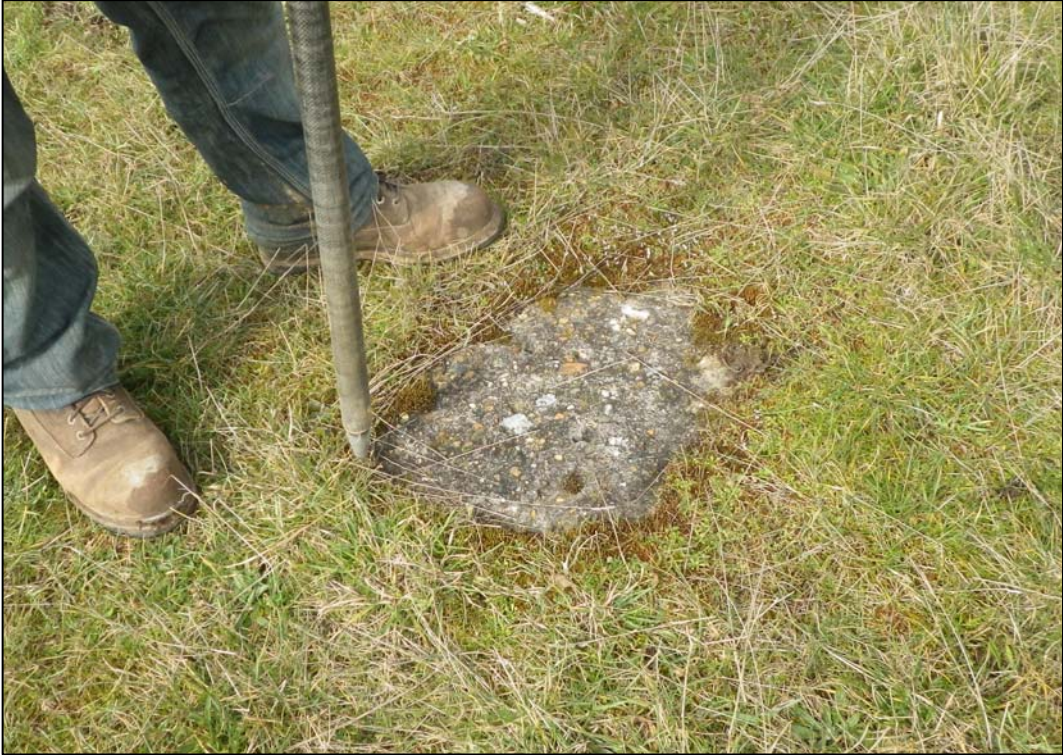
Plate 35. concrete slab, probable anchor block (0073)

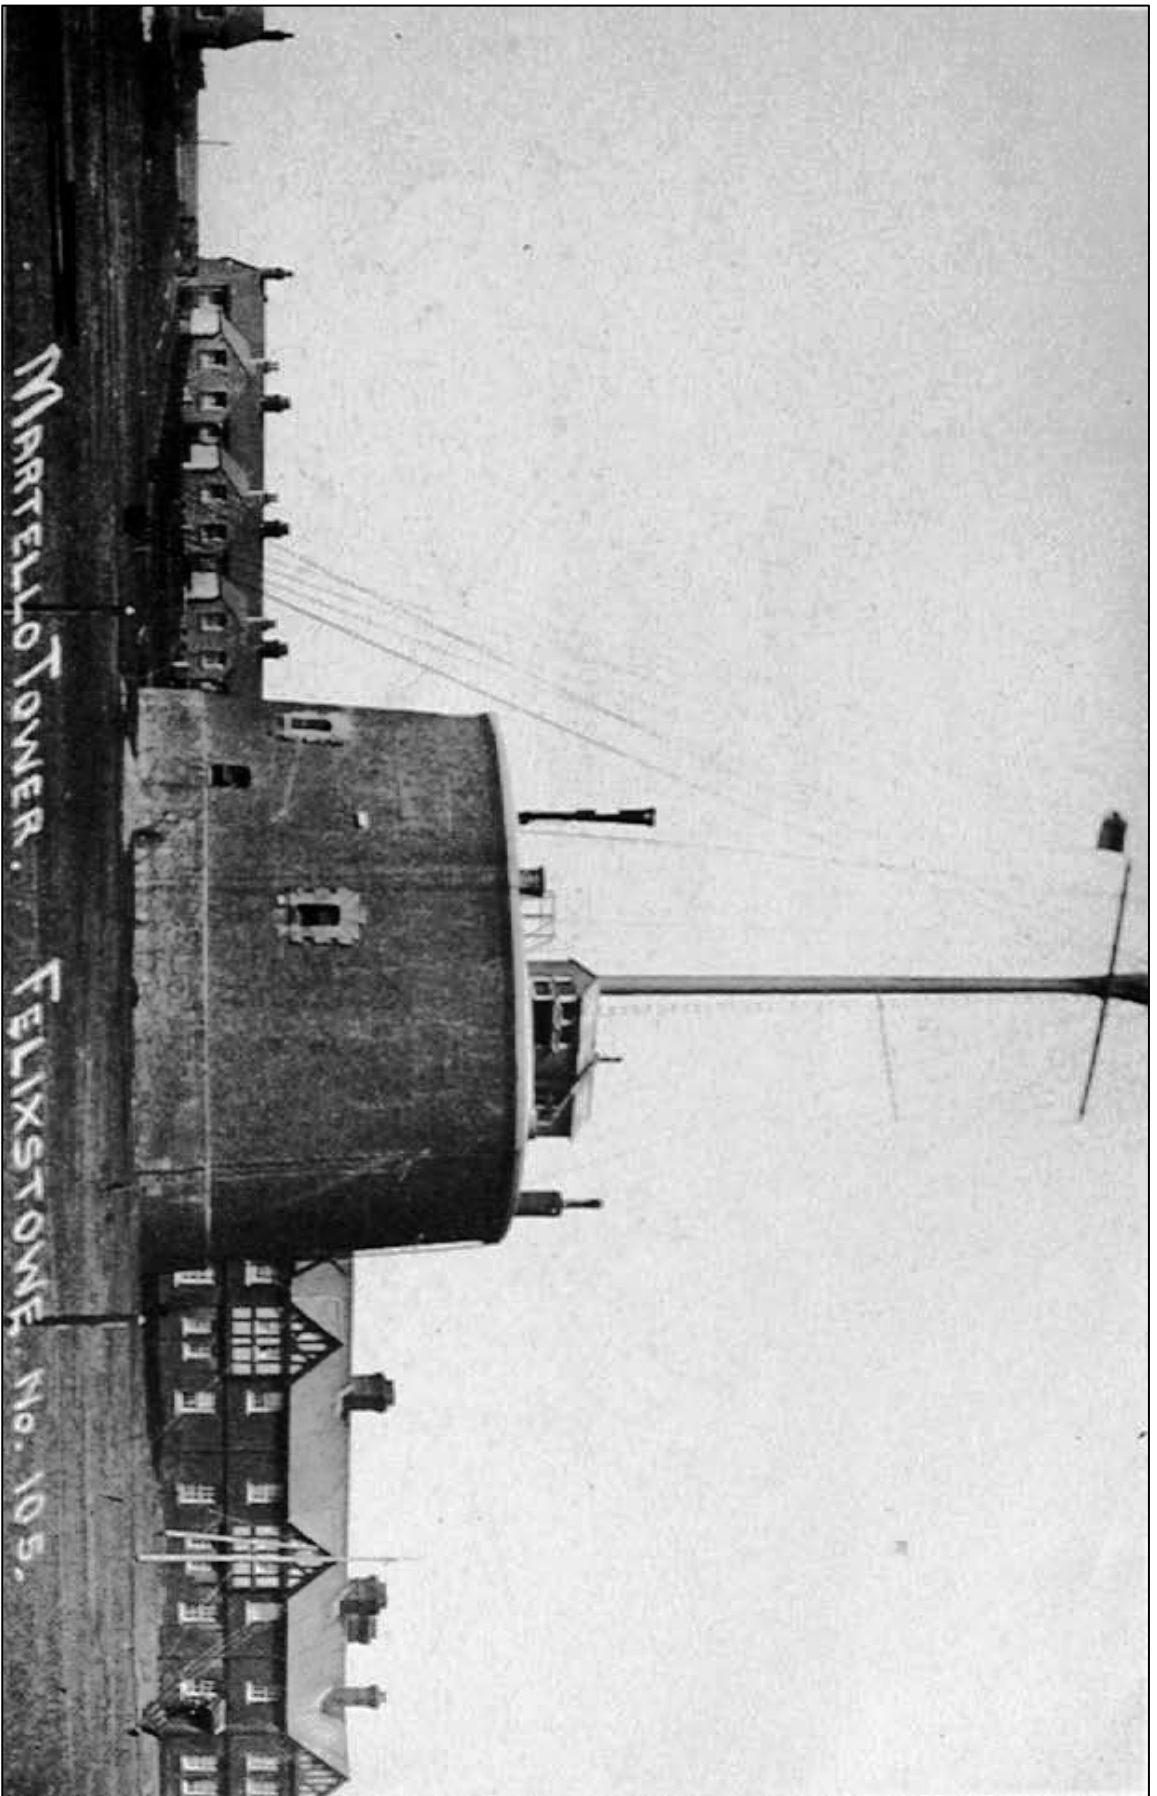
Plate 37. undated photograph of the tower with a radio antenna mast

The survey of the area around the Martello Tower revealed a number of features, the majority of which have been interpreted as anchor points for guide wires or stays supporting a mast or antenna mounted on the roof of the tower during its use as a Naval Wireless Station in the early 20th century. An undated photograph of the tower (plate 37) shows part of a mast on the roof of the tower being supported by a number of wire hawsers. What appears to be one of the large anchor blocks (probably 0054) can be seen to the bottom right of the photograph holding four separate hawsers that run up to various points on the mast.

The other, smaller anchor points recorded around the tower may be related to different phases of masts and antennas at the tower although the early photograph shows at least one other wire running down to the ground to the left of the larger anchor, to a location that possible corresponds with block 0060 suggesting that both the large and
