ARCHAEOLOGICAL ASSESSMENT REPORT

Lawney's Farm, Rougham
RGH 055

A REPORT ON THE ARCHAEOLOGICAL INVESTIGATION

SCCAS Report no. 2006/062

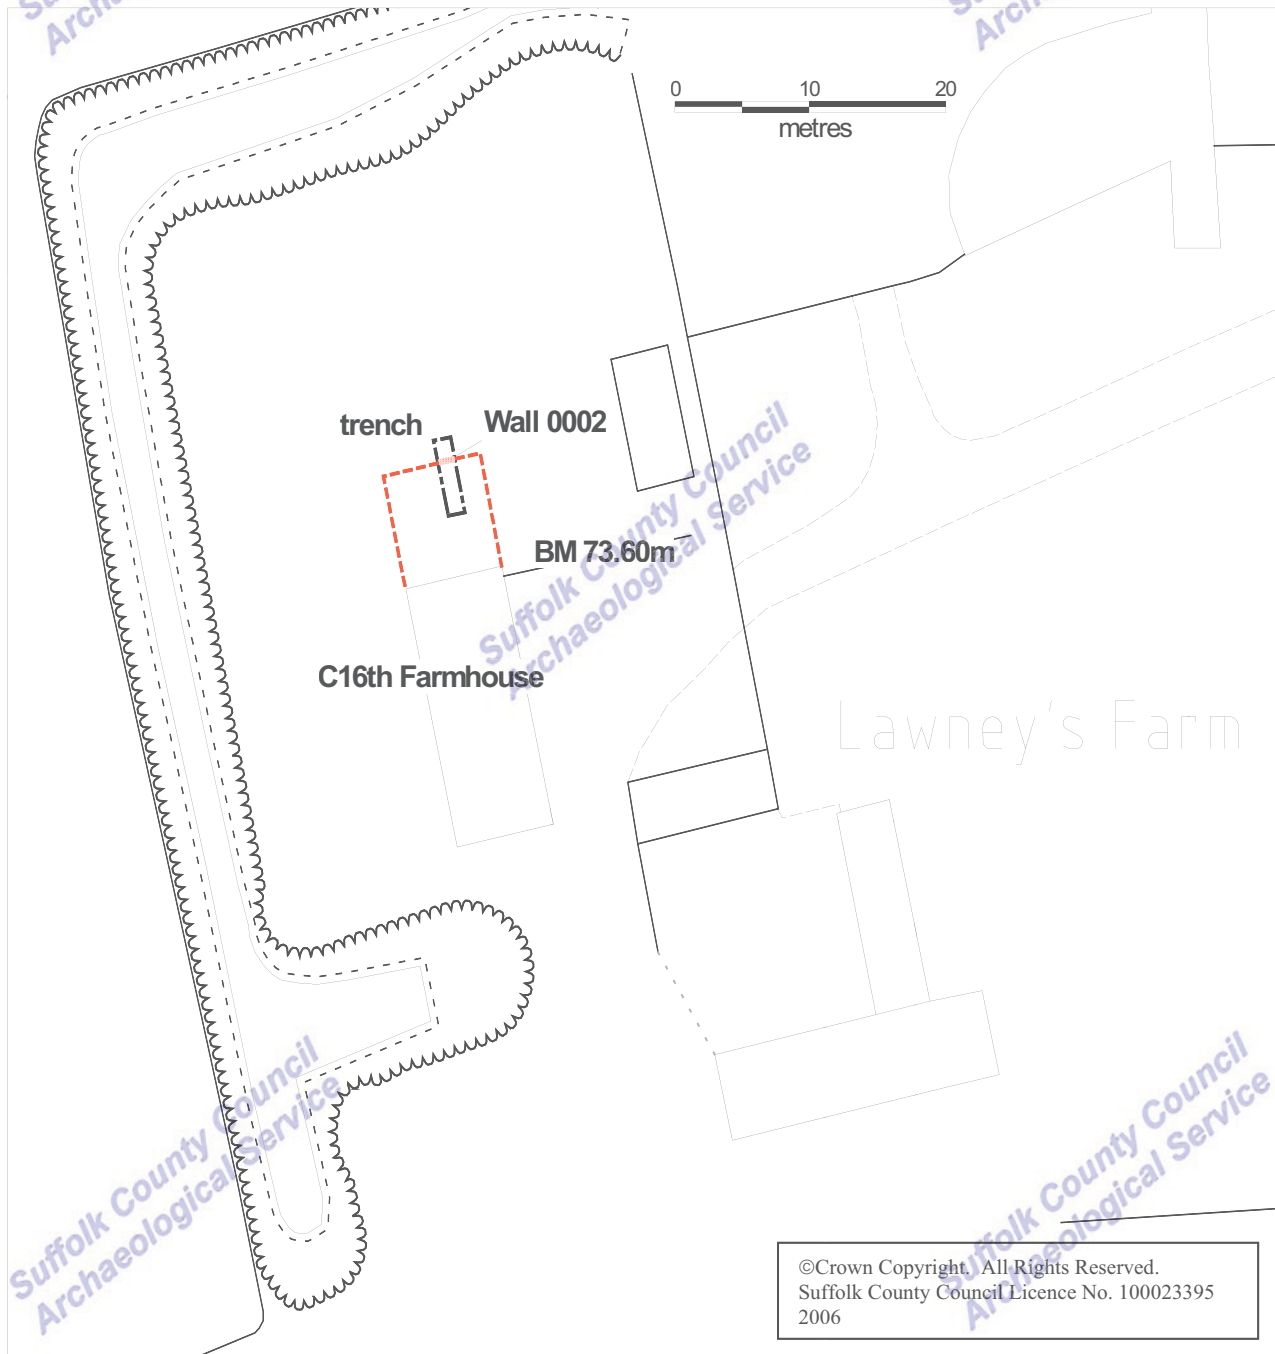
Figure 2. Site plan

A dwarf wall was recorded running E-W across the trench at mid length and 7.8m from the end of the house (Figures 2 and 3). It was constructed within a footing trench and was truncated so that the surviving top of the wall (72.61m) was below the surface of the adjacent clay 0005. The observed length demonstrated two phases of build. The earliest part, 0002, was constructed of medium sized flint cobbles bonded with a fine pale brown lime mortar, two courses of flints survived and within the build were fragments of hand-made brick suggesting either a medieval or early post medieval date for the wall. A second phase of build, 0003 had been completed in brick, this build extended outside the footing trench and continued along the inside face of the earlier wall 0002. The bricks here had been removed but were evidenced by their mortar bed, 0004. The bricks were well made and fine textured (2 1/8" thick x 4" wide) and bonded with a white lime mortar and were post medieval in date ((?)16th-17th century).

The remains of the missing bay of the building are close to the present ground surface and any development in this area would impact upon them. An archaeological excavation of the footprint would be necessary if the owner intended build over the lost bay.

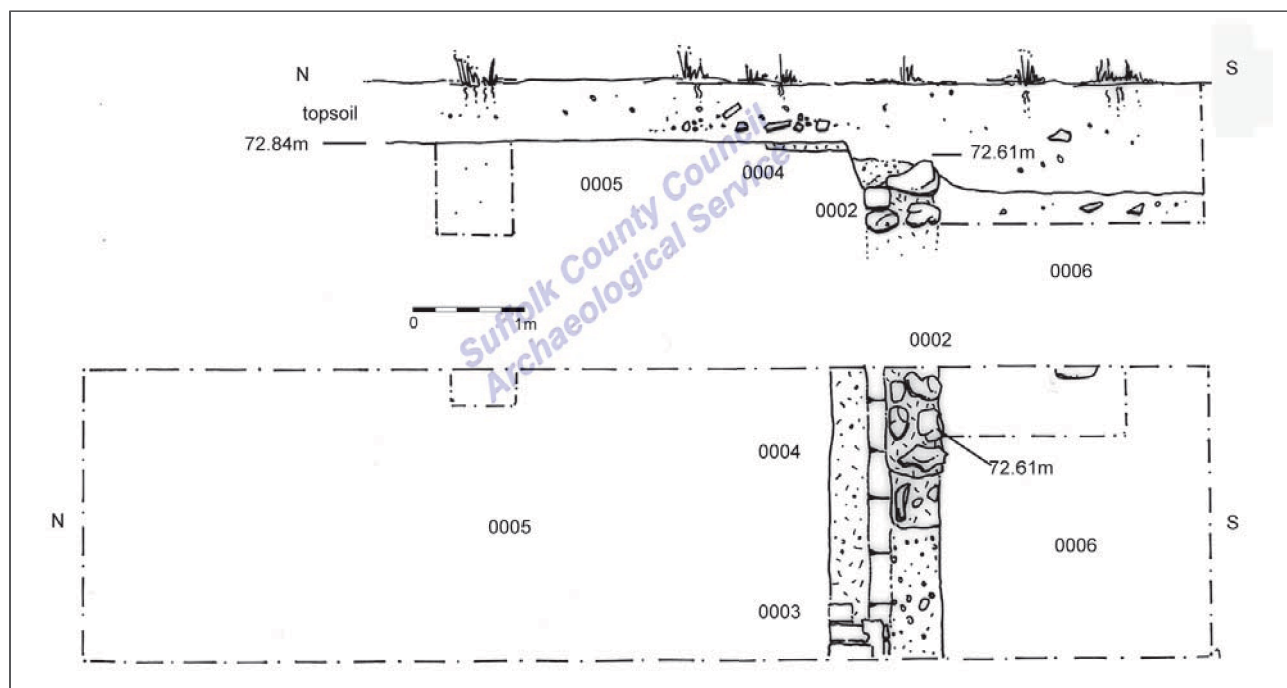
Figure 3 Trench plan and section

At the southern end of the trench, within the area of the supposed missing bay, the machine removed c. 25cm of well worked garden loam exposing a clay subsoil 0005 (72.84m). Fragments of crushed hand-made brick and lime mortar were observed within the topsoil, this material was also compressed into the clay surface but below this the clay was clean (Figure 3).

On the outside edge of the wall (N. side) the topsoil was deeper and the clay subsoil recorded west of the wall was not seen. The topsoil over-lay a deposit of made up soil, 0006 which contained brick and peg-tile fragments and two small sherds of LMT pottery (Late Medieval Transitional, 15 -16th century) the layer was at least 10cms deep, extending to the base of the dwarf wall. A sondage was excavated into 0006 but this immediately filled with ground water.

The test trench shows that the building was once longer and suggests that the earlier OS map was an accurate representation of the building's footprint when the map was drawn. The work suggests that the building was demolished to ground level and most of the material removed and there was no indication of surviving floors or their level within the building. The trench shows different ground levels either side of the wall, outside the wall the soil profile is made up of re-deposited fill and suggest that the ground has at one time been excavated. There was no indication to the extent of this within the trench and further investigation was beyond the remit of the work. The discovery of the missing bay suggests that the chimney was originally intended to be in the centre of the building, and it is possible that the building was symmetrical around it. The southern end of the building has a cross wing and it is therefore possible that this was repeated at the northern end although the OS map does not show it as so.
