Land at RAF Horham, Low Road, Denham
DEN 011

Archaeological Building Record

SCCAS Report No. 2013/101

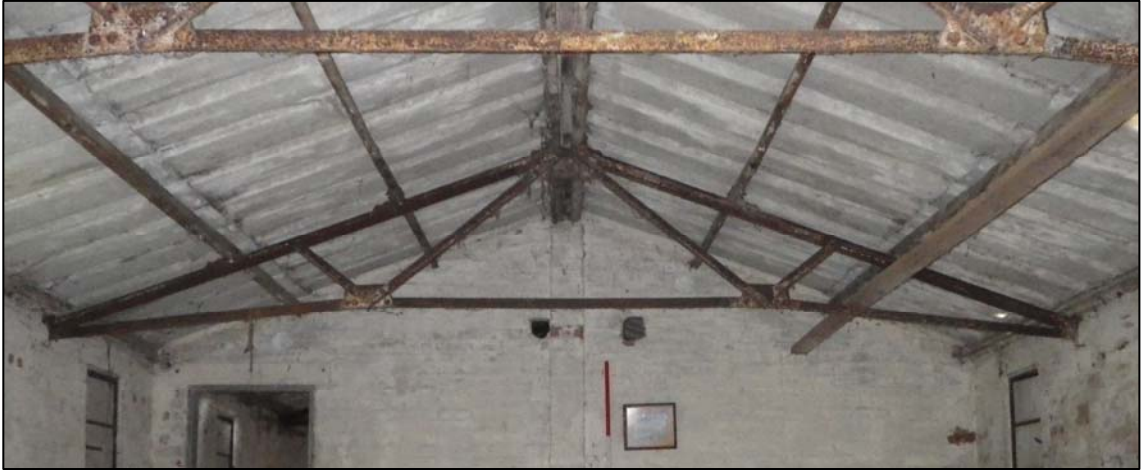
The walls are spanned by steel trusses formed of lengths of angle-iron bolted together with flat iron plates (see plates 9 to 12 and Fig. 9). These are spaced at 3m intervals, unless an internal wall is present in which event the wall itself directly supports the roof. External buttresses are present to coincide with each truss or dividing wall. The trusses

Plate 9. Typical roof truss, as seen in Building 1(ref. HTQ 65 [crop])

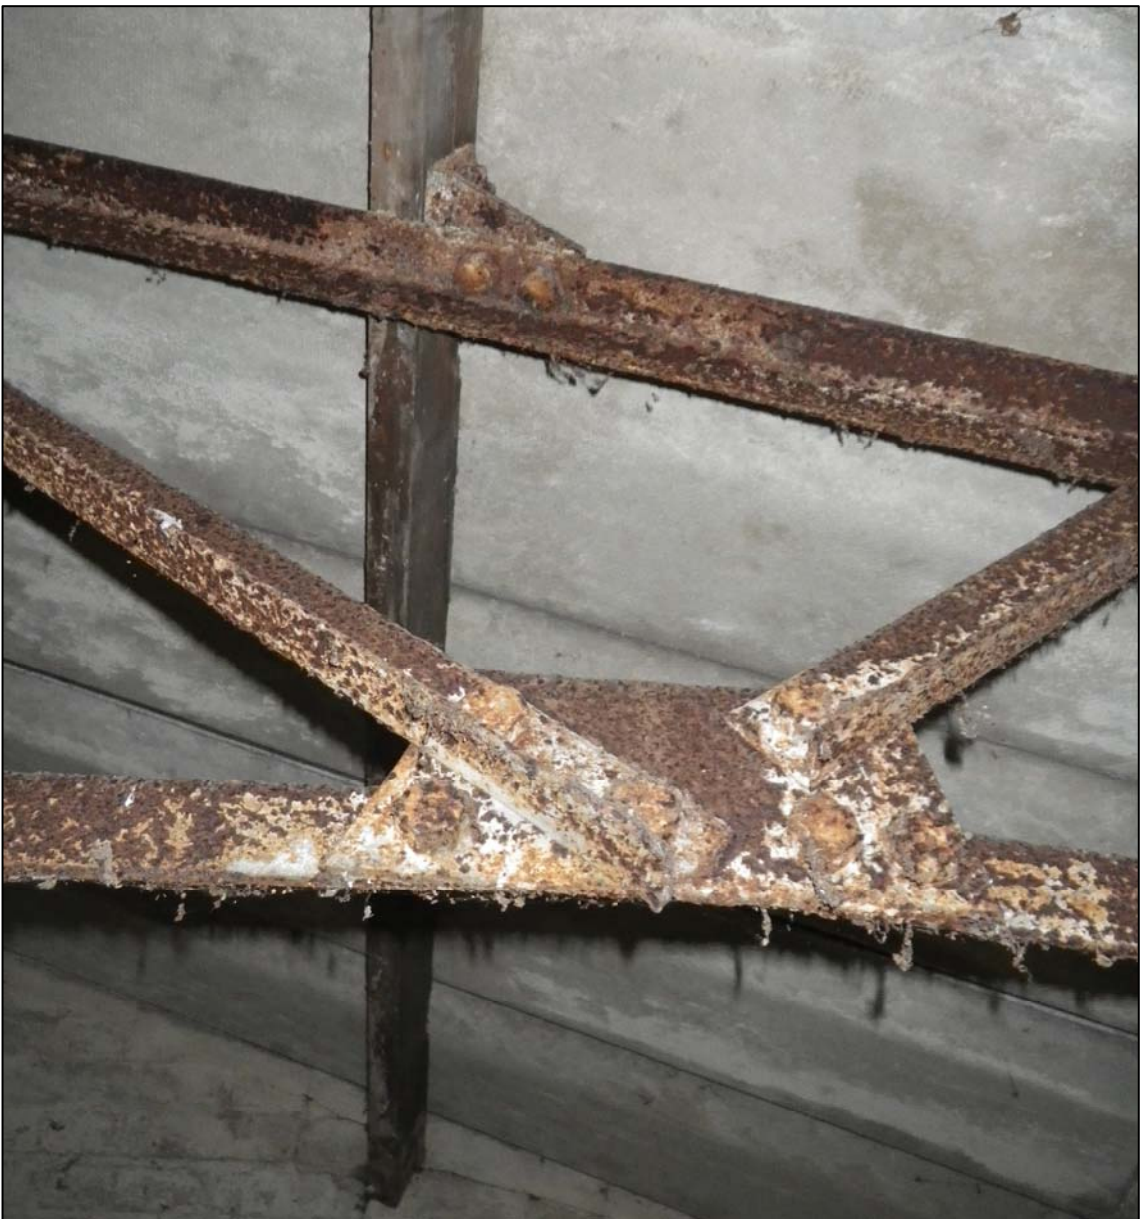
themselves rest on small concrete or stone blocks set into the brickwork rather than just plan brickwork. Timber purlins are attached to the trusses using angled brackets. The whole is then covered with corrugated fibreboard, which is nailed to the purlins. Shaped lengths of fibreboard span the gap at the apex. Where the roof covering meets the walls it is laid on specially shaped lengths of fibreboard which fill the spaces left by the board's corrugated shape. In parts of both buildings, flats sheets of fibreboard were fixed to the underside of the purlins.

Plate 10. roof truss detail showing bolted plate joints and angled bracket holding a purlin (ref. HTQ 73)

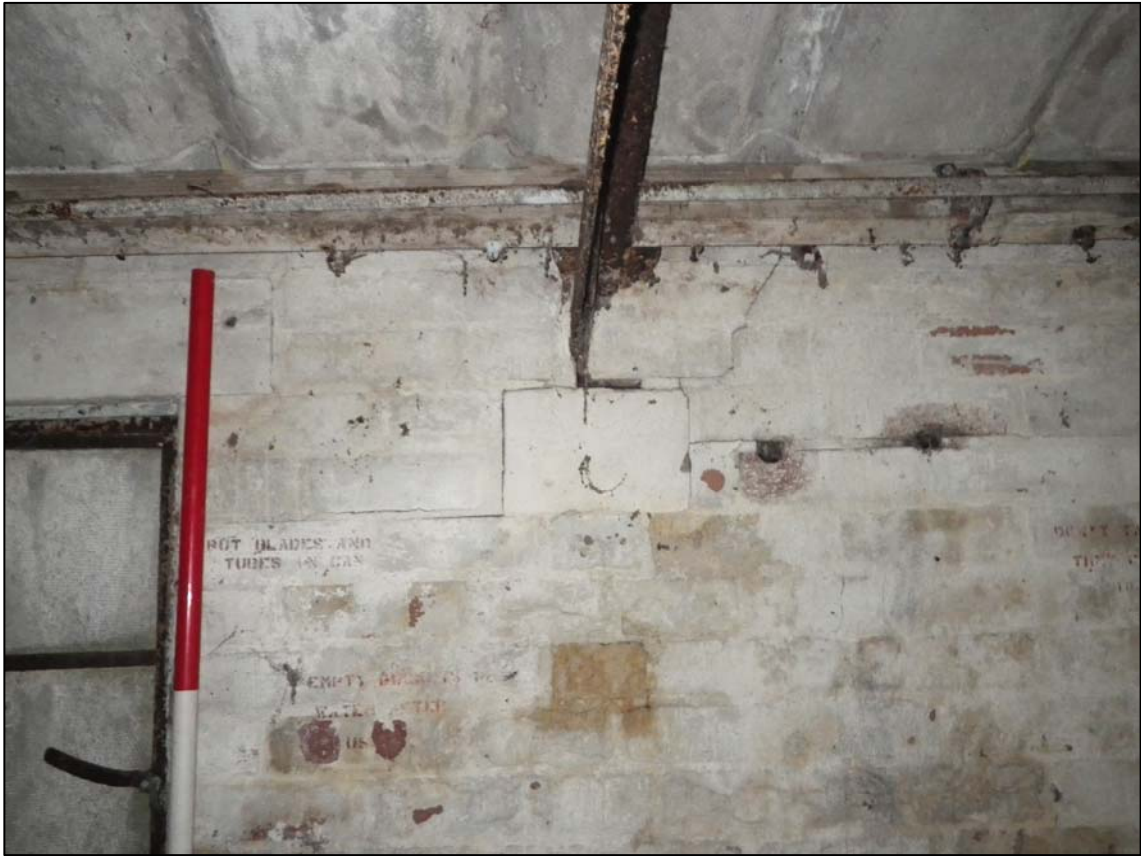
Plate 11. roof truss detail - foot of truss resting on block within wall (ref. HTQ 94)

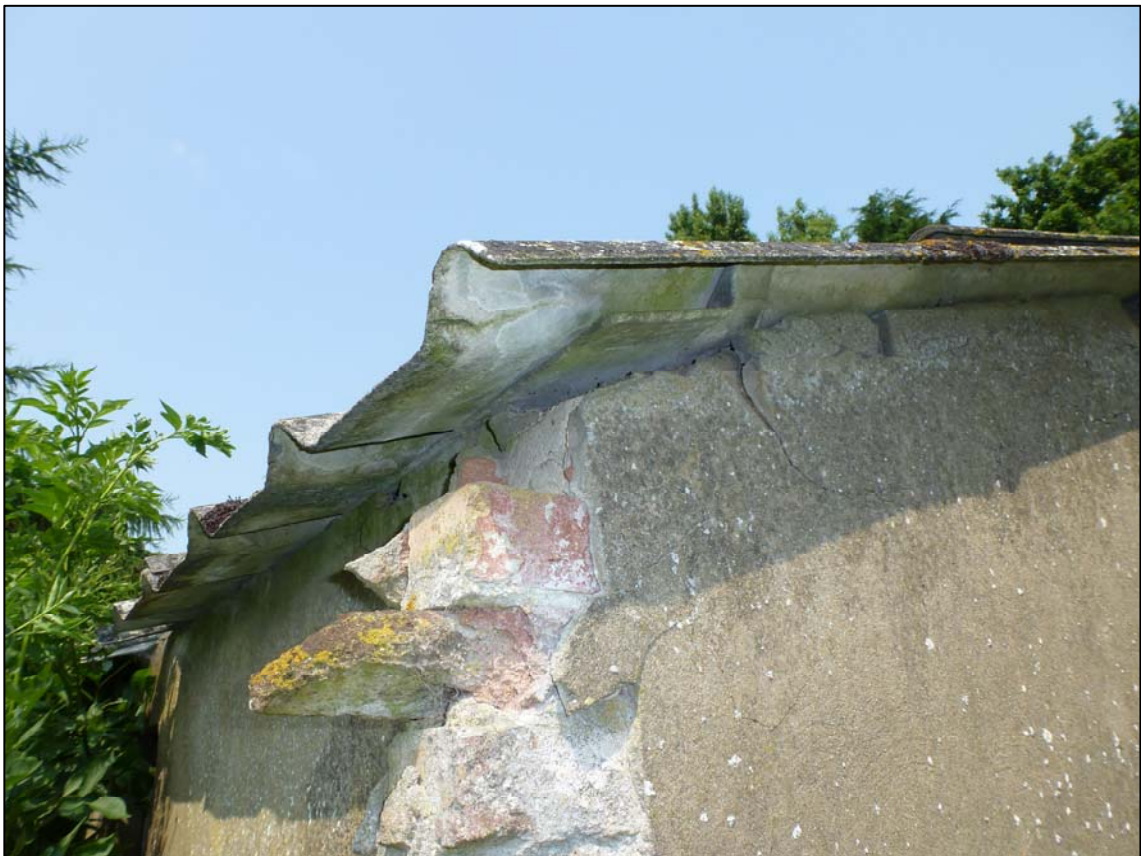
Plate 12. roof detail - shaped fibre board upon which the roof rests (ref. HTQ 44)

n.b. A not *in-situ* pair of these are visible Plate 33

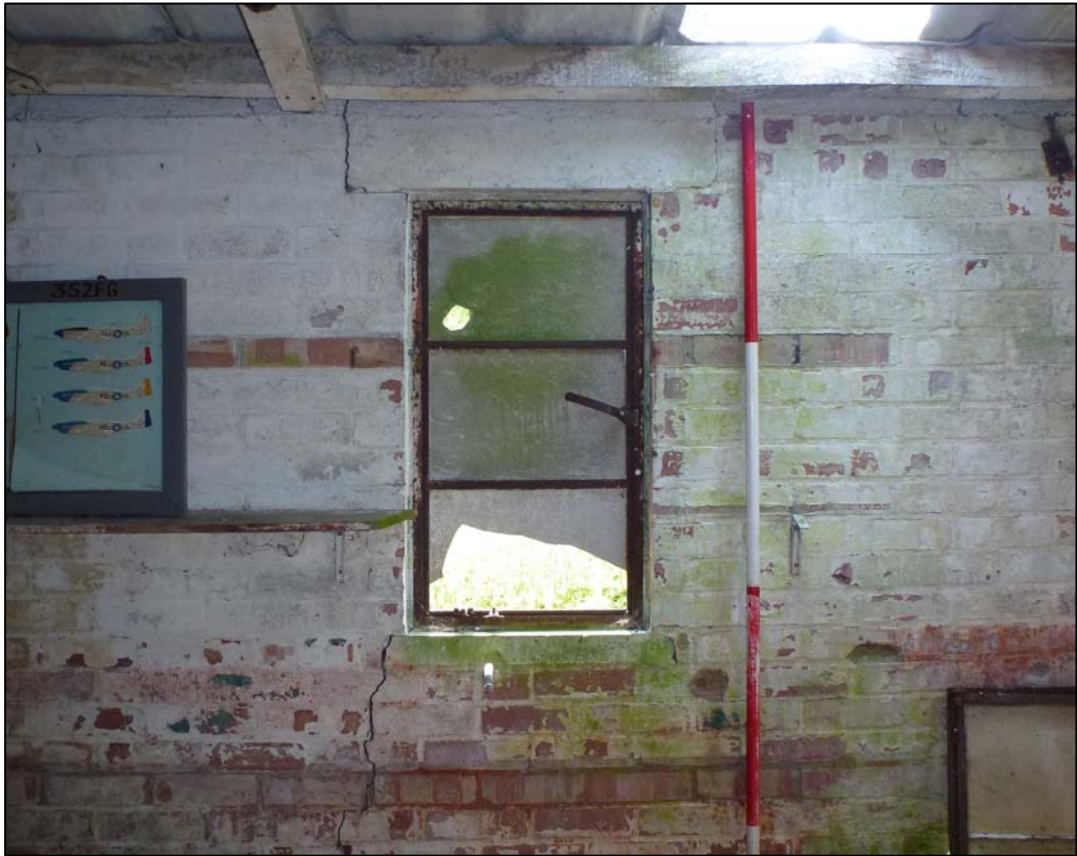
Fenestration comprised a series of three paned, cast iron formed windows arranged along both sides of Buildings 1 and 2 with an additional window in the north eastern wall of Building 2. The frames were cemented into openings in the brickwork with concrete sills and lintels (plates 13 and 14). Many of the individual panes had been replaced with sheets of fibreboard rather than glass.

Plate 13. typical window frame, internal view (ref. HTR 23)

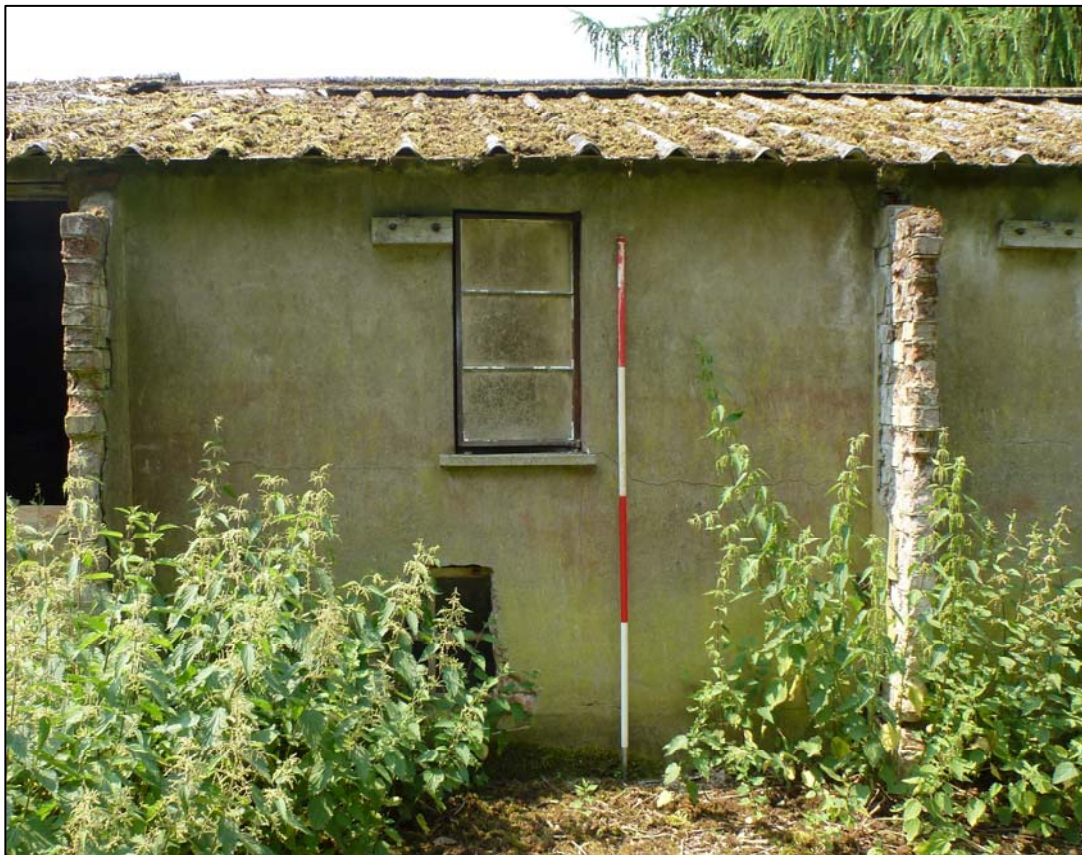
Plate 14. typical window frame, external view (ref. HTQ 18)

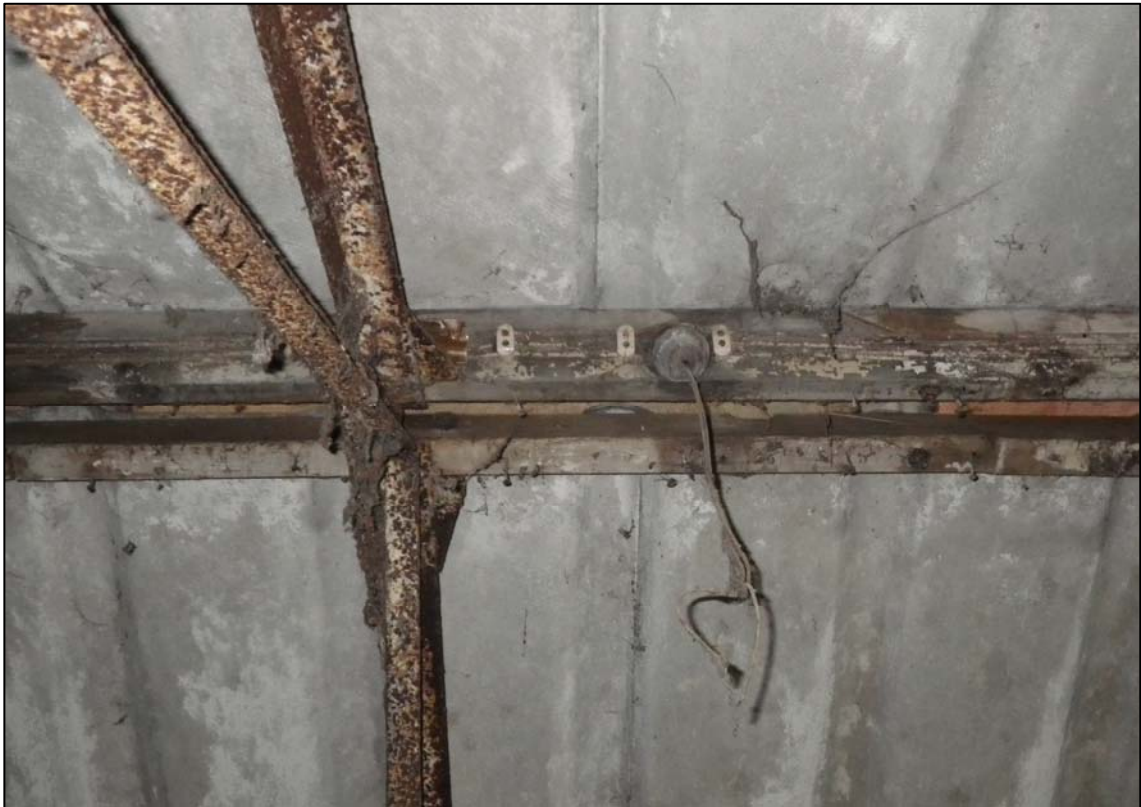
Both buildings were equipped with electrical lighting and occasional remains are present in the form of wiring, lamp brackets and switches, or evidence for the siting of these. Attached to the central purlins using ceramic fasteners are lengths of twisted two core flex which run from switches adjacent the doorways to ?bakelite electrical fittings from which lamps, presumably with shades, would have been hung (plate 15). Where light switches were present they were mounted on wooden backplates, which concealed the wiring with the adjacent wiring occasional encased in wooden ducts (plate 16).

Plate 15. electric light fitting - Building 1 (ref. HTR 23)

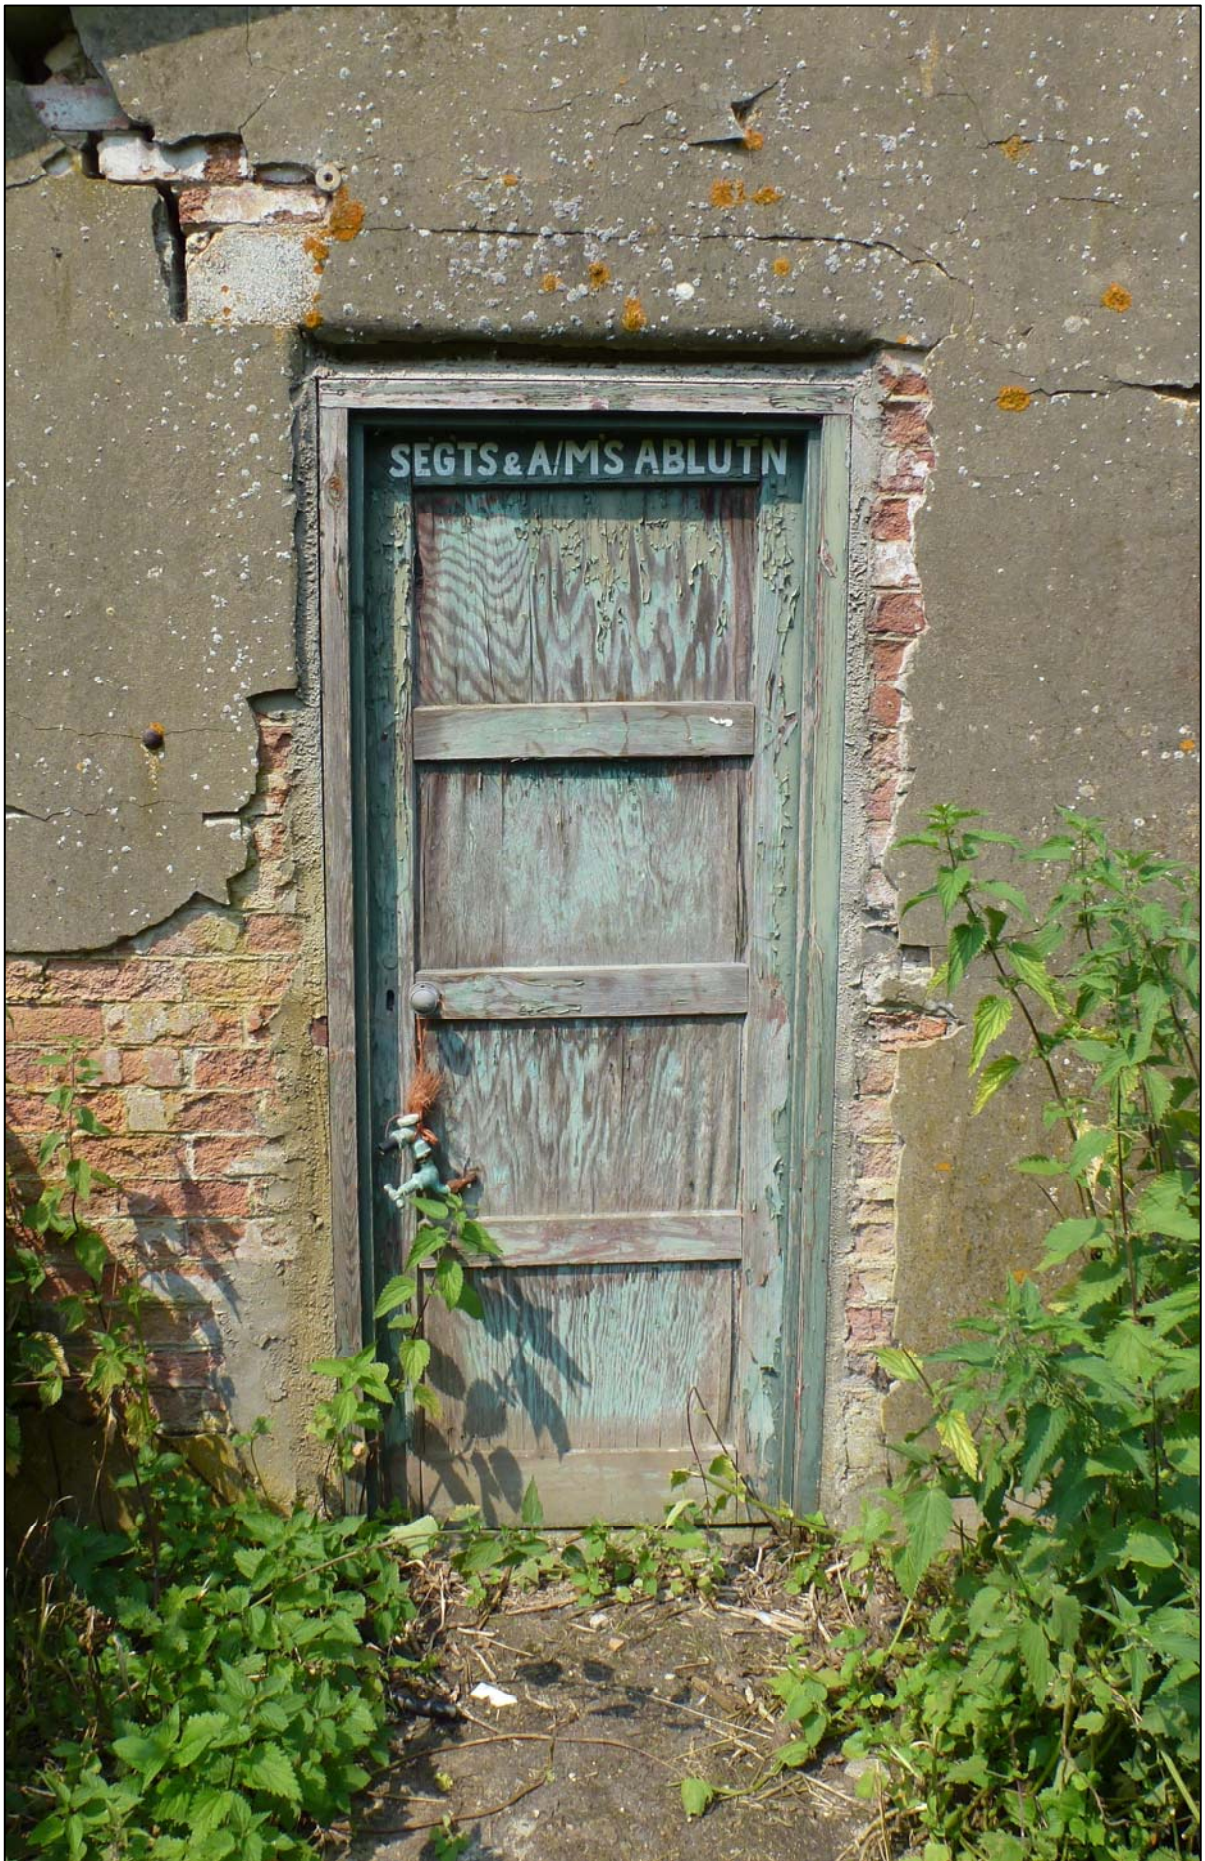
Room 1 (plates 18 and 19) Access to this room was via Door 1 in the southern wall of the building. This door was constructed of four panels held in a timber frame (Plate 17). Painted on the outer face of the door, along the top edge is the text 'SE'G'Ts & A/M'S ABLUT'N', which is presumably an abbreviation for *Sergeant's and Air man's Ablution*, and confirms this building's use as an ablutions block.

Plate 17. Building 1, Door 1 (ref. HTQ 45)

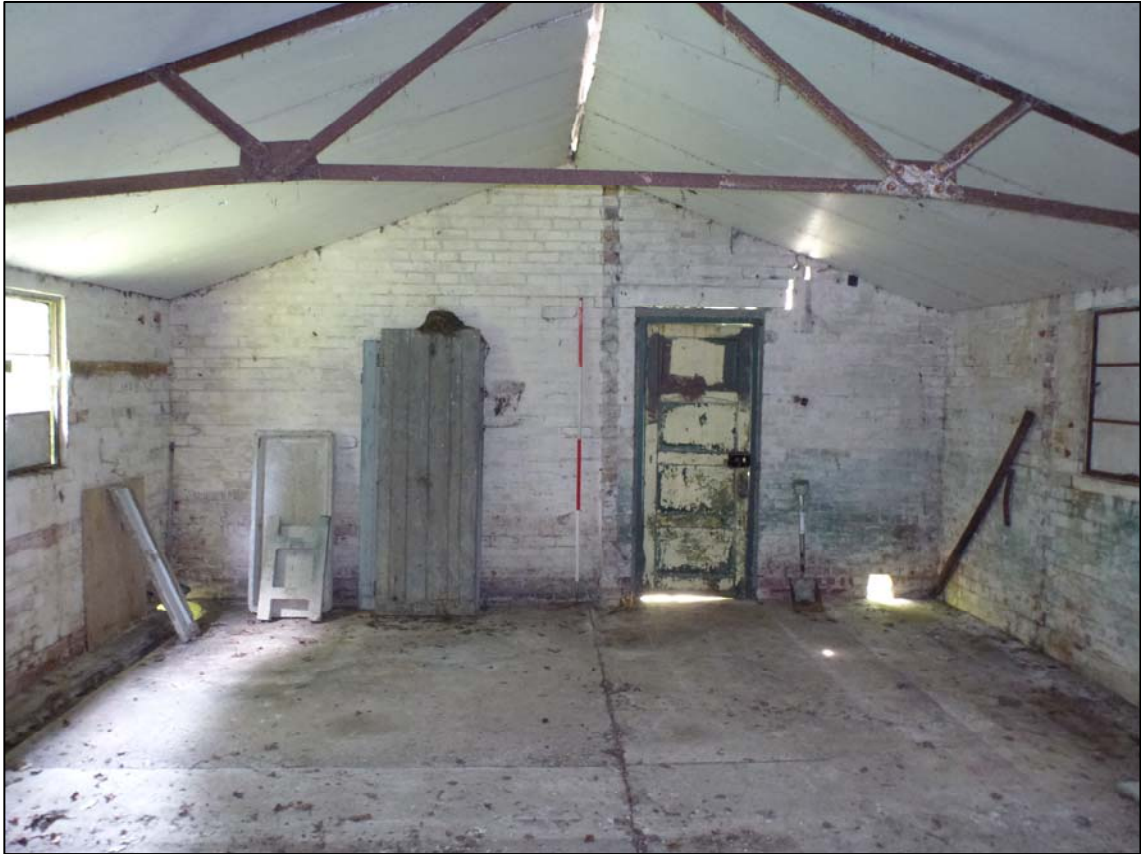
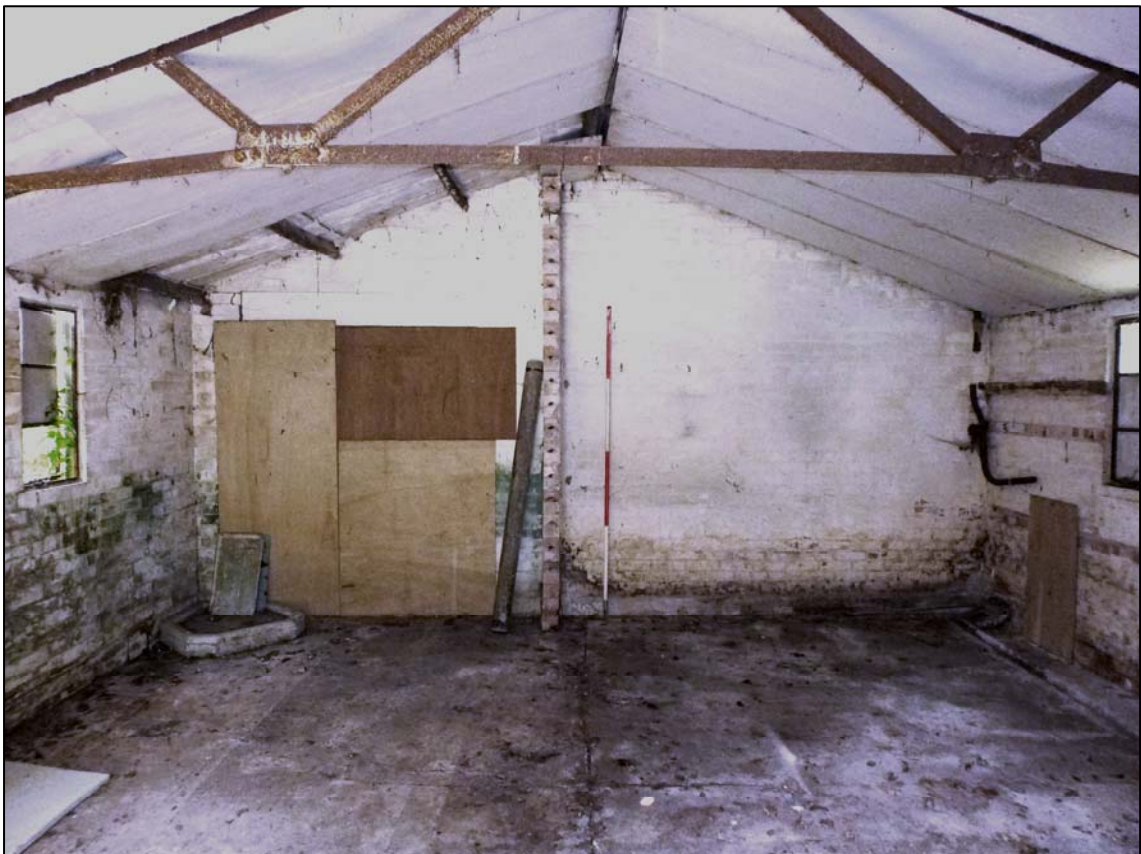
Plate 18. Building 1, Room 1, camera facing south (ref. HTR 05)

Plate 19. Building 1, Room 1, camera facing north (ref. HTR 04)

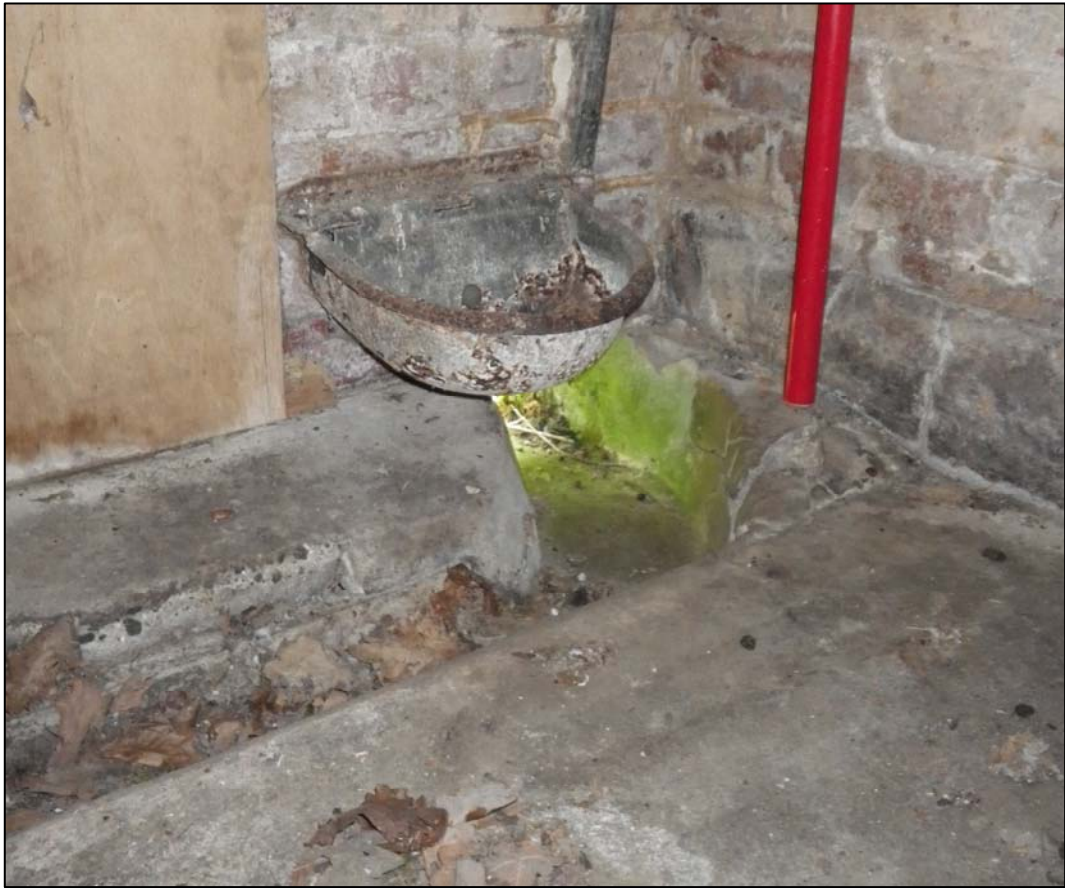
Plate 20. Building 1, Room 1, exit of eastern drain (ref. HTQ 80)

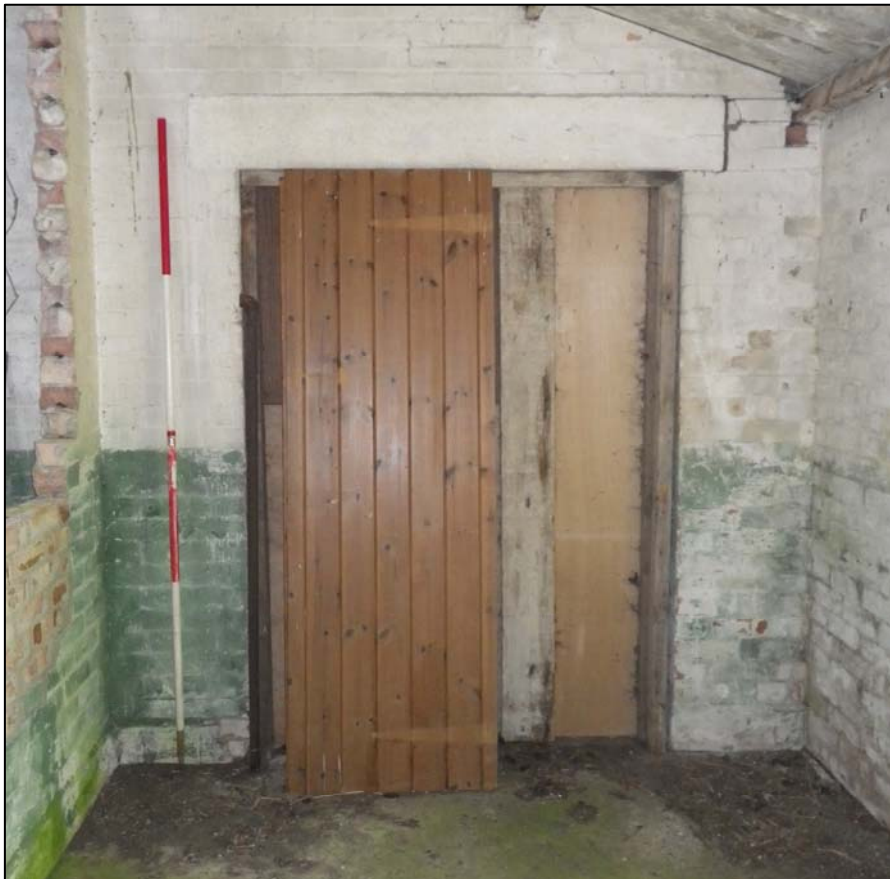
A large opening with concrete lintel was present in the north west corner of room 1 which would have given access to Room 2, although at the time of the survey this was blocked by timber sheeting.

Plate 21. Building 1, Room 2, blocked opening to Room 1 (ref. HTQ 80)

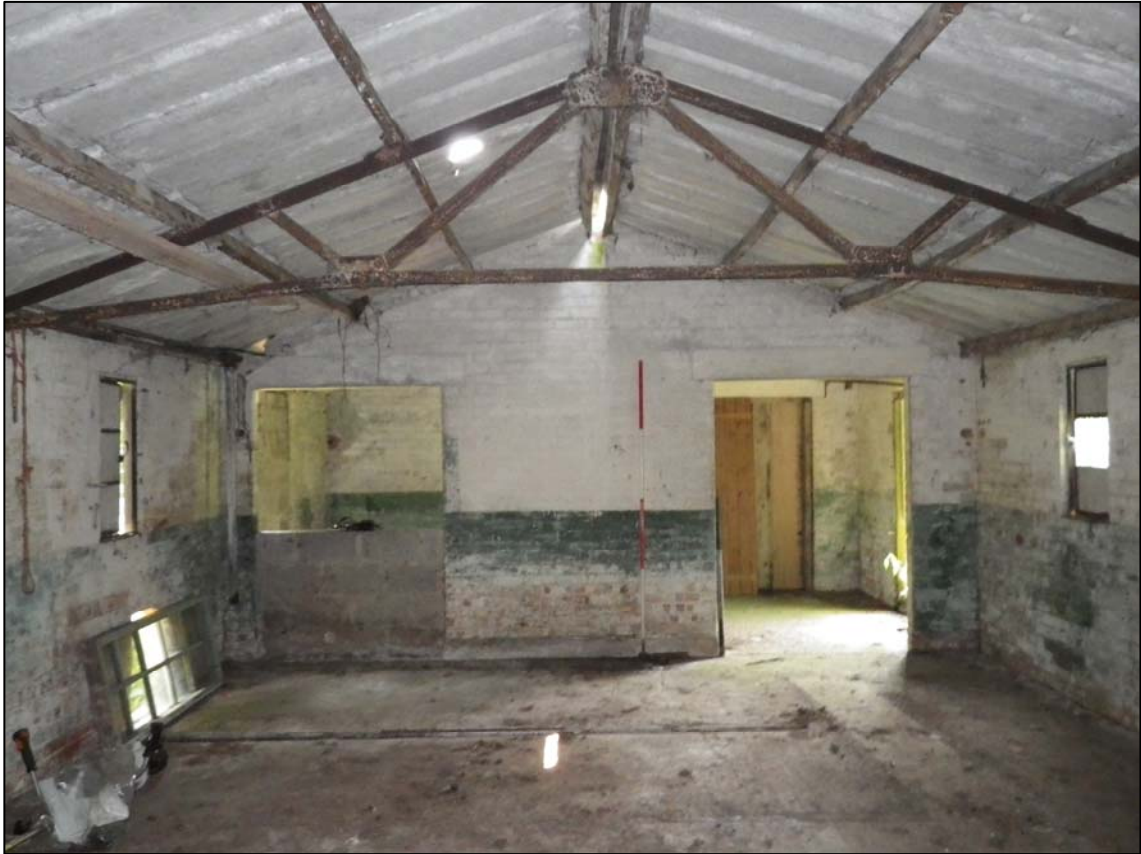
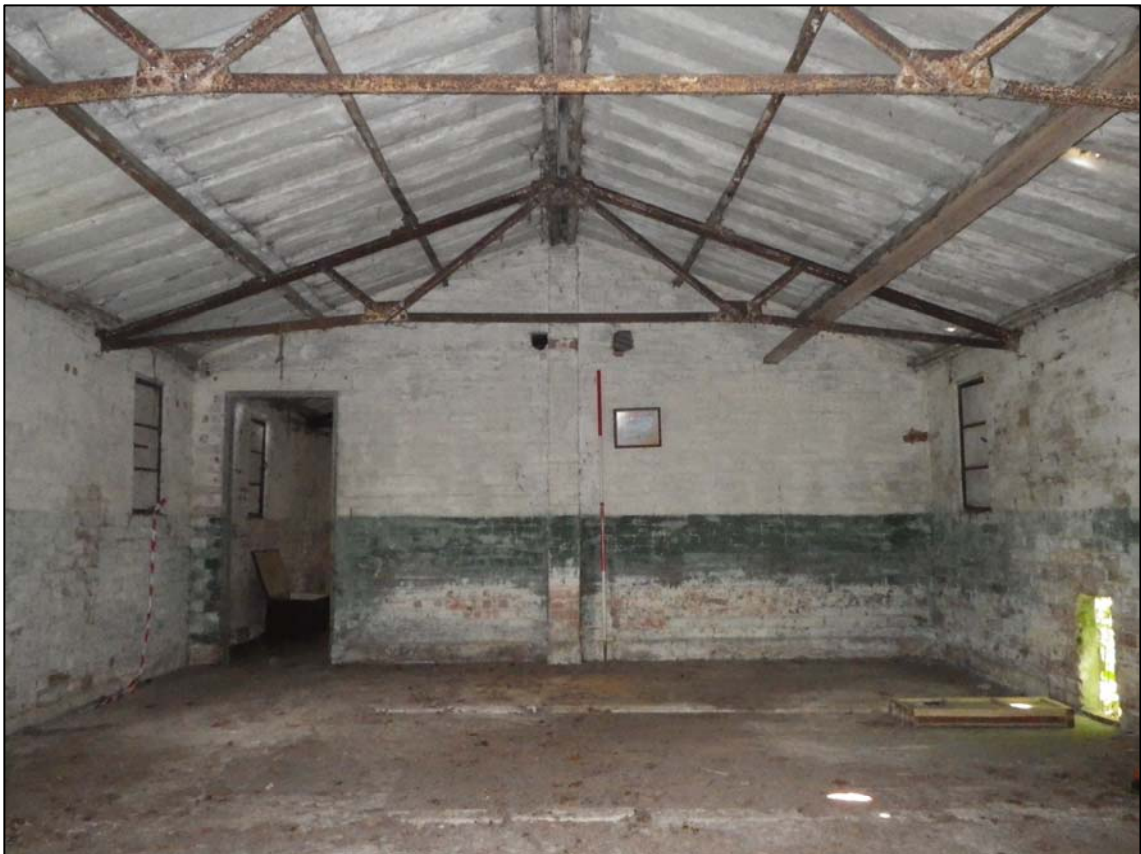
Room 3 measured 7.5m by 5.4m. The bare walls were painted as in Rooms 1 and 2, half off white and half pale green (Plates 22 and 23). Two drains ran across part of the

Plate 22. Building 1, Room 3, camera facing south (ref. HTQ 64)

Plate 23. Building 1, Room 3, camera facing north (ref. HTQ 65)

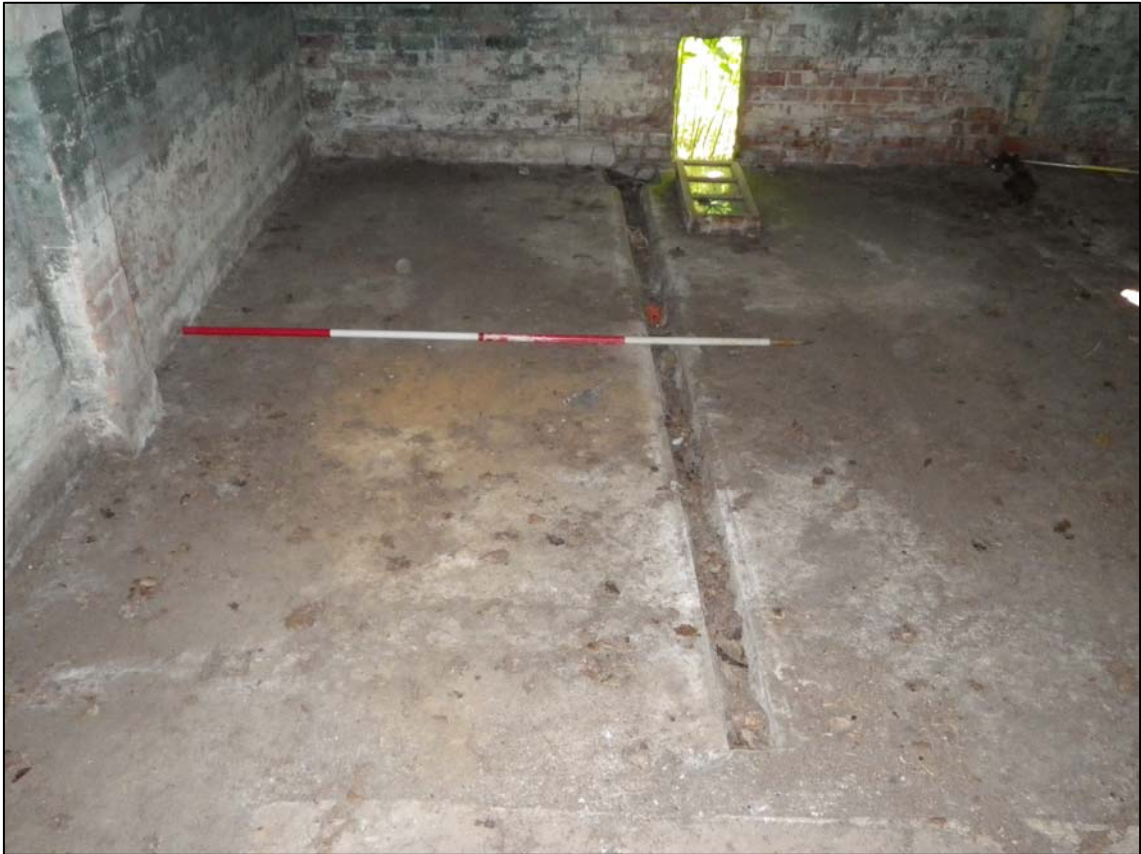
width of the room, both terminating in open drain holes adjacent the east wall (plate 24). A scar of the floor indicated a dividing wall rang across the width of the room but that this stopped short of the west wall leaving a large open access way. A scar on the east wall indicated that this wall only had a height of 0.94m. Adjacent the two drains, two rows of three metal fittings, or their sites, were present (plate 25). The drains, the dividing wall and the metal fittings suggest that two back to back rows of three shower cubicles once existed in this room.

Plate 24. Building 1, Room 3, one of the two drains across the floor (ref. HTQ 68)

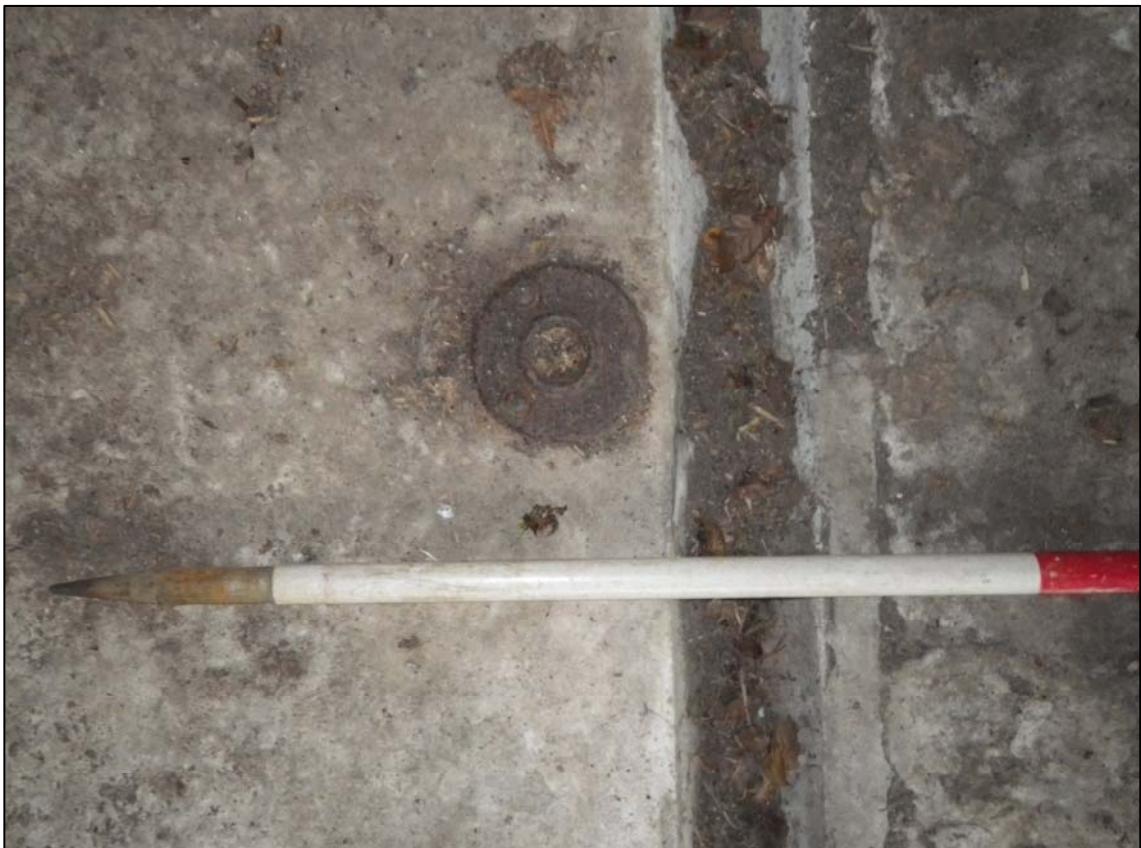
Plate 25. Building 1, Room 3, sample of a metal fitting adjacent to the drains (ref. HTQ 80)

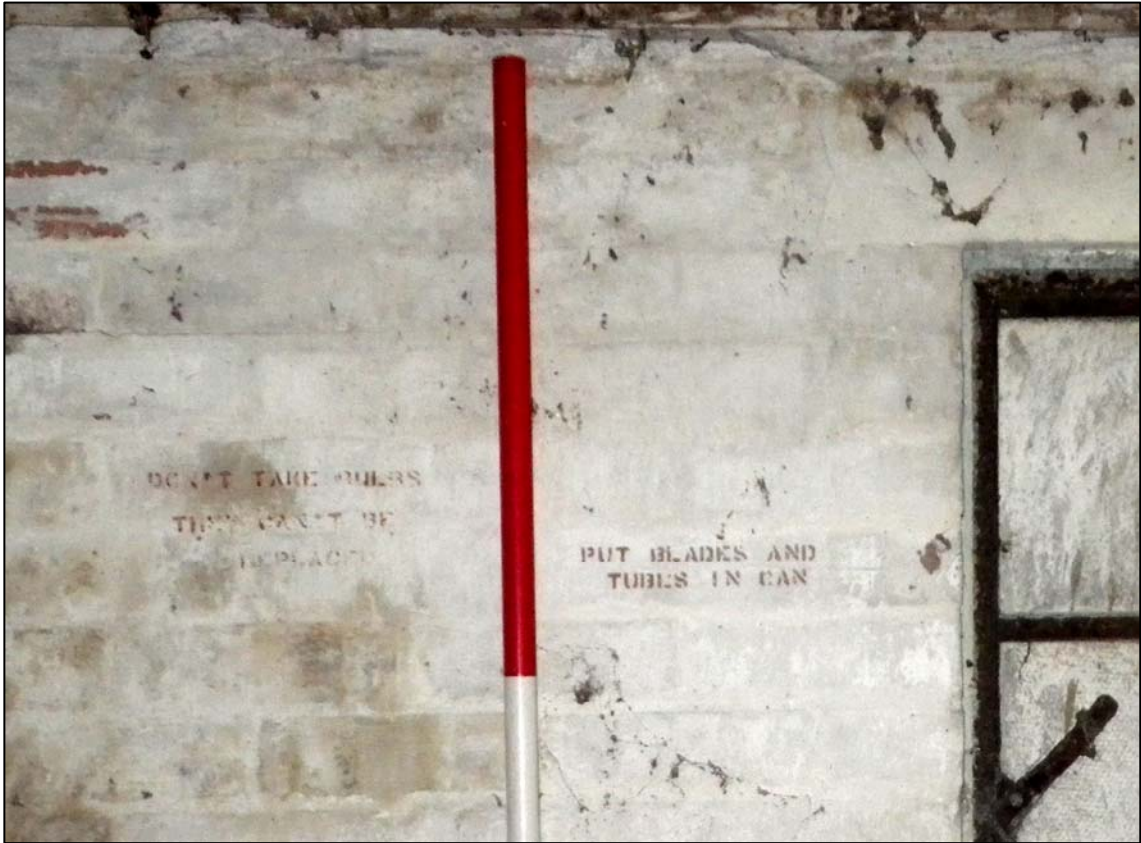
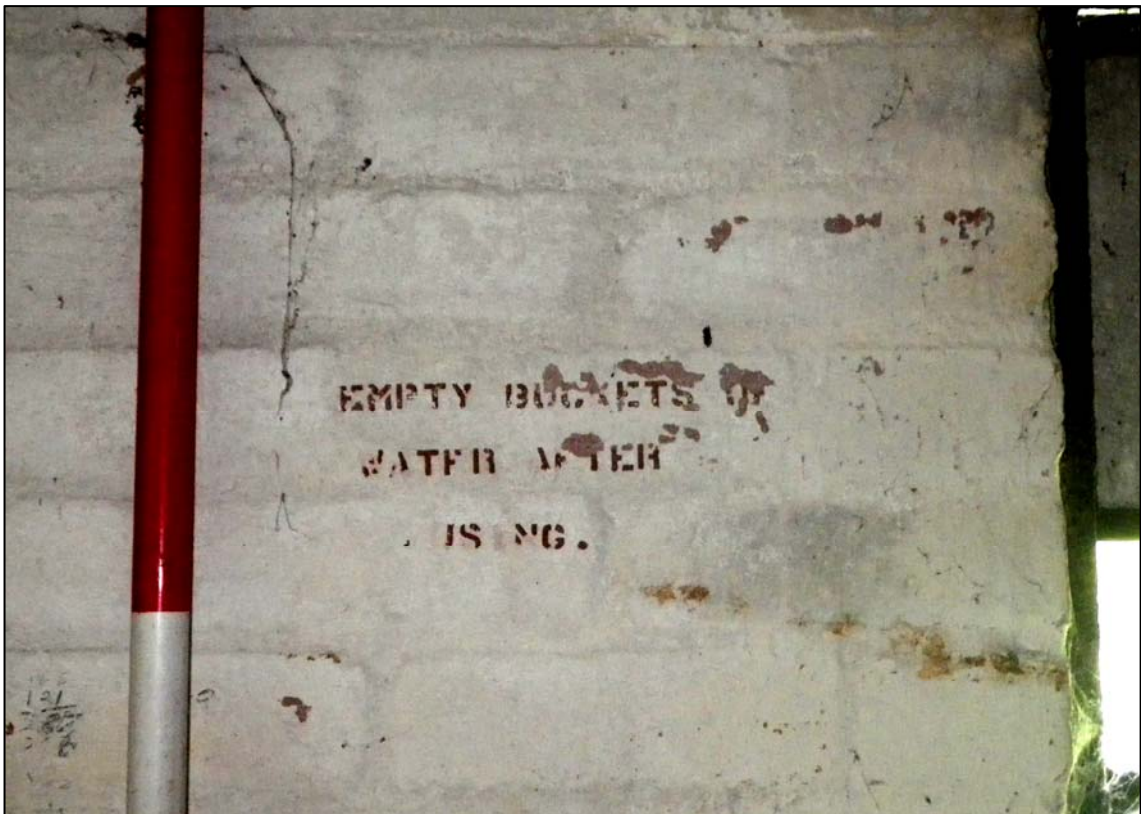
Repeated a number times around all four walls of this room were three sets of stencilled text (plates 26 and 27), these stated:

EMPTY BUCKETS OF
WATER AFTER
USING

DON'T TAKE BULBS
THEY CAN'T BE
REPLACED

PUT BLADES AND
TUBES IN CAN

Plate 26. Building 1, Room 3, examples of stencilled text (ref. HTQ 76)

Plate 27. Building 1, Room 3, examples of stencilled text (ref. HTQ 76)

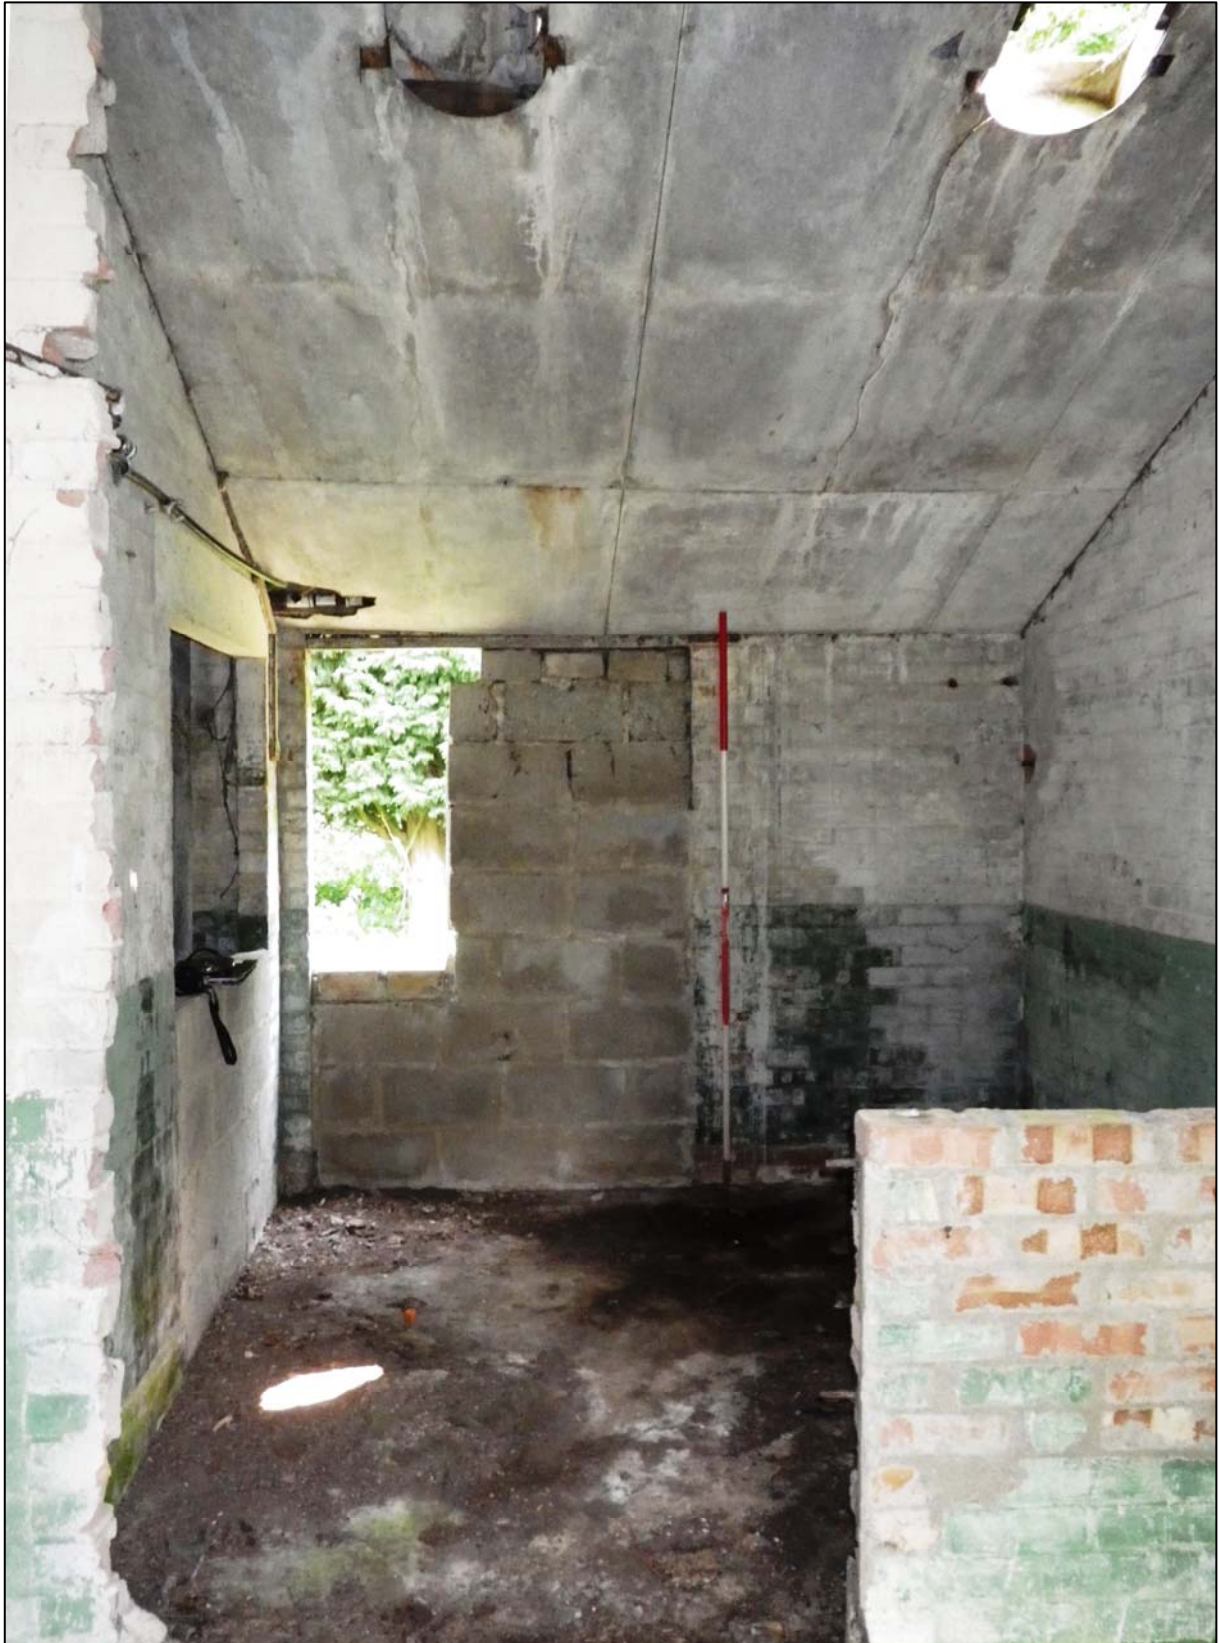
Room 4 measured 2.8m by 2.8m and was painted half and half off white and pale green (plate 28). A large opening was present in the east wall which had been partly closed with block work. This is coincidental with a small extension to this building visible in technical plan (Fig. 3) and may been an opening into this additional space. Two circular openings were present in the roof of this room.

Although not conclusive, it seems possible that this space may have been associated with provision of hot water for the Ablutions Block with the roof vents being related to heating equipment and the small extension visible on the technical plans being a relatively small tower that supported a water tank.

Plate 28. Building 1, view into Room 4 from Room 2 (ref. HTQ 76)
