Land at RAF Horham, Low Road, Denham
DEN 011

Archaeological Building Record

SCCAS Report No. 2013/101

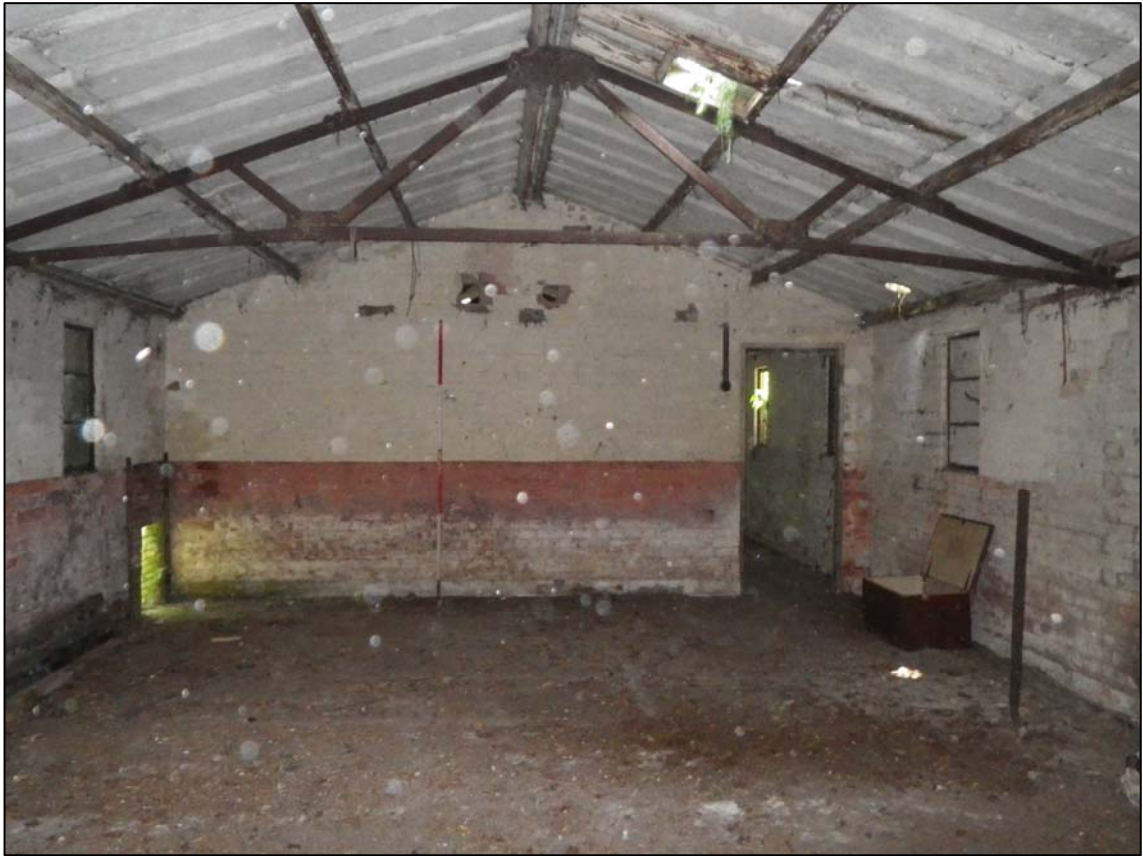
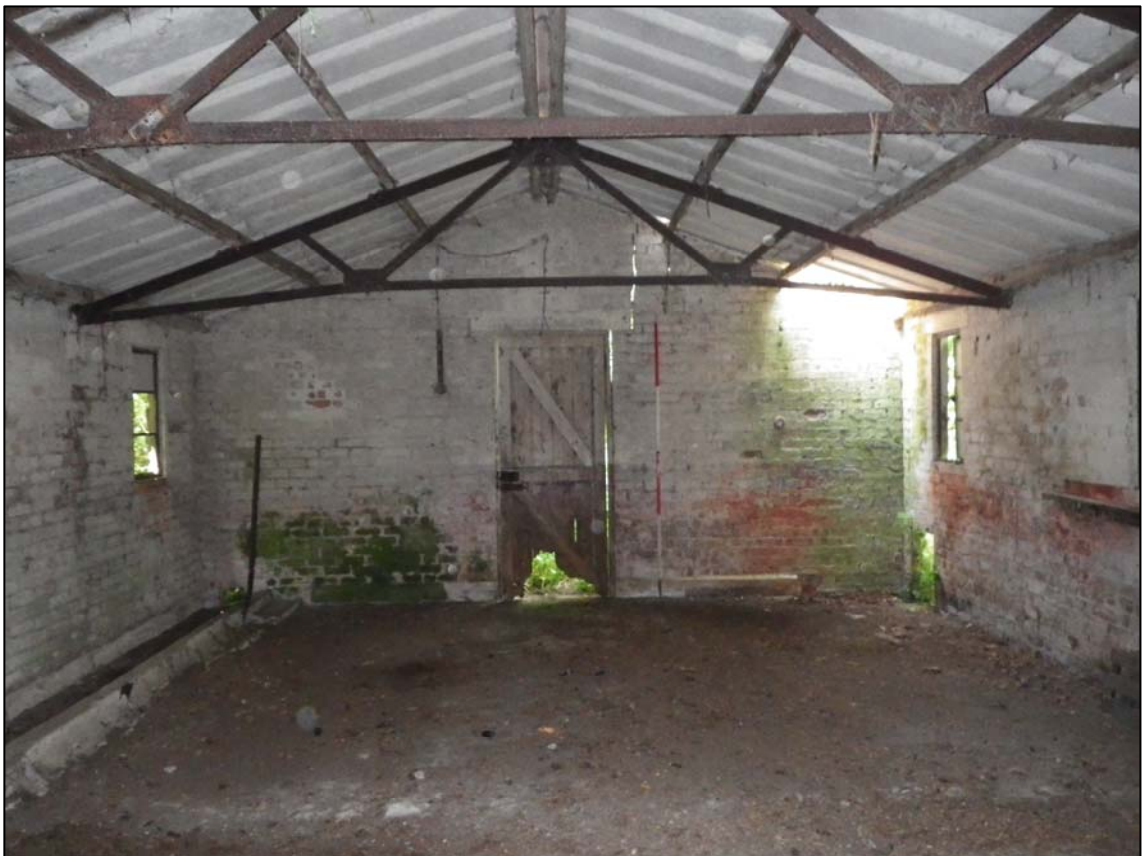
Room 5 comprised a large open space measuring 8m by 5.4m (plates 29 and 30). An access point to the building, Door 3, was present in the northern wall. This door consisted of a vertical timbers set within a frame rather than the panels of Door 1. Externally, the door was also marked 'SE'G'Ts & A/M'S ABLUT'N', but this was much faded.

Plate 29. Building 1, Room 5, camera facing south (ref. HTQ 88)

Plate 30. Building 1, Room 5, camera facing north (ref. HTQ 89)

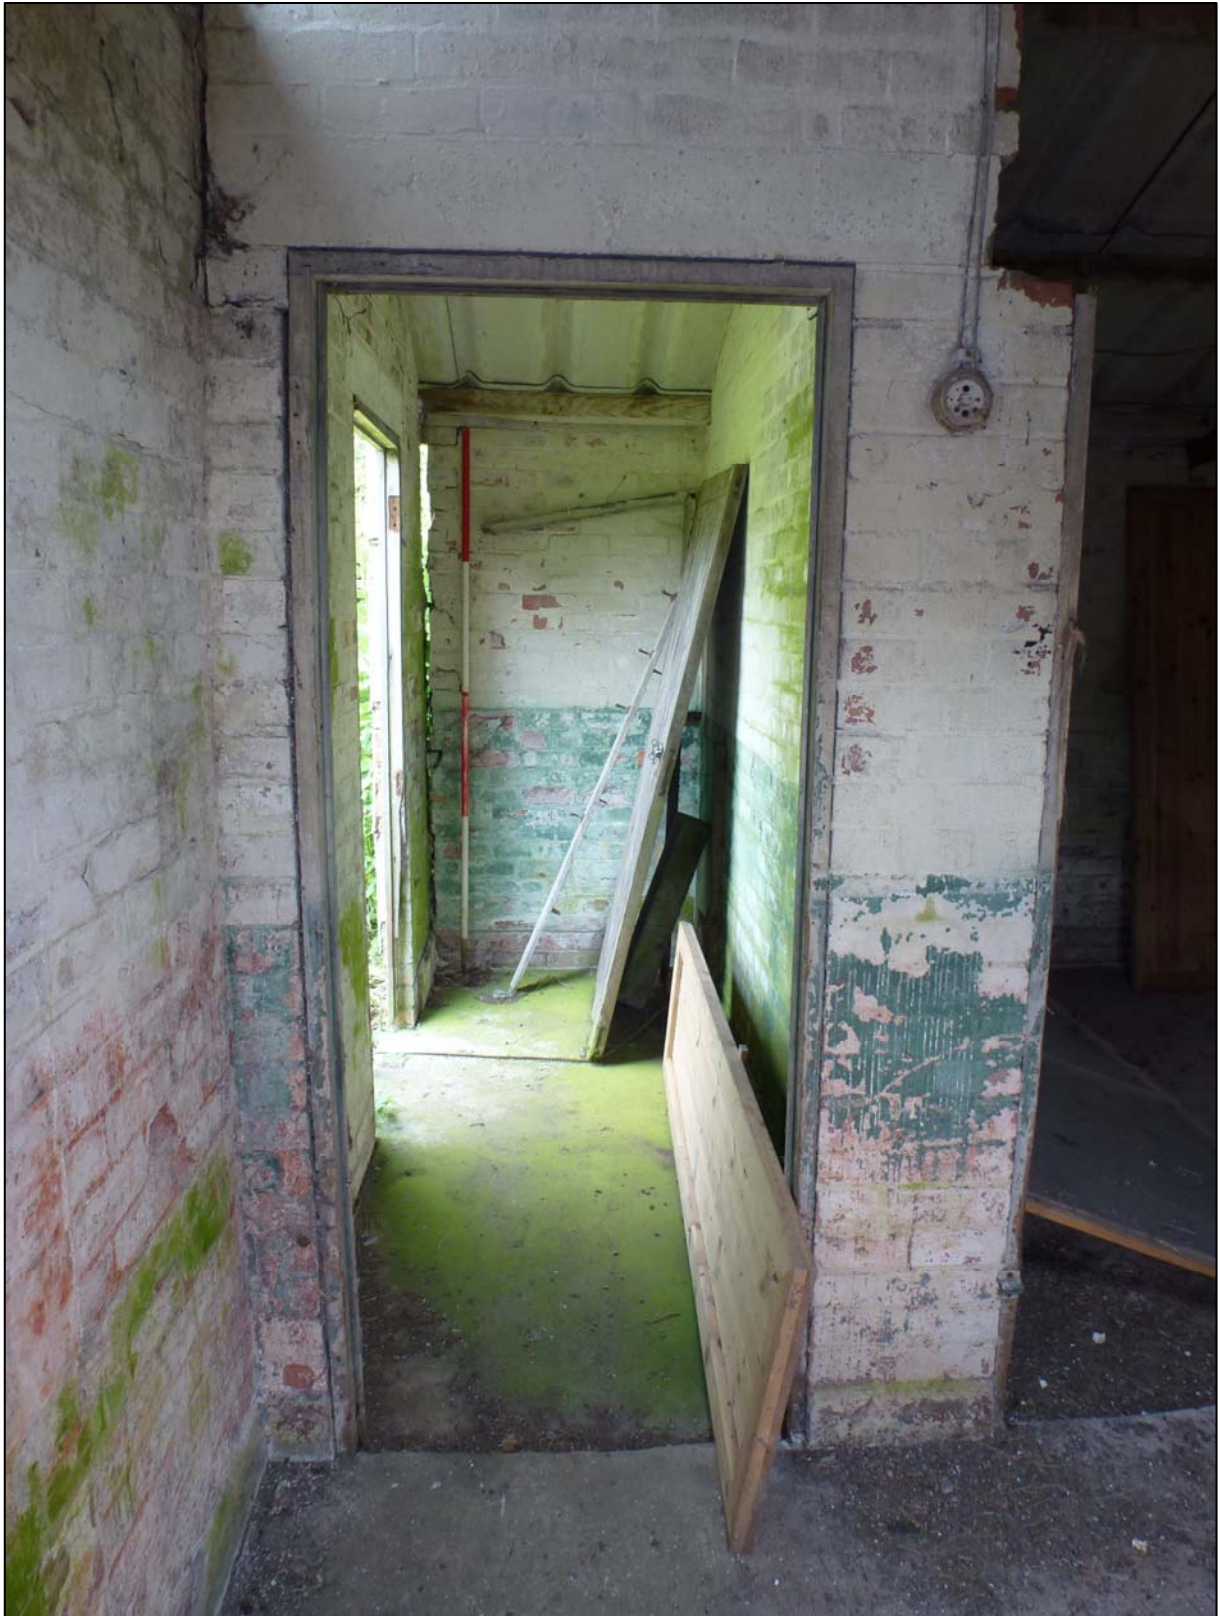
Plate 31. Building 2, Room 1, viewed through Door 4 (ref. HTR 21)

Room 1 at the northern end of the building is a short access corridor that leads into Room 2 via Door 4 (plate 31). Internally, the upper half of the bare brickwork is painted off-white whilst the lower section is pale green, similar to much of Building 1. Both Door 3 and 4 were set in wooden frames although at the time of the survey both doors were missing. A door was present in Room 2, lying against the wall, which is likely to have been the outer door (Door 3). It was formed of vertical timbers in a timber frame, similar to Door 3 in Building 1.

Room 2 was a large open space (plate 32) although evidence in the form of a single course of brickwork across the floor and scars of removed walls visible on the wall surfaces indicated that it had once been divided into three smaller rooms (marked in italics as Rooms 2a, 2b and 2c in Fig. 9). One room (Room 2a) occupied the south west half of the full length of the building whilst the north eastern half had been divided into two separate rooms (Rooms 2b and 2c). Part of a wooden doorframe was present adjacent Door 4 (Door 5, visible in plate 31) indicating that Room 2b had been accessed from Room 2a.

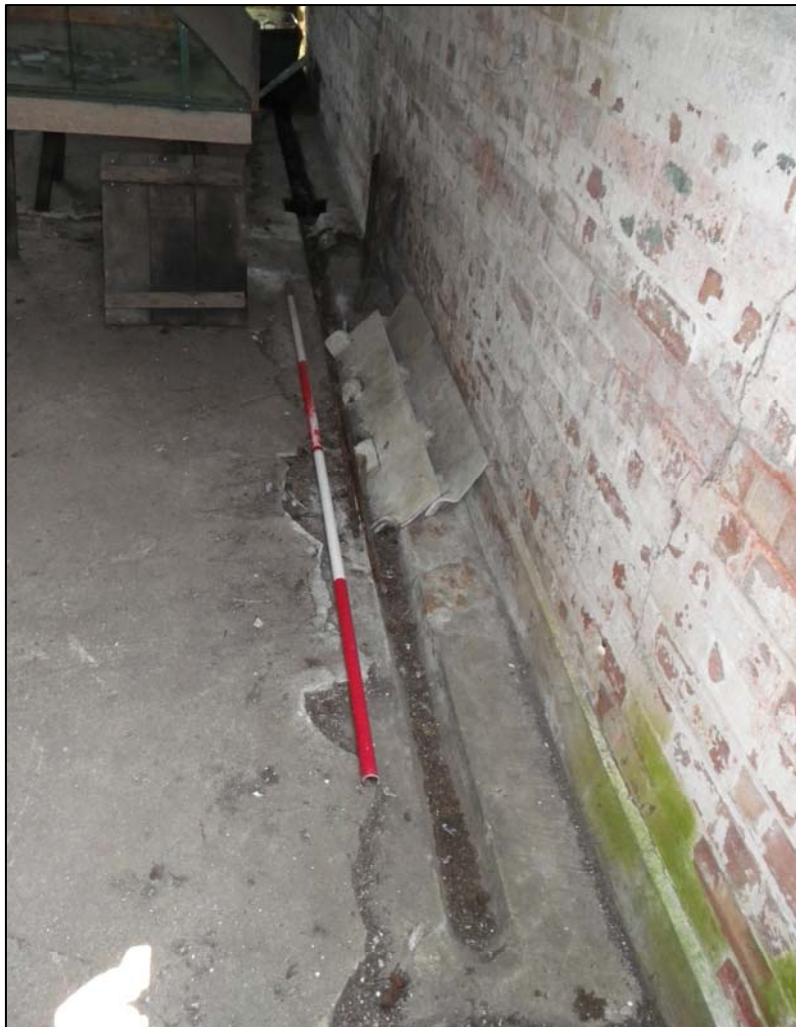
The floor in this room has been raised by c. 5cm, by adding a screed although it is not clear if this was carried out during the RAF/USAAF use of the site or was undertaken during the building's later use. The drain described above is situated in the original floor level.

Plate 33. Building 2, drain in Room 2a (ref. HTR 17)

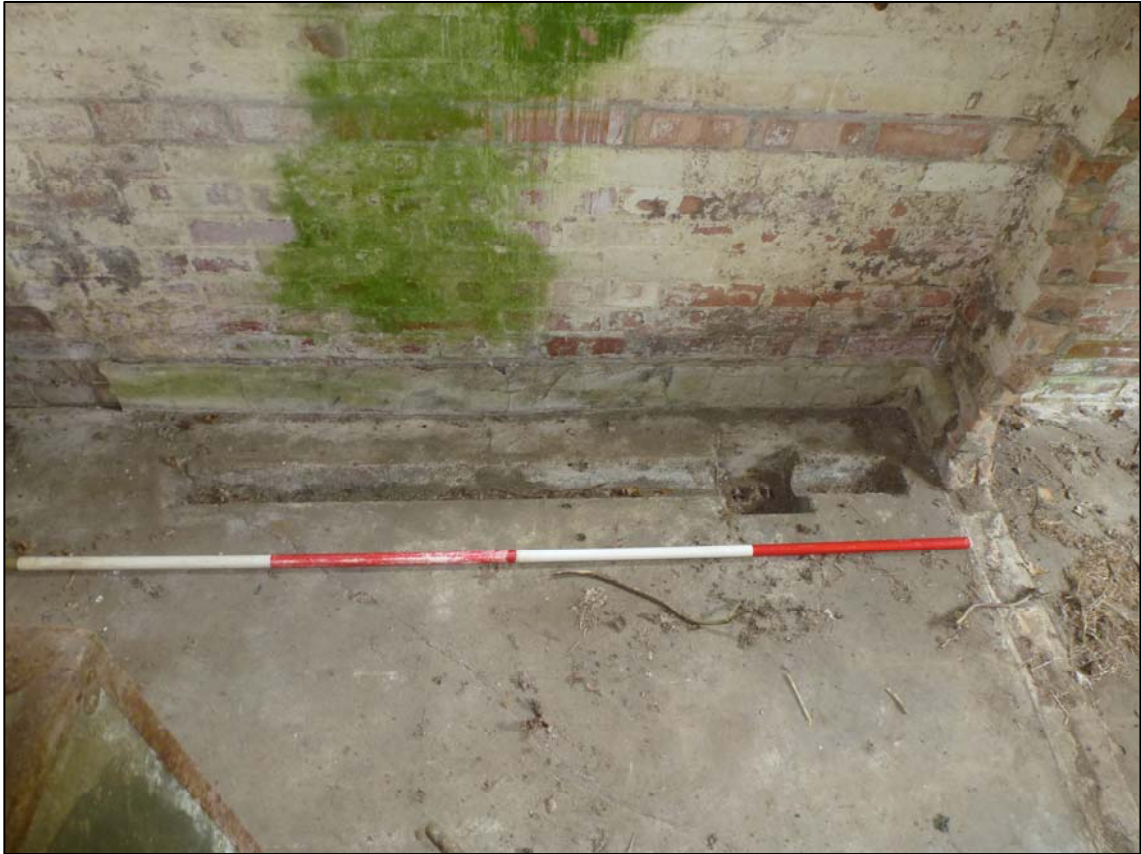
Room 2b measured 2.8m by 4.5m and appeared to be white off-white from floor to ceiling. A short length of drain is present in the eastern corner of the room running along the north east wall and draining into a square sump/drain (plate 34).

Plate 34. Building 2, drain in Room 2b (ref. HTR 24)

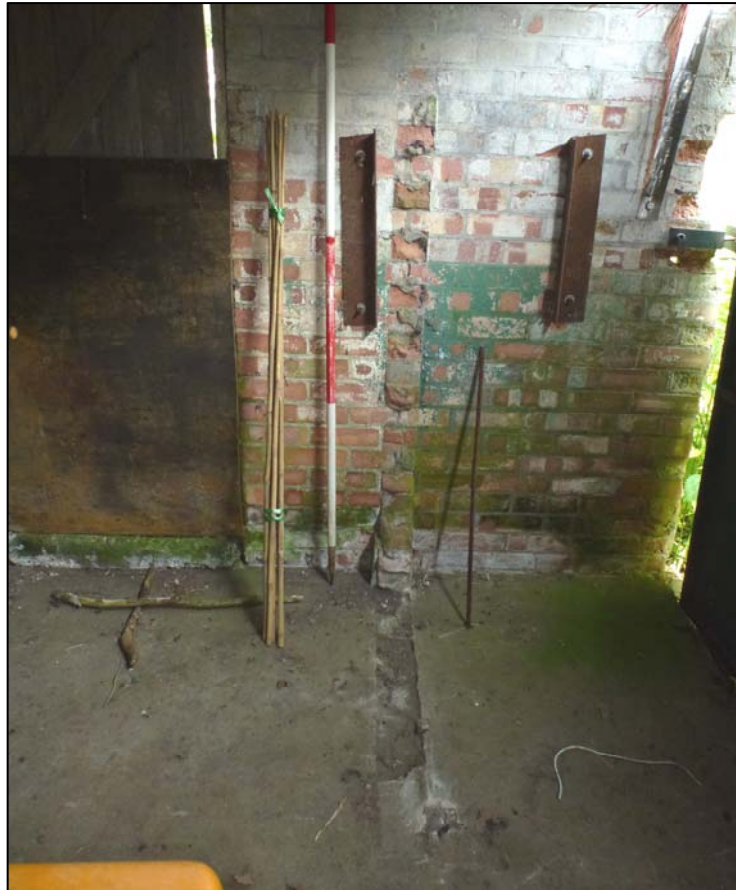
Room 2c measured in total 3.3m by 2.8m and also appeared to have been painted wholly off-white in colour although scars on the floor and the north east wall indicated further subdivision creating a 0.9m by 2.8m space, possibly a cupboard or a toilet, although there was no evidence for any plumbing. This smaller space was painted half and half with the lower half being pale green (plate 35).

Plate 35. Building 2, Room 2c showing evidence for further division (ref. HTR 26)

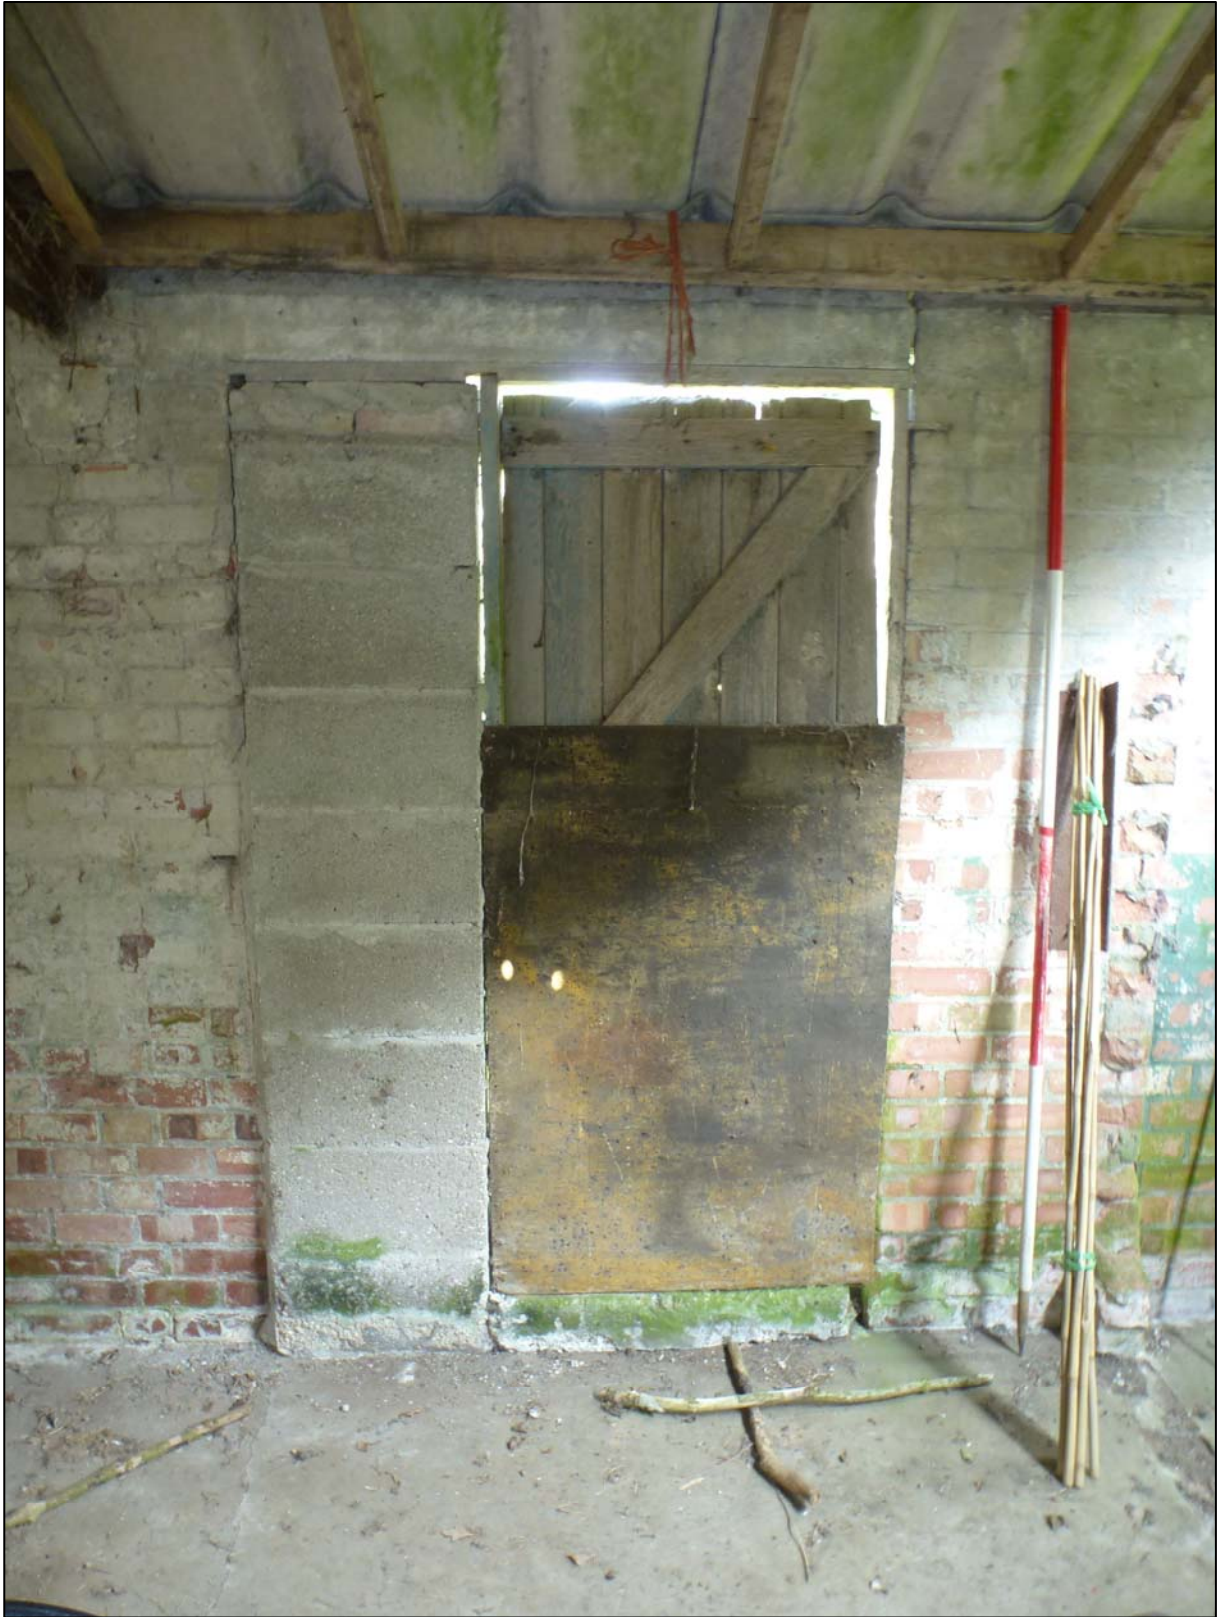
Door 2, in the north east wall of Building 2 opens into Room 2c. A wooden door is fitted into a frame although the space immediately to the north west has been filled with modern block work (plate 36). A concrete lintel spaces the entire opening. The arrangement of the door and block work is slightly odd but it is not clear what has occurred. It is possible the door was once wider and that a smaller door has been fitted and the doorframe altered to accommodate this or a window may have been present.

Plate 36. Building 2, Room 2c, Door 2 internal view (ref. HTR 25)

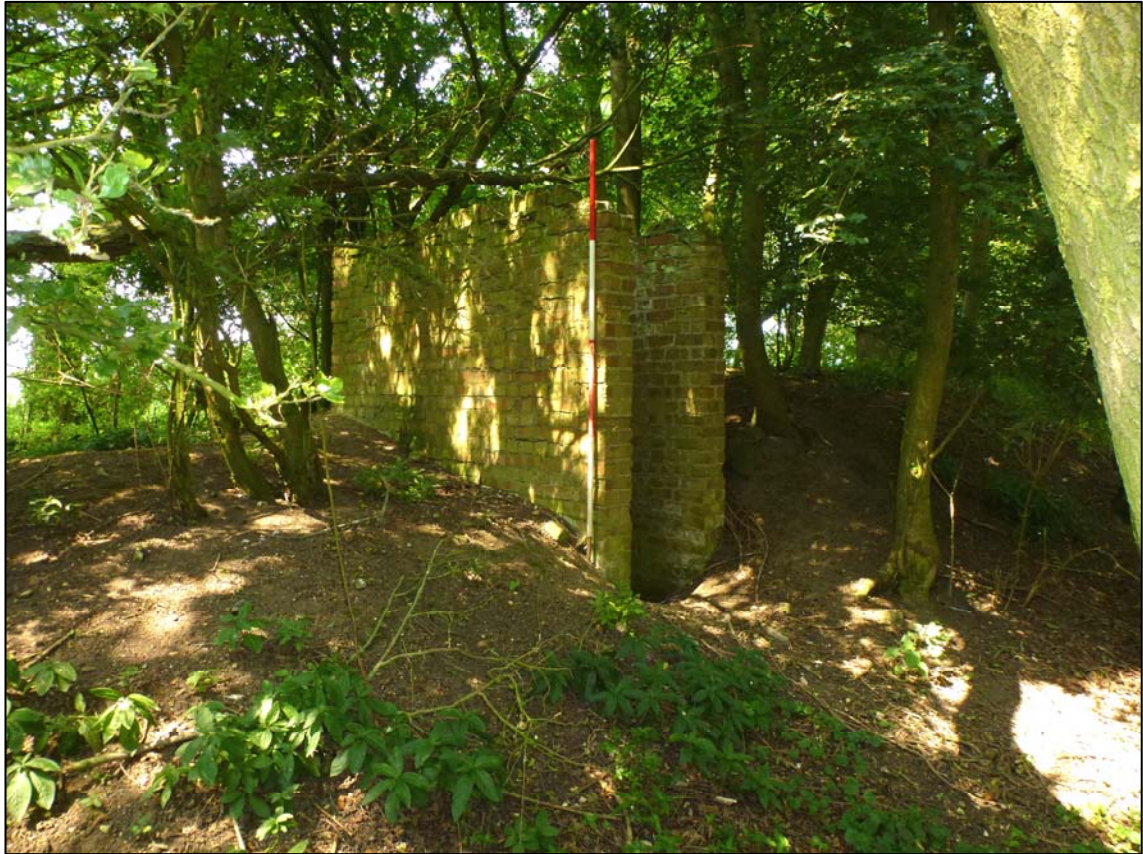
At this site the access stairways have been built of brickwork with concrete steps. All three would have been identical although Shelter 3 has lost its entrance stairway.

Plate 37. Shelter 1 showing the brick lined entrance (ref. HTR 44)

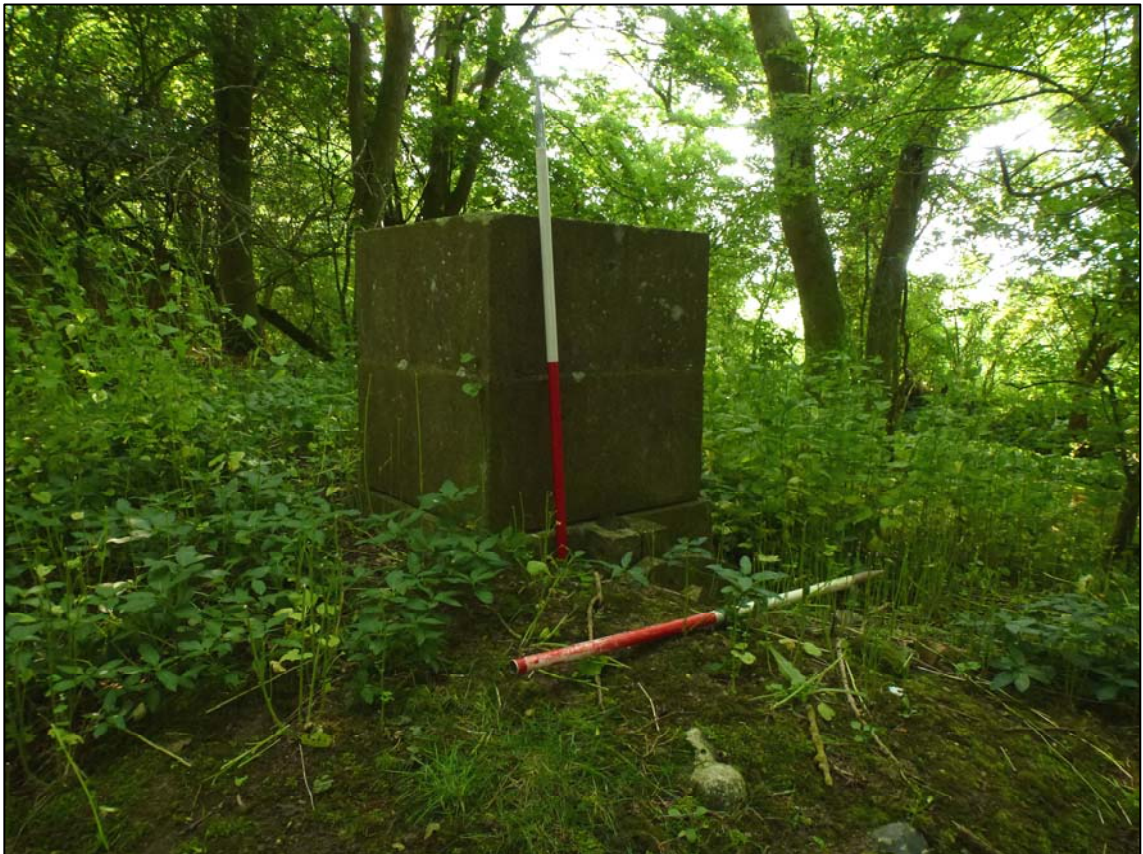
Plate 38. Shelter 1 showing the top of the escape shaft (ref. HTR 45)

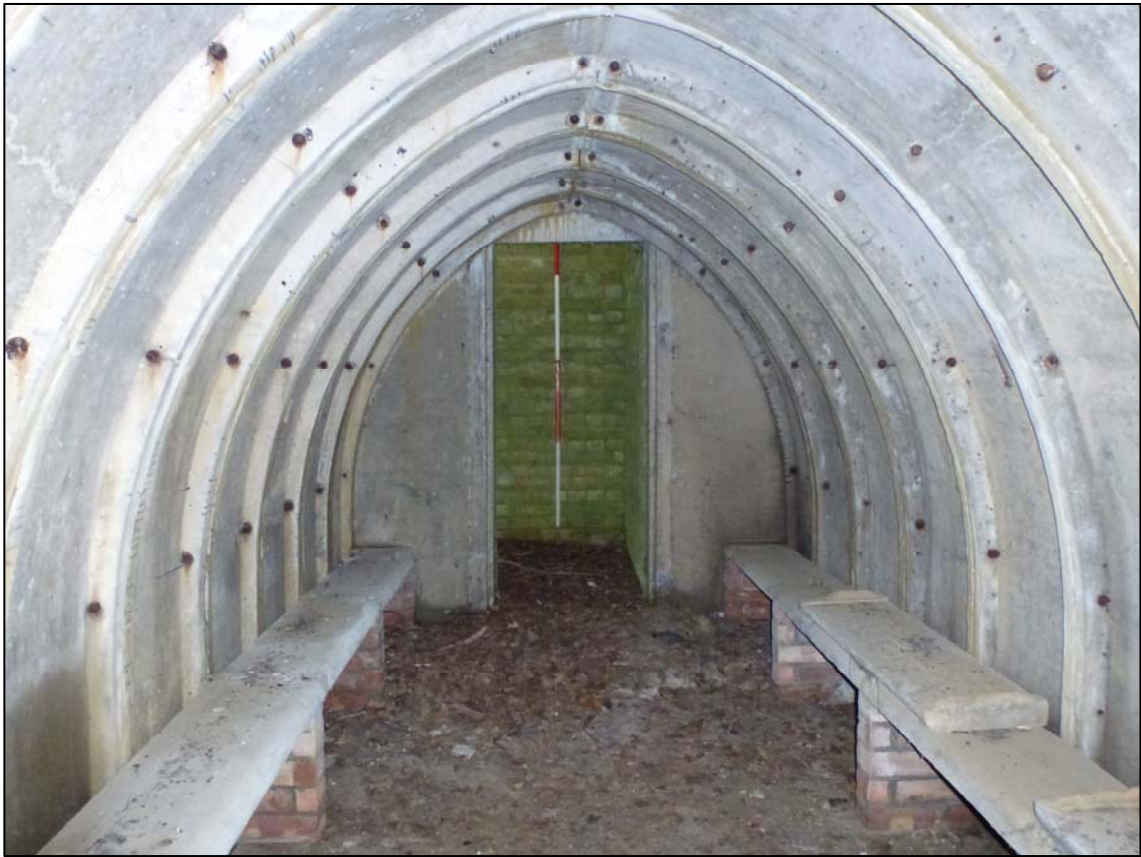
Plate 39. Shelter 1 internal view facing main entrance (ref. HTR 43)

Three separate air raid shelters were noted at this site (for locations see Fig. 4). All appear to be the Stanton type that was manufactured by the Stanton Ironworks Co Ltd near Nottingham. They are constructed in shallow excavations of pre-cast concrete panels that are bolted together. Access stairs are then built at one end (plate 37), usually at an angle to the entrance to help deflect blast, and an escape shaft is formed at the other end (plate 38). Once complete the whole structure is covered in soil to create a partially subterranean shelter (plates 39 and 40). The Air Ministry standard for this type of shelter was for a capacity of 50 men.

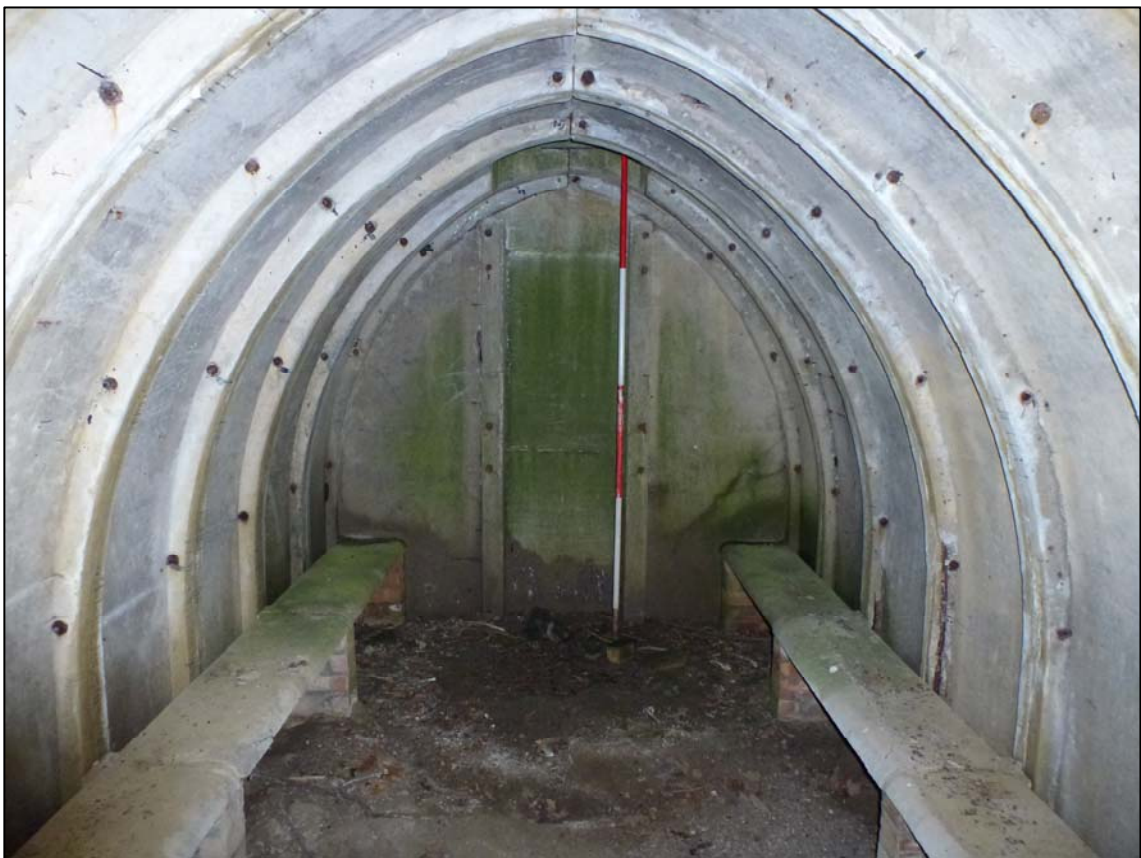
Plate 40. Shelter 1 internal view towards the rear wall, the entrance to the escape shaft is visible in the roof (ref. HTR 41)

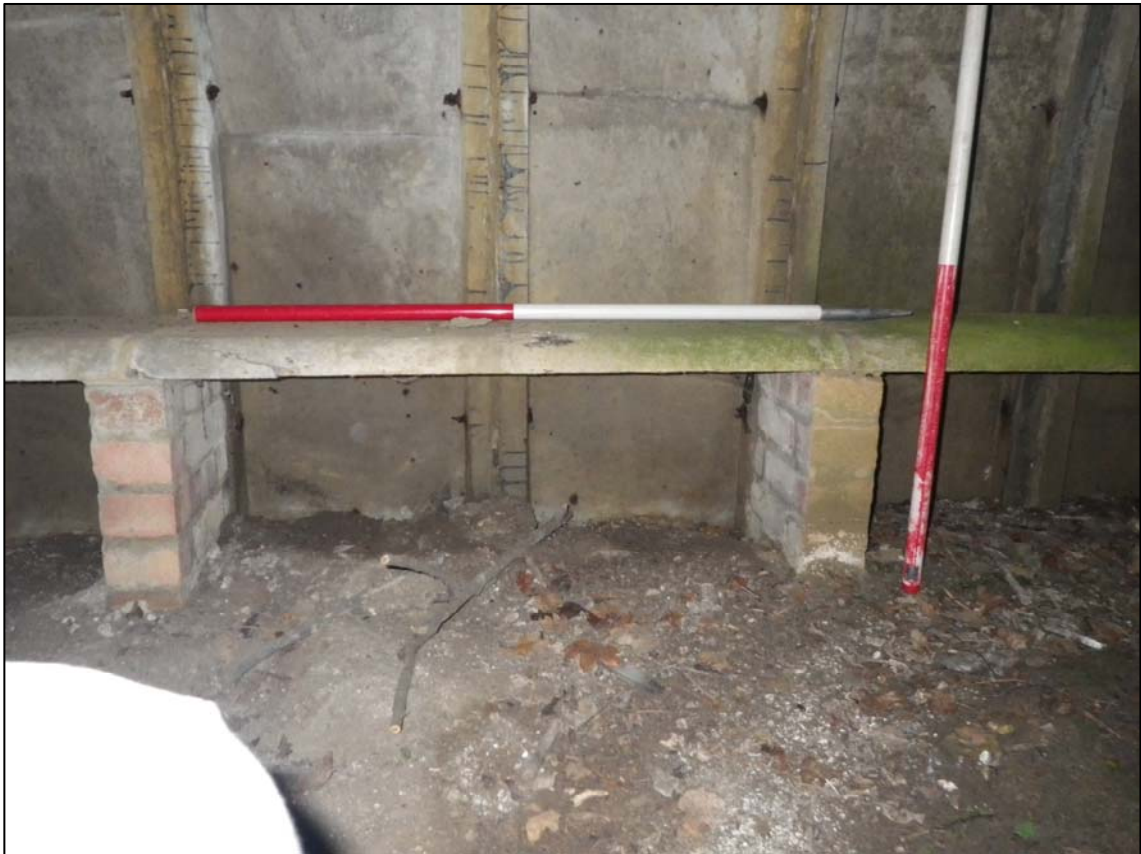
Benches formed of brick uprights and spanned by concrete slabs are present in Shelter 1 (plate 41), but these have been removed from Shelters 2 and 3 although traces remain (plates 42 and 43).

Plate 41. Shelter 1 view of one of the internal benches (ref. HTR 31)

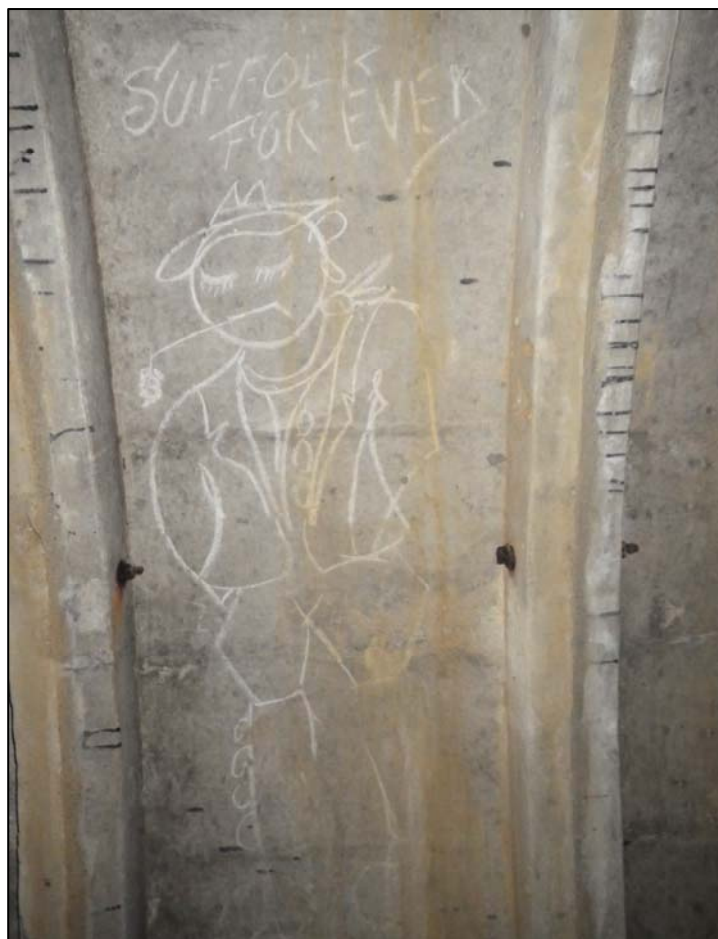
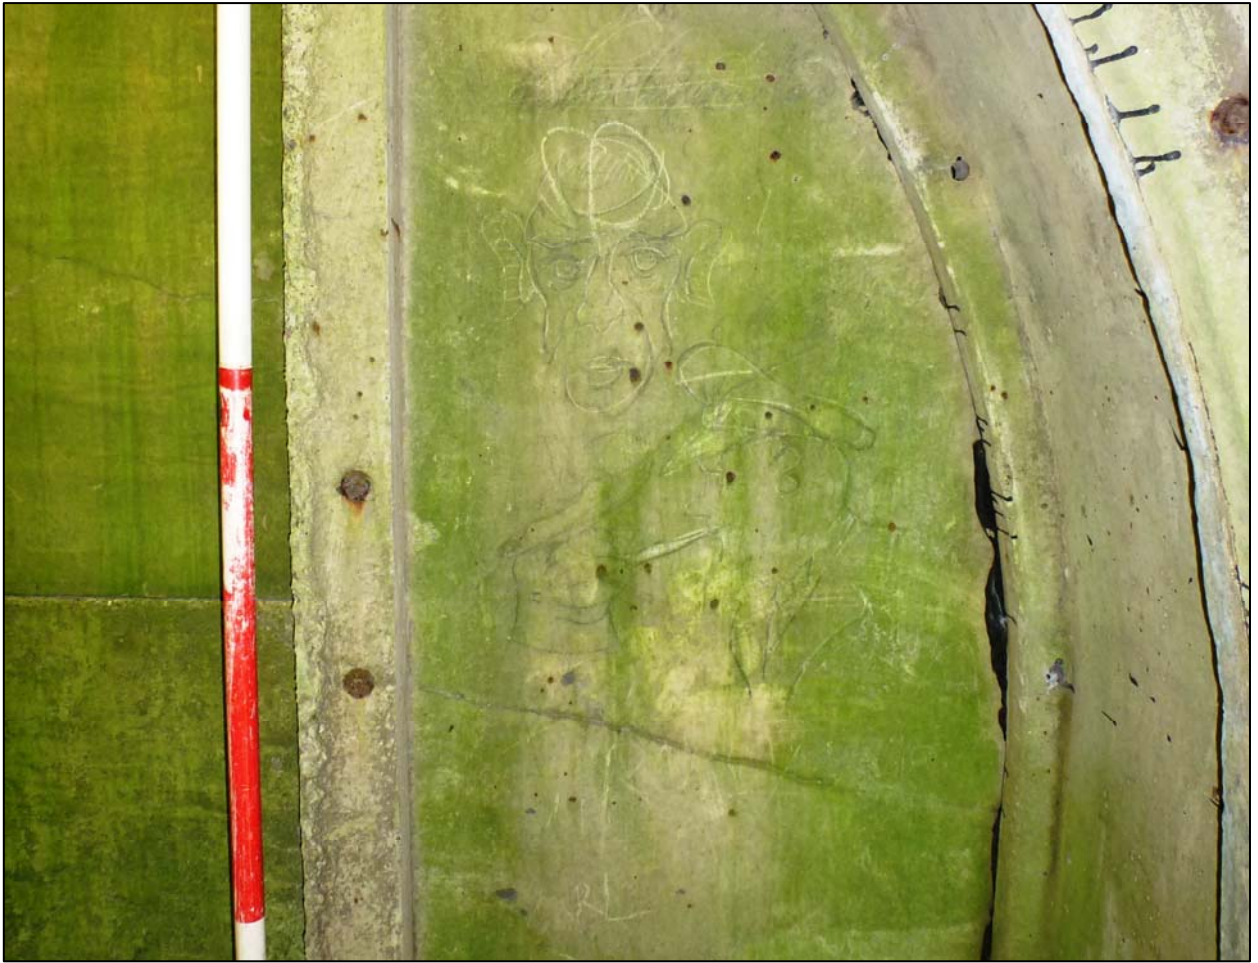
Some graffiti was noted in Shelters 2 and 3. In Shelter 2 there is a chalk drawing of what appears to be a typical farmer, eyes closed and chewing a bit of straw with hat neckerchief and boots, and the words 'Suffolk Forever' written above (plate 43). In Shelter 3, on the end wall, a full face illustration just above a profile of a military man wearing peaked cap and smoking a cigarette is drawn with pencil and chalk (plate 44). These are relatively detailed drawings and are likely to be representations of real people, probably personnel serving at the base.

Plate 43. Shelter 2, graffiti on internal wall (ref. HTR 54)

Plate 43. Shelter 3, graffiti on internal face of south west end wall (ref. HTR 63)
