## ARCHAEOLOGICAL MONITORING REPORT

SCCAS REPORT No. 2013/090	Parish: Mildenhall
<b style="color: blue;">Extension to the rear of Shrubland House, Mildenhall MNL 695</b>	Planning Application No.: F/2009/0412/FUL
	OASIS No. C1-153915
	HER Event No.: MNL 695
Address: 2, King Street, Mildenhall	Grid Reference: TL 711 747
	Number of Site visits: 2
	Date of visits: 13/14 June 2013

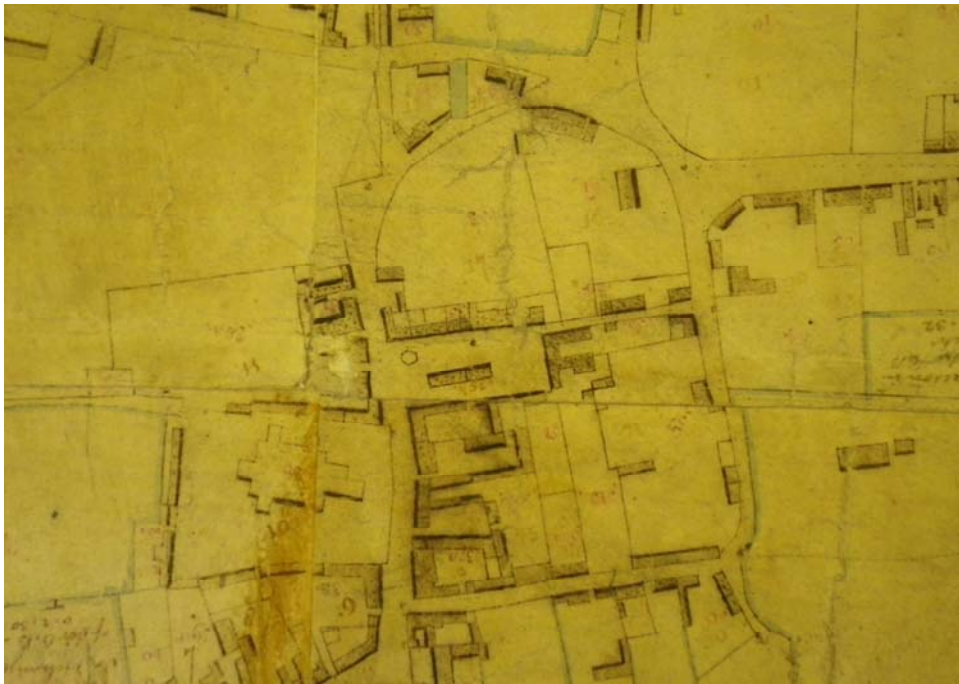
Historic Map

Mildenhall Enclosure Map 1812 showing what appears to be Shrubland House already in existence (Bury RO ref 260/B/P1)

The earliest available maps of Mildenhall (Fig.3) date from the first half of the 19th century

and depict what is believed to be Shrubland House in varying guises. The archaeological deposits are strong evidence of the site's occupation prior to the construction of Shrubland House and the re-used brick, extensive charcoal layer and the high clay content with the soil, possibly the result of the inclusion of degraded building fabric (infill panels or flooring), suggest the demolition of an earlier building indeed the development area may actually be within the footprint of a previous building which would explain absence of 'backyard feature' such as rubbish pits/cut features within the sample area.

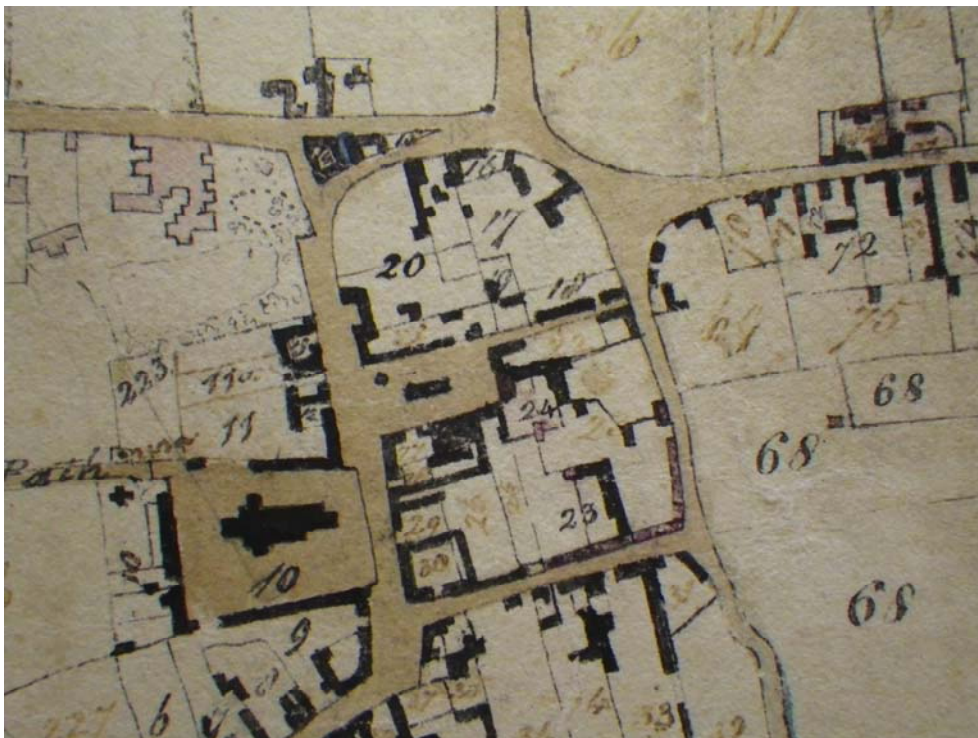
W.H. Youngs' Map of Mildenhall 1834 shows the house with additional ranges (no longer extant) attached to the front of the building (RO ref EF 505/1/82)

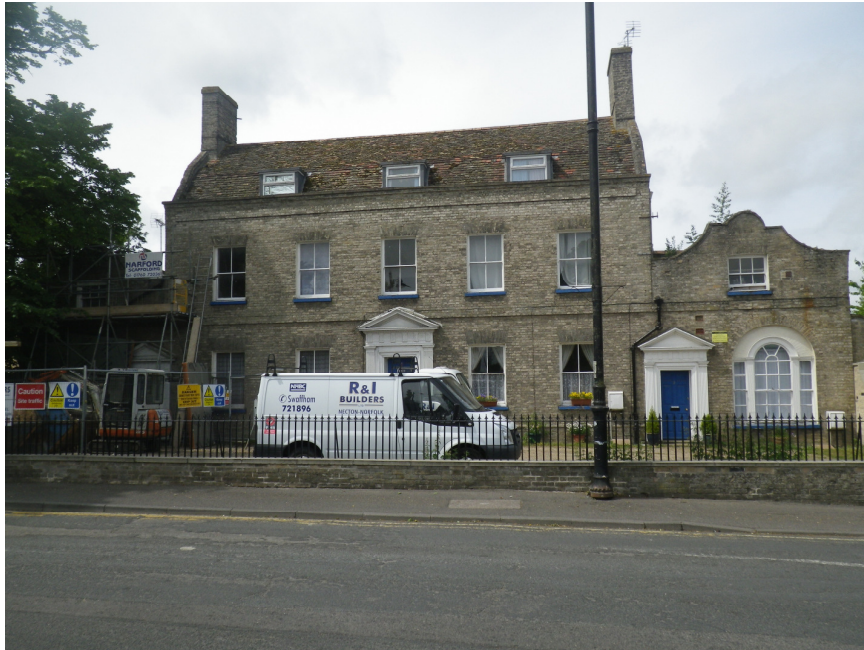
Plate 1. Shrublands House is a late 18th century flanked on both sides by symmetrical wings. The development site is behind the wing to the left which was just a façade and masked a (now demolished) C20th flat-roofed garage.

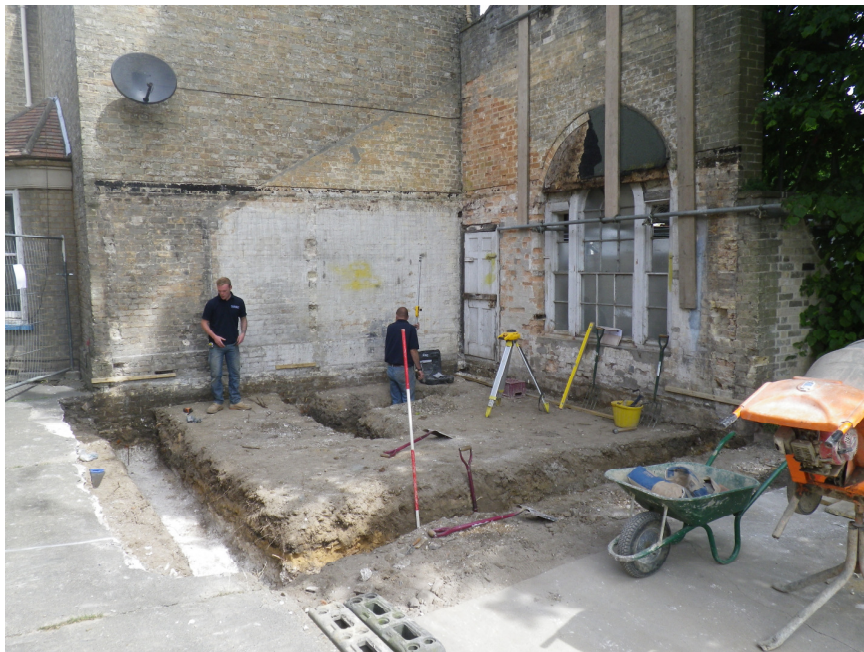
Plate 2. The development site with the foundation fully excavated. The soil profile within the trench nearest the camera shows a dark, clay-rich soil deposit over a thin charcoal spread relate to the century use/clearance of the site prior to the construction of Shrublands House in the 18th century .

The footing trenches for a lean-to in the angle between the gable end of Shrubland House to the north and a wing façade to the east. The site was formerly occupied by a modern garage constructed on a floor slab. At the time of the monitoring the floor slab had been removed and the site cleaned (Plate2).

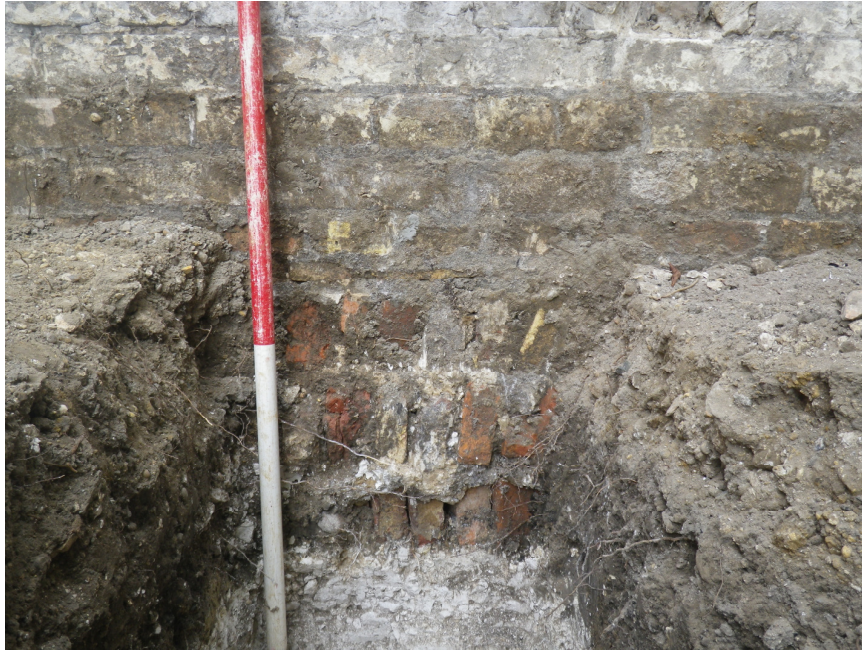
Plate 3. Foundation of Shrublands House made of re-used bricks which date from C15-16th and are in contrast to the gault bricks of the wall above ground. Three courses of bricks (roughly laid with the bricks on edge) make up the foundation which is built directly off the surface of the underlying chalk geology. The footing trench for Shrubland cut occupation/demolition deposits associated with previous occupation of the site (shown below)

Cut features comprised only a small posthole (0002) and a narrow linear feature (0004) packed with clay but these were sealed beneath an extensive clay rubble (0006) and charcoal layers (0005) which were laid down prior to the construction of Shrubland House. Layers 0005 and 0006 were cut by the later buildings foundations which were constructed from 'Tudor' bricks salvaged from a late C15th-early C16th building (most likely its chimney); possibly a building that previously occupied the site (Plate.3).

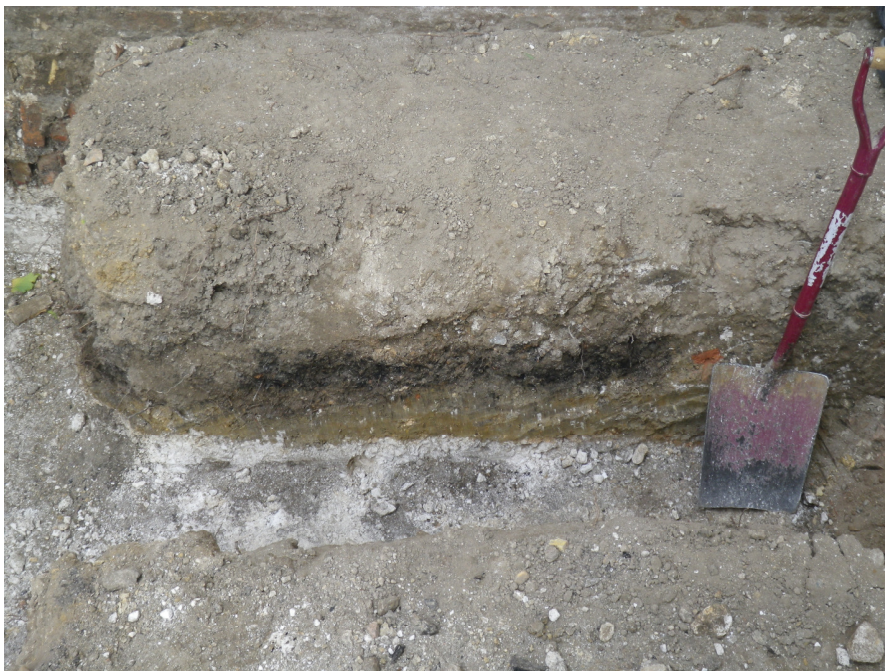
Plate 4. An extensive spread of wood charcoal overlay a floor surface or structure made from imported clay. At its west end of the clay overlay a row of bonded broken bricks which dated to the 15th-16th century. These occupation layers lay directly over the natural chalk suggesting that the site had been prepared prior to their deposition.
