ARCHAEOLOGICAL MONITORING REPORT

SCCAS REPORT No. 2013/091	Parish: Lakenheath
	Planning Application No.: N/A
Accessible Community	OASIS No. Suffolkc1-154147
Play Area,	HER Event No.: LKH 353
RAF Lakenheath	Grid Reference: TL 7381 8064
LKH 353	Number of Site visits: 3
	Date of visits: 27/06/13-02/07/13

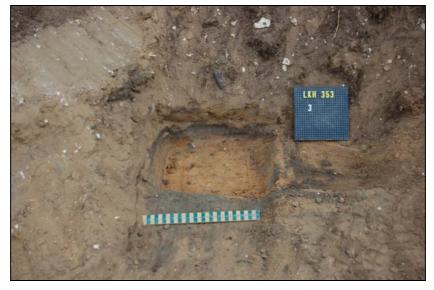
Plate 1. Hand-dug test-pit 3, showing observed stratigraphy
