New School Hall, Rougham CEVCP School RGH 075

Archaeological Evaluation Report

SCCAS Report No. 2013/104

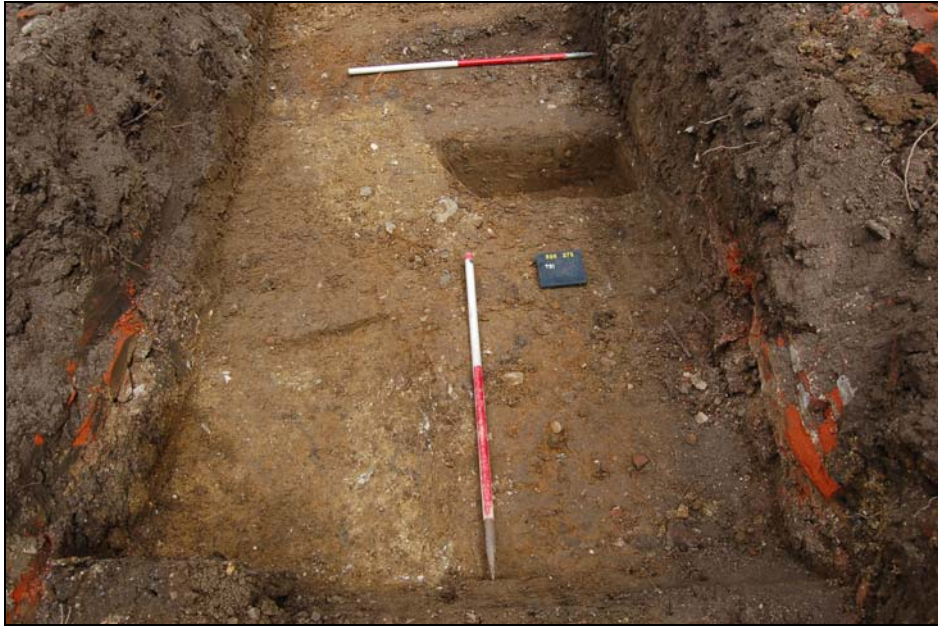
Plate 1. Gully 0001 and Pit 0003, facing north (2 x 1m scales)

This trench was 11.8m long, 1.6m wide and up to 0.75m deep, orientated approximately north-south and situated in the eastern edge of the proposed new footing of the school hall development (Pl. 1).

The features consisted of two large pits on the eastern side of the trench and a small gully (orientated approximately north-south) passing under the wall footing at the southern end of the trench (Pl. 2). The fills of all three features were similar slightly greenish grey/brown silty clays with moderate small/medium stone and chalk flecks, occasional CBM fragments and flecks and pottery fragments, while the northernmost pit had small coal lumps in it.

A small piece of undiagnostic post-medieval ceramic building material (11g) was present in the gully fill 0002 (fabric type ms). It is fragmentary and has mortar on broken edges, indicating that it has been redeposited.

Further fragments of post-medieval ceramic building material were present in the fill 0004 of pit 0003 (172g). The group consists of six fragments of fully oxidised roofing tile and three small pieces of brick (fabric types ms and msf)*.

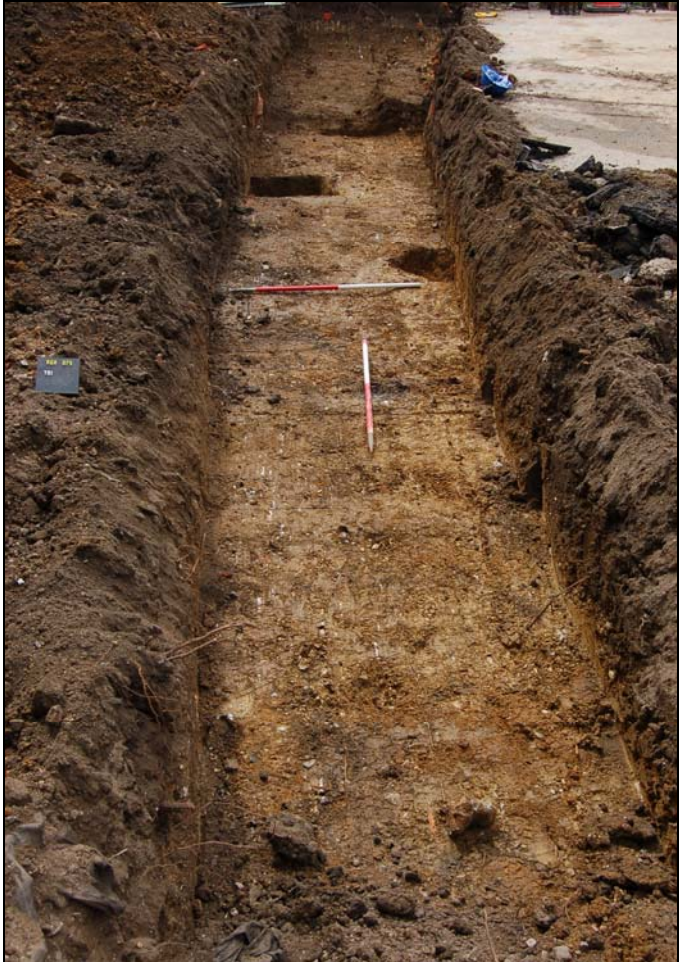
Plate 2. Trench 1, facing south (2 x 1m scales)

The general stratigraphy consisted of approximately 0.6m of very disturbed dark brown humic soil with frequent small/medium flints and stones, ceramic building material (CBM) fragments and modern detritus (china, plastic, metal pipe). This overlay natural chalky till – a mid/pale creamy brown stiff clay with frequent small chalk flecks and several glacial stripes filled with pale/mid yellowish brown soft sandy clays.

Three post-medieval/modern features were observed cutting into the natural geology at the base of the trench, and a wall footing was noted in section, running east-west across the trench towards the southern end which was believed to be the remains of a playground dividing wall visible on the 1880 Ordnance Survey map of the site. The wall appears to have been demolished some time between 1957 and 1973 when it ceases to be shown on maps.
