Rear of Castles Bar & Restaurant, Earsham Road, Bungay, (BUN 067); Record of an Archaeological Evaluation

Report No. 2006/126; Oasis ID No. suffolkc1-15662

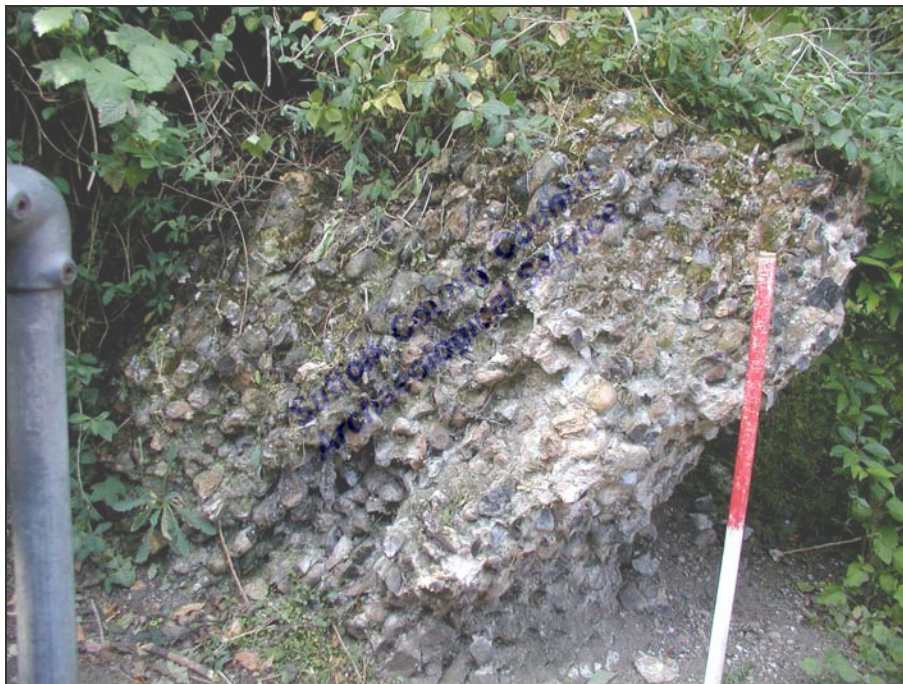
Tumbled block of medieval wall fabric

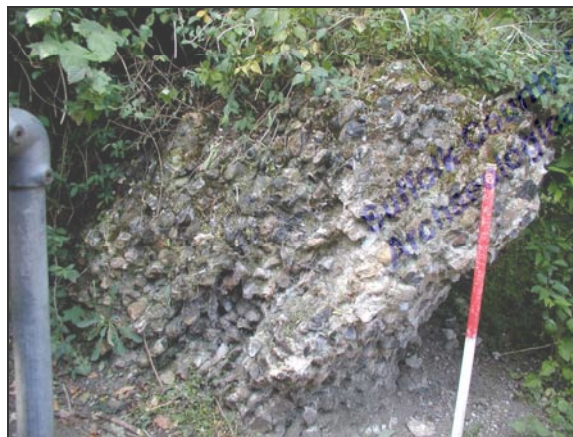
Plate 1: East End of Wall Section 1

Wall section No. 1: This section of wall did not appear to form any part of the extant buildings and was entirely located within the open area to the east, with a maximum length of 6 metres, a thickness of *c.*1.5 metres and a visible height of *c.*1.2 metres. The internal structure of the wall was exposed with courses dipping at *c.*60° towards the north (Plate 1 & front cover) indicating that this was definitely a tumbled block and not *in situ*. Voids between the included flints and the mortar were all on the southern, upper side, of the courses. This observation suggests that the block was upside down in relation to its original position within the wall as these voids usually occur beneath the flints during construction.

The fabric itself was characterised

by regularly sized flint pebbles/cobbles up to 10 centimetres in size set in a light cream coloured lime mortar with common inclusions of chalk.

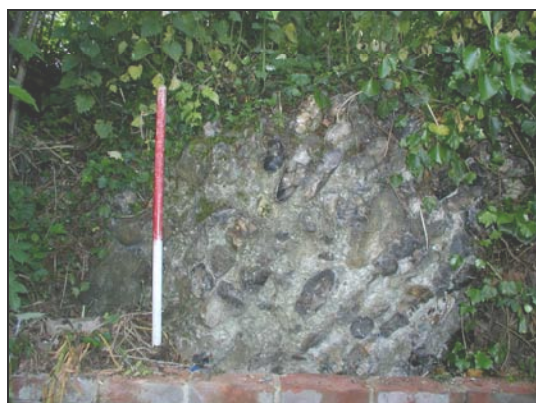
Plate 2: East End of Wall Section 2

Wall section No. 2: Located immediately south of Wall Section 1, this section of wall continued for c.16.5 metres, albeit discontinuously, and formed significant parts of the northern wall of the central two rooms and the southern wall of the north garages (Figs. 2 & 3). A maximum width of 2 metres was recorded at its exposed eastern end (Plate 2), reducing to only 0.75 metres towards the west. This reduced thickness may not entirely be the result of natural erosive processes, but the deliberate removal of fabric to increase the size of the southern rooms.

Similarly to Wall Section 1, the courses at the eastern end dipped at c.60° towards the south. Where observations could be made within the standing buildings, the coursing dips consistently in this direction. Again this must be considered to be evidence proving that Wall Section 2 was a tumbled block and while now comprising three separate fragments, would once have formed part of a single lump or at least pieces that were adjoining within the original wall.

The character of the fabric is markedly different to that of Sections 1 and 3 in that the clast size is much larger, c.10 centimetres to c.30 centimetres, mainly flints but with some sandstone and igneous fragments. One distinct lift line was visible. Voids beneath the flints were seen on the northern, underside of the courses which suggests that this block was the right way up in relation to its original position in the wall.

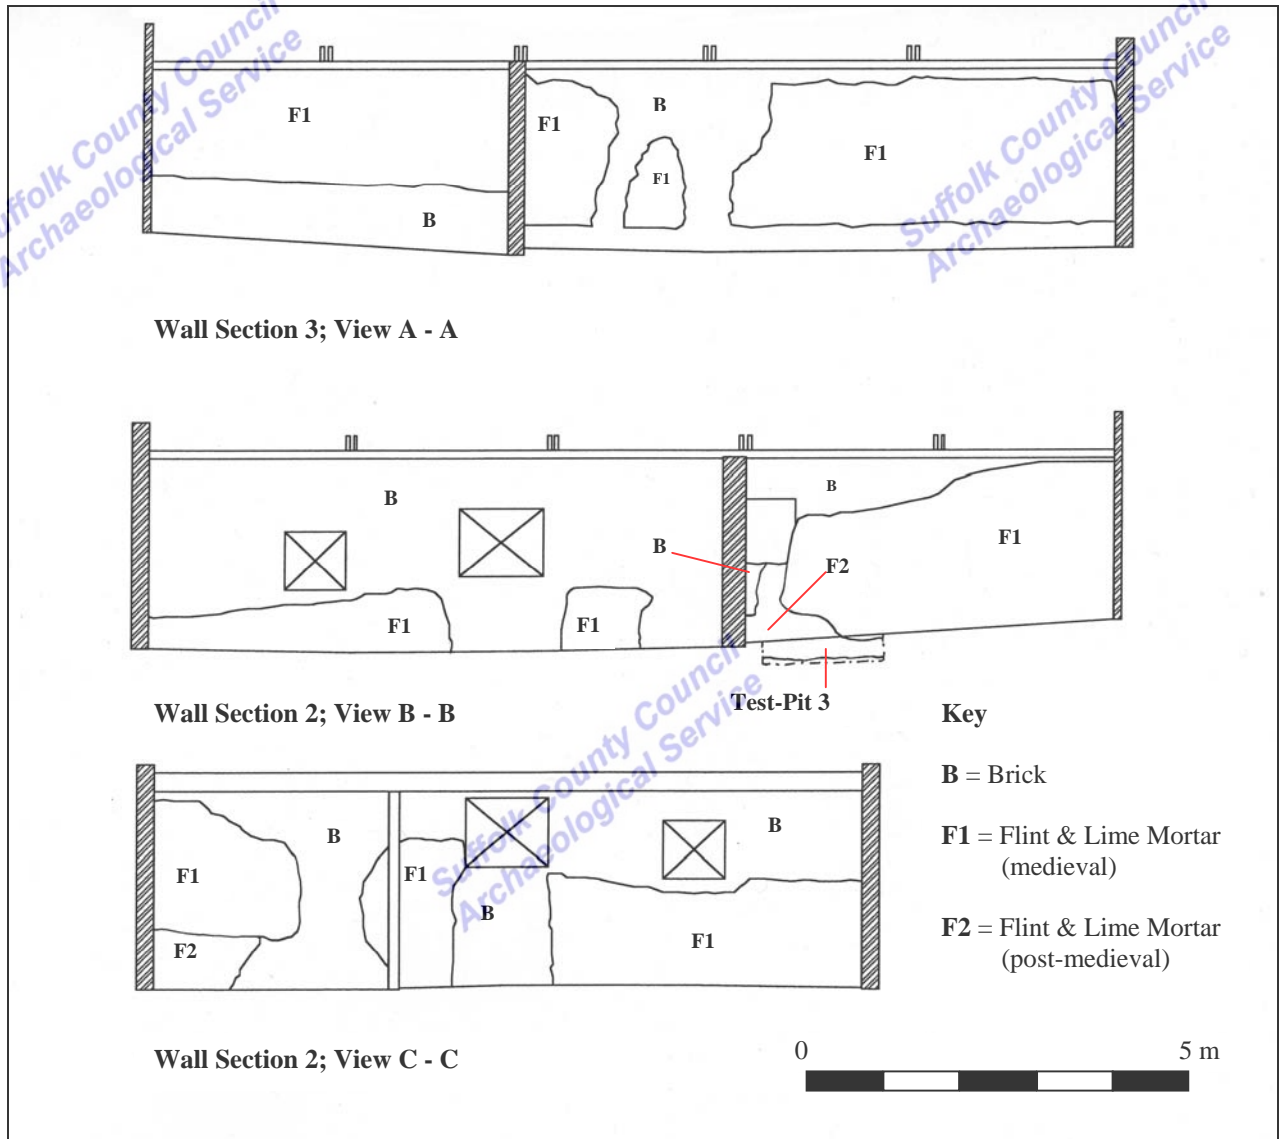
Fig. 3 1:100 Scale Elevation Drawings

Elevations were recorded of both the north side, in the garages on the north side of the standing buildings, and south side, in the central two rooms (see Fig. 3, Views C - C & B - B respectively & also Appendix II). At the eastern end of the easternmost central room, Wall Section 2 formed the full height of the wall (c. 2 metres), this reducing towards the west, until at the western end of the westernmost central room only 0.5 metres was visible above ground. In the garage immediately to the north the floor level is 0.6 metres lower and a correspondingly greater amount of the flint and mortar wall is visible above the surface.

One of the two windows between the western central room and the garages to the north was formerly a doorway through what would then have been an external wall. This doorway has since been partially blocked with material that includes re-used copingstones. The relatively straight junctions between the blocking material and adjacent wall may represent a deliberate cutting through the flint and mortar wall fabric to form the door opening.

Immediately through the doorway into the easternmost central room, in the vicinity of Test-Pit 3 (Figs. 2 & 3), the flint and mortar wall is underlain by a wedge of later flint and lime mortar fabric that had almost certainly been introduced to fill the gap.

A similar blocking filling of roughly horizontally coursed flint and mortar was also recorded in the garage immediately to the north (Fig. 3, View C - C, F2).

Surface treatments included whitewash (predominantly in the western room) and lime mortar render/plaster in the eastern room (Fig. 3, View A - A & Appendix II).

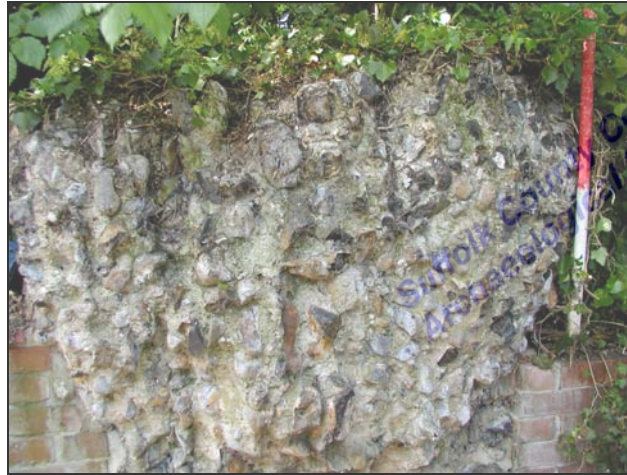
Plate 3: East End of Wall Section 3

Wall section No. 3: Located south of Wall Section 2, this piece of wall formed an unbroken stretch 16.5 metres in length, 1.5 metres wide at its eastern end, with a height of c.2 metres for the majority of its length and forming the southern wall of the central two rooms (Fig. 2). Where exposed in the open area to the east of the standing buildings it is clear that again this represented a tumbled block, although in this instance the coursing is vertical with the voids beneath the flints indicating that the southern side was the uppermost in the original wall (Plate 3).

The wall fabric was variable in character with c.5 courses on each side similar to those from Wall Section 1, with c.10 centimetre-sized flints, and a central c.5 courses more like those of Wall Section 2 with clasts of up to 25 centimetres.

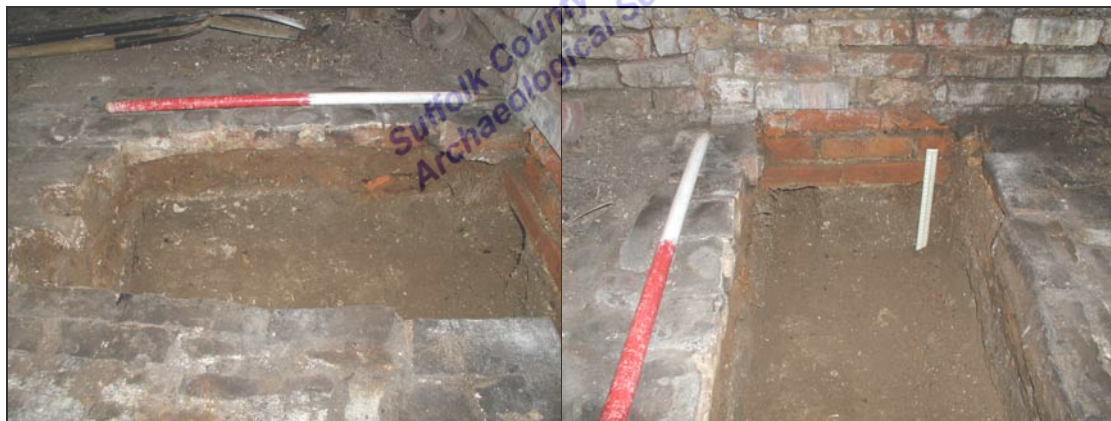
Plate 4: Test-Pit 1

Test-Pit 1: Located against the northern face of Wall Section 3 in the eastern room previously utilised as a cowshed or stable (Fig. 2). The floor in this room comprised predominantly of hard 'Stable Bricks' with patchings/repairs of flint cobbles and miscellaneous bricks.

A) N-S Section

B) Base of Wall

Removal of these bricks in the 0.5 metres by 1 metre area of the trench revealed a c.8 centimetres thick bedding layer of dirty orange/brown sand which, in turn, overlay homogenous brown sandy loam that continued on down beyond the bottom of the trench at a depth of 0.4 metres (Fig. 4 & Plate 4). Three and a half courses of red bricks (9 x 4 x 2³/₄ inches) were recorded above the existing ground surface with a further two and a half seen below. The bricks had been laid directly on the loam layer with no formal footing. Excavation and probing back c.0.4 metres beneath the wall failed to encounter solid material and it must be assumed that the bricks or the flint and mortar fabric did not continue down to this level at this juncture.

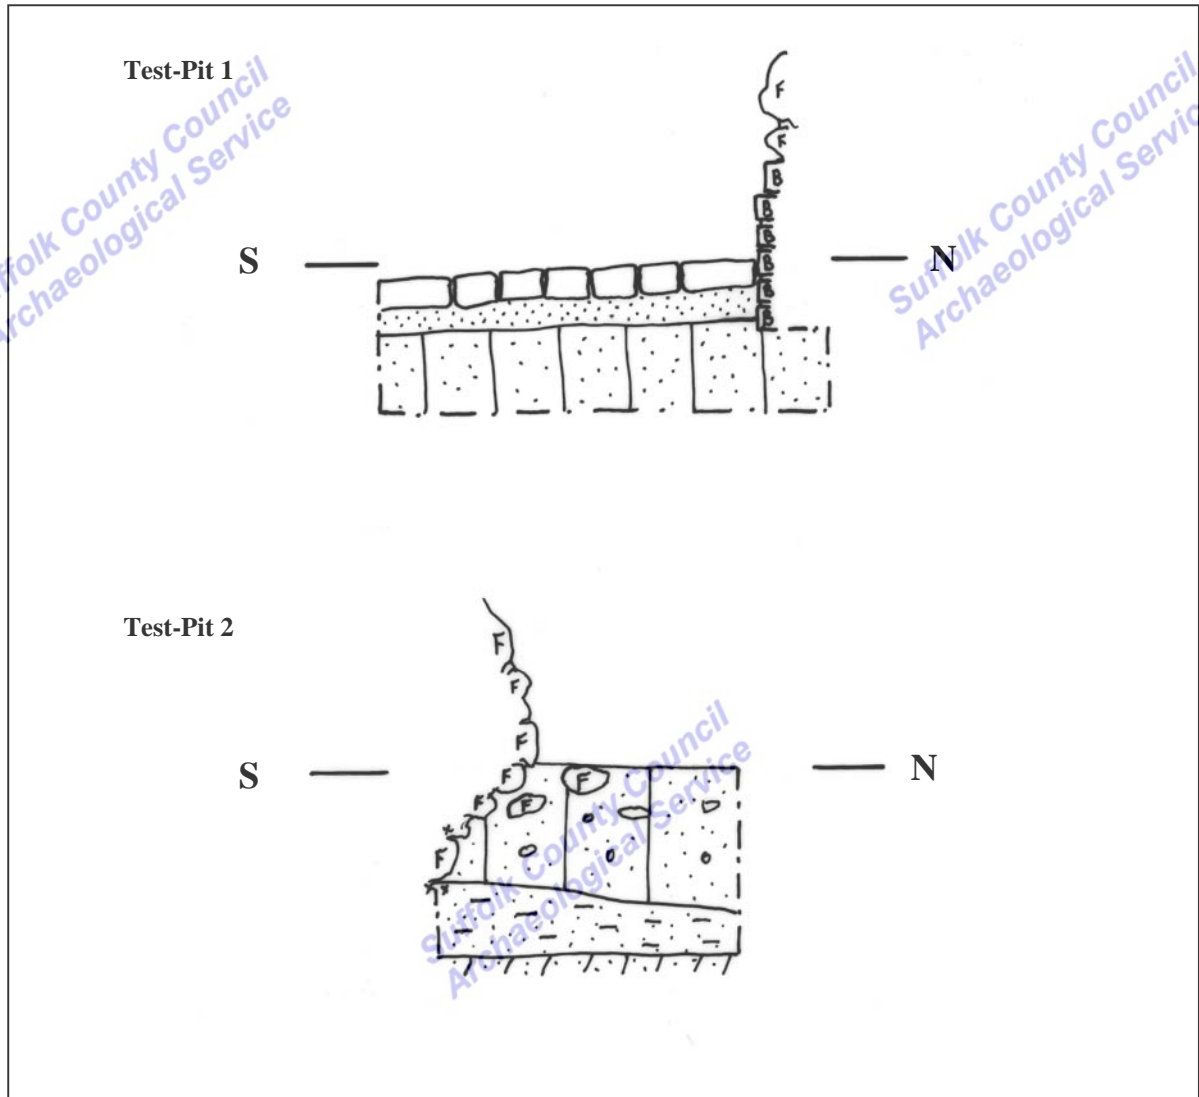
Fig. 4 Test-Pits 1 & 2, 1:20 Scale Section Drawings

Section drawings were inked and are reproduced in this report as Fig. 4.

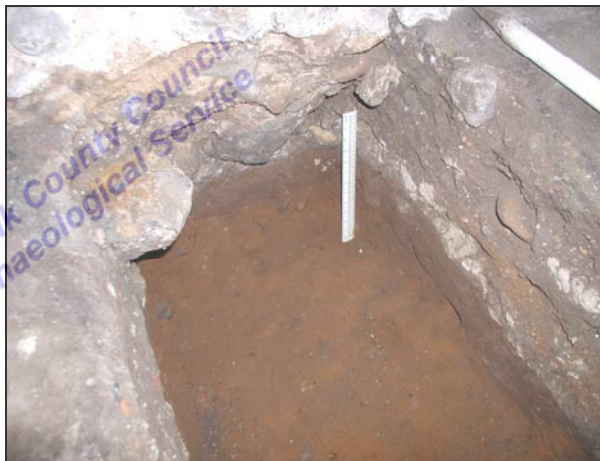
Plate 5: Test-Pit 2

Test-Pit 2: Located in the westernmost garage against the north face of Wall Section 2 (Fig. 2), the existing floor surface here comprises hard packed earth.

The stony, sandy loam upper layer was found to be 0.3 metres thick at the base of the wall, increasing to 0.4 metres at the northern end of the 0.5 metres by 0.6 metres test-pit (Fig. 4). The upper loam overlay a variable thickness of homogenous brown silty sand, 0.2 metres in line with the base of the wall reducing to 0.1 metres at the northern end of the test-pit. The excavation of the test-pit was halted when the brown silty sand gave way to homogenous orange sand which may represent

naturally occurring subsoil.

Below ground, the uneven face of the flint and mortar wall sloped back sharply to the south with its base at c.0.3 metres below the existing ground surface, effectively corresponding with the interface between the upper loam and the underlying brown silty sand layers. There is no evidence for a formal footing.

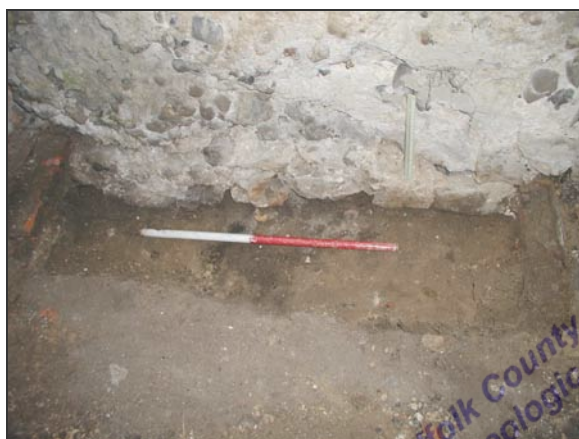
Plate 6: Test-Pit 3

Test-Pit 3: Located within the easternmost of the central two rooms against the southern side of Wall Section 2 (Figs. 2 & 3). At this juncture the base of the existing wall was clearly constructed from flint and mortar, but was found to be a later insertion below the more continuous Wall Section 2 fabric and appears to have performed the same function as the inserted brickwork seen elsewhere, but primarily on the north face of Wall Section 3.

The floor in this room, underneath a thick accumulation of earth and rubbish, comprised floor bricks. These were removed in the 0.5 metres by 1.5 metres area of the test-pit revealing a mixed layer of loam, sand and mortar. The base of the inserted flint and mortar wall fabric was encountered at only 0.25 metres below the existing ground surface and there was no evidence of a formal footing (Fig. 3 & Plate 6).
