**St. Mary's Church,  
Harkstead,  
Suffolk.  
HRK 041**

**Archaeological Monitoring Report**

**SCCAS Report No. 2013/72**

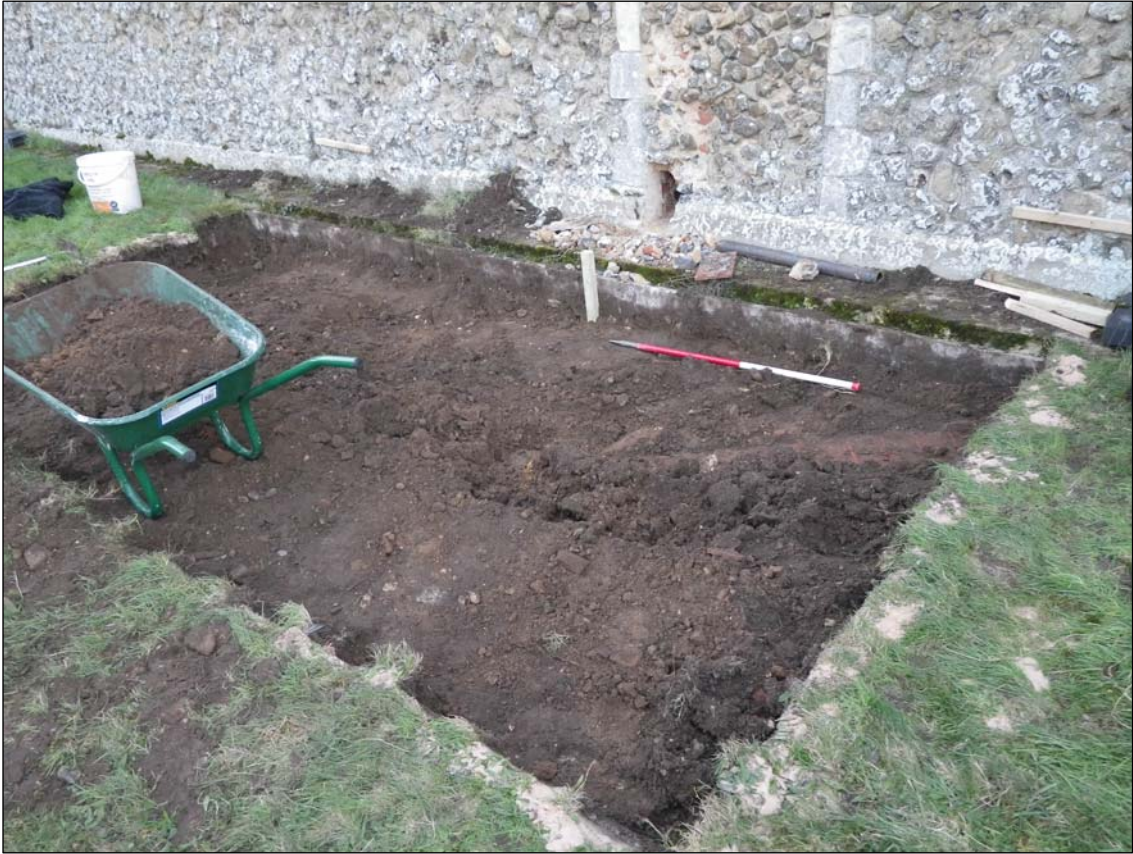
Initially, the extension footprint was stripped of c.0.25m of turf and topsoil (Plate 1), subsequently removing a further 0.15m, which exposed the subsoil. No cut features were observed at this depth but one sherd of medieval coarseware was recovered from the subsoil. A brick drain was seen cutting across the site from a downpipe on the north wall of the church in a north easterly direction. The bricks were soft red unfrosted and likely to be of 19th century date.

Plate 1. Stripped extension footprint, looking SE

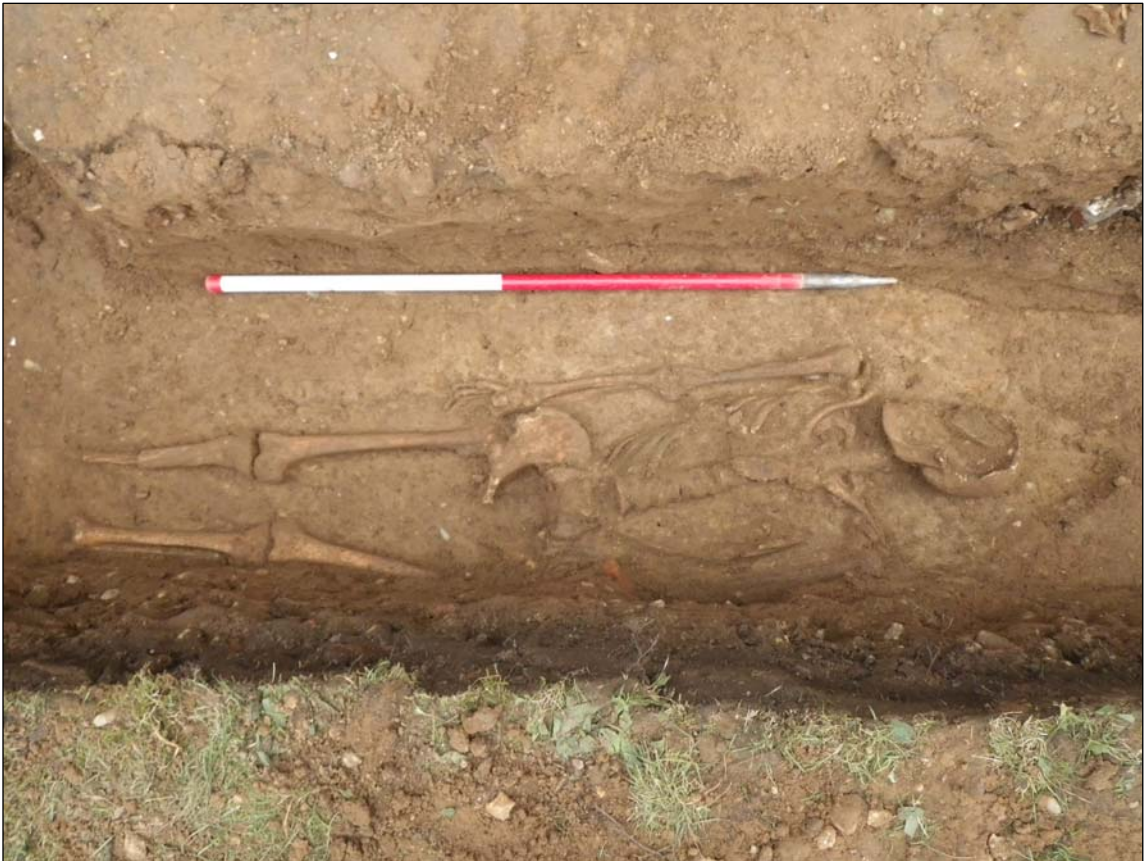
In the north east corner of the footings, a single grave cut was observed and excavated, revealing the almost complete skeletal remains of an adult, aligned approximately east to west (Plate 2). The feet had been cut away during the digging of the trench whilst the skull had been damaged by the brick drain which cut across it. The grave cut was not clearly defined but appeared to be a traditional six-sided coffin shape, tapering from the shoulders to the feet. However, no evidence of a coffin was present either in the form of staining, nails or coffin furniture. The grave fill was almost indistinguishable from the lower subsoil and no finds were recovered by which to date the burial. However, the fact that part of the skull had been removed by the brick drain suggests that it was an old, unmarked grave, at least by the time the drain was inserted.

Plate 2. Excavated grave, looking S

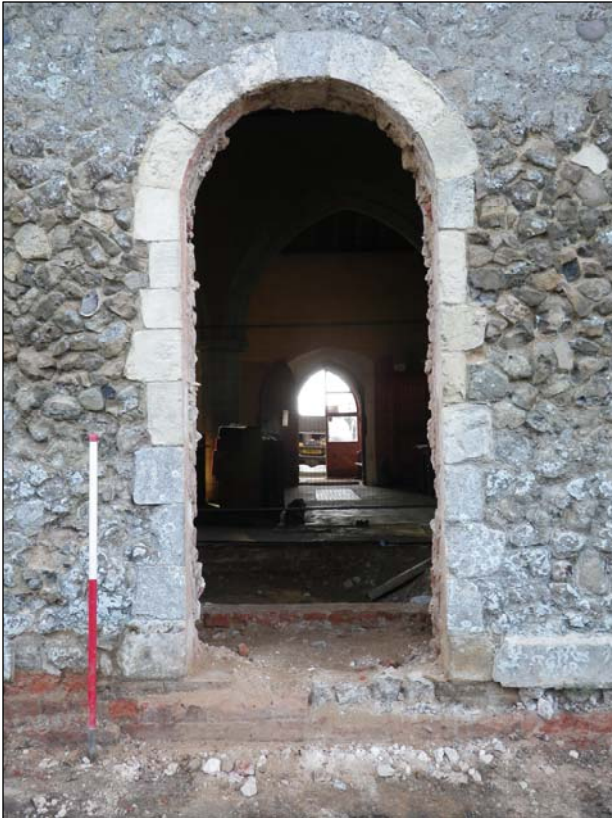
Plate 3. The north doorway, looking S. The worked limestone was recovered from the void just inside the doorway, in front of the red bricks

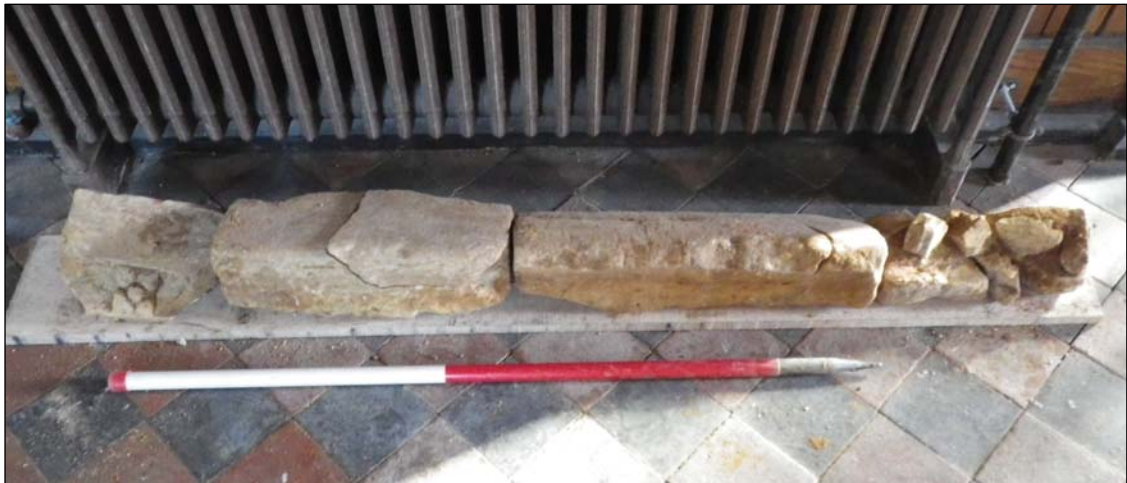
Plate 5. Worked limestone fragments recovered from the step inside the north door

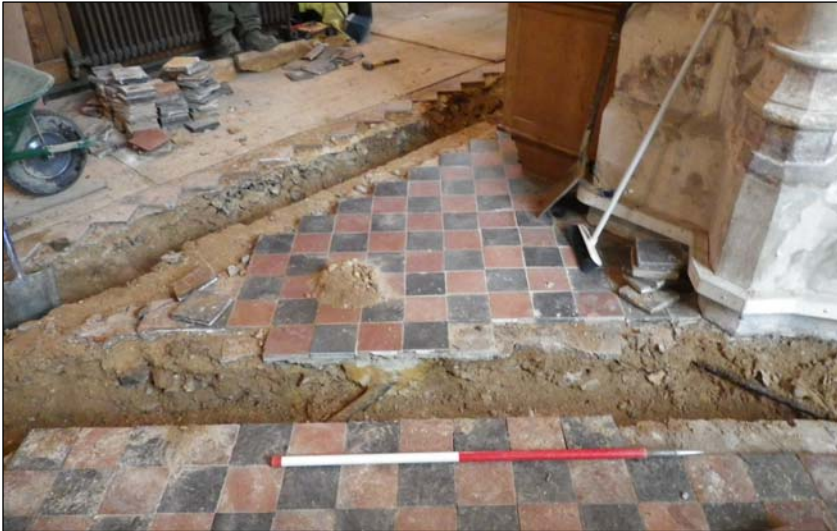
Two narrow, shallow trenches were cut below the quarry tile floor and through associated sub base. These measured 0.2m-0.3m wide and 0.2m deep and revealed a uniform mid greyish brown sandy clay. Modern disturbance from old water pipes was noted but no other features or finds were present.

Plate 6. General view of internal service trenches

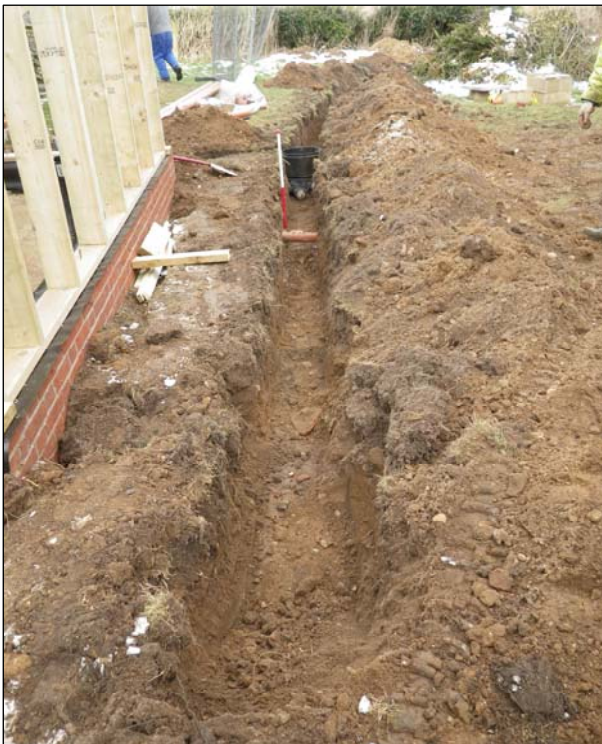
A service trench to the north of the church was excavated to a depth of 0.6m through the same soil sequence seen in the footings, described above. No

archaeological features were visible in the trench sections or base and no pre-modern finds or disarticulated bone were recovered from the spoil.

Plate 7. General view of external service trenches, looking E
