# Land off Valley Road, Leiston LCS 174

## **Archaeological Evaluation Report**

**SCCAS Report No. 2013/143**

**Client: Badger Building Ltd**

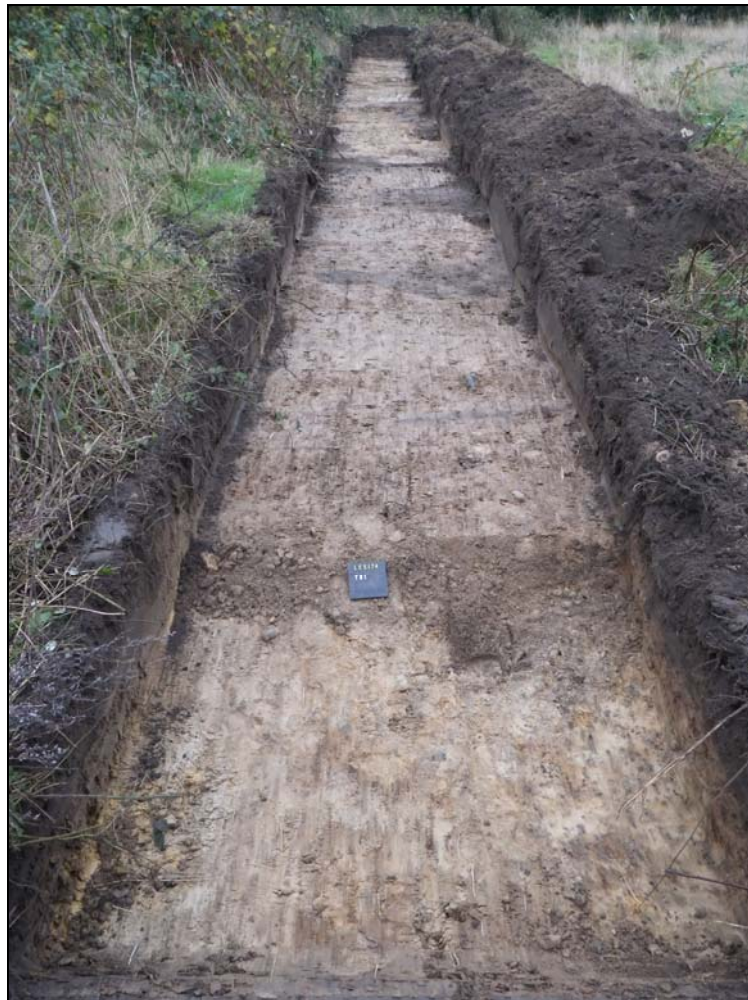
Plate 1. Trench 1, facing east

This trench was 30m long, 1.6m wide and up to 0.45m deep, orientated east-west across the northern end of the site. The exposed stratigraphy consisted of 0.3m of mid brown sandy organic-rich silt topsoil over silty sandy clay natural geology. Some modern disturbances were noted, dated by the modern LBC-stamped brick and brick fragments as well as assorted ironwork recovered (door hinges, short iron rods, etc). No finds or features of archaeological relevance were observed within this trench.

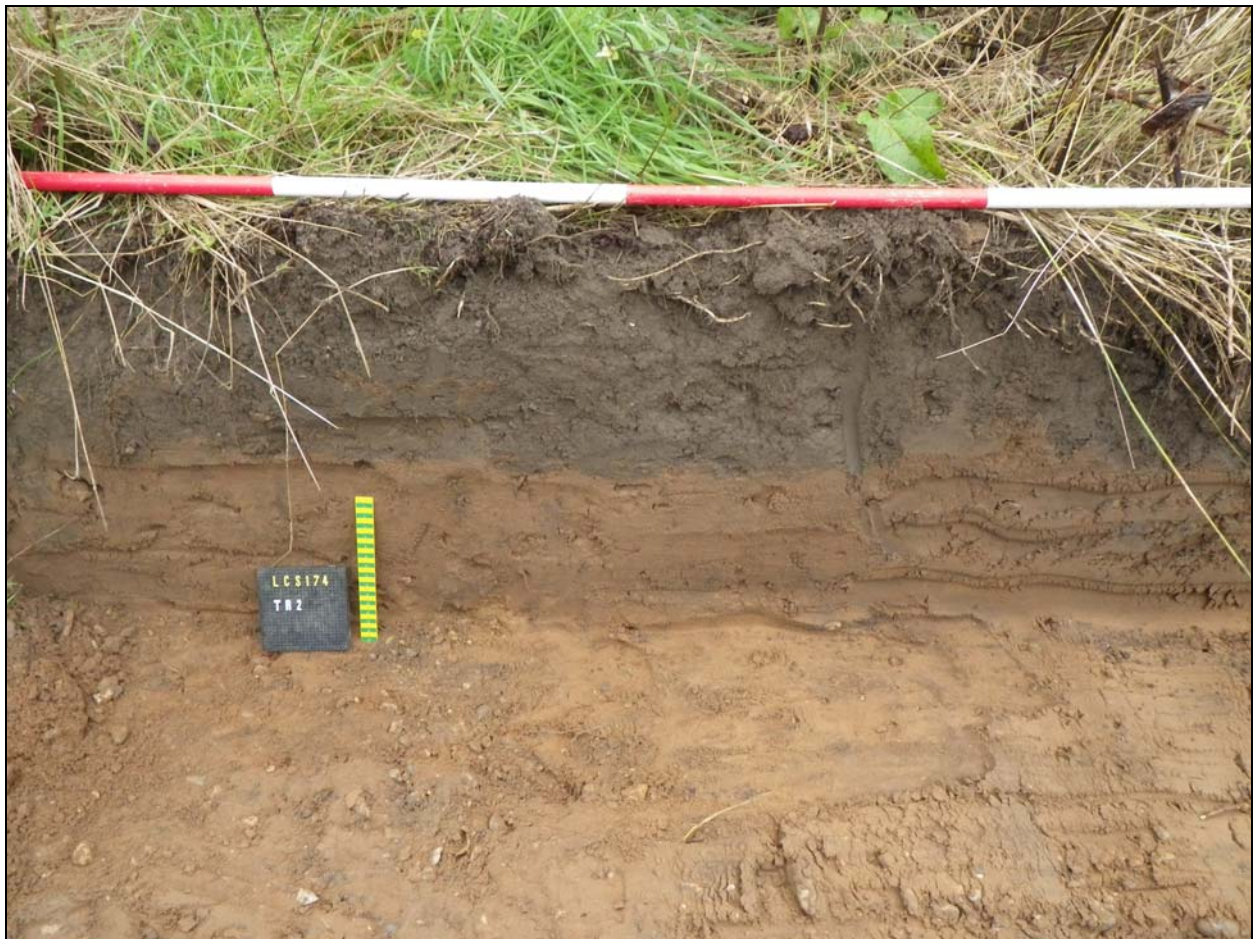
Plate 2. Trench 2 section, facing west (0.3m and 2.0m scales)

This trench was 30m long, 1.6m wide and up to 0.45m deep, orientated north-south along the centre of the site. The exposed stratigraphy consisted of 0.35m of mid brown sandy organic-rich silt topsoil over silty sandy clay natural geology in the northern half of the trench, with a change in the geology to more typical mid orangey brown sandy Crag deposits approximately half way along and a thickening subsoil deposit of mid/dark orangey brown silty sands (up to 0.4m thick at the southern end of the trench). Some modern disturbances were noted, mostly north-south orientated plough scarring but including a single modern posthole (dated by brown bottle glass – not retained). No finds or features of archaeological relevance were observed within this trench.

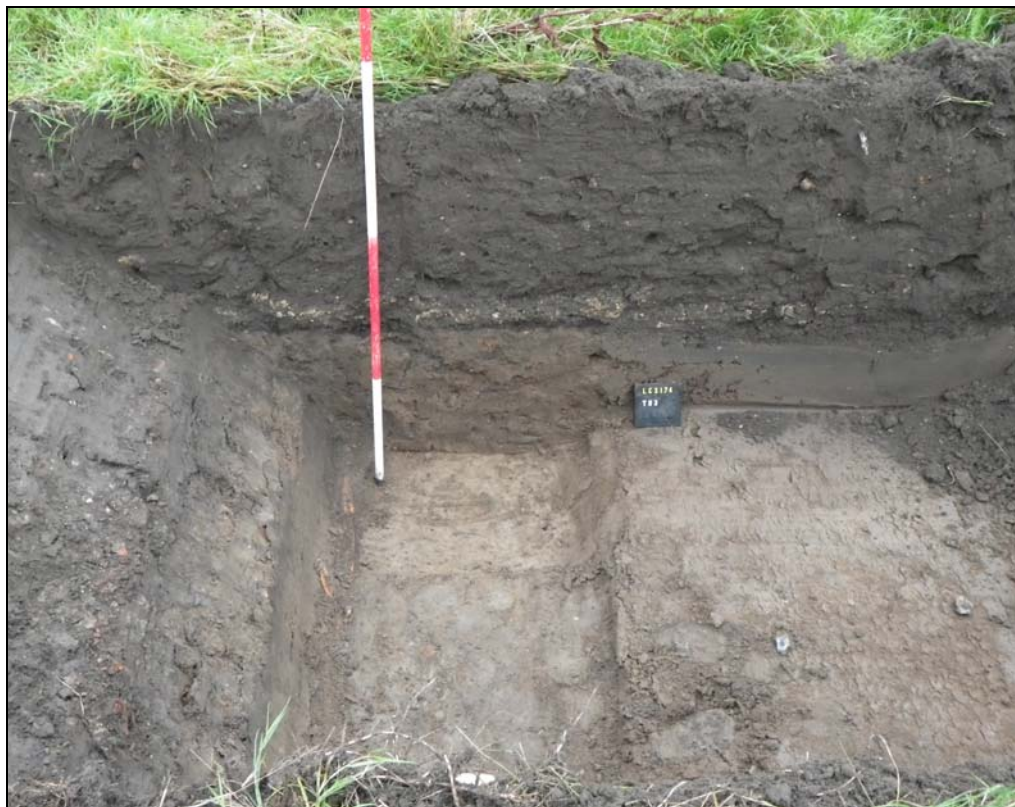
Plate 3. Trench 3 east end section, facing south (2.0m scale)

This trench was 30m long, 1.6m wide and up to 2.0m deep, orientated east-west across the southern end of the site near to Valley Road. The exposed stratigraphy consisted of 0.6m of mid brown sandy organic-rich silt topsoil over a thin band 0.12m thick of mixed silt and pale clays with frequent modern inclusions (glass/modern brick/CBM). This overlay a very thin layer (some 0.03m thick) apparently of iron panning/natural concretions. Below this was the mid orangey brown subsoil deposit seen in Trench 2, but at a greater thickness (0.55m thick) with natural geology (pale leached mottled silty sands) occurring at a depth of 1.35m at the eastern end of the trench.

Due to the depth of the observed natural, only intermittent sondages were possible to reach this layer, with a sondage in the centre of the trench reaching natural mid orange sands and gravels at approximately 1.8m deep and one at the western end of the trench reaching 2.0m before encountering underlying geology. Due to the depths it was not possible to obtain a clearer view of the sections and precise stratigraphy involved but it is believed to be broadly similar to that noted in the eastern end of the trench, with a deepening layer of subsoil leading to the added depth.
