21, Long Bessels, Hadleigh, Suffolk
HAD 143

Archaeological Evaluation Report

SCCAS Report No. 2013/134

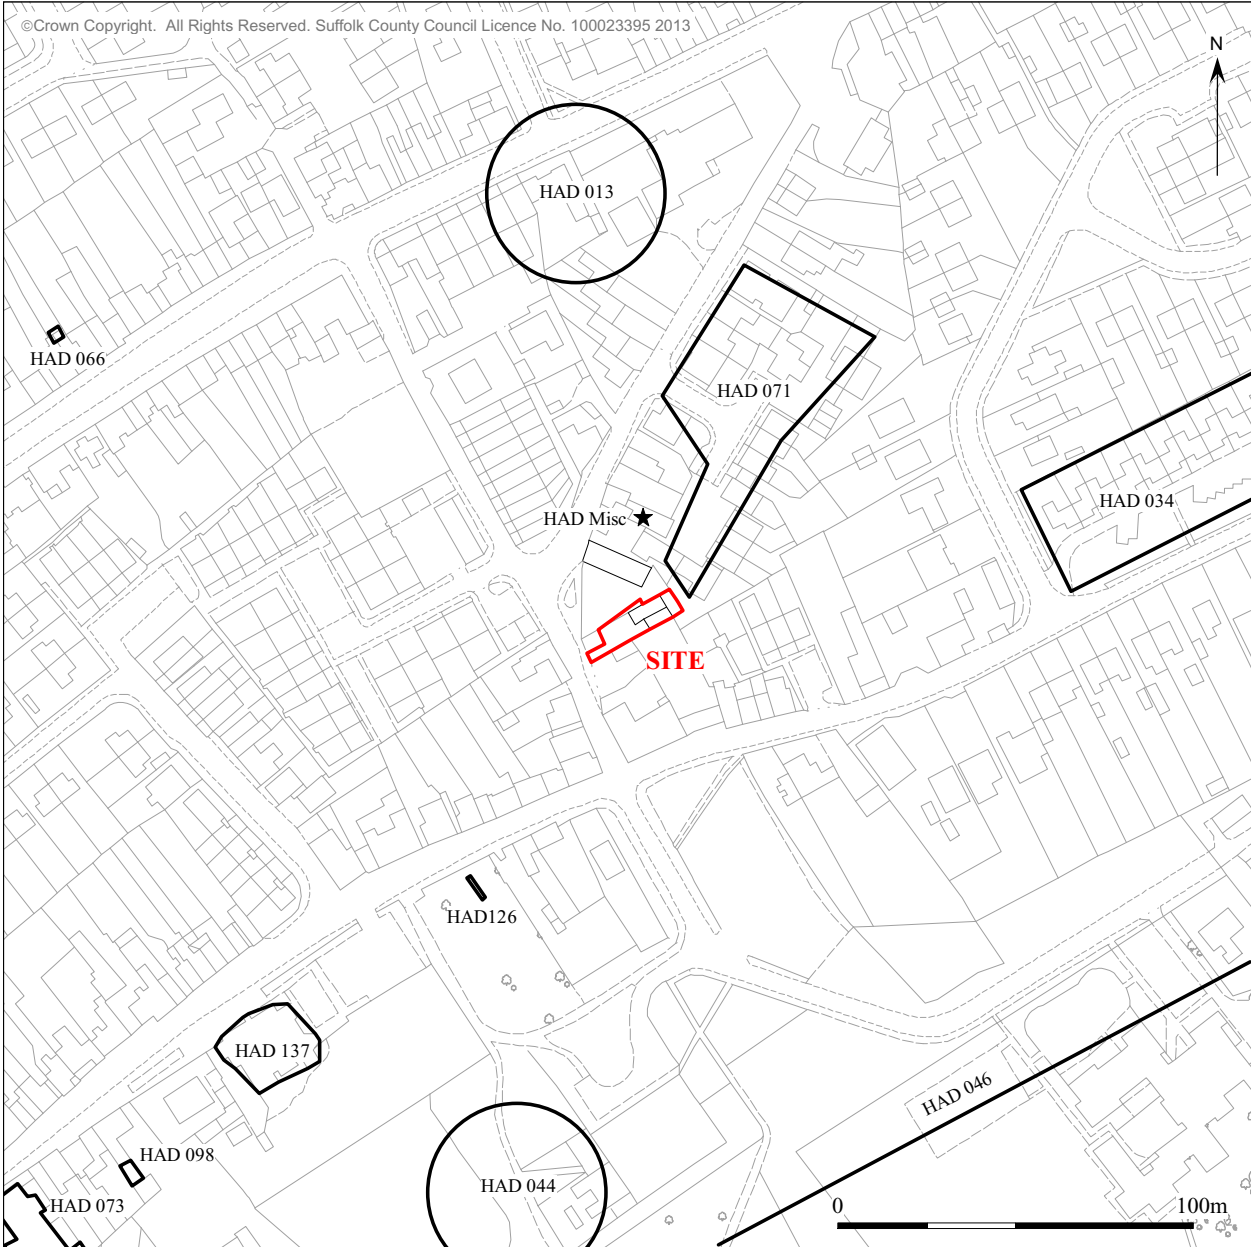
Figure 2. Sites recorded on the HER

A number of archaeological sites or findspots are recorded on the Historic Environment Record (HER) within the vicinity of the development site. A summary of these entries is presented in Table 1; the recorded locations of are marked in Figure 2.

HER ref.	Summary
HAD 013	Anglo-Saxon cremation urn, small, embossed decoration. Found by Dr Style in grounds of East House, circa 1930 (<i>Note: East House is further south at TM 0288 4260, probably this is mis-reading of original grid reference - see HAD 044</i>)
HAD 034	Chapel to almshouses. Late 15th-16th century timber framed building. Secular almshouses founded in 1497 and not suppressed in the 16th century, now rebuilt.
HAD 044	Reference: 'Hadleigh, East House (TM 0295 4287). A portion of a small Anglo-Saxon cinerary urn found during the last 30 years (circa 1931-1961) by Dr Style was loaned to the Hadleigh Town Council'. The cited grid reference, TM 0295 4287 (HAD 013), is wrong for East House and is probably a misreading of an original (handwritten?) reference of TM 0295 4257, which is situated within the former garden of East House.
HAD 046	Area of the medieval town of Hadleigh defined as 'area of archaeological interest' in Babergh Local Plan (April 1990).

HAD 066	Watching brief on a conservatory extension produced no stratified archaeological evidence although one sherd of c.12th-c.14th century, and two sherds of c.16th-c.17th century pottery were recovered from the topsoil. A fragment of flat hand quern was also found of a type that is used throughout the medieval and post medieval periods and is not closely dateable.
HAD 071	Trial trenching revealed made up ground over the majority of the site, to a depth of over two metres in places and suggestive of the presence of large, backfilled pits. Documentary evidence points towards gravel quarrying on the site and finds recovered during the evaluation indicate that backfilling probably took place after the late 15th century.
HAD 073	Hadleigh Baptist Church: Observations of work undertaken during alterations to the church revealed the remains of a brick-lined baptismal pool, thought to date from the building's original construction in 1830.

HAD 126	Post-medieval, red brick footings likely to be associated with a building which formerly fronted George Street were identified in a service trench, along with a large undated probable extraction pit.
HAD 137	18th century Grade II* listed house with an impressive façade, which also appears to contain some 17th century features. It has seen substantial rebuilding and alterations, particularly during the 19th century when a number of extensions were constructed and also after the house was damaged by fire during the 1990's. It was used as offices for a time, but it is now proposed to convert it back into housing.
HAD Misc.	Brass ring, probably 15th-16th century, found in garden of 19 Long Bessels.

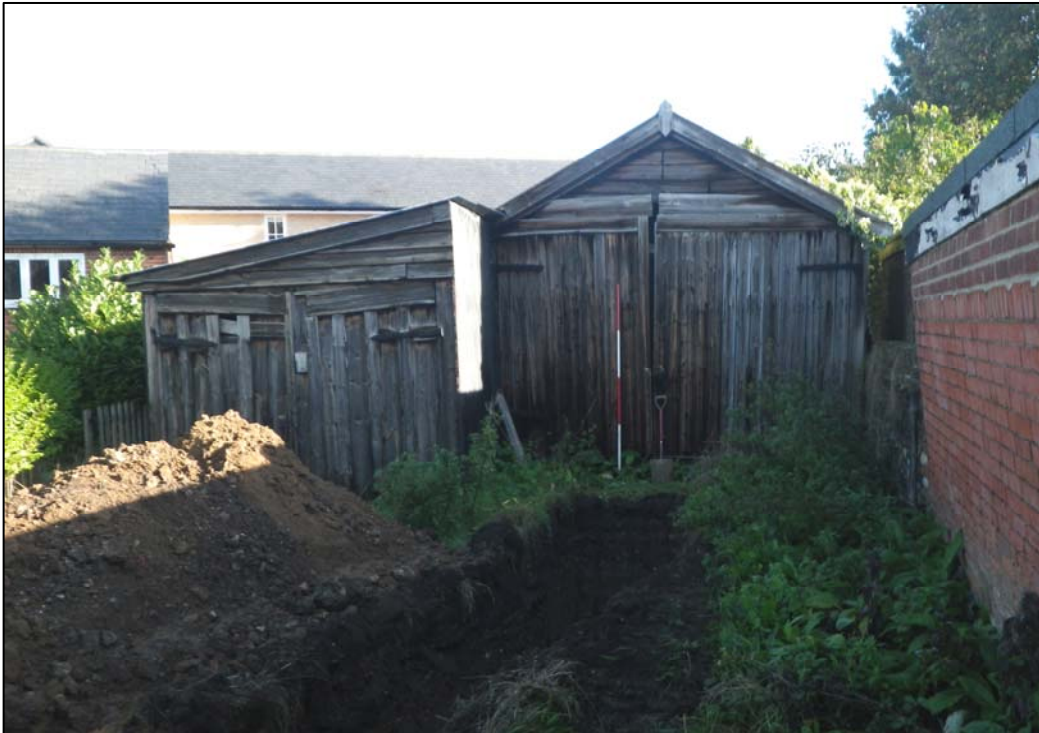
Plate 1. General view of the outhouses to be demolished (ref. HUI 76)

The trial trench was machine excavated down to the level of the natural subsoil using a small tracked excavator fitted with a toothless ditching bucket, although a toothed bucket was also required to break through the upper layers. The location of the trench was broadly in accordance with the trench plan approved by the County Conservation Team although due to the fact the existing outhouses (plate 1) had not been cleared it was necessary to move the trench slightly to the southwest.

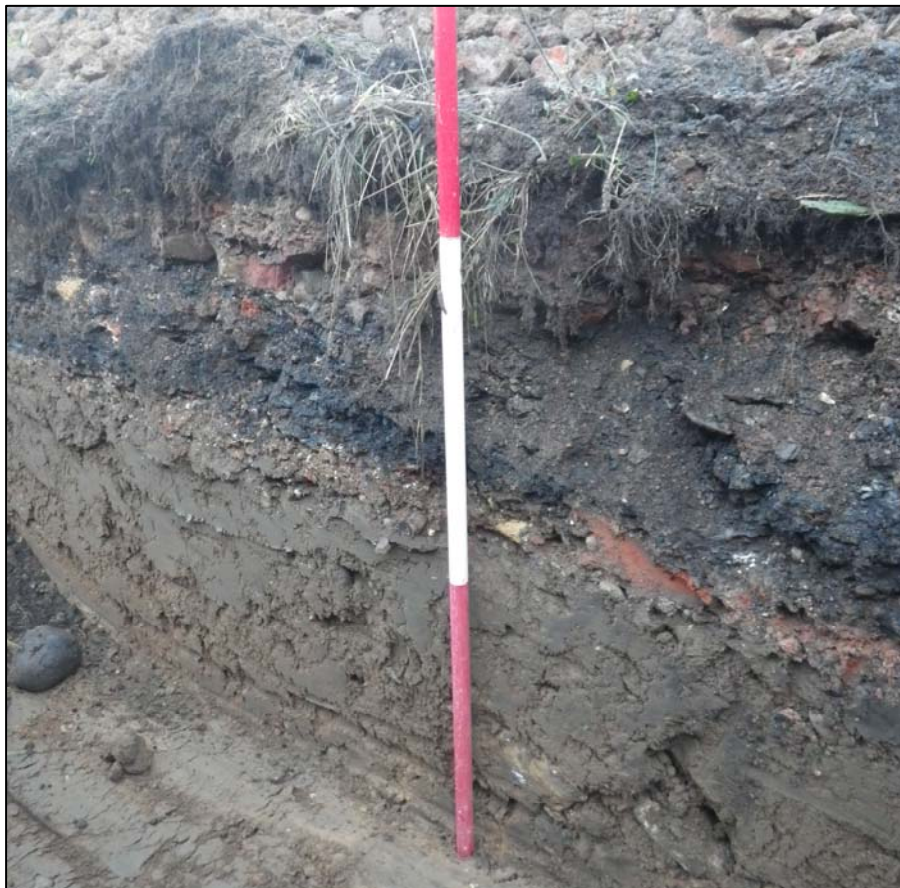
Plate 2. stratigraphy as revealed in the north side of the trench (ref. HUI 77)

A single evaluation trench was excavated (fig. 3) which revealed a natural subsoil consisting of pale yellow sandy silt with large flint nodules at a depth of c. 1.1m. It lay beneath an overburden of c. 0.55m of layers of hard, compacted made ground and a c. 0.55m deposit of homogenous grey-brown sandy silt (see plate 2).

The made ground comprised layers of brick rubble, ash and clinker with other occasional post-medieval debris. It was highly compacted and very hard. The interface between this layer and the underlying grey-brown sandy silt was sharp. The interface between the grey-brown sandy silt and the underlying natural subsoil was blurred with no positive indication of any modern truncation.

The grey-brown sandy silt is likely to be a former topsoil that has been buried under the layers of imported made ground. The sharp interface could suggest some preparation of the former topsoil surface prior to the laying of the imported deposits. The made ground deposits form a hard compacted surface between the outhouses and the roadway and were presumably laid to form an area of hardstanding. It was likely this hardstanding initially consisted of just a layer of ash and clinker but was raised through a later deposit of brick rubble.
