ARCHAEOLOGICAL MONITORING REPORT

SCCAS REPORT No. 2012/110	Parish: Southwold
70 HIGH STREET,	Planning Application No:
SOUTHWOLD	DC/12/0139/FUL
SWD 060	HER Event No: SWD 060
Address:	Grid Reference: TM 5071 7626
70 High Street,	
Southwold,	Number of site visits: 1
Suffolk.	Date of visits: 19.07.2012

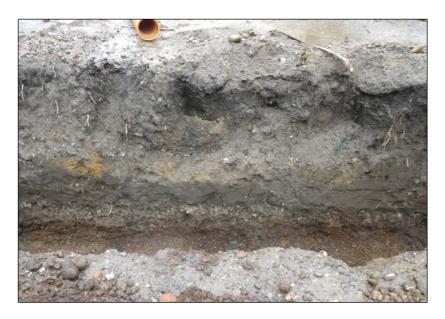
Monitoring of machine excavated footings for an extension. Footings measured c.0.8m wide and c.0.8m deep.

Plate 1. Example of the excavated footings

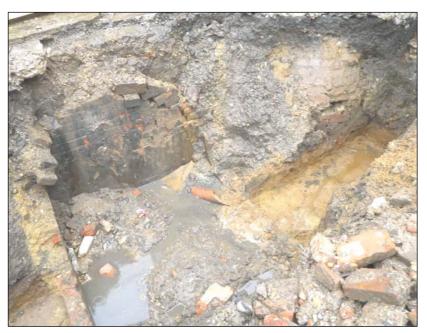
The final subsoil layer graduates into the coarse orange gravelly sand natural subsoil and may be a natural subsoil with black mineral staining. The lower two subsoil layers observed are characteristic of heathland soils. Two red brick domes, assumed to be the caps of wells (Plate 2), were observed in the trench edges at the rear of the building. Immediately north east of these was an arched red brick structure to the full depth of the trench (Plate 2), aligned WNW - ENE and appearing to continue east beyond the excavation. The function of this was not clear and it does not obviously relate to any buildings or features shown on the 1st-3rd edition Ordnance Survey maps.

Plate 2. Brick structure and capped well

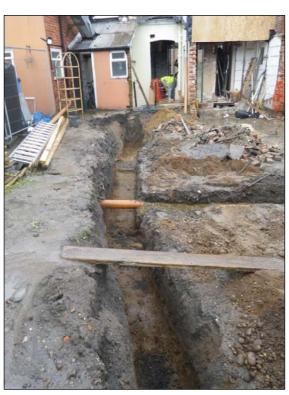
Plate 3. General view of the excavated footings
