Old Grammar School Playing Field,
Bungay, Suffolk

BUN 105

Archaeological Evaluation Report

SCCAS Report No. 2013/136

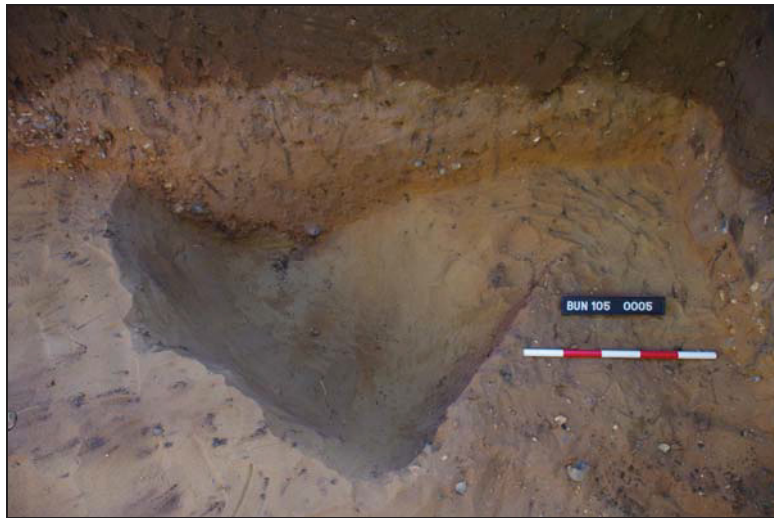
Plate 1. Cut feature 0005 in Trench 1, looking SW (0.5m scale)

Cut feature 0005: Curvilinear cut feature measuring >2m long (west–east) x up to 1m wide x 0.38m deep, with moderately steep sides and a concave base (Fig. 3; Pl. 1). Its fill 0004 was soft/friable, mid greyish brown silty sand with occasional to moderate small to medium pebbles but no cultural material. 0005 cut the natural sand and gravel and was sealed by subsoil 0003.

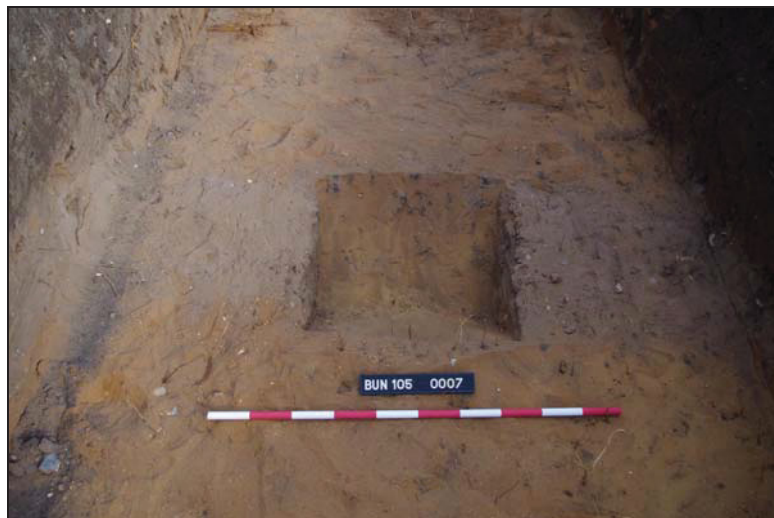
Plate 2. Cut feature 0007 in Trench 1, looking NE (1m scale)

Cut feature 0007: Linear cut feature measuring >1.8m long (northwest–southeast) x 0.66m wide x 0.34m deep, with moderately steep sides and a narrow, concave base (Fig. 3; Pl. 2). Its fill 0006 (which was indistinguishable from overlying subsoil 0003) was light grey silty sand with occasional pebbles but no cultural material. 0007 cut the natural sand and gravel and was sealed by subsoil 0003.

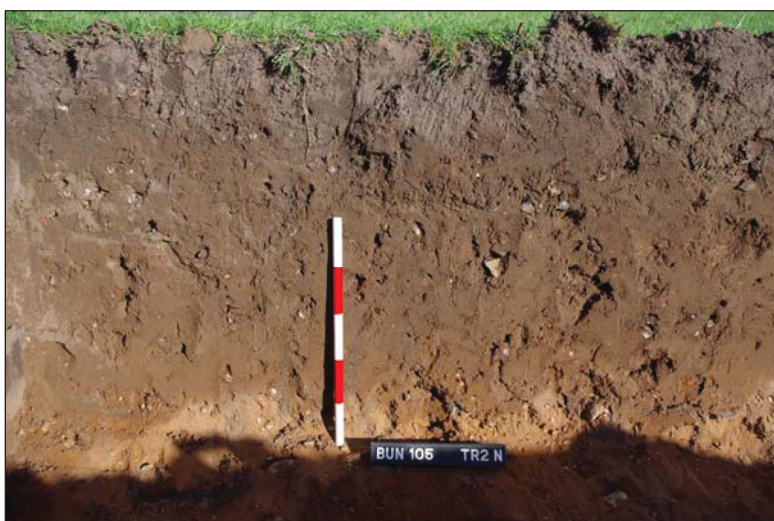
Plate 3. SW facing section at the NW end of Trench 2 (0.5m scale)

For turf/topsoil 0001 and soil horizon 0002 see Trench 1. The natural stratum in Trench 3 was loose, light yellowish brown sand with gravel. See Plate 3 for a typical soil sequence.

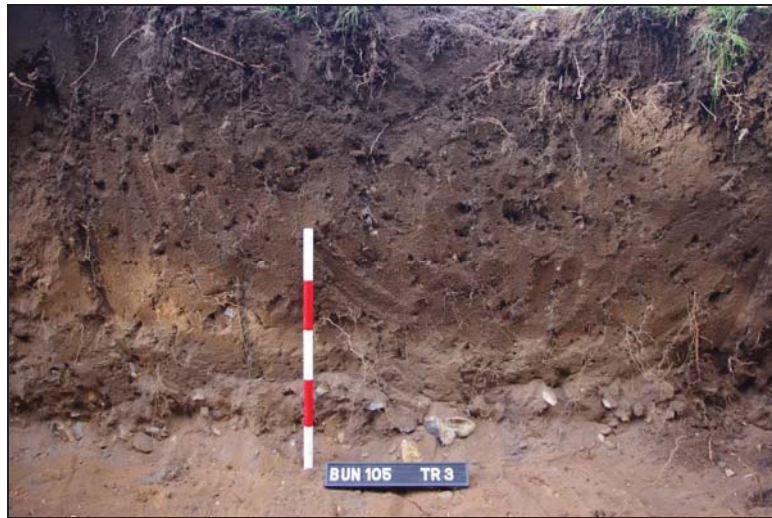
Plate 4. SE facing section in the middle of Trench 3 (0.5m scale)

For turf/topsoil 0001 and soil horizon 0002 see Trench 1. A typical soil profile is shown on Plate 4.

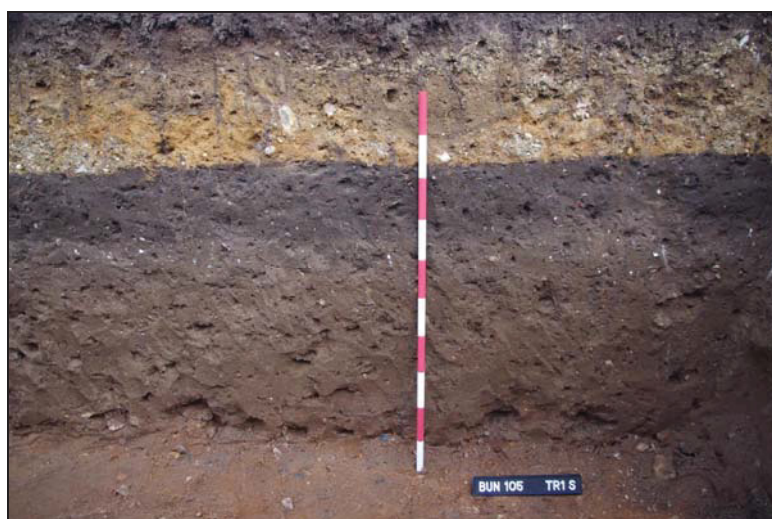
Plate 6. SW facing section at the SE end of Trench 4 (1m scale; incorrect trench number)

No archaeological deposits or features were identified in Trench 4 and no artefacts were recovered. A typical soil sequence is shown on Plate 6.

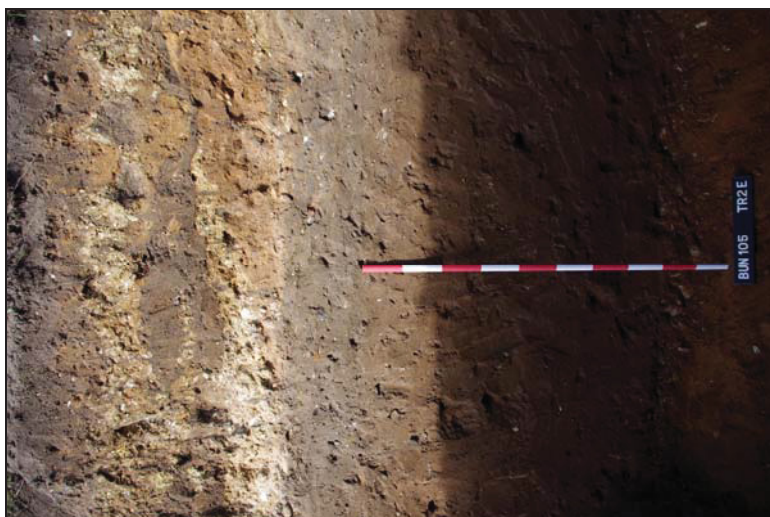
Plate 7. SE facing section at the NE end of Trench 5 (1m scale)

See Trench 4 for deposits 0009, 0012 and 0013 and Trench 3 for subsoil 0011. The soil profile at the northeast end of the trench is shown on Plate 7. Note that soil horizon 0009 was particularly deep in this part of the site (0.85m).

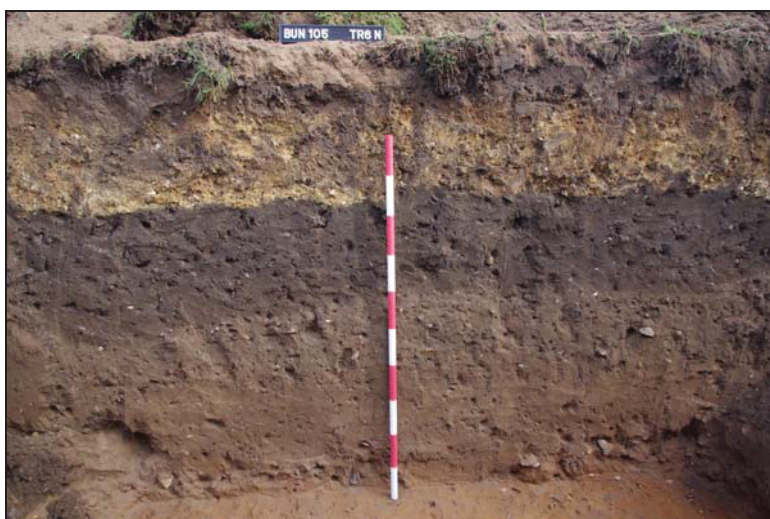
Plate 8. SW facing section at the NW end of Trench 6 (1m scale)

See Trenches 3–5 for soil descriptions. A typical soil profile is shown on Plate 8.
