# ARCHAEOLOGICAL MONITORING REPORT

SCCAS REPORT No. 2013/146	Parish: Letheringham
<b>LEATHERINGHAM MILL</b>  <b>LEATHERINGHAM</b>	Planning Application No.: C/13/0724 & C/13/0725
	<b>HER Event No.: LRM 019</b>
	<i>OASIS ref: suffolkc1-161966</i>
Address: Letheringham Mill, Hall Road, Letheringham	Grid Reference: TM 2795 5812
	Number of Site visits: 2
	Date of visits: 19th and 27th November 2013
Nature of the work: excavation of a series of foundation pads in association with the conversion of existing buildings.	
Reason for condition: the buildings are attached to an 18th century mill; Anglo-Saxon pottery has also been found onsite (LRM 006). They are close to a medieval moat (LRM 001, also a SAM) and the site of a lost medieval church (LRM 005).	
% of total seen: all nine of the excavated pads (each 1m square and 1.5m deep).	
Location Map:

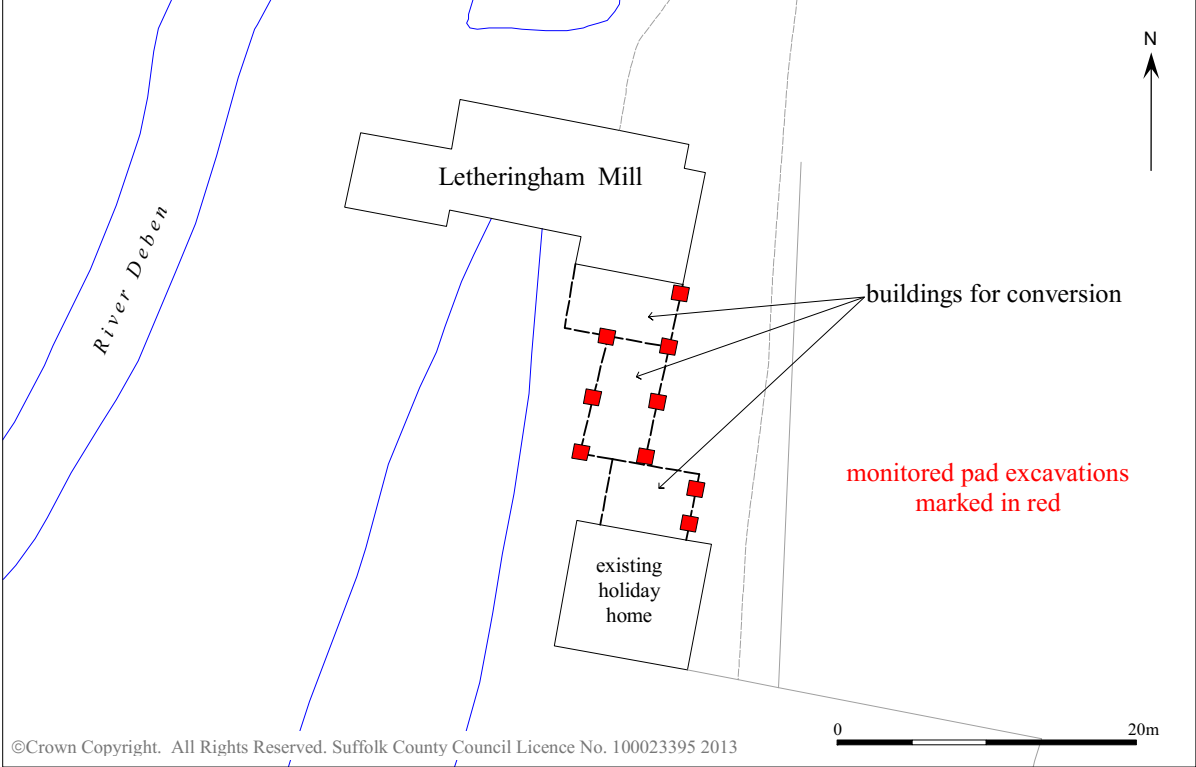
<p>The map shows the River Deben on the left. Letheringham Mill is a large building in the center. To its right are several smaller buildings labeled 'buildings for conversion'. Further south is an 'existing holiday home'. Nine red squares, representing 'monitored pad excavations', are marked along a dashed line connecting the mill and the buildings for conversion. A north arrow is in the top right, and a scale bar (0 to 20m) is in the bottom right.</p>

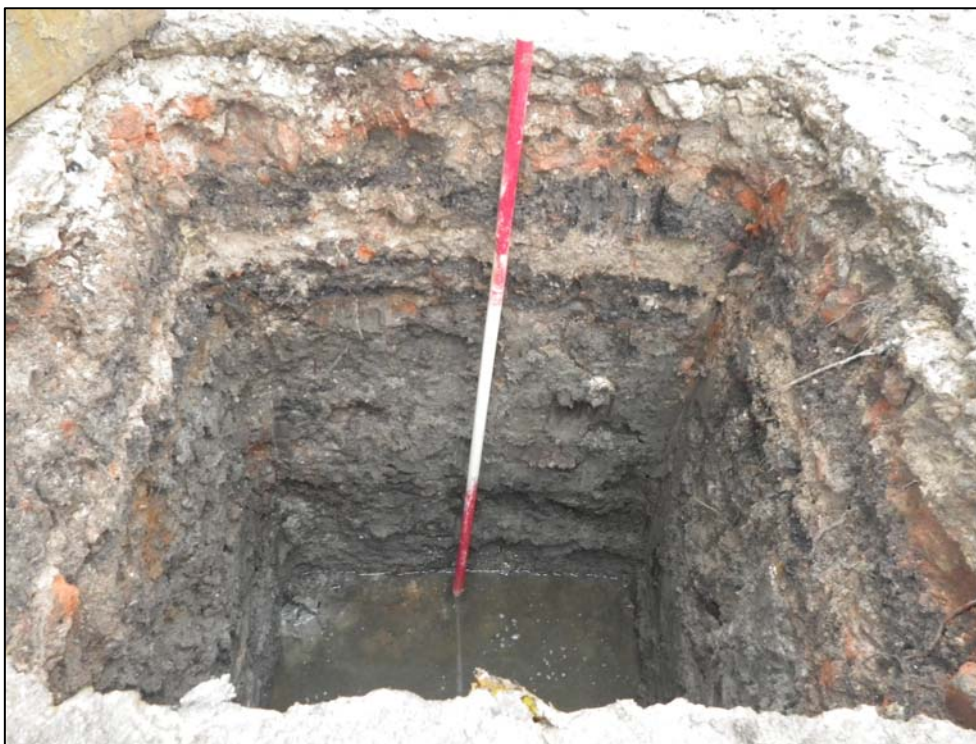
Each pad measured 1m by 1m and was excavated to a depth of 1.5m below the present ground level. The exposed stratigraphy was similar across all pads and comprised of c. 0.5m of made ground, consisting of concrete over brick rubble over grey silty loam with charcoal over crushed mortar and chalk over grey loam, over a mass of grey silty clay which continued to the base of the excavation.

Plate 1. Stratigraphy as revealed in a foundation pad excavation.
