ARCHAEOLOGICAL MONITORING REPORT

SCCAS REPORT No. 2013/138	Parish: Brandeston
Office Farm, Mutton Lane BRN 013	Planning Application No.: 11/1144
	OASIS No. Suffolkc1-163030
	HER Event No.: BRN 013
Address: Office Farm, Mutton Lane, Brandeston,	Grid Reference: TM 2495 6078
	Number of Site visits: 2
	Date of visits: 31/10 – 11/11/2013

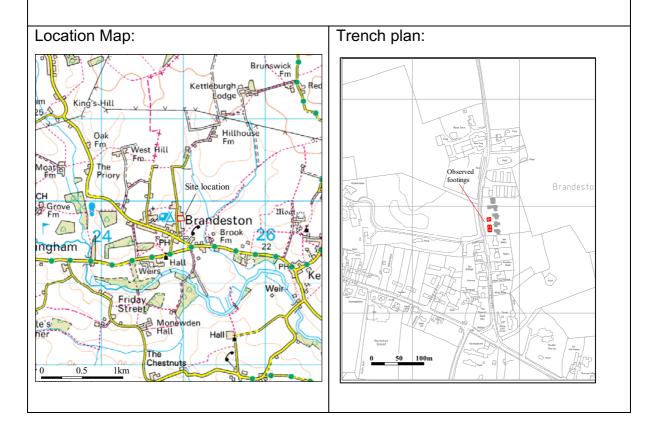
After initial evaluation of the site revealed ditches dating to the Roman period, archaeological monitoring of intrusive ground works near to Mutton Lane was required as part of the mitigation strategy for this development. Footings for three garages were observed (shown in red on the trench plan below), measuring 0.6m wide and 2.0m deep. The house footings were not observed as they lay outside the area of interest.

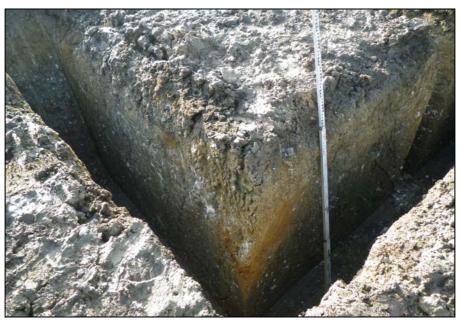
Plate 1. Garage footings (facing south-west)

Minimal topsoil removal had occurred prior to arrival on site for the monitoring of the garage footings, with approximately 0.1m of topsoil and turf removed across the area of interest. Footings were observed with clean edges whilst dry, although significant churning of the stripped layer prevented any inspection of the stripped soil for stray finds. An access road laid for the construction work was built up above the topsoil on geotextile matting using imported hardcore and as such did not penetrate to the archaeological horizon. The stratigraphy observed in the footings consisted of approximately 0.2m of topsoil over natural sandy silt patches and blue/grey chalky clays (interpreted as geological weathering of the recorded deep clay/chalky till of the Hanslope Series). No features or deposits of archaeological relevance were observed and there was no trace of a charcoal-rich deposit noted in the previous evaluation trench nearby. A single tree-bole was observed in the southernmost set of garage footings, close to the road, only appearing in one side of the footing.
