ARCHAEOLOGICAL MONITORING REPORT

SCCAS REPORT No. 2013/147	Parish: Clare
Jacaranda House, Clare CLA 081	Planning Application: SE/13/0111
	OASIS No. Suffolkc1-164202
	HER Event No.: CLA 081
Address: Jacaranda House, Bloomfield Court, High Street, Clare, CO10 8NY	Grid Reference: TL 7688 4529
	Number of Site visits: 3
	Date of visits: 25-27/11/2013

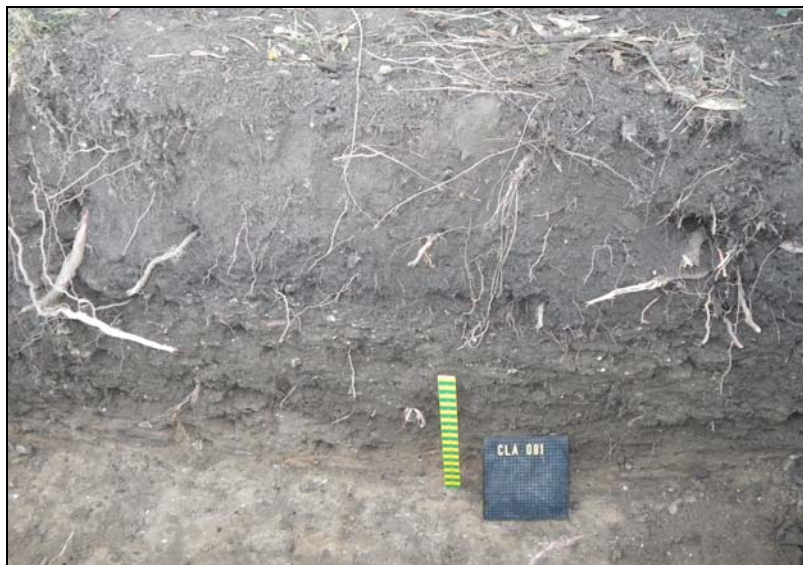
Approximately 85% of the footings were observed during excavation, with a similar soil profile observed throughout. A layer of mid/dark brown soft clayey silt topsoil approximately 0.3m-0.35m thick overlay a mixed deposit of mid greyish brown silty clay some 0.4m thick with moderate amounts of chalk flecking and occasional ceramic building material (CBM) and tile fragments. A significant amount of root disturbance was noted through both the top and subsoil deposits, with roots up to 0.1m diameter observed, and two modern drains were observed entering the westernmost footing (though not observed in any other footings). The topsoil is suspected to be imported to the site, while the subsoil appears to be the previous topsoil, showing signs of marling, and thus likely to have been in use as arable land at some point in the post-medieval period. The underlying natural geology was a mid/pale yellowish/orangey brown clayey sands and gravels, common through much of Clare where the rivers have cut through the heavy boulder clay found on higher ground.

Plate 1. Eastern footing section – view facing west of outside edge of footing (0.3m scale)
