# Barsham Water Treatment Works BRS 037

# **Archaeological Evaluation Report**

SCCAS Report No. 2013/142

**Client: Essex and Suffolk Water**

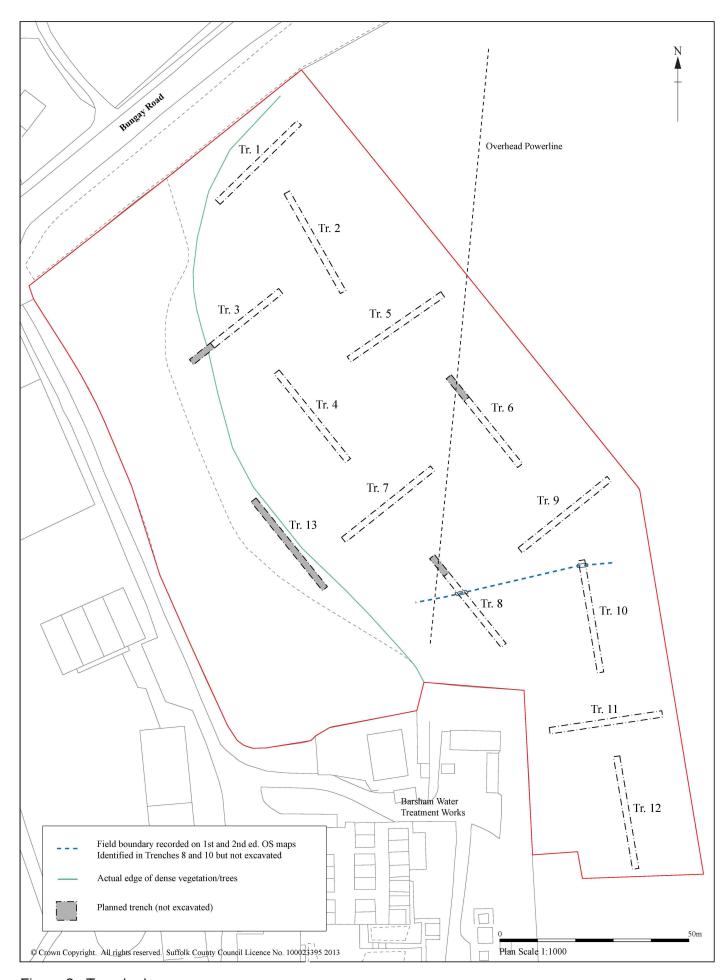
Figure 2. Trench plan

Twelve evaluation trenches were excavated (fig. 2). A thirteenth trench was planned but its location placed it within the root protection area of a number of mature trees that are to be retained. The trenches were excavated on perpendicular alignments, being either northwest to southeast or southwest to northeast.

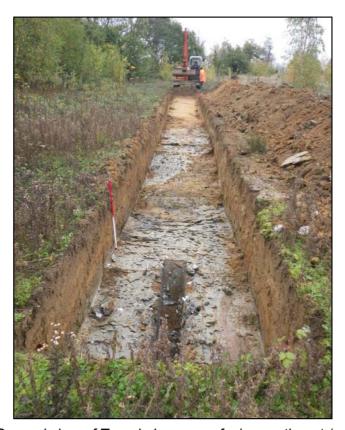
Plate 1. General view of Trench 1, camera facing northeast (ref. HUI 78)

All trenches revealed a similar natural subsoil consisting of yellow to pale brown sand and gravel, occasionally silty and/or chalky, although a small area of stiff grey boulder clay was noted in trenches in the northwest corner of the development area (plate 1).

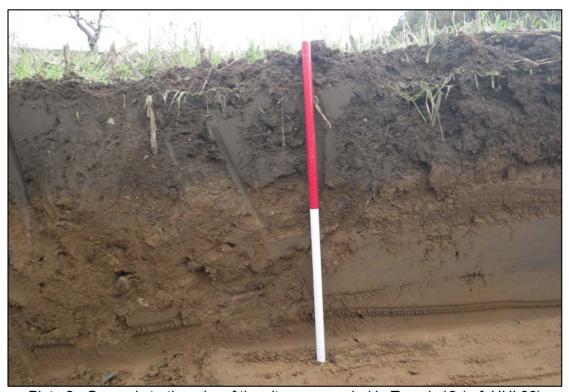
Plate 2. General stratigraphy of the site, as revealed in Trench 12 (ref. HUI 96)

In areas not disturbed by the dumping of imported material the natural subsoil generally lay at a depth of 0.4m to 0.5m beneath an overburden of topsoil and a layer of pale brown silty sand (plate 2), which is probably a hill wash from the higher up Barsham Hill or a result of weathering of the surface of the natural subsoil.

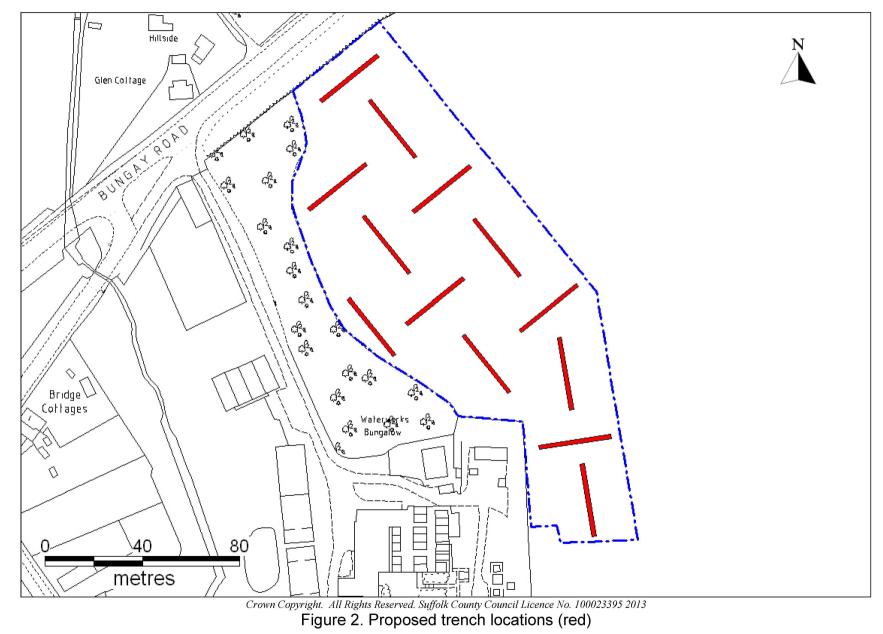
- 3.1.2 Evaluation of the development ar ea will employ trial trenches to cover approximately 5% of the proposed development area (PDA).
- 3.1.3 In this case this requires *c.* 390m of 1.8m wide trench. This would be broken up into thirteen (13) indivi dual 30m long trenches spread out to give as even coverage as possible. The proposed trench layout is shown in Figure 2.
