# Suffolk County Council Archaeological Service

## Archaeological Monitoring Report

### 3 High Street, Lavenham

SCCAS Report No. 2006/127

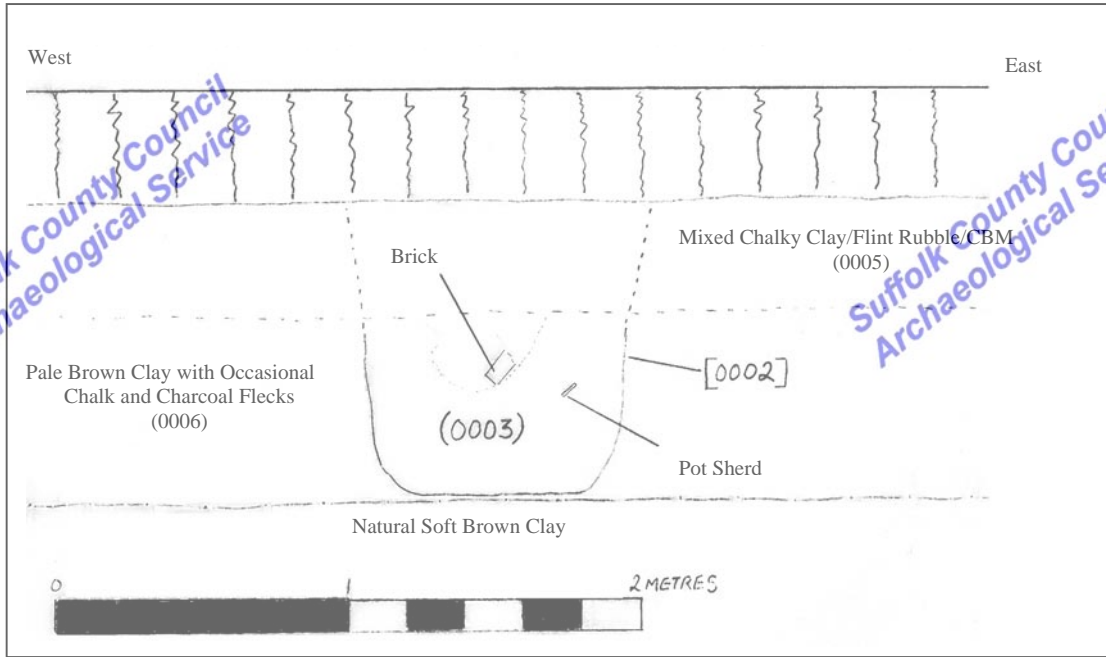
**Fig. 4 North Edge of Site Section: Possible Pit 0002**

Possible Pit 0002 Only one archaeological feature was observed during the monitoring. This was located within the north edge of site section (see Fig. 3-5), where a possible pit was recorded. The upper part of the pit may have been truncated and was sealed by a layer (0005) of mixed chalky clays, flint rubble and mixed ceramic building materials. This layer occurred along most of the north edge of site section. The pit cut a layer of pale brown, possibly natural clay (0006), before terminating just above the soft brown clay deposit. The feature had near vertical sides and a virtually flat base. A single fragment of a strap handle from a medieval jug was found securely stratified within the fill of the pit dating to the late 12<sup>th</sup>-14<sup>th</sup> century. A fragment of an early post-medieval brick was located within the upper area of the fill (See Fig. 4 & page 6).

The upper limit of the possible pit 0002, was initially thought to have been truncated, however, this level approximately corresponds with the floor levels within the late medieval building (see general site view on page 1). This may suggest that a ground build up of around 0.70m. may have occurred since the construction of the timber-framed structure. Equally, if this is the case, the total lack of any features within the lowered ground surface may indicate that the rear of the property had few substantial
