Swimming pool building at Gifford's Hall,
Wickhambrook
WBK 045

Archaeological Monitoring Report

SCCAS Report No. 2013/149

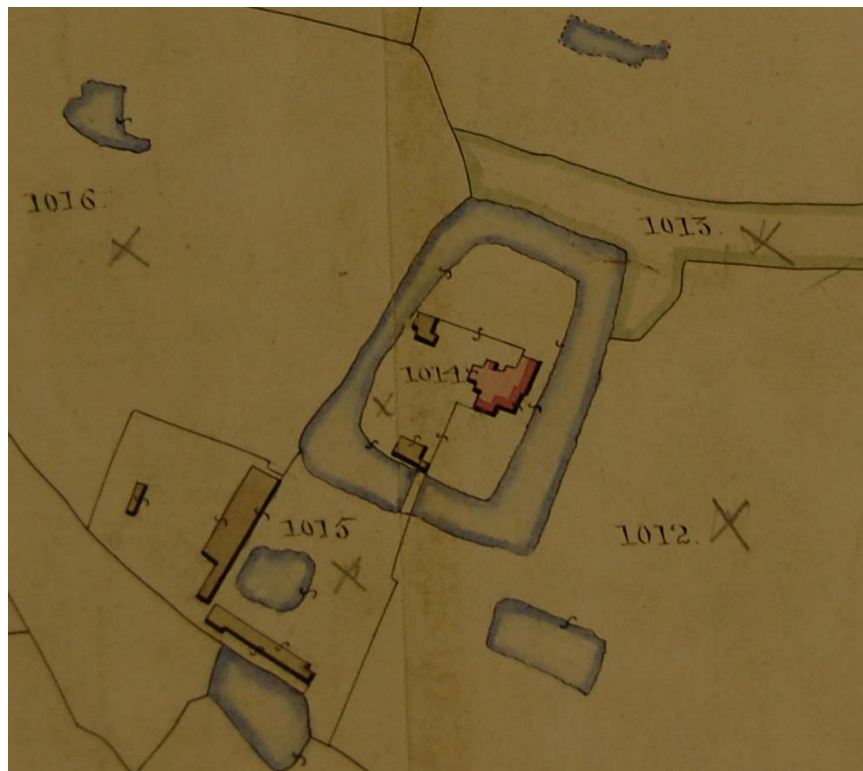
Figure 2. Tracing of the Wickhambrook Tithe map of 1841
(Suffolk record office ref FL652/3/14/2)

The site lies with the parcel of land numbered as 1015 on the Wickhambrook tithe map drawn in 1841 (Fig. 2). It is described in the tithe apportionment as 'Yard and Buildings' and is part of the hall then owned and occupied by Wooton Issacson. A large pond is shown in at the centre of this parcel of land with buildings on its south and west sides with a second pond further to the south. It is interesting to note that the row of 18th century cottages (the long narrow building between the ponds) are coloured grey which usually signifies agricultural buildings or other buildings as opposed to the red of an occupied dwelling which suggests that the cottages may not have been used as housing at the time.

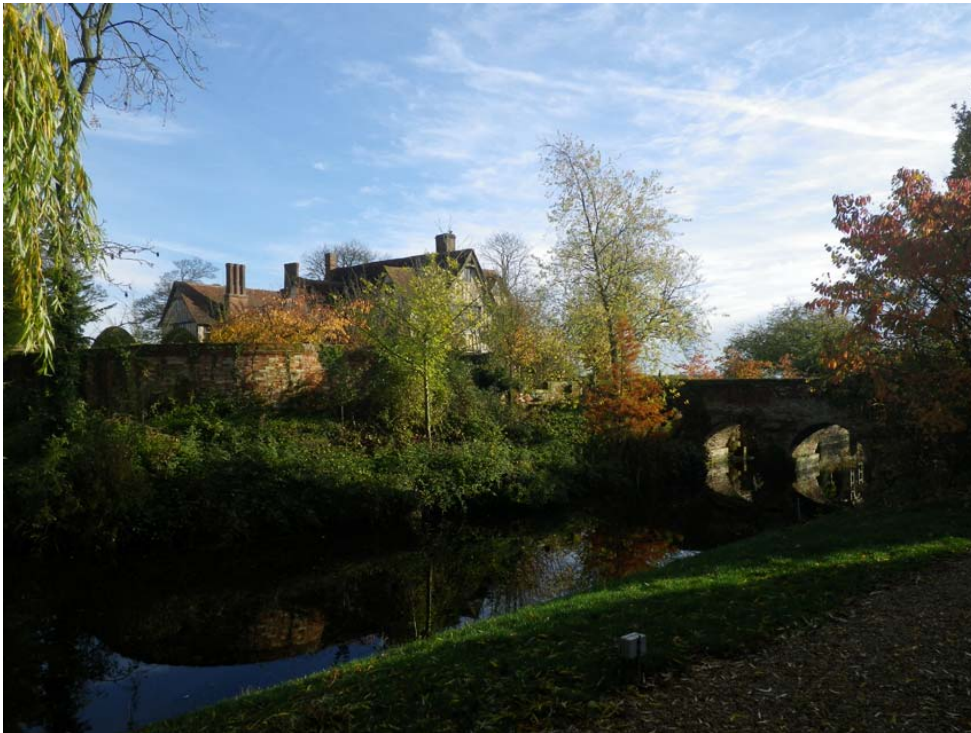
Plate 1. Gifford's Hall stands within its own moated enclosure. Typically in a complex of this date the hall would have been located at the end of a base or lower court. The base court would be enclosed by the ancillary buildings, like the stables and brew house, arranged around its margins and access to the hall would be by a driveway through the central axis (and in this case over a bridge) of the base court. The current brick-built bridge has shallow pointed arches in a late medieval style but the bricks suggest a more recent (?C18th) date.

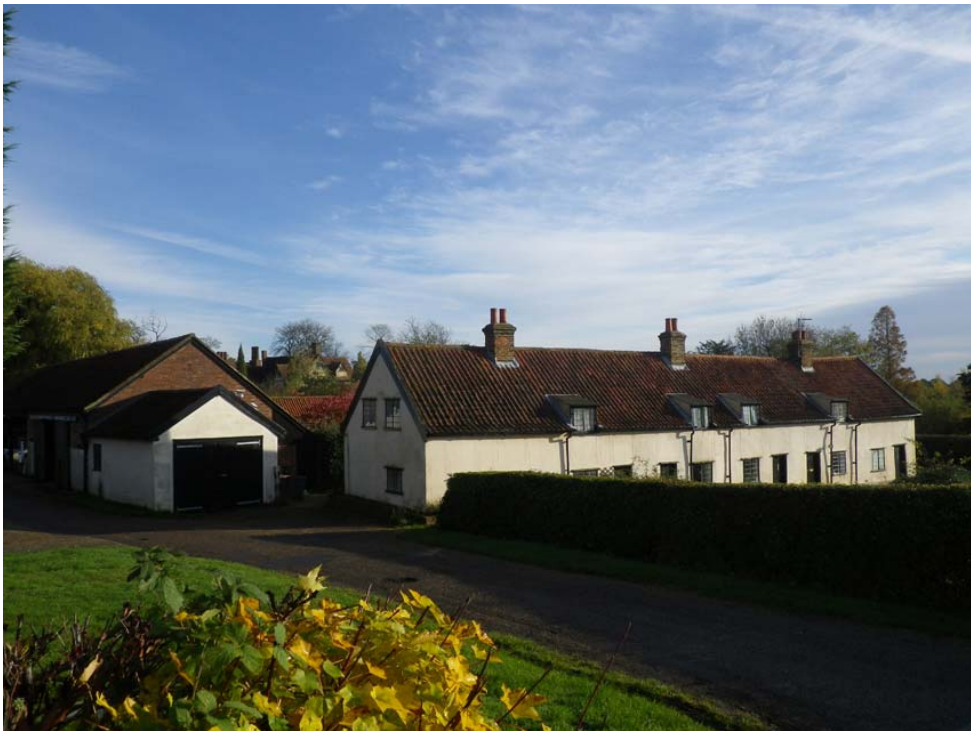
Plate 2. The Grade II cottages fronting the road are located on the south edge of the putative base court. The cottages are described in the listing as 18th century but not identified as dwellings on the tithe survey of 1840. The tithe map shows large ponds located to the front and rear of the cottages; these have been infilled but the gardens to the front of the cottages remain sunken and lower than the adjacent road. The photograph is taken looking north and site was located to the rear of the cottages

The dumped clay found just beneath the topsoil over most of the site is the result of previous excavations nearby. The most likely source for the clay is the excavation for the former swimming pool alongside the site or the dredging of the moat (the west arm of moat was re-excavated in the 1990's). The volume of clay seems considerable against the size of the old pool but, as the clay was quite clean, the former seems more likely. The date of creation of the two ponds in the area is unknown but the map evidence shows that they were infilled during the second half of the 19th century and this dating is supported by the results of the monitoring. The redeposited clay has raised (by a small degree) what was formerly a low-lying area and the sunken nature of the immediate topography is highlighted by the cottages which appear to be located in a hollow (Pl. 2).

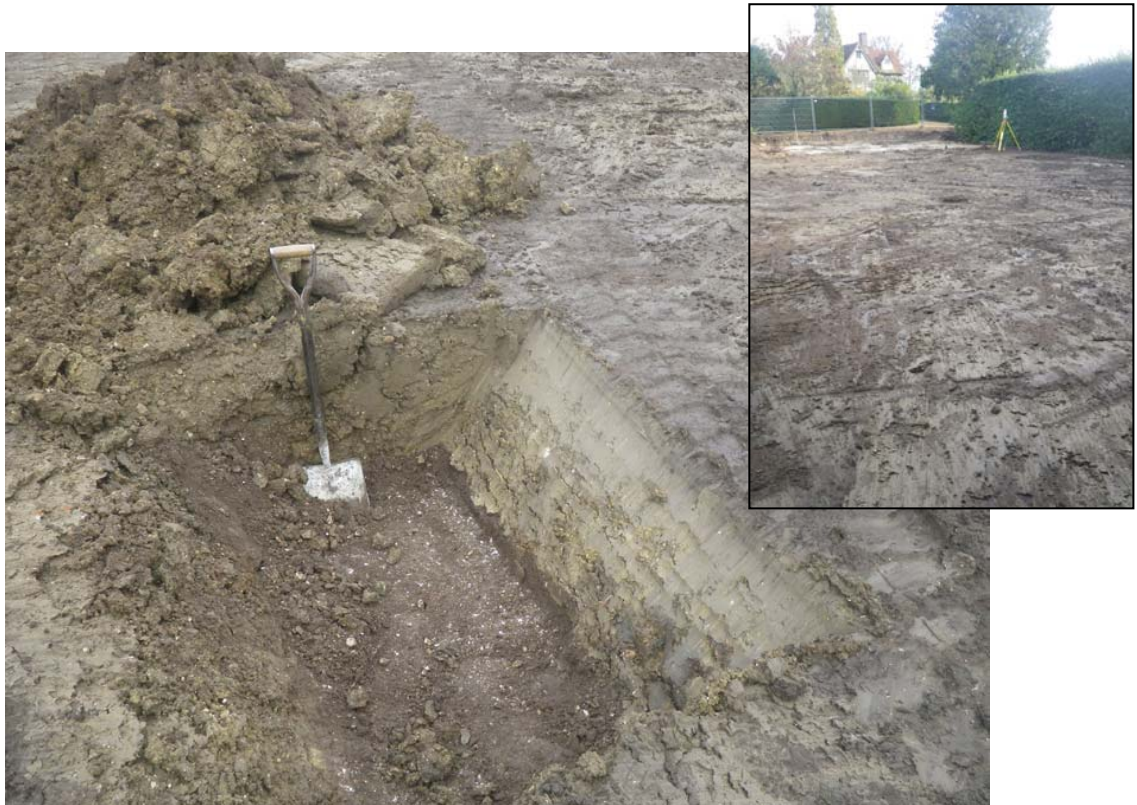
Plate 3. Thick layer of compacted redeposited clay covering the entire development area photographed following the removal of a thin topsoil layer. The clay, the result of dumping either from moat dredging or the excavation of a previous swimming pool alongside the development area, was relatively clean and contained only a few small fragments of brick/tile. The former ground surface can be seen in the main picture at the bottom of the test hole.

The topsoil was stripped from the whole of the development area to the top of a thick layer of green/grey boulder clay, 0002 (see sections and Pls. 3 and 4). This material is similar to the local geological clay found at depth of c.1.5m below the surface and must have been dumped onto the site from a previous deep excavation somewhere in the immediate area. The redeposited clay was spread over the entire stripped area and had been compacted or rolled to create a flat, level band. The clay contained occasional fragments of broken brick/tile but these were uncommon and the deposit was generally 'clean' and devoid of debris. Excavation for the pool house footing, through the clay,

revealed the former ground surface and buried topsoil, 0003 (Sections and Pl.3) and demonstrated a clay thickness of 400mm at the north end of the site increasing to 700mm at the south. The buried topsoil had a thin surface of gravel and chalk, which was possibly a make-shift yard and the topsoil contained a lot of Victorian brick rubble.

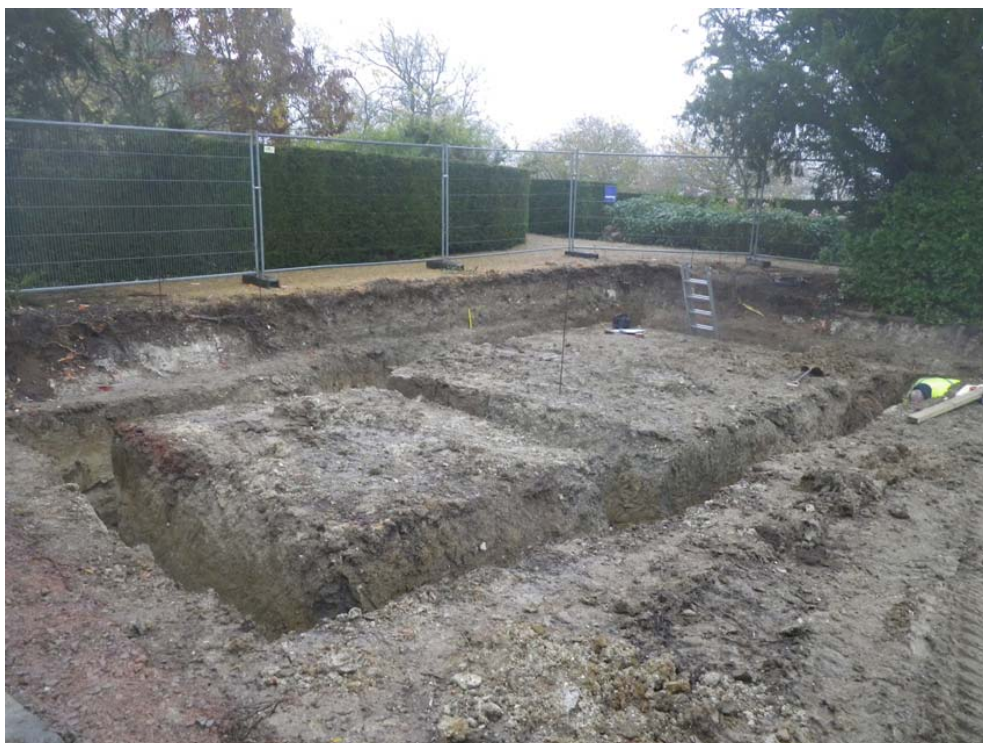
Plate 4. Strip footing for the changing rooms at the north end of the development area looking north towards the hall. The path beyond the far corner of the site is on the line of the medieval driveway and approach to the bridge through the break in the hedge. The area has been reduced by the partial removal of the redeposited clay which can be seen in section on the edge of the site. The 'reduced-dig' level is close to but still above the medieval ground level which is considerably lower than the access to the bridge. Does this imply that the driveway was on a raised causeway at this point? The driveway ditch which crosses this area is beneath the clay.

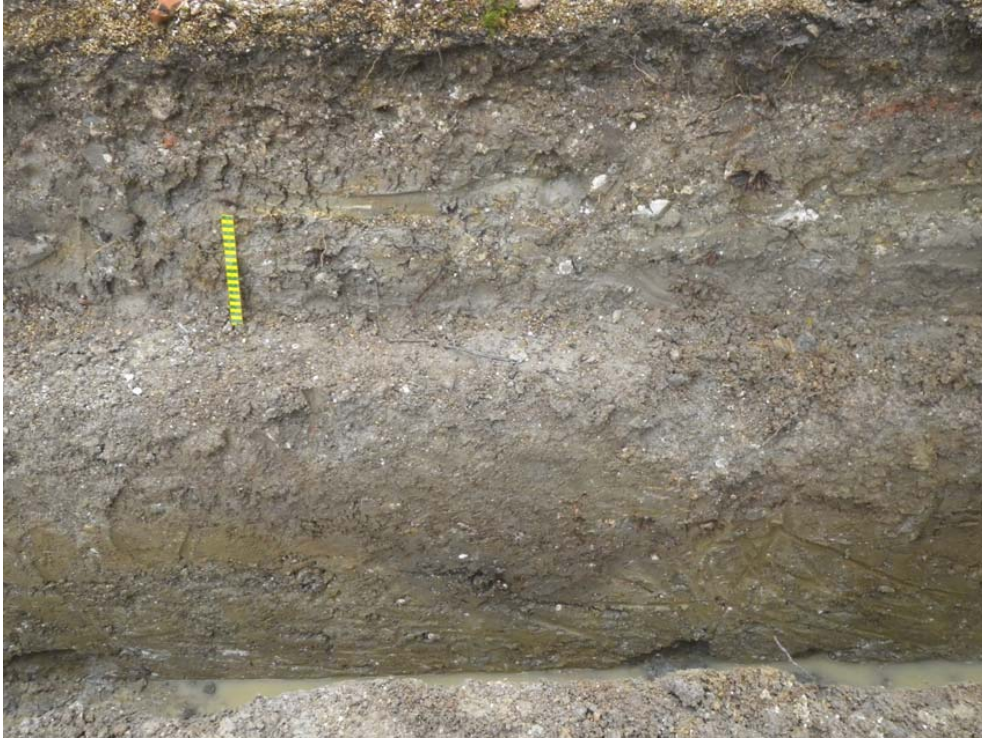
Plate 5. A section through ditch 0009 thought to be a roadside ditch flanking the medieval driveway. The ditch (the V-shape of darker clay in the middle of the picture) produced no finds and therefore was not closely dated but was of antiquity; sealed beneath the redeposited clay and a layer of buried topsoil.

A large ditch, 0008, ran N-S down the east half of the site (Fig. 4 and Pl.5). The ditch was 1.8m wide and 1m deep from the base of the redeposited clay and was filled with a grey coloured, fine, stone-less clay silt. In the lower half of the ditch the silt was mottled with iron staining and the general impression was that this was a silted-up waterlogged channel. Apart from the staining the silt was homogenous and archaeologically sterile with no sign of organic or cultural material.

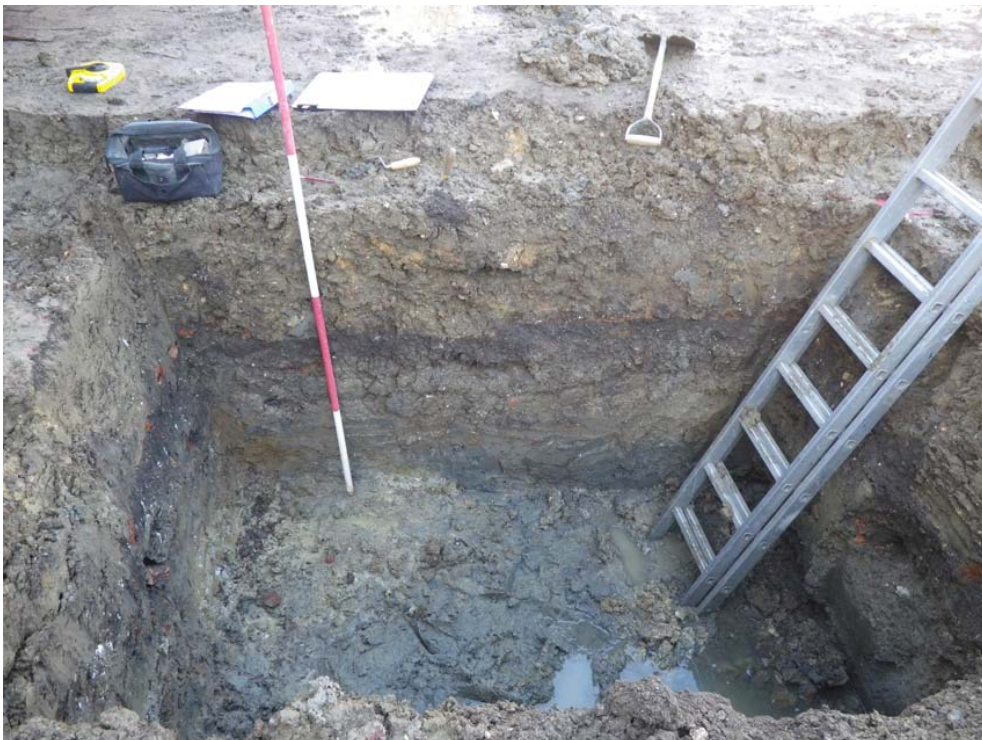
Plate 6. Pond silts seen in the excavation for the pad-footing SW of the proposed swimming pool. The dark strip at mid-depth is the former ground surface and topsoil. This horizon contained brick rubble from the demolition of the late-Victorian *'high-farming'* building which occupied the site at the end of the 19th century. Immediately beneath the buried topsoil is the mid-19th century infill and at the base of the excavations are the dark grey pond muds. The scale bar rests on natural clay and the south edge of the pond can be alongside it.

Black, fine clay/silts (Fig. 4 and Pl. 6), the muds and infilling layers of an ancient pond, were recorded beneath the buried topsoil in all of the square pad-footings on the west side of the pool building. No pond deposits were recorded in the eastern pad-footings or in the strip footings to the north indicating that the pond was centred somewhere to the west of the development. A steep-sided 'cut' edge to the pond was recorded in the southern pad-footing and in the northern one the underlying natural was seen beneath only a shallow (300mm thick) layer of silt suggesting this was close to the north edge but in the central footings the pond silts were not bottomed. The silts appeared devoid of cultural material; however hand excavation to retrieve possible finds was limited as the silts occurred at or below ground water level. The pond was sealed beneath a soil layer 0004 deposited after the pond was filled in which produced coal and 19th century brick. Three sets of field drains crossed the site; the uppermost set were modern but the lower two sets cutting the pond backfill were handmade dating to the 19th century.
