# Crows Hall, Debenham DBN 150

## **Archaeological Monitoring Report**

**SCCAS Report No. 2014/32**

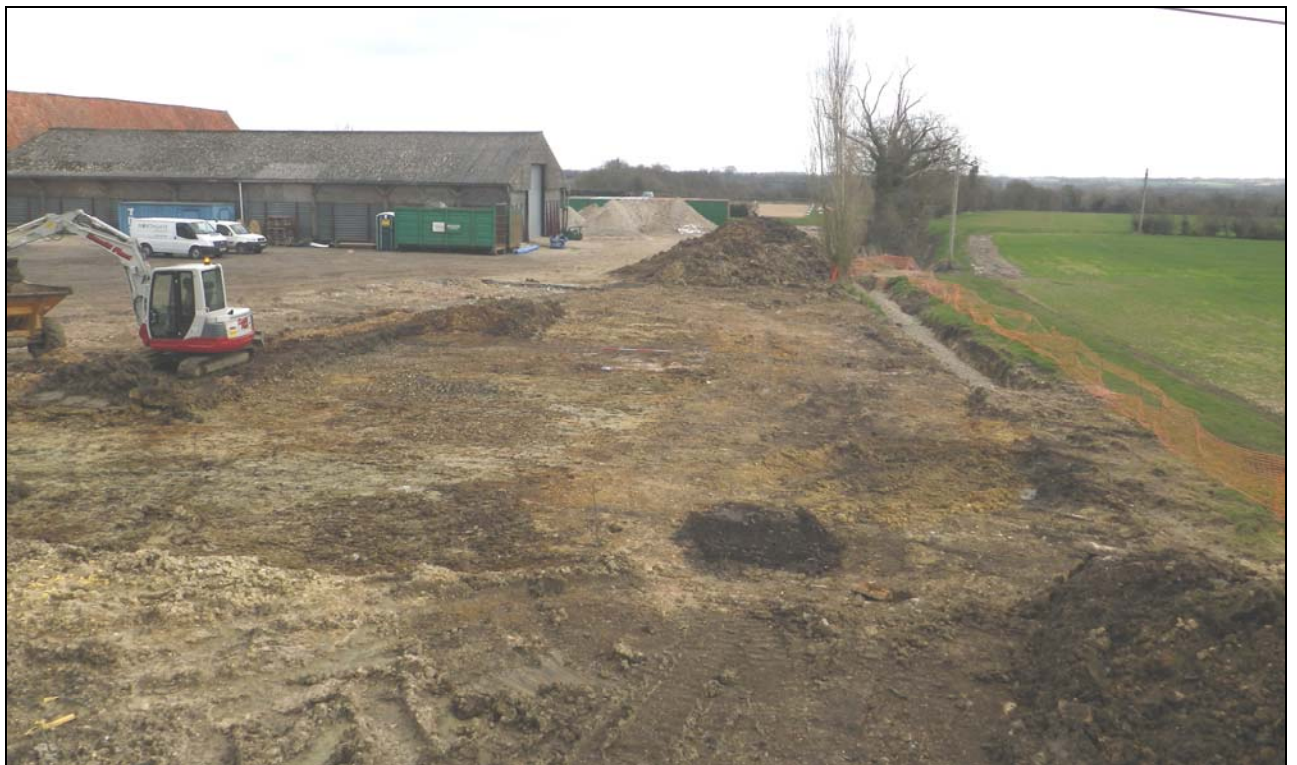
Plate 1 The stripped area taken from the west (2m scale)

Virtually the entire footprint of the new building was observed during the monitoring visit (Fig. 2 and Plate 1). The only exceptions being a small area at the western end, coinciding with the location of earlier below ground concrete structures which had recently been removed, and a small area on the north side below the existing concrete hard standing where the archaeological levels had already been compromised.

The soil-strip involved removing a c.0.3m depth of a deposit which included topsoil, but also a high concentration of mixed building debris. The interface between the removed material and the underlying naturally occurring clay subsoil was sharp and for much of the area was characterised by the presence of a concentration of flint pebbles with brick and tile inclusions at the junction between the two layers. The bricks included pieces of 20<sup>th</sup> century flettons. These observations gave the overall impression that the area had

previously been stripped, with the flint pebbles deliberately introduced to function as a hard surface forming an extended part of the farmyard to the north.

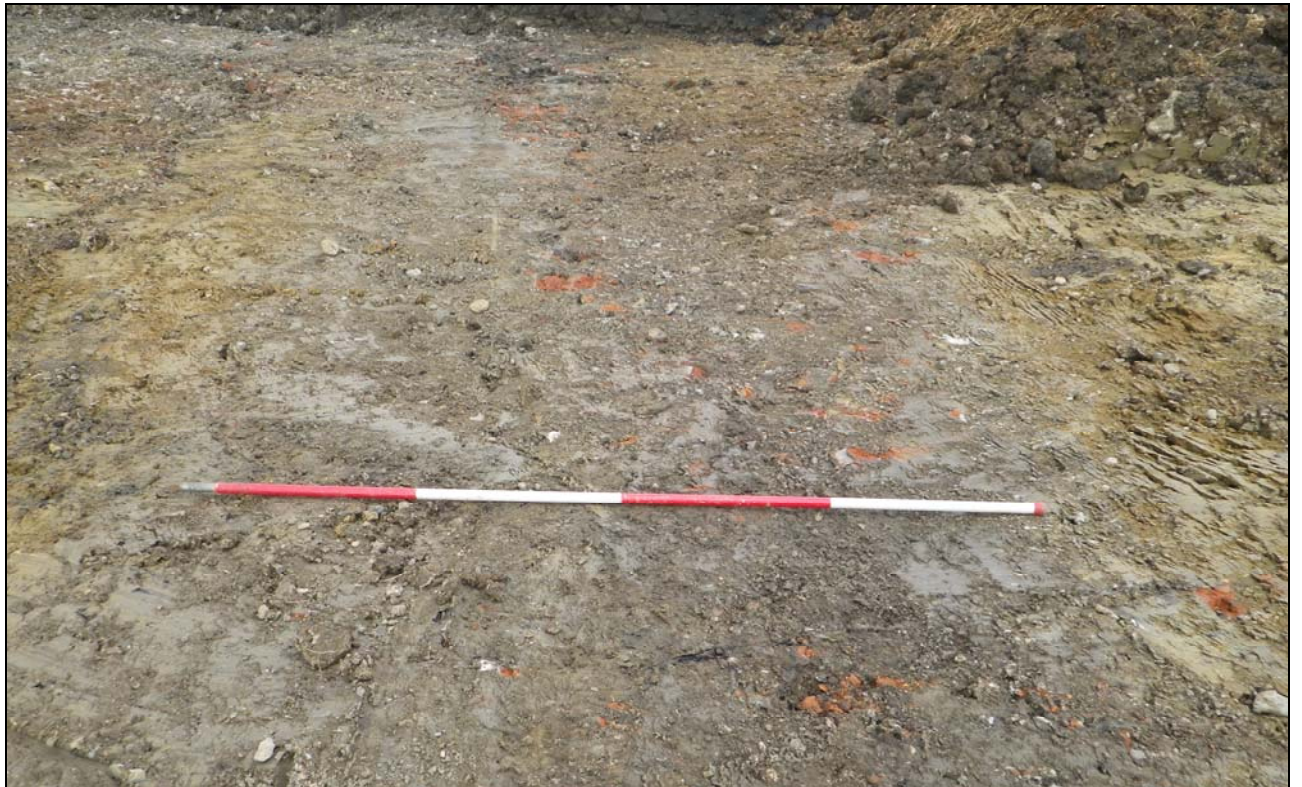
Plate 3 Ditch 0004 taken from the south (2m scale)

Ditch 0004 was orientated north-north-west to south-south-east across the stripped area, but was not seen in the sides of the open ditch c.3m to the south (Fig. 2 and Plate 3). The feature was c.2.5m wide with fill (0005) comprising stiff grey silty clay with moderate small stones, chalk lumps and roots with frequent inclusions of CBM (ceramic building materials in the form of bricks and roof tile).

An inspection of the included bricks revealed that the only surviving measurable dimension was thickness which varied between 2 inches and 2 <sup>1</sup>/<sub>4</sub> inches. The majority of the brick fabrics exhibited a relatively deep red colour with some darker surfaces with localised vitrification. These bricks were consistent in both size and character with those seen in the 16<sup>th</sup> – early 17<sup>th</sup> century phases of the standing buildings which locally included diaper-work utilising similar over-fired bricks to form the geometric patterns.

One feature of interest, a north-north-west to south-south-east orientated ditch was not closely datable. However, the presence of significant quantities of tudor-type brick fragments in its fill suggest that it only became redundant after the demolition of at least part of one of the site's 16<sup>th</sup> or early 17<sup>th</sup> century structures. In addition, it does not appear on the 1<sup>st</sup> edition OS map of c.1880, when the area of the new grain store formed part of a small discrete field or paddock (Fig. 3), although it does appear to broadly align with a boundary to the north which runs up to the barn and then continues on a similar alignment to the north of the building.

Using the available evidence, the window for the redundancy of the ditch can be refined somewhat. On balance, it seems likely that the ditch was backfilled during the later 17<sup>th</sup> to the mid 19<sup>th</sup> centuries, and while the dating of its original excavation and period of use cannot easily be determined, there is no reason why it could not have formed part of the medieval and early post-medieval agricultural landscape contemporary and directly associated with the Crows Hall building complex.

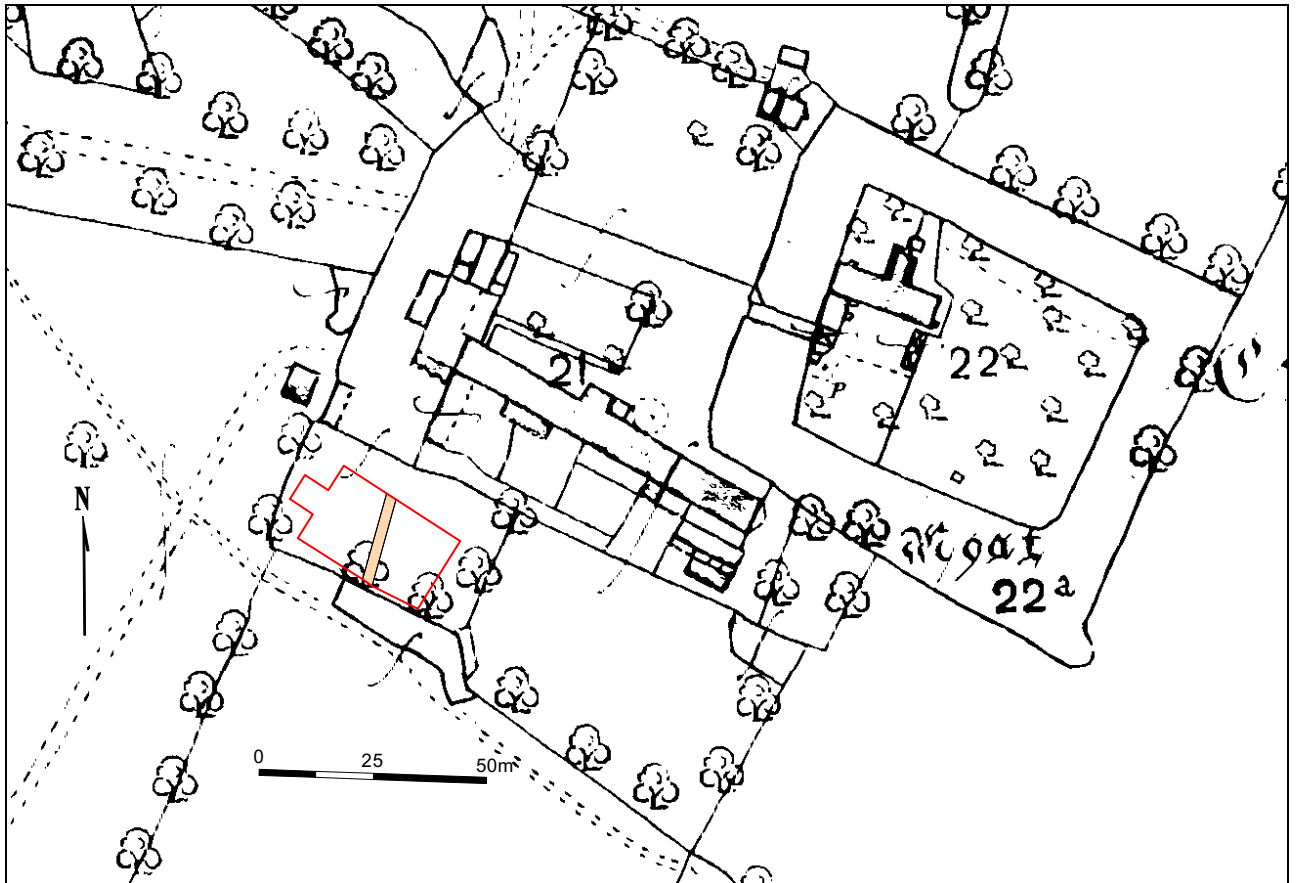
Figure 3. Extract from the OS 1<sup>st</sup> Edition map of c.1880

Dating evidence recovered from the surface of the ditch was limited to brick and tile fragments, the former comprising exclusively of 2 – 2 <sup>1</sup>/<sub>4</sub> inch thick pieces, some poorly fired and vitrified, consistent with a 16<sup>th</sup> to early 17<sup>th</sup> century date and were similar to those used in the construction of the adjacent barn and Crows Hall itself. It is thought that the ditch could formed part of the contemporary agricultural landscape surrounding the hall, becoming redundant before the end of the 19<sup>th</sup> century where it was absent from the 1<sup>st</sup> Edition OS map of 1880.
