Mill House, Hall Road, Letheringham
LRM 019

Archaeological Monitoring Report

SCCAS Report No. 2014/035

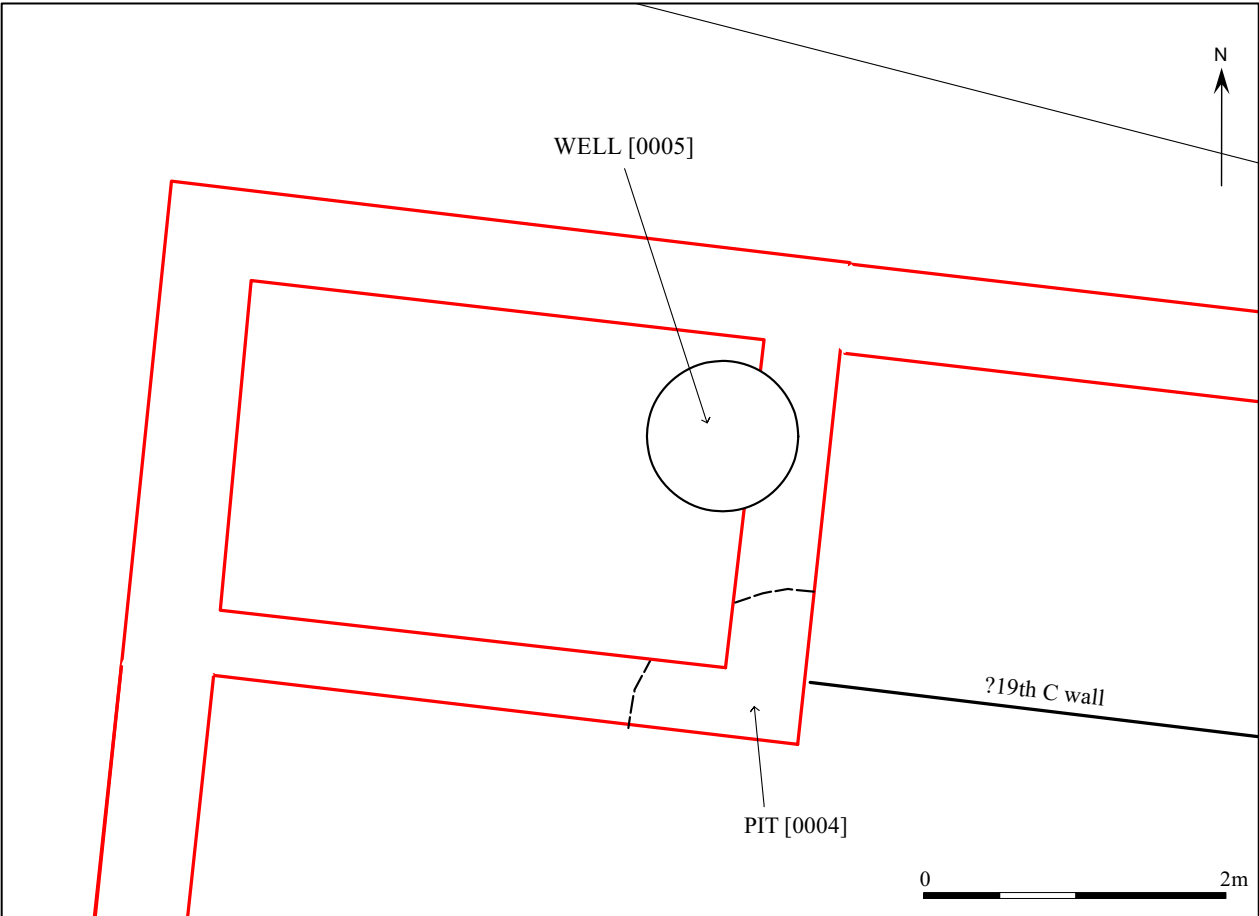
Figure 4. Features noted in footing trench

Two features were noted (Fig. 4). One consisted of a pit (0004) that was situated in the corner of two footing trenches close to the northwest corner of the house (Plate 8). It measured at least 1.8m by 1.3m and had a depth of just over 1m. The fill comprised dark sandy loam with occasional flecks of crushed red brick or tile. The footing the northern wall of the existing house runs across the top of this feature indicating it predates this part of the structure, which appears to be a 19th century extension to the original 18th century house. No other dating evidence was recovered.

The other feature consisted of a brick lined circular shaft (0005) filled with silty sand and occasional brick rubble (Plate 9). It measured just over 1m in diameter and was greater than 1.2m deep. It was formed of soft red bricks which had been laid without mortar.

The pit located within the footings for the extension of the house is undated but lay underneath one of the walls of a 19th century extension to the original house. It would therefore have been in area outside the 18th century house. The nature of the fill suggests the pit is relatively late and it may therefore be related to the construction of the extension or activities associated with the 18th century house.

The brick lined shaft was unmortared suggesting a well or soakaway. A 'P' for pump is marked on the 2nd edition Ordnance Survey map of 1904 and the indicated site of the pump is very close to the location of this shaft (Fig. 5). It therefore seems likely that this feature is a well that was originally covered and buried, possibly under the floor of the extension, from which water was drawn by the pump as marked. No such feature is marked on the 1st edition of the map, dated 1884, indicating the construction date for the well falls between the two surveys.

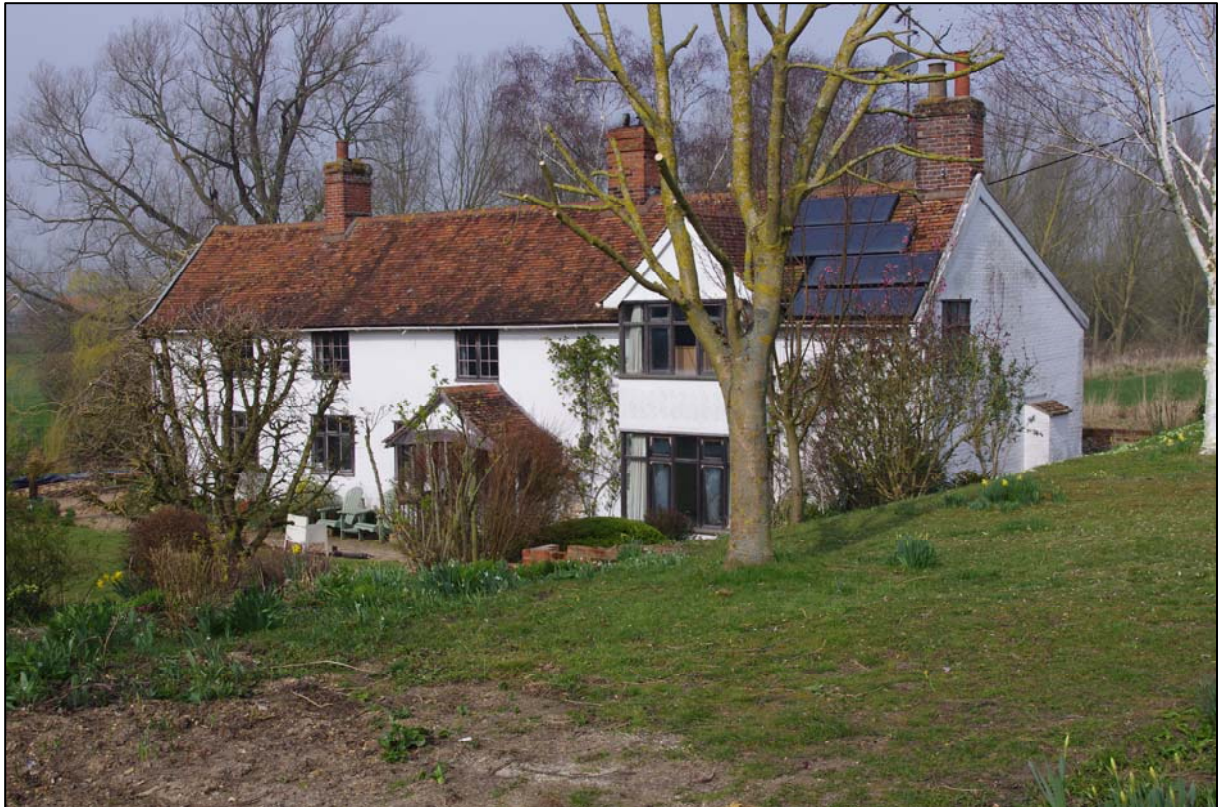
The actual house site lies immediately to the east the River Deben at a level of approximately 15.3m OD. Letheringham Mill, a water mill, sits astride the river channel to the southwest of the house. The land to the west of the mill comprises low-lying meadows in the flood plain of the river. At this location the river channel is close to the edge of the flood plain as the land rapidly rises to a height of just over 20m OD to the south and east. Due to this rapid rise the eastern 19th century extensions to the house have entailed cutting into the slope to create a flat terrace partly retained by brick walls (Plate 1).

Plate 1. General view Mill House cut into the west facing slope, camera facing NW (ref. HXB 88)

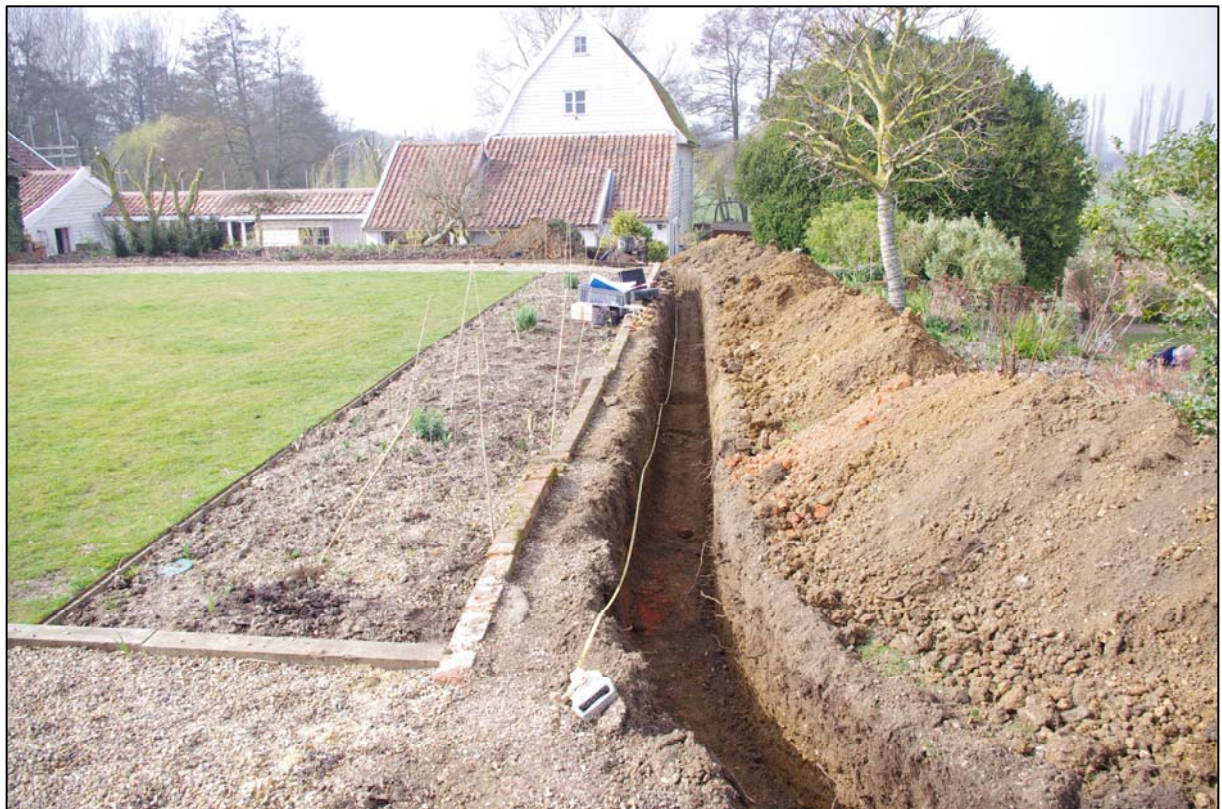
The excavated trench was inspected on the 14th March 2014 (Plate 2). The majority of the trench was blank with no obvious archaeological features or deposits except for in one specific area where a series of bones had been disturbed during its excavation by the on-site contractors (Plate 3). These were quickly identified as being of human origin and upon cleaning of the base of the 0.75m deep trench two further bones, interpreted as the lower legs of a single individual inhumation were exposed (Plates 4 and 5). These were located in what appeared to a roughly rectangular feature, interpreted as a grave (Fig. 3). The bones recovered from the trench consisted of parts of a skull, fragments of humerus, radius and ulna that appear to represent more than one arm, at least one femur, parts of a pelvis and numerous fragments of ribs and vertebrae along with other small bones. The collection would suggest a formerly complete, single inhumation in a single grave had been disturbed.

Plate 2. general view of biomass heating duct trench in the vicinity of the grave.
The mill building can be seen in the background (ref. HXB 88)

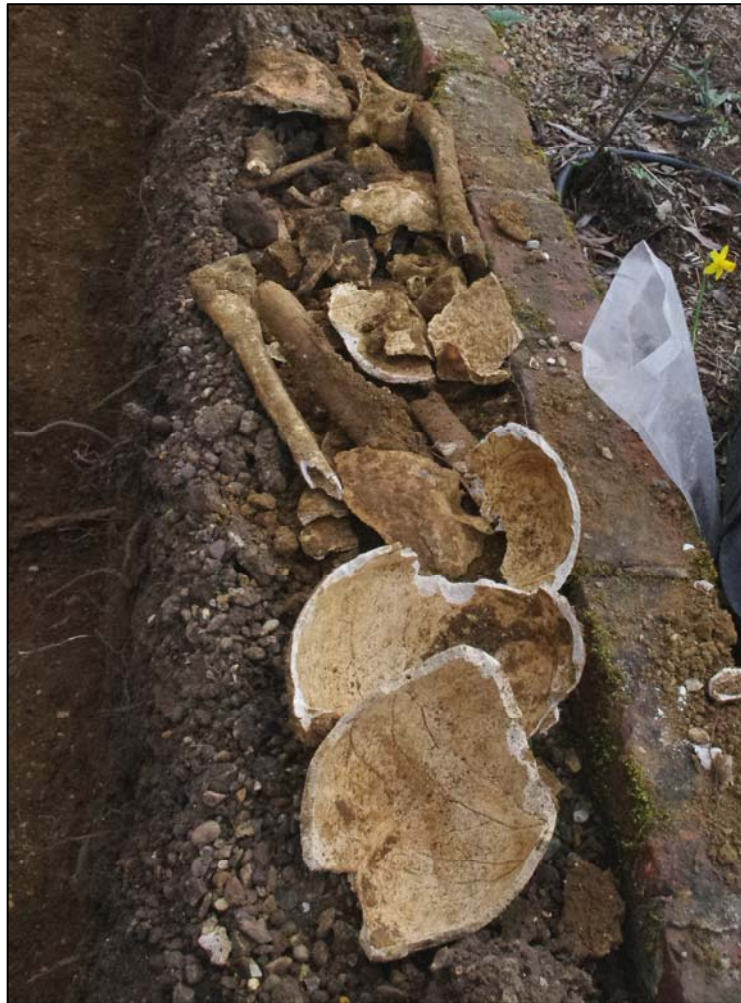
Plate 3. Collection of human bone from the grave in biomass heating duct trench (ref. HXB 84)

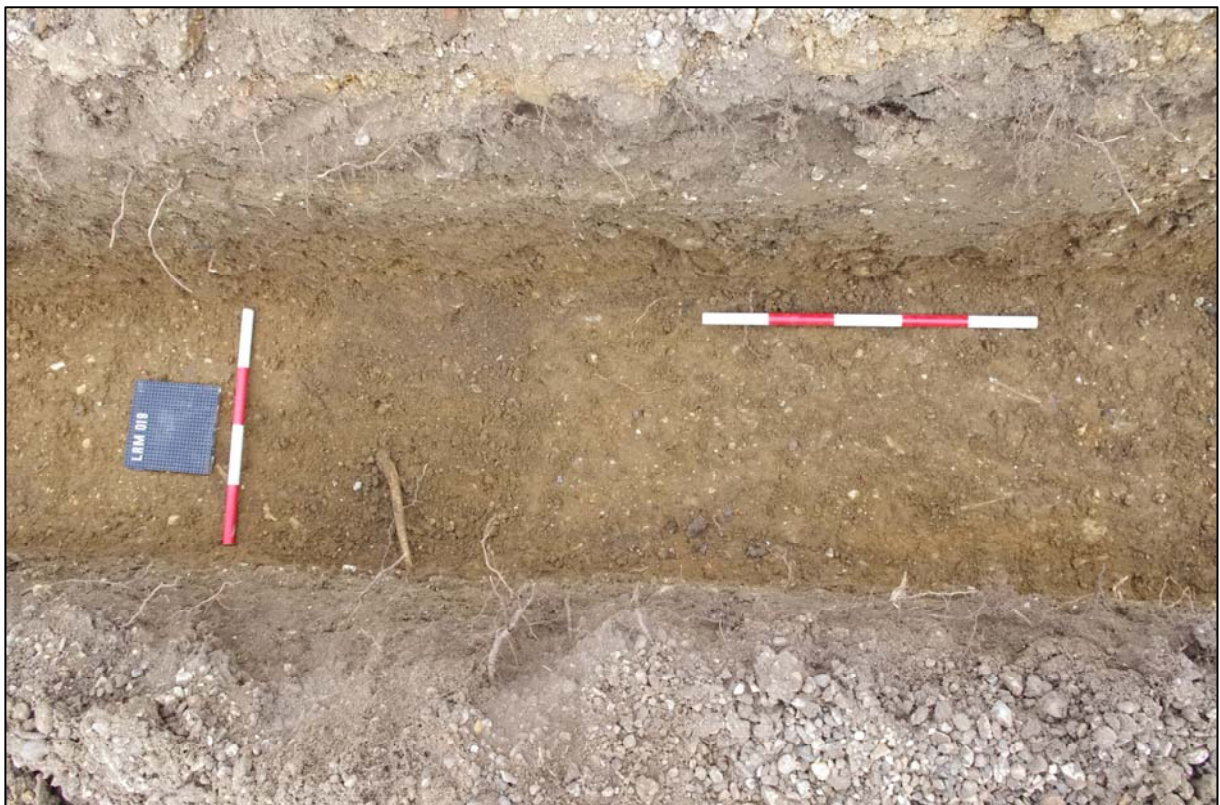
Plate 4. View of the grave as seen at the base of the biomass heating duct trench (ref. HXB 80)

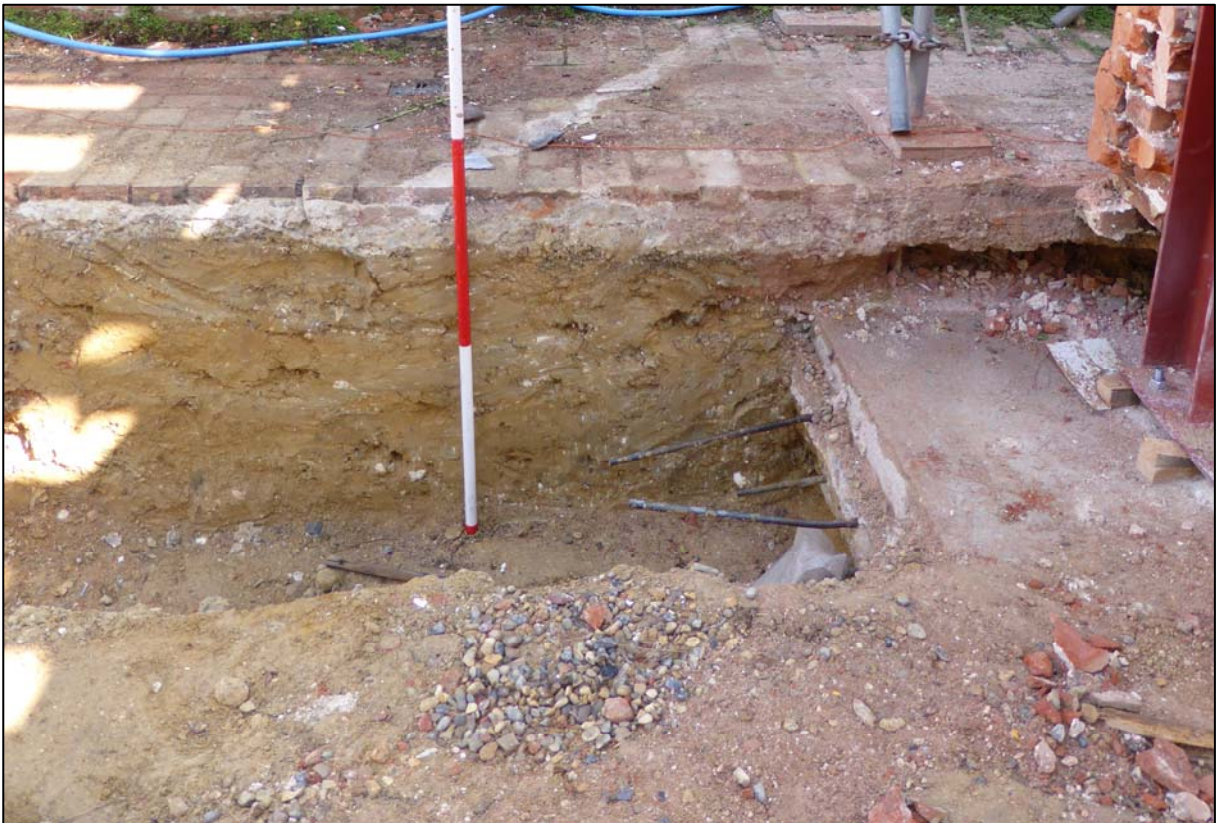
In all footings trenches the surface of the natural subsoil appeared to have been truncated suggesting previous landscaping. This was particularly clear at the east end of the house where its extension had necessitated cutting into the rising ground to the east.

Plate 6. Footing at east end of house showing truncation of natural subsoil (ref. HXB 92)

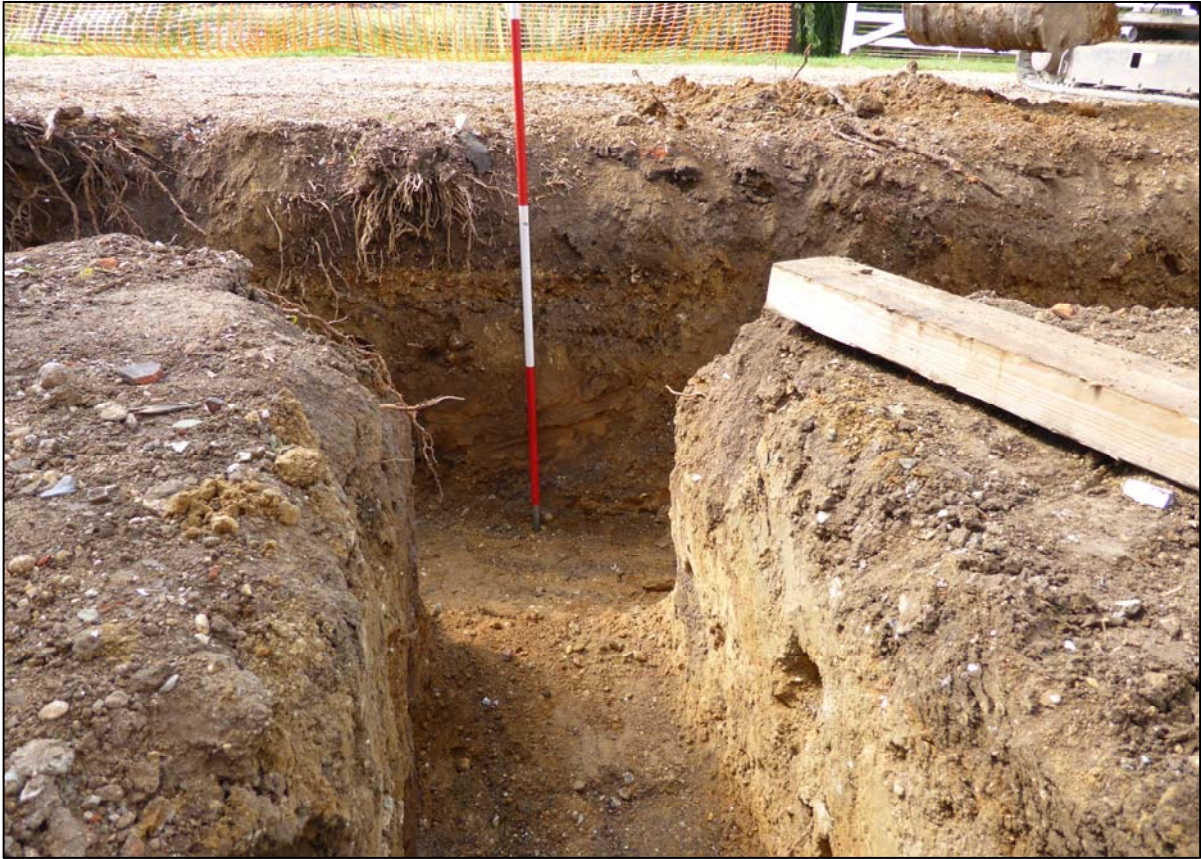
Footings for a series of extensions to the rear of the house (the north side) were examined during two visits in August 2014. These revealed natural subsoil of either dense pale grey/blue boulder clay or a yellow sand and gravel. At the east end of the house, which was clearly cut into the edge of the rising ground, this lay directly below the make-up of a concrete surfaced pathway (Plate 6). At the west end of the house an overburden of topsoil, with occasional fragments of brick, was present. The interface between the two layers was very abrupt suggesting previous truncation of the natural subsoil (Plate 7).

Plate 7. Footing at west end of house showing the abrupt interface between
The overburden and the natural subsoil (ref. HXB 90)

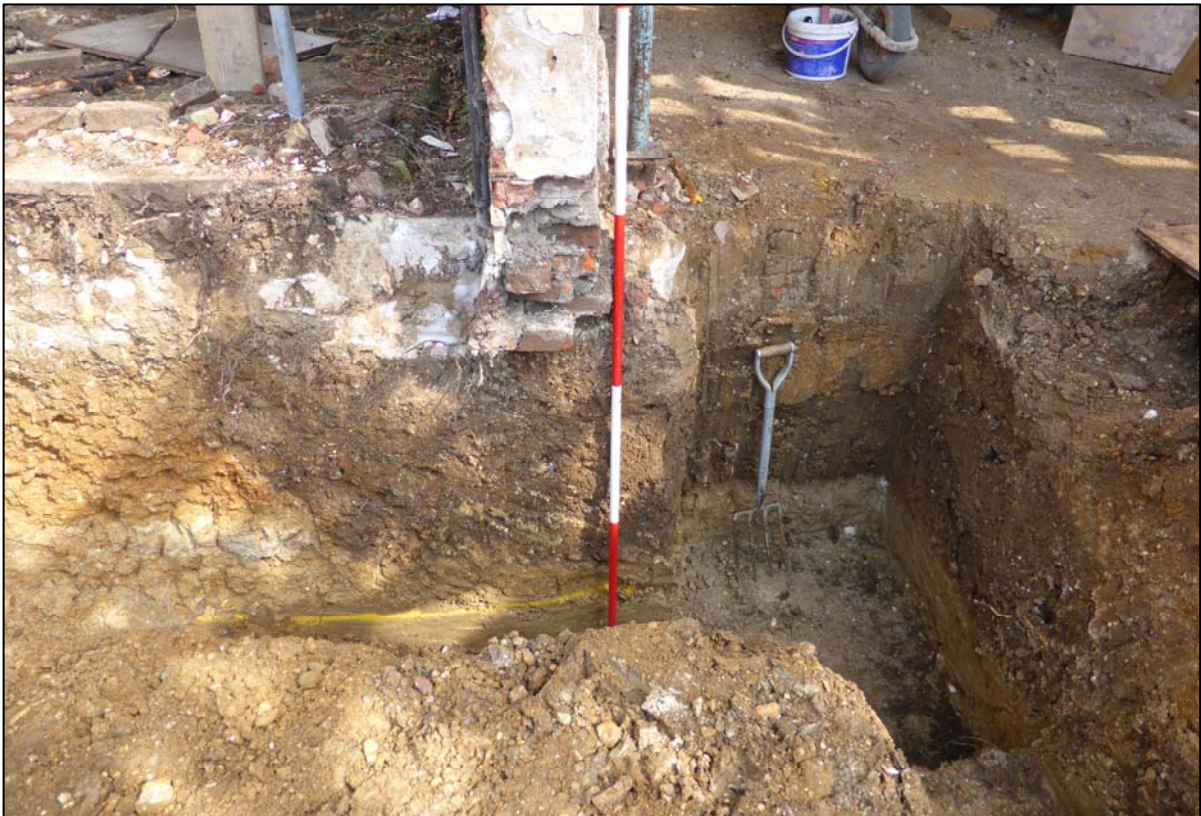
Plate 8. Pit visible in the exposed side of the footing trench (ref. HXB 89)

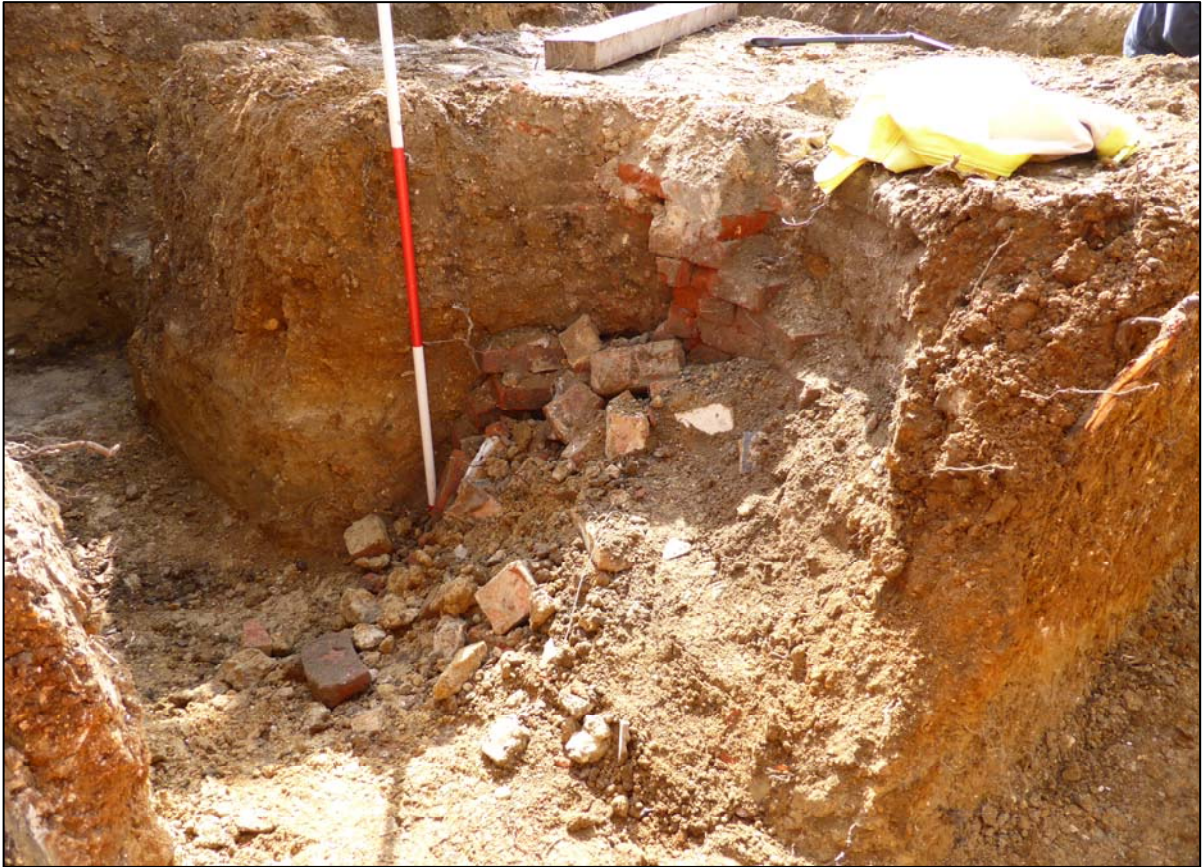
Plate 9. Remains of probable well shaft at west end of house (ref. HXB 91)

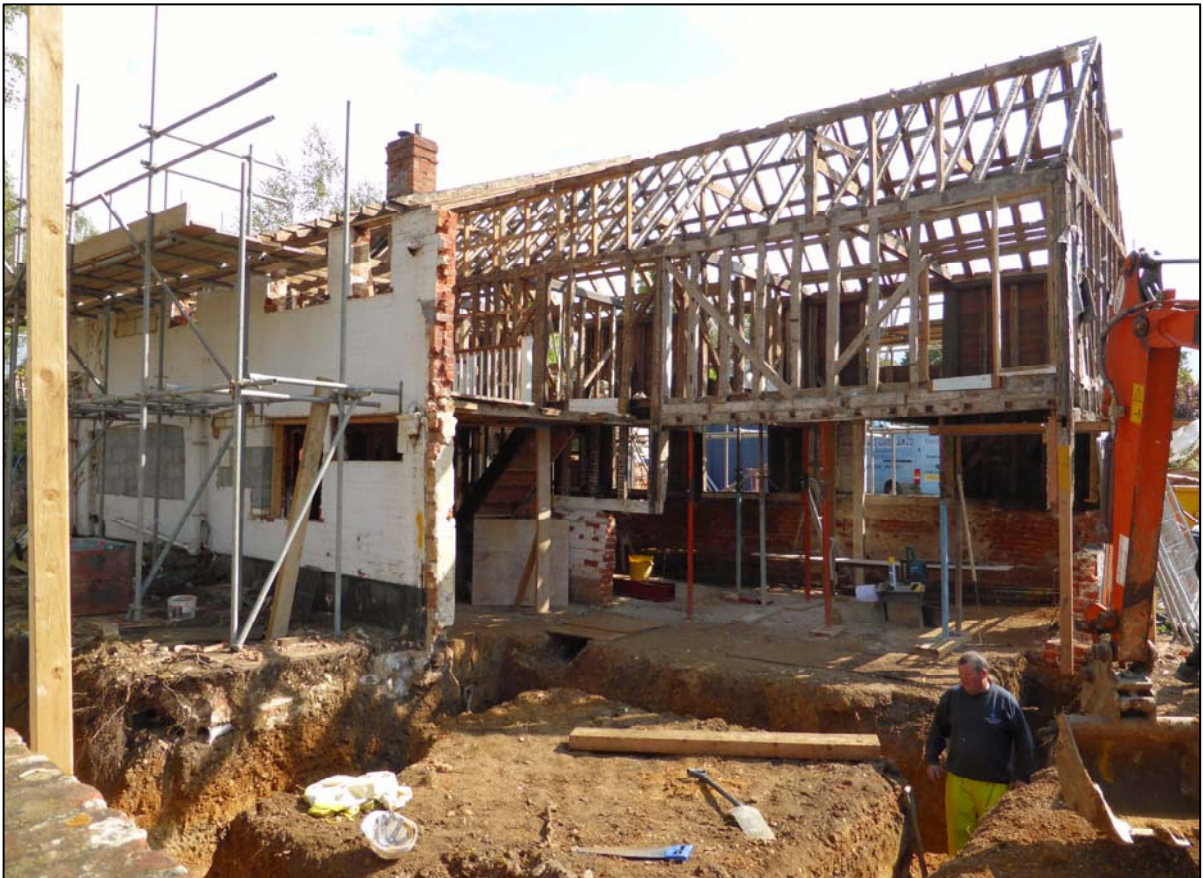
Plate 10 comprises a general view of the west end of the house showing the original 18th century timber frame and the later brick built extension.

Plate 10. General view of the reconstruction of northwest corner of the house
Camera facing southeast (ref. HXB 93)
