# ARCHAEOLOGICAL MONITORING REPORT

SCCAS REPORT No. 2014/041	Parish: Whatfield
<p style="text-align: center;"><b>THE COTTAGE</b></p> <p style="text-align: center;"><b>WHATFIELD</b> (EXTENSION TO HOUSE)</p>	Planning Application No.: B/13/01041
	<b>HER Event No.: WHA 017</b>
	<i>OASIS ref: suffolkc1-176127</i>
Address: The Cottage, Church Lane, Whatfield	Grid Reference: TM 0255 4661
	Number of Site visits: 2
	Date of visits: 26th and 31st March 2014
Nature of the work: excavation of strip foundations for an extension to the existing house.	
Reason for condition: the site is adjacent to the medieval parish church (ref. WHA009) and 'The Cottage' is a 16th-17th century Grade II listed building	
% of total seen: 100% of the excavated footing trenches.	
Location Map:

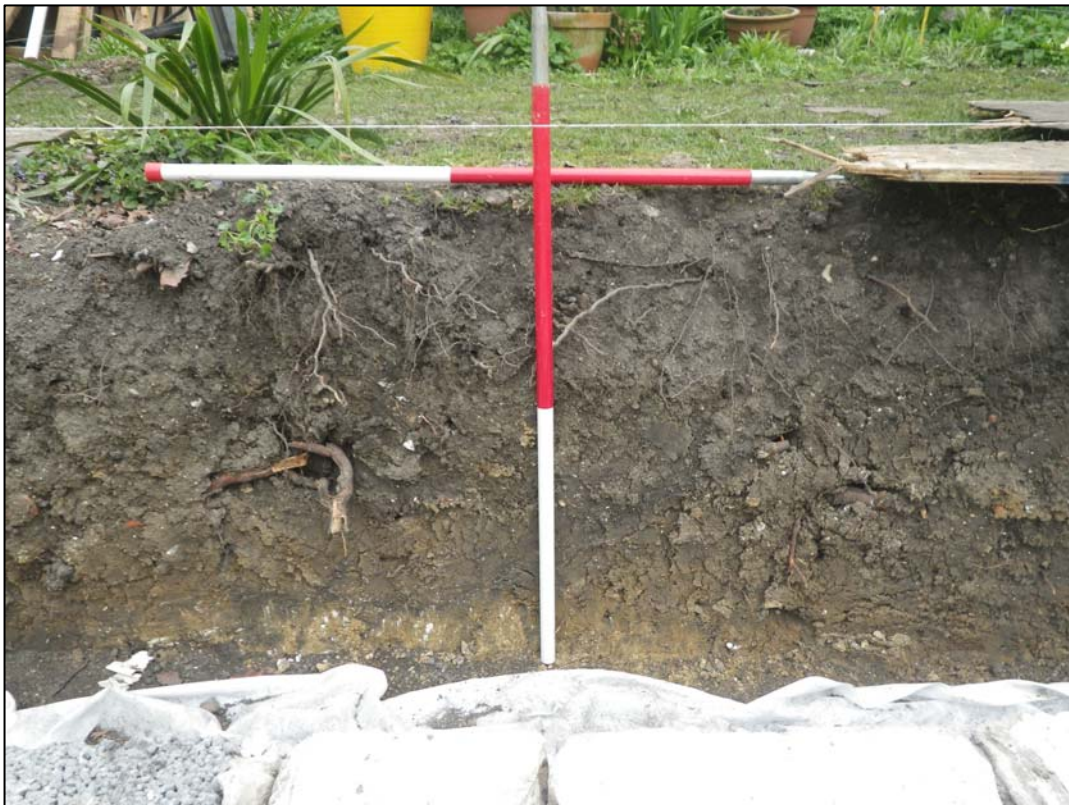
Plate 1. Stratigraphy as revealed by the footing trench at the rear of the extension  
camera facing northeast

The trenches were excavated to a depth of 0.8 m just reaching into a deposit of yellow-grey clay with small chalk fragments that was interpreted as the natural subsoil (plate 1). The overburden comprised a dark loamy topsoil, c. 0.3m thick that overlay a similar material although it was slightly lighter in colour. Occasional fragments of post-medieval brick and tile were noted throughout the sequence but no archaeological features of any period were identified.
