The Barn, Wash Lane, South Elmham St. Margarets (SEM 024); Record of an Archaeological Evaluation

SCCAS Report No. 2006/152; Oasis No. suffolkc1-17649

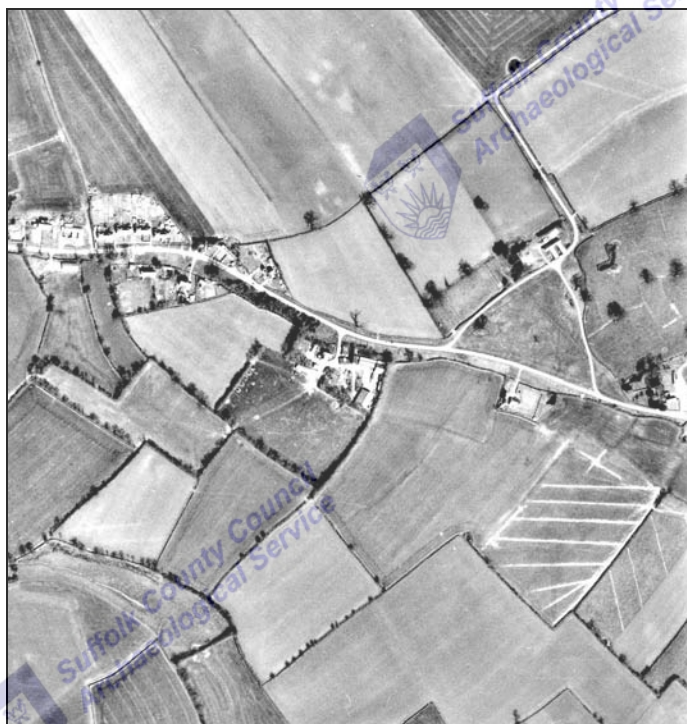
Plate 2 Aerial Photograph No. 3,171 165 (1971)

The next run of photographs date to 1971 (Plate 2).

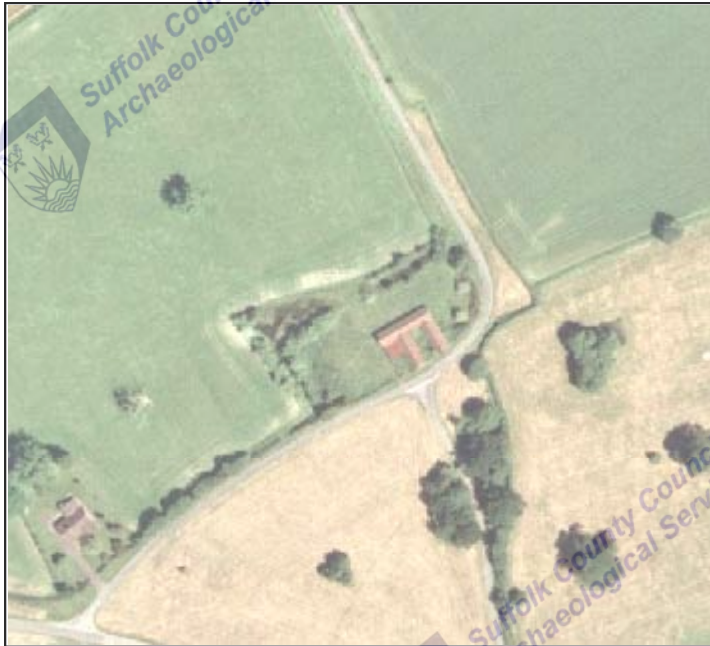
Plate 4 Aerial Photograph (1999)

Suffolk County Council also holds aerial photographs dating to 1991, 1996 and 1999. For the purposes of this report it was considered unnecessary to include the 1991 and 1996 photographs as so little had changed on the site and none provided evidence for an earlier building. However, the most recent, the 1999 run, has been included and clearly shows the site as it has remained to the present day.

There was no evidence in the form of soil-marks that would help locate earlier buildings that had been present. Particularly, there was no sign of the

house that had occupied the southernmost end of the enclosure.

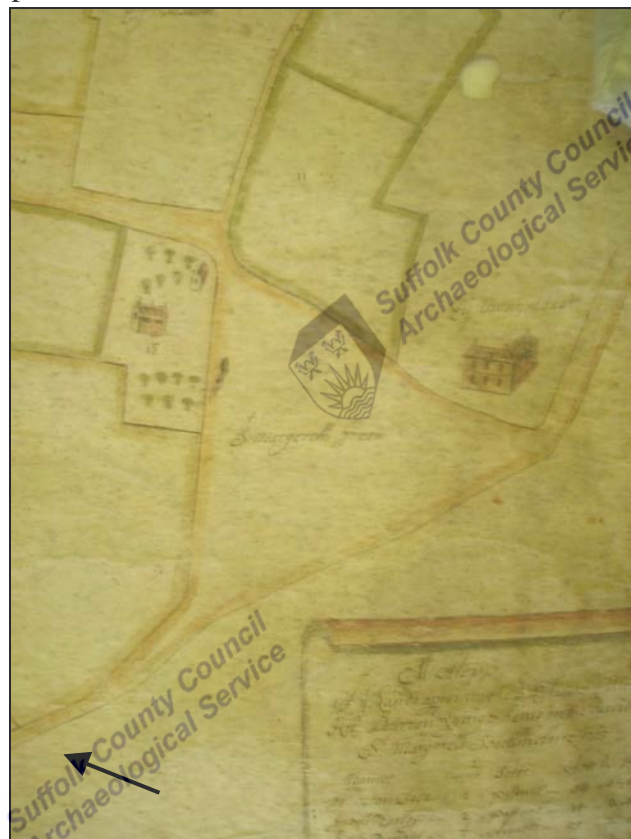
Fig. 2 Extract from estate map of 1705

parchment thinned with use. Inscribed on the legend is “*A Mapp of ye lands ap’teining to Sir Edward Ward knt Barron’t lying & being in the Parish of St Margaret South Elmham 1705*” and beneath this there is a schedule of the lands. Unfortunately this schedule is very worn and part of the lettering is missing. The site of the house is numbered 15 on the map and described in the schedule as “*Homestall & Ortyards 15 meadow 1 acre 1 rood 18 pearches*”. The adjoining lands appear to be named “*Home Close 7 pasture 8 acres 22 pearches*” and “*Horiscourt ? 8 meadow 2 acres 3 roods*”. To the west of the green the field 198 on the tithe map and named “*Ale Yard*” appears here as “*Eals Yard 11 meadow 1 acre 1 rood 18 pearches*”.

An estate map of 1705 (ref.741/D4/8) shows the site and a digital photograph taken of part of this map appears as Fig. 2. The map is endorsed with a label written in a later hand as “*A Plan of a farm in Joshua Moore’s use jnr. in St Margarets South Elmham*”. The map is in poor condition and the

In summary, the map evidence indicates that the configuration of buildings on the site has remained fundamentally unchanged from the later 19th century, but the north range of the barn is an earlier structure than those inserted later to the south. The Tithe Map is the first map to show the earlier house in an accurately surveyed position rather than the more subjective manner of the estate map of 1705 (Fig. 2).

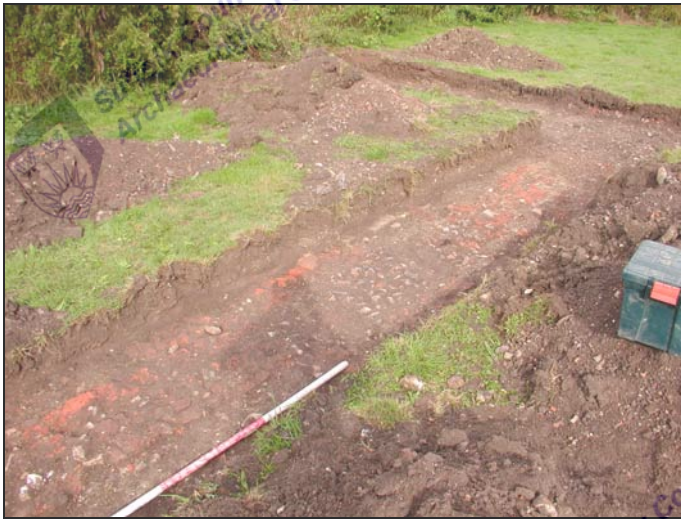
Plate 5 Trench 1, Wall base 0007

The most significant feature recorded in Trench 1 was the formal base of a north-west to south-east orientated wall (0007) (Fig. 10 & Plate 5). The southern end of the wall corresponded exactly with the end of the earlier building as shown on the 19th century plan (Fig. 8). While it could not be traced turning towards the east to form the southern wall of the building, the distance from the barn indicated that it represented

the western wall of the earlier house. Structurally, the wall comprised unmortared part-bricks (all 2-inch thick reds), forming the external faces, with a rubble interior.

The wall was recorded for a length of c.5 metres, possibly running under 0002 cobbling/rubble layer to the north, and was c.0.45 metres wide.

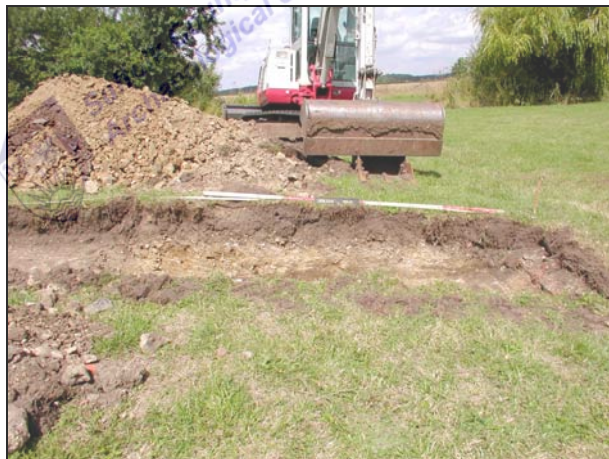
Plate 6 Trench 2, Clay platform 0003

The ground surface for the westernmost c.12 metres of the trench was relatively level (at c.0.35 metres higher than ground level north of barn), but dropped down by c.0.3 metres at its eastern end where it approached the established route/track across the site. On excavation it became clear that rather than the route/track representing an incised feature, the slope was due to the deliberate construction of a platform (0003) on which the earlier building had been constructed (Plate 6 & Fig. 11).

The layer forming the platform (0003) was excavated at the easternmost end of the trench and found to comprise very clean yellow chalky clay characteristic of the local drift geology (Lowestoft Till). A thin, c.0.1 metre thick, layer of brown silty clay below 0003 was interpreted as the vestiges of an earlier, pre-platform, topsoil. No dating evidence was recovered from 0003 or the underlying topsoil.

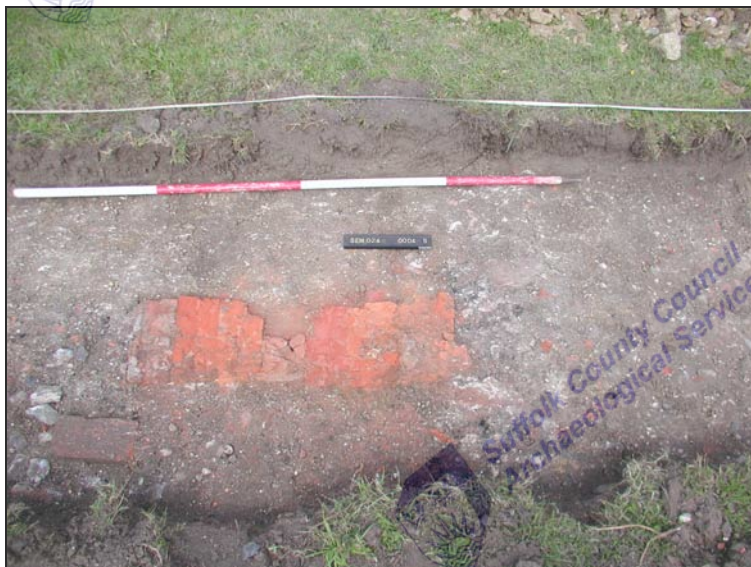
Plate 7 Trench 2, slot 0004 & threshold 0005

the chimney stack to the south (Fig. 7). Threshold 0005 also provides evidence for the floor level in the earlier building.

Slot 0004 was 0.45 metres wide with an indeterminate depth (remaining unexcavated) and a fill (0012) comprising loose mortar, brick & flint fragments with common charcoal inclusions (Plate 7).

Structural evidence within the trench comprised a north-west to south-east orientated slot (0004), a brick-built door threshold (0005) and a small rectangular structure (0006) (Fig. 10, Plates 7 & 8).

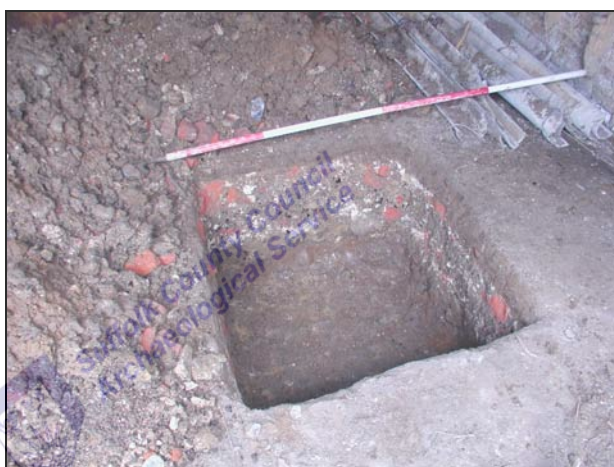
Plate 9 Trench 3, south side of trench

The existing clay floor of the barn (0009) was found to be 5 to 10 centimetres thick comprising hard packed homogenous brown clay (Plate 9 & Fig. 12).

Immediately below clay floor 0009, a *c.*0.35 metres layer of mixed clay, brick rubble, mortar and charcoal (0010) was encountered which, itself, overlay a *c.*0.2 metres layer of poorly mixed sand and clay (0011) (Plate 9 & Fig. 12).
