ARCHAEOLOGICAL SURVEY REPORT

SCCAS Report No. 2006/095

A brick and concrete air-aid shelter in the rear garden of No 118 Northgate Street, Bury St Edmunds was surveyed prior to its demolition. The shelter was an example of a *double domestic* surface shelter, the blue print for which was issued by the government in May 1939.

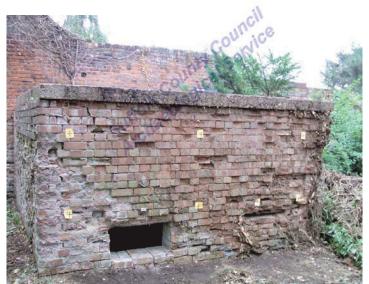
Figure 2. The shelter, south elevation

The shelter is wholly above ground, it is constructed of brick, built off a concrete slab floor and has a cast concrete roof (Fig. 2). The ground level in the garden has been raised and banked up against the south side of the shelter, burying the floor slab and the bottom four courses of brick and part blocking the emergency exits. At the north end the slab is above ground forming a step up into the shelter.

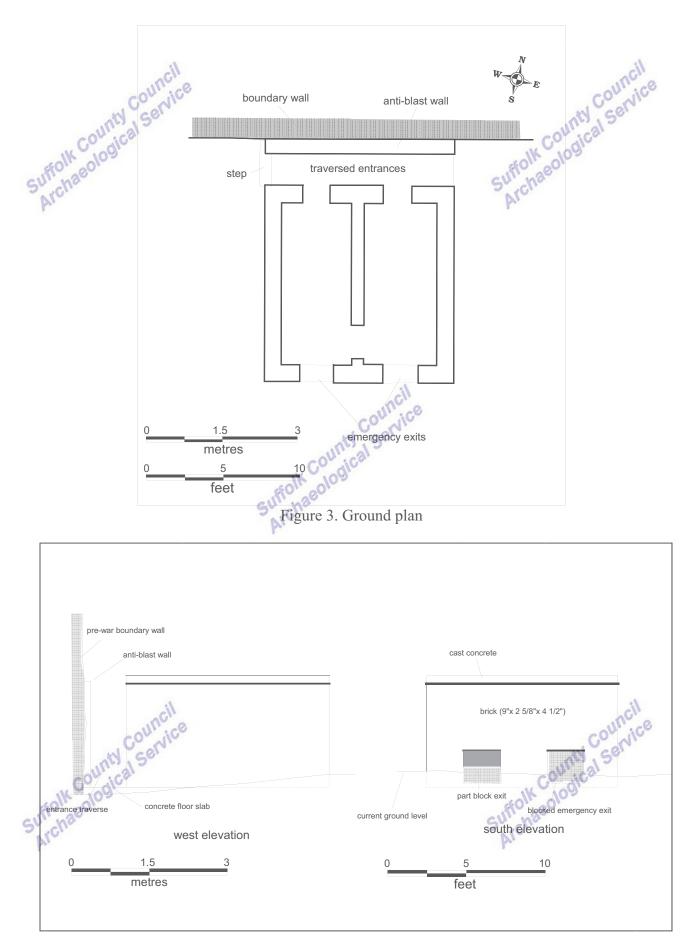
Figure 4. Elevations

The emergency exits in the south wall are close to the floor and 0.68m high x 0.71m wide (Figs. 4 and 5). There is a cill, one course of bricks from the floor and the head of the opening is supported on a flat-sectioned iron lintel. The sides of the opening have no splay. The east opening is blocked and the west partly blocked, the bricks of the infilling are not bonded and

although similar to the bricks that make up the wall, are stamped *LBC PHOURPRES 12*. The height of the part blocking in the west opening coincides with the raised external ground level. A white band has been painted around the inside of each of the openings, so they could be found in low light, and this follows the vertical edge of the openings but is the second course of bricks above it (Fig 5). The emergency exits would have covered by mild steel plates; these would have been attached to the inner and outer faces of the shelter and secured by wing nuts fastened from the inside. The gap between the plates was filled with unbonded bricks that could be pushed out when the plates were removed and as these bricks still appear to be place it seems that the shelter had a quiet war.

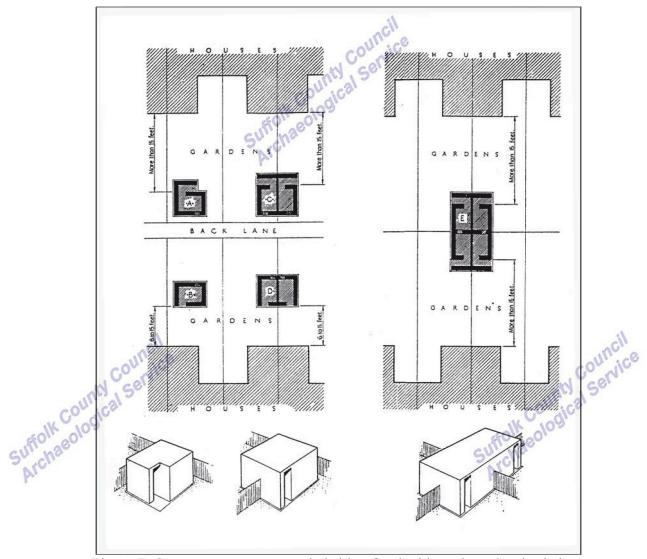
Figure 7. Government recommended siting for double and quadruple shelters

Other variations to the standard plan observed in the shelter were; the inclusion of the blast wall and traverse across the entrances, this was usually a feature on shelters constructed more than 15ft away from other buildings, closer than this and it was considered that the blast protection was provided by the those buildings: the opening in the partition between the two halves and the position of the emergency exits which are closer to the ground than those on the government blueprint.
