# Refectory Garden Wall, Bury St Edmunds Historic Asset Assessment report

## **Archaeological Survey Report**

**SCCAS Report No. 2014/049**

**Client: St Edmunds bury Borough Council**

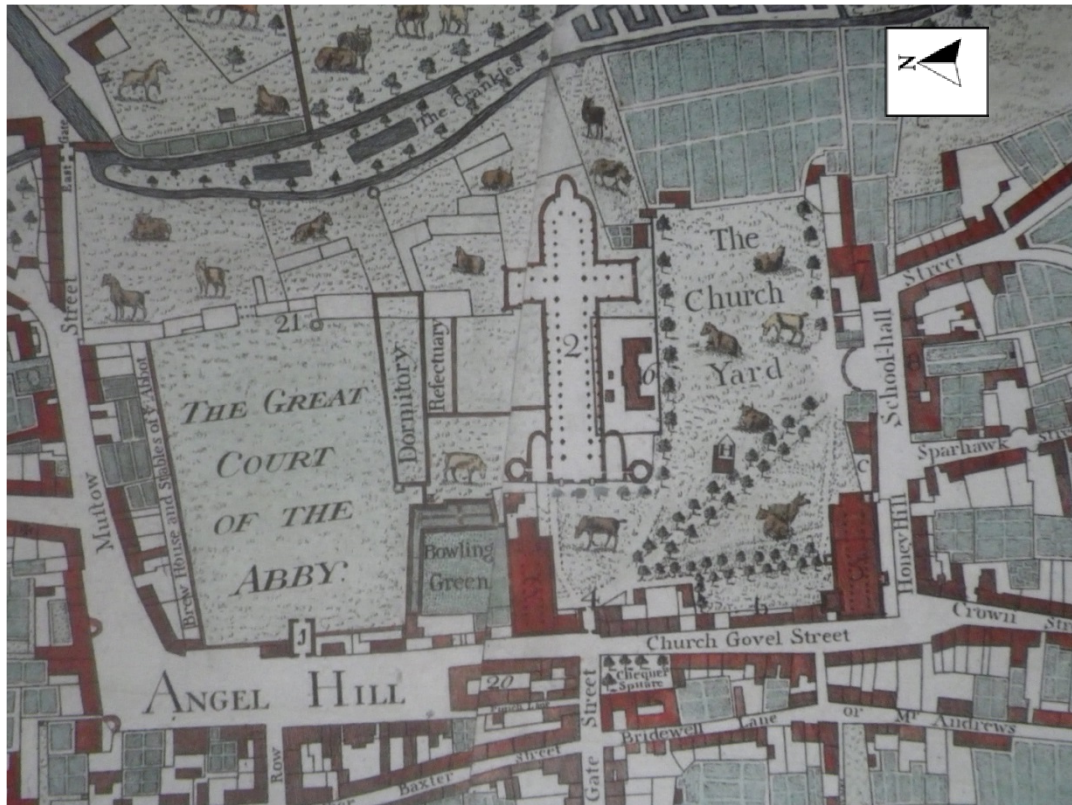
Figure 2. Extract from Thomas Warren's map of Bury St. Edmunds showing the abbey grounds in 1747 which suggests that the building remains were more complete and identifiable than they are today. The abbey church (numbered 2) and the Abbot's Palace (21) are shown as complete outlines together with the monastery's dormitory and refectory. The area of the current refectory gardens alongside St James church coloured red is labelled as a bowling green (north is to the left of the map).

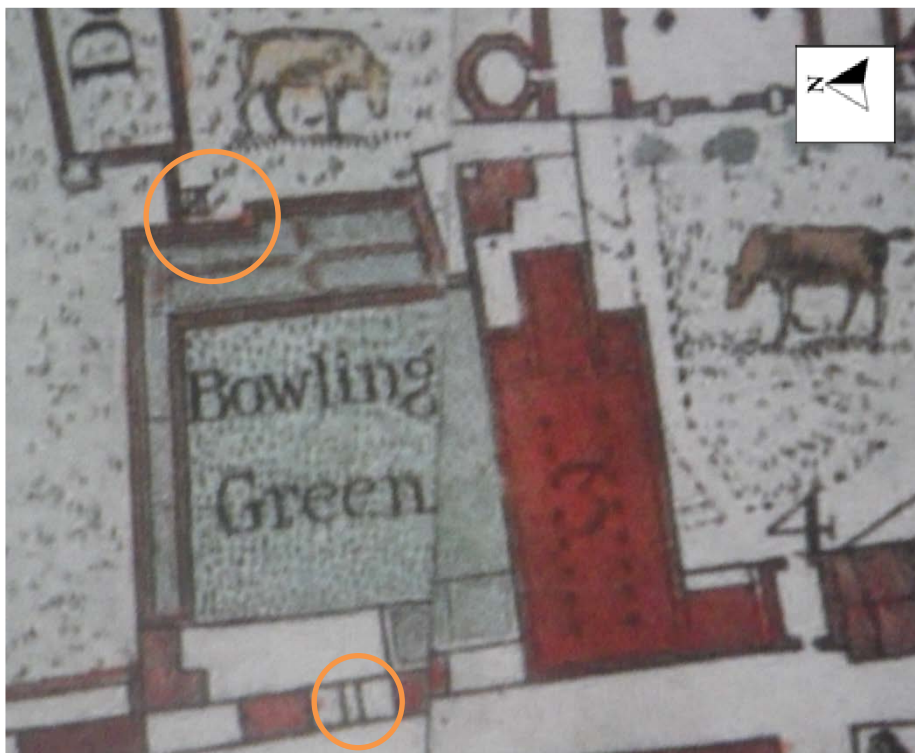
Figure 3. Detail of Thomas Warren's map. The bowling green is bordered on its north and east sides by walled enclosures. The walls fronting the bowling green itself have since been demolished but the survey section (circled) is recognisable by the dog-leg and is connected to the remains of the dormitory by a short linking wall through which there is a gate. At the east end of St James' church is a dwelling demolished in c.1770 and to the north of and east of this is the right of way between the palace garden and the churchyard. The only entrance to the bowling green/Palace Garden from Angel Hill is depicted as two closely spaced parallel lines (circled).

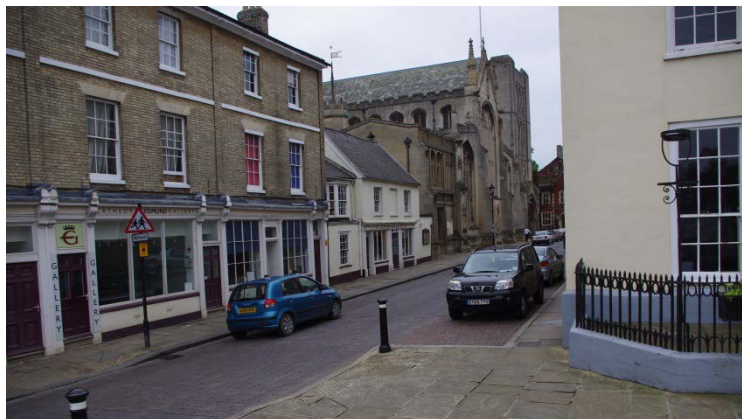
Figure 4a. The former entrance off Angel Hill (just ahead of the blue car) now in-filled with a small building between the Cathedral shop and art gallery.

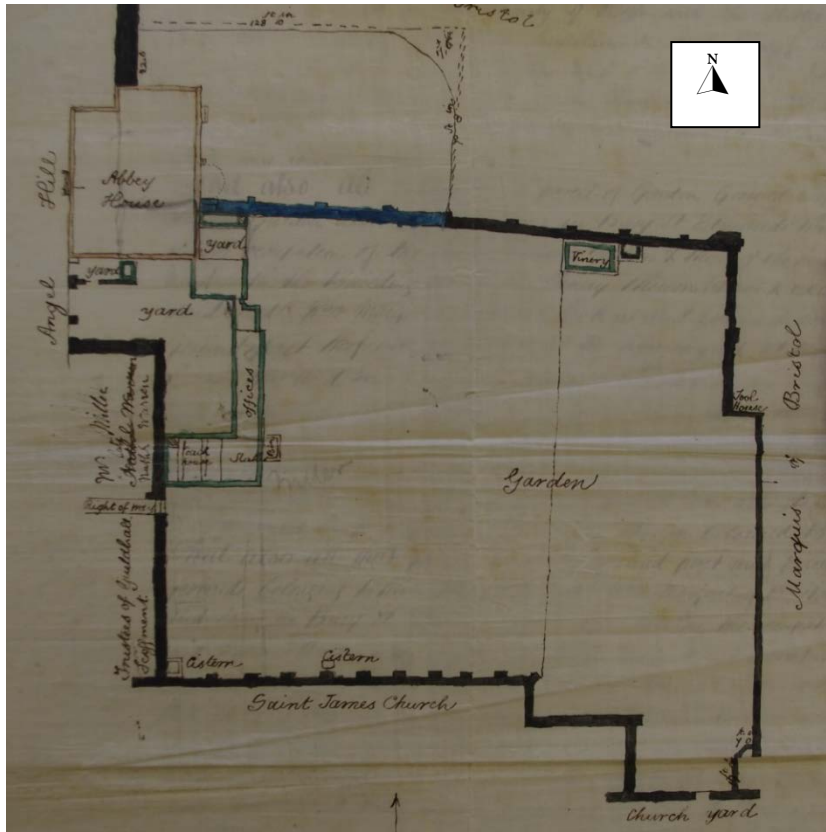
Figure 5. Plan of Abbey House from the sale deeds of c.1830 which shows the Abbey Gardens as no longer part of the house's grounds. The entries to the abbey park have been blocked whilst the connecting doorway through the north wall to the newly created ornamental gardens behind Abbey House has not been created. The section of wall coloured in blue was defined as part of Abbey House and its upkeep was the responsibility of the owner as distinct from the rest of the wall circuit; it is stated that the (blue) wall had to be maintained at the same height as the adjacent length.

Plans drawn up in 1823 and 1831 (Figs. 4 and 5) show the layout of the Abbey House grounds and depict the precinct yard as a kitchen garden. The surveyed door is not shown as an opening in either of these plans and access to the garden is by pedestrian gates from the churchyard behind St James, from Angel Hill (next to the cathedral shop) and from the Abbey gardens via the, now blocked, medieval door at the end of the 'tombstone path'; replaced after 1823 by the creation of a door in the north wall from what is now the herb garden.

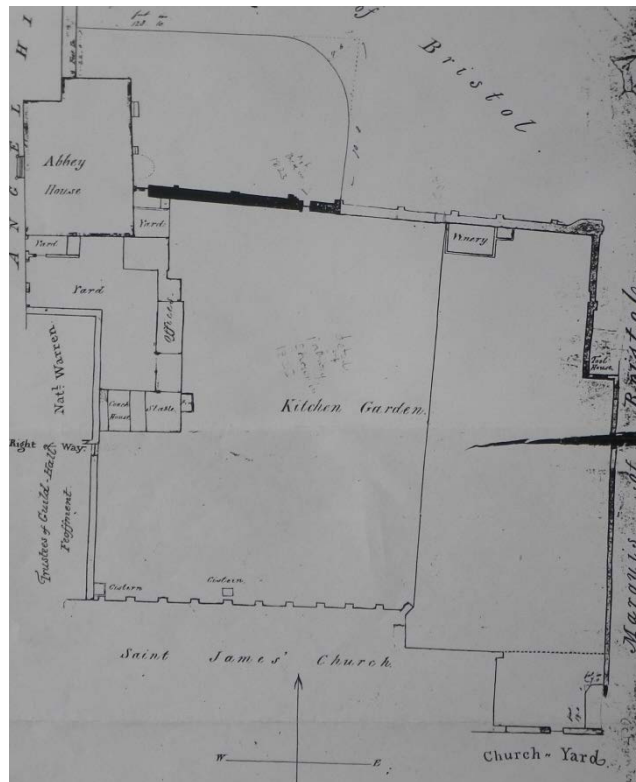
Figure 6. Plan from the deeds of 1831 now showing the door from the herb garden creating a link from the ornamental garden behind Abbey House to the kitchen garden. The Vinery is shown attached to the south face of the north wall on this and the previous map.

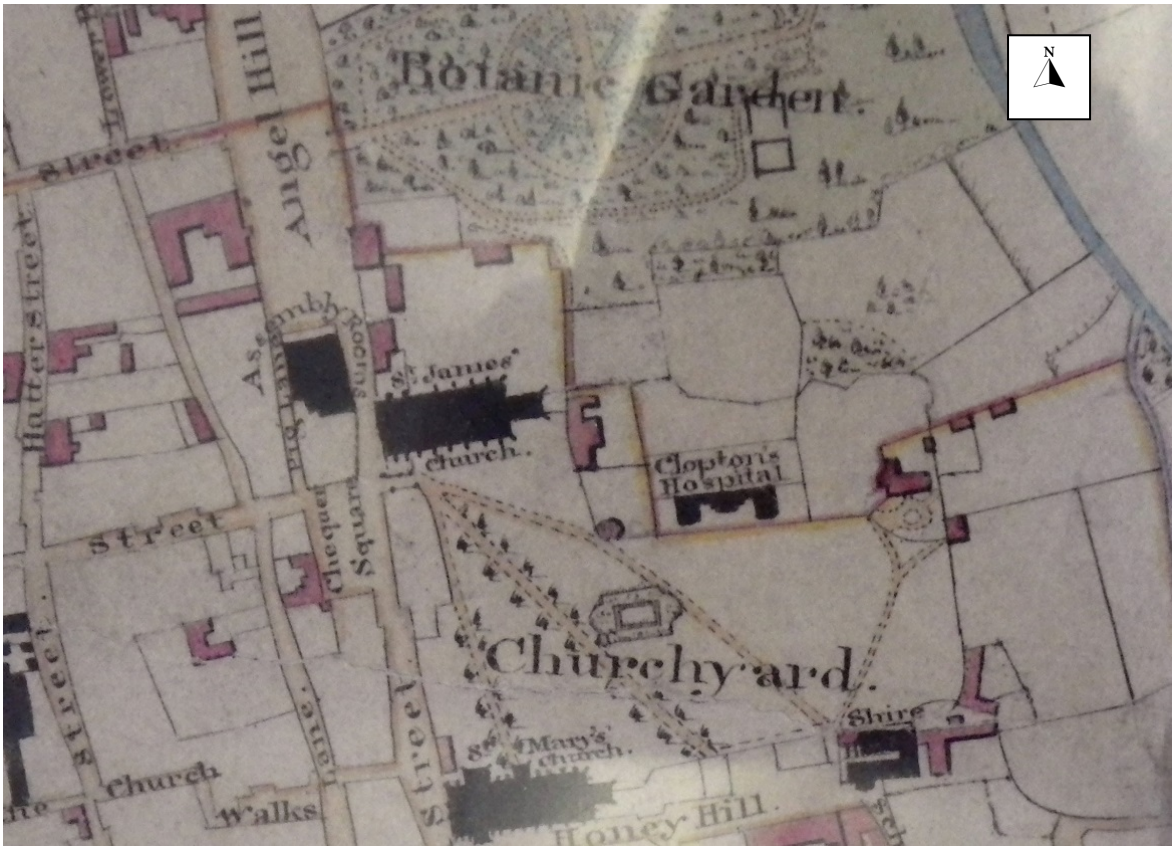
Figure 7. The title map of St Mary's and St James dated 1845 showing Abbey House as part of group fronting Angel Hill with a further building (the Vinery) within the grounds of the refectory garden attached to the north boundary wall. By the normal convention of title maps the buildings coloured pink are dwellings on which tithes are payable, but this probably not the case here.

The wall that encloses the refectory garden on its north and east sides forms the boundary between the town's parishes of St James' and St Mary's (Fig. 7) and consists of at least four distinct phases of build. The wall section that makes up half of the eastern boundary, the length attached to St James' church and which runs behind the Refectory building itself, post-dates the dissolution of the abbey and probably dates to the 17th or 18th century, but the rest of the circuit was once part of the abbey complex and includes within it parts of two early medieval buildings which have been called Building 1 and 2 for identification within this report (Fig. 1b). These early buildings were once separate structures but were linked together to create a larger building as part of a remodelling of the area probably sometime before the end of the 14th century. The blocked door, and the subject of the assessment, is set within this later bridging wall.

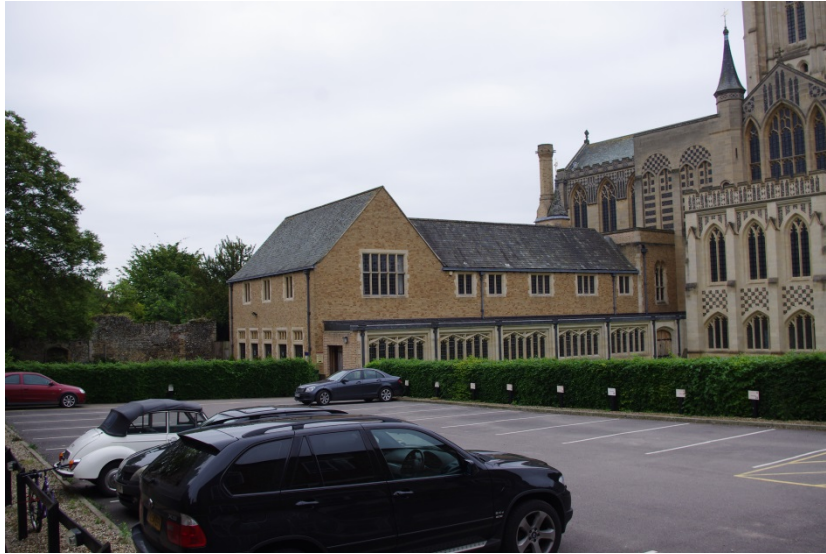
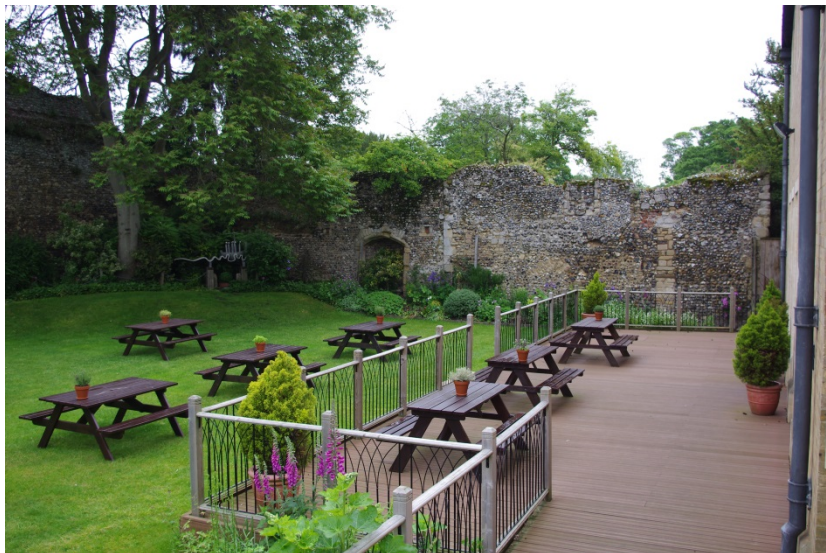
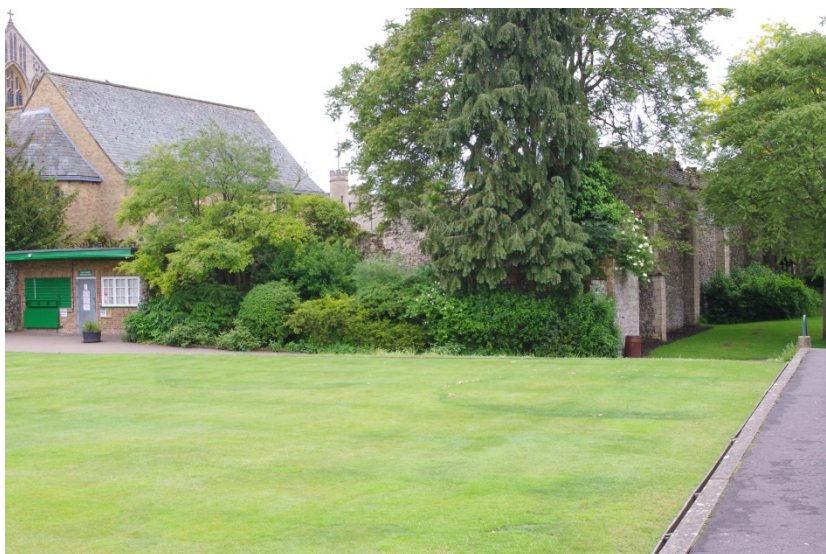
Plate 1a-c showing the location of the surveyed section of wall in relation to the Refectory and Cathedral from within the yard looking east (a) and from without looking west (c). The interior elevation of the surveyed door can be seen just beyond the picnic tables (b); the exterior face no longer exists and its position is obscured by the shrubs by the bowls hut (c)

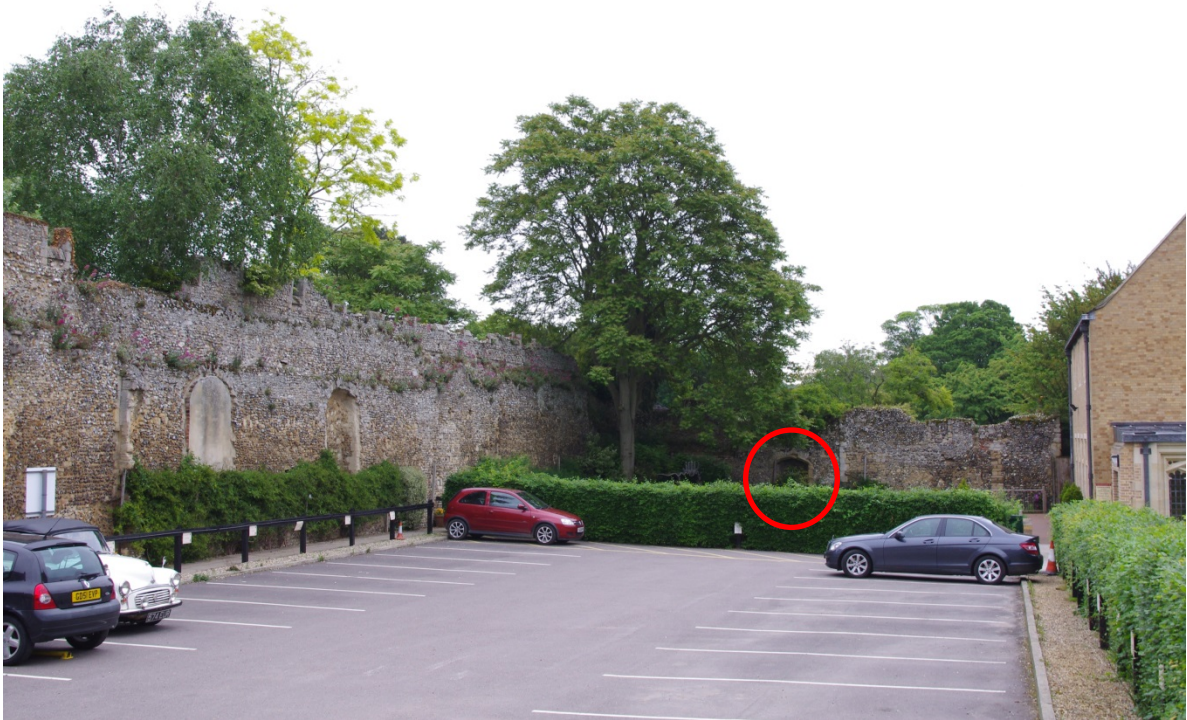
The two early medieval buildings were both E-W aligned and from the refectory garden Building 1 is viewed as the exterior face of an end gable in the east boundary, whilst Building 2 is viewed as the interior face of a long wall in the north boundary (Fig. 1 and Pl.2). The southwest corner and the short surviving length of the south wall of Building 1 formed the dog-leg in the east boundary wall and the building's two remaining corners can be identified by the limestone blocks that formed the quoins (Pl. 3). The building is 9m wide and has a small centrally placed window set high in the wall; the top of the wall has been truncated and only the lower portion of the window remains. Extending from the southwest corner a short stub of the south wall survives and is pierced by a narrow lancet window at ground floor level. The narrow pointed arch of the lancet places the construction of the building into the 13th century, a dating which is supported by the presence of horizontally coursed flint work, in part of the west face, and the use of Barnack stone for the dressings (coursed flint epitomises the handiwork of Norman masons whilst the Barnack quarry had been worked out by the 14th century - the later phases of build the abbey being completed largely using stone imported from Caen).

Building 2 was a large hall-type building of which only the northern long wall remains. The building stood in, and bordered the north-side of, the refectory garden and so, from the garden; it is the interior face of the wall that is on view (Fig.1b and Pl.2). The building was divided into two unequal sized chambers, the largest of which was pierced with two tall windows and a door at the east end (all now blocked). The windows have angled reveals and together with the head of the door are edged in a soft, clunch-type stone which indicates that this is the internal face and the windows rise to almost the full height of the wall suggesting a large, single storey, open hall. The door here (now hidden by a shrub at the end of the path made up of tombstones) has a later moulding and is 300mm lower than the surveyed door (Pl. 6). The buttresses attached to

Plate 2. The surveyed door (circled) between the remains of abbey buildings. Immediately to the right of the door is the exterior face of an end gable (Building 1) whilst to the left of the picture the interior face of a second building (Building 2) can be identified by the tall windows. Building 2 stops just beyond the red car and the survey door is set within a length of wall added in the 14th century which joined the remains of the two earlier building together

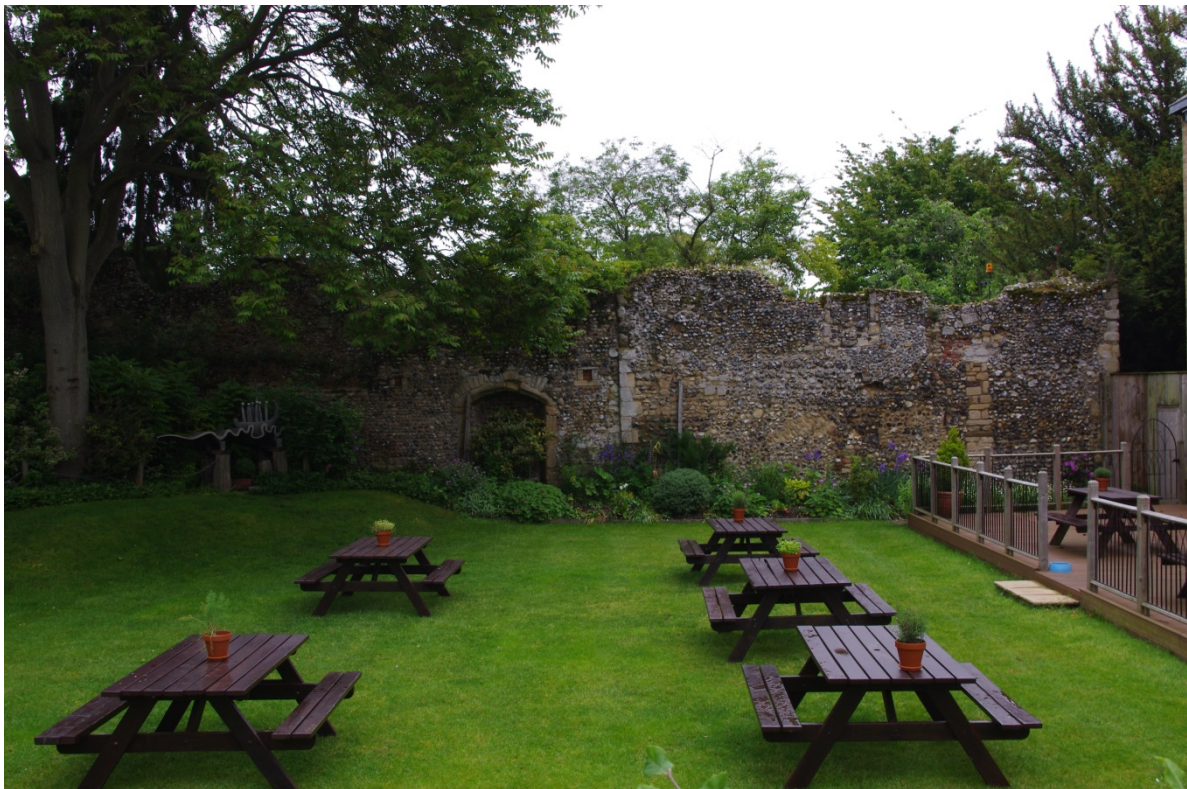
Plate 3. The surveyed door alongside the end gable of Building 1 (which extends to the wooden fence at the right of the picture). Soil imported in the 17th century buried the bottom of the ruins; the level in the refectory garden has since been reduced (note ground surface below the tree to the left) but the level of the picnic lawn is still c.120mm above the medieval threshold level. The floor of the building was sunken below this and was not found during the current work.

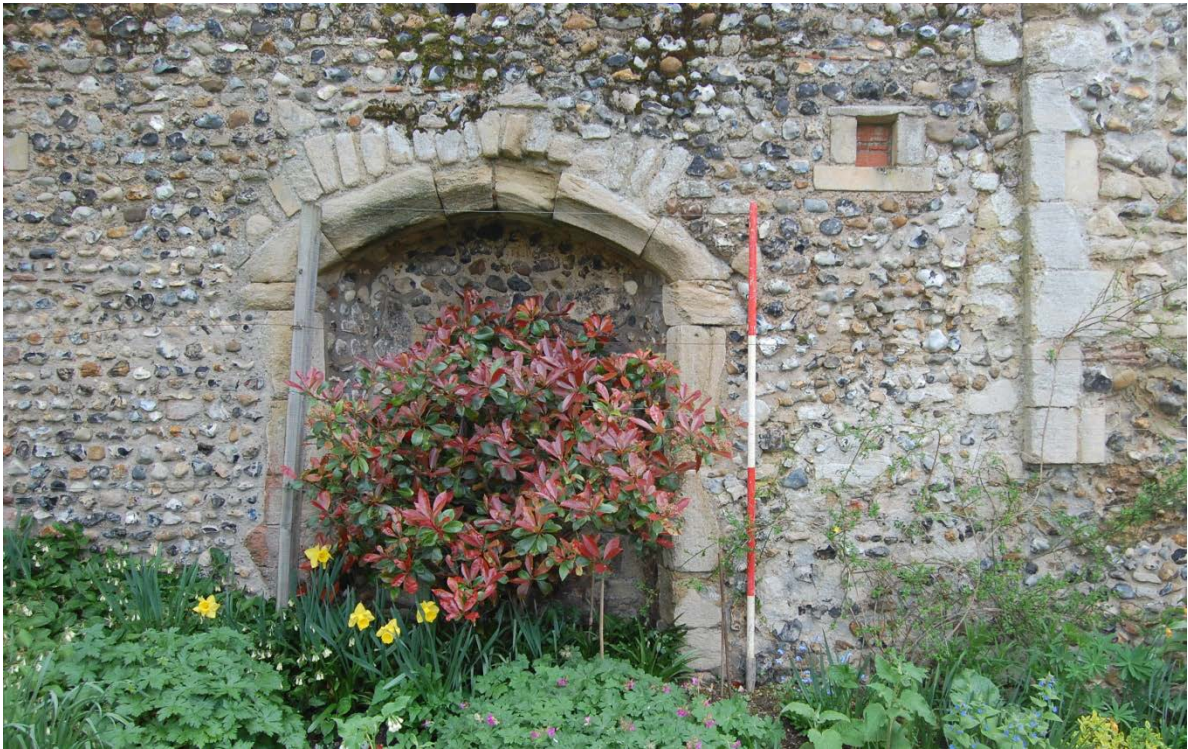
The door opening is 1.4m wide and 2.7m high and appears as a blind recess 0.5m deep from the refectory garden; the sides of the opening are splayed indicating that the refectory side is the internal face. The arch has a shallow rounded shape and the voussoirs are part of a complete set; all are sourced from the same quarry, share a common convex roll moulding and, apart from one voussoir, are equally weathered. The stones that form the springing points are both present and the arch span and radius fit with the width of the opening correctly. The stones of the jamb are a similar stone type to the arch but the moulding is not carried through to the verticals. Above the arch is a 'strainer' course made up of radiating narrow fragments of limestone (the same stone type as the voussoirs). The 'strainer' course extends through the core of the wall and the base of it can be seen in the arch soffit; a construction technique which is typical of medieval arches and seen elsewhere in the abbey complex. The general impression from the stone surround is that this is a coherent structure rather than a collection of re-cycled parts (Pl. 4).

adjacent to the door that abuts Building 1. The door appears to be original to this section of the wall although not all of the workmanship is of the highest order expected of the abbey's mason and the absence of the strainer course and poorly aligned stones at the top of the jamb on the south side of the door suggest it has been partly disturbed/reset during subsequent repairs. The wall on the north side of the door is made up of small coursed flints; these abut right to the edge of the stones in unbroken courses and the style of the flint work can be traced through to the east end of the north boundary wall suggesting that the linking section of wall is all one phase of build and the door is contemporary with it. The stones at the base of the north jamb show signs of being burnt *in-situ* and the burning extends to the flint wall face.

The stone dressings were removed from the exterior face (Abbey Garden side) when the door was blocked up with bonded flint. The infill was built from the Abbey Garden's side to be flush with the outer face and included covering the scars left by the extracted stone surround; the work is so neat that the former opening is near invisible on this side.

Plate 4. The stones that make up the surveyed door stones are consistent across the top and down the left side and the flint-work to the left is unbroken to the door edge indicating that these are contemporary original features. The top stone of the right jamb is not well matched with the springing point and the absence of the strainer course suggests that this part of the wall has been repaired. The column of stones to the right is the quoin that forms the NW corner of Building 1 - this does not extend to the ground and therefore has also been remodelled.

The dressings from the outside of the door have been removed and re-opening it would require consolidation of the entrance and an engineering assessment of the arch's strength. The wall over the arch is part of the ruin and as such has the vulnerable core flintwork exposed; invariably this would shed flints (there is already a pile in the recess) and it would need stabilising or capping if people were to pass underneath.

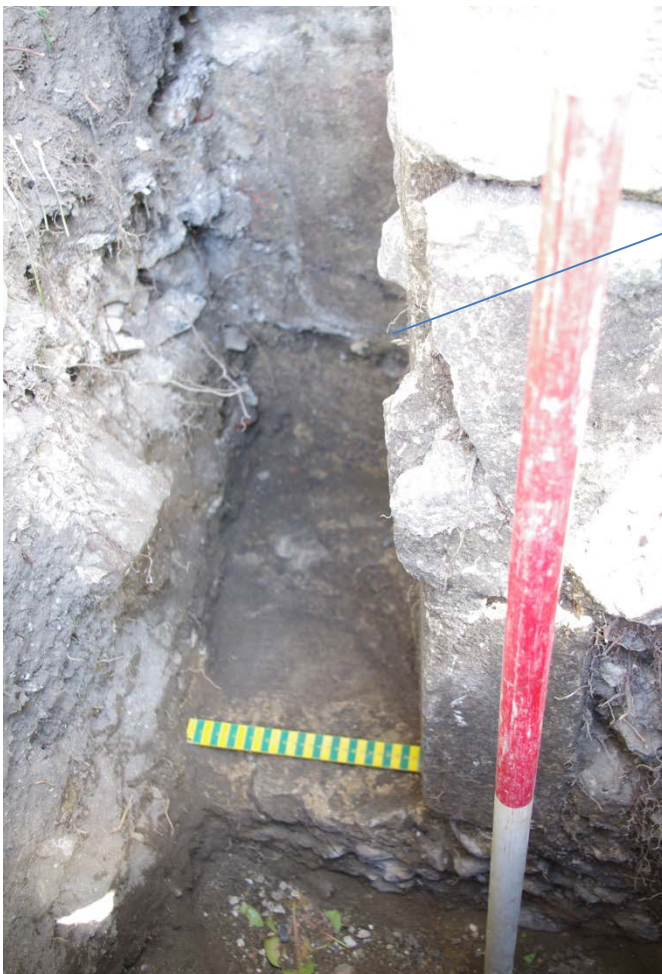
top step

The external (Abbey Park side) ground level is higher than the internal one; the excavations showed that the internal threshold to the opening is 0.6m below the current ground level and rises by one 0.3m step within the thickness of the wall. The stones at the base of the jamb are plain and finished without a moulded stop, the step's treads had been removed but a bedding surface for the lower step is well preserved and unworn. The gap between the step and the base of the door jamb, created by the removal of the tread, is narrow suggesting that the step was surfaced with timber rather than a flagstone. Inside the wall, below the lowest step a further 200mm depth was excavated through early post-medieval rubble and debris without finding evidence of the internal floor. Spot heights taken with a dumpy level across the site recorded the lawn in the refectory gardens at 36.44mOD with the steps within the doorway at 36.32m and 36.60m, whilst the ground level in the Abbey Gardens is 37.12m (see sketch section). The limit of the excavation in the test hole was 36.00m, evidence from the 1993 excavations would suggest that it is close to the medieval ground level.

Plate 5. The green/yellow scale rests on the bottom step of the door threshold at 0.6m below flowerbed level with a higher one built within the thickness of the wall (labelled). The internal floor level, below the bottom step, was not found. The soil removed during the excavation was related to the raising of the ground level in the 17th century or later.

The difference in the ground levels means that there are implications for the below ground archaeology, as the level inside the yard is lower than that outside in the abbey park. This was also the case in the medieval period and when the door was created in the 14th century the difference was bridged by steps built into the thickness of the wall. The external level is now such that the clearance on the door head is only 1.9m. Raising the top of the door would not be an option and lowering the external ground levels would have implications for the underlying deposits which would require archaeological excavation.

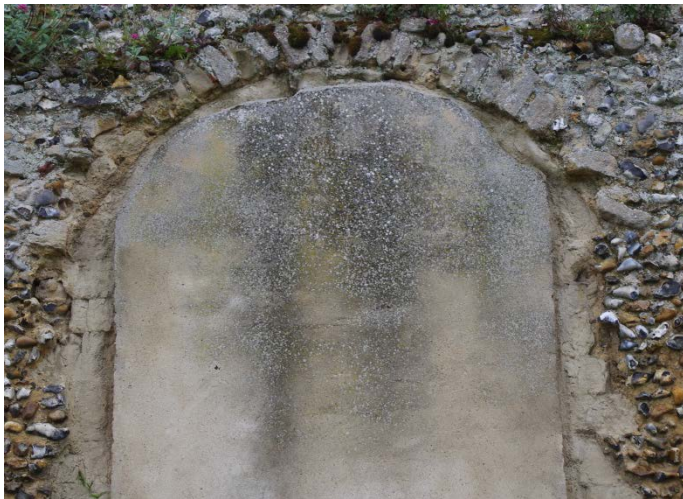
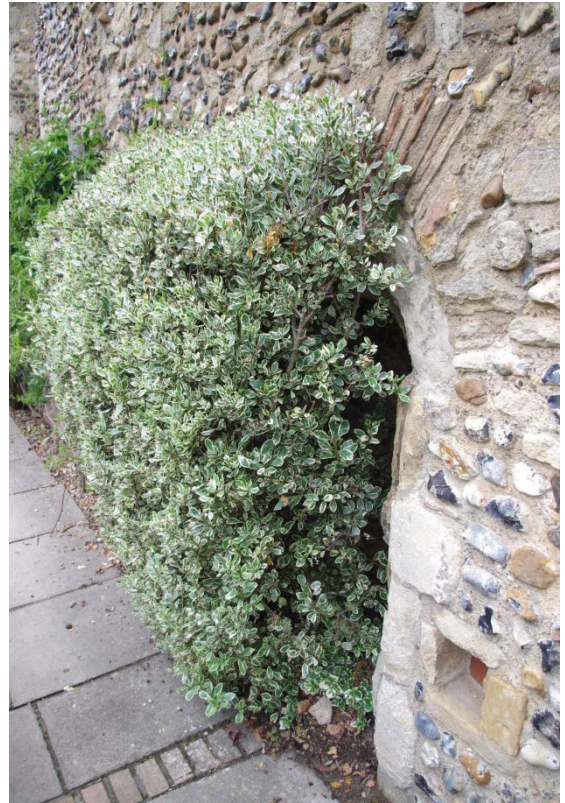
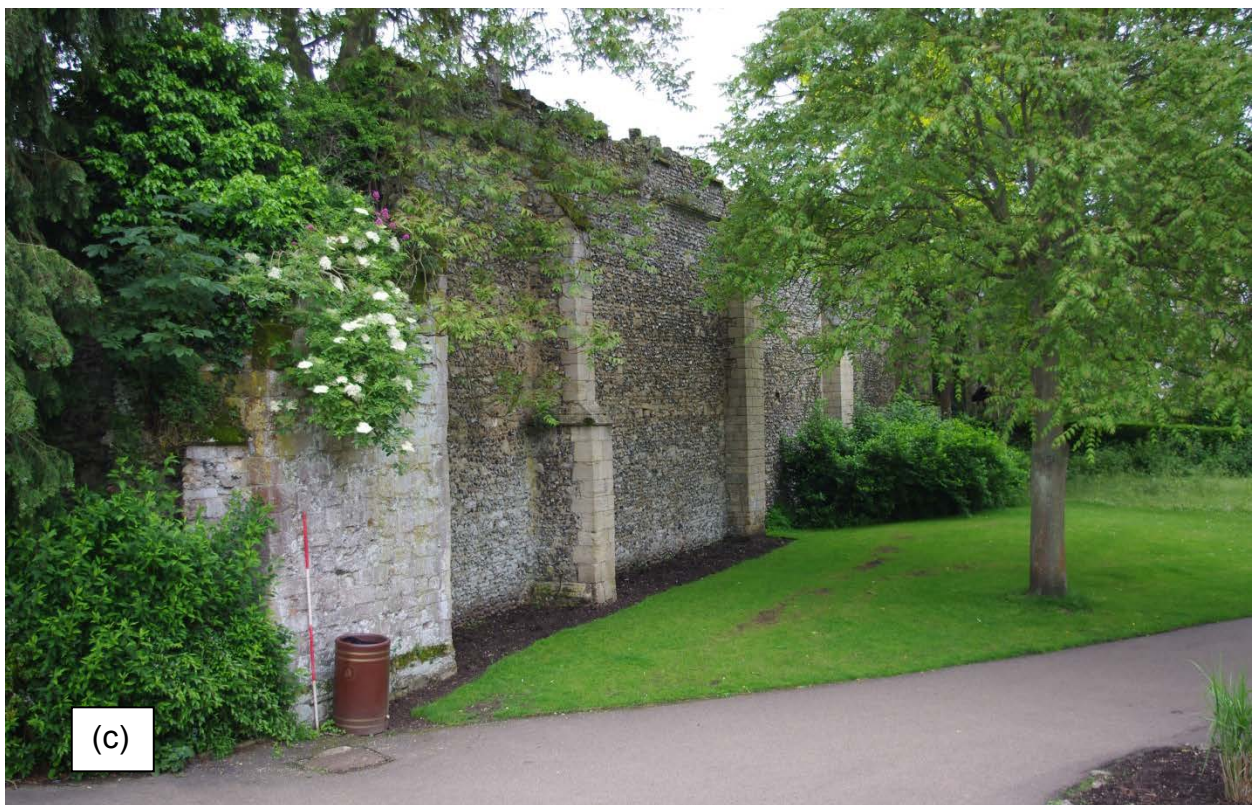
Plate 6. The north wall of the Precinct Yard was extended westward to join with the precinct wall and eastward to form the current corner in the 14th century (c). The limit of the original 12th century building is defined by the flat buttress at the far end of the narrow bed. The features of the later building include the bay (behind the bin) beneath what would have been an oriel window at first floor level and later buttressing on the corner and north wall face. The blocked window (6a) and door (6b) are occur with the early section of the walling but the door certainly is a post 12th century inserted feature.

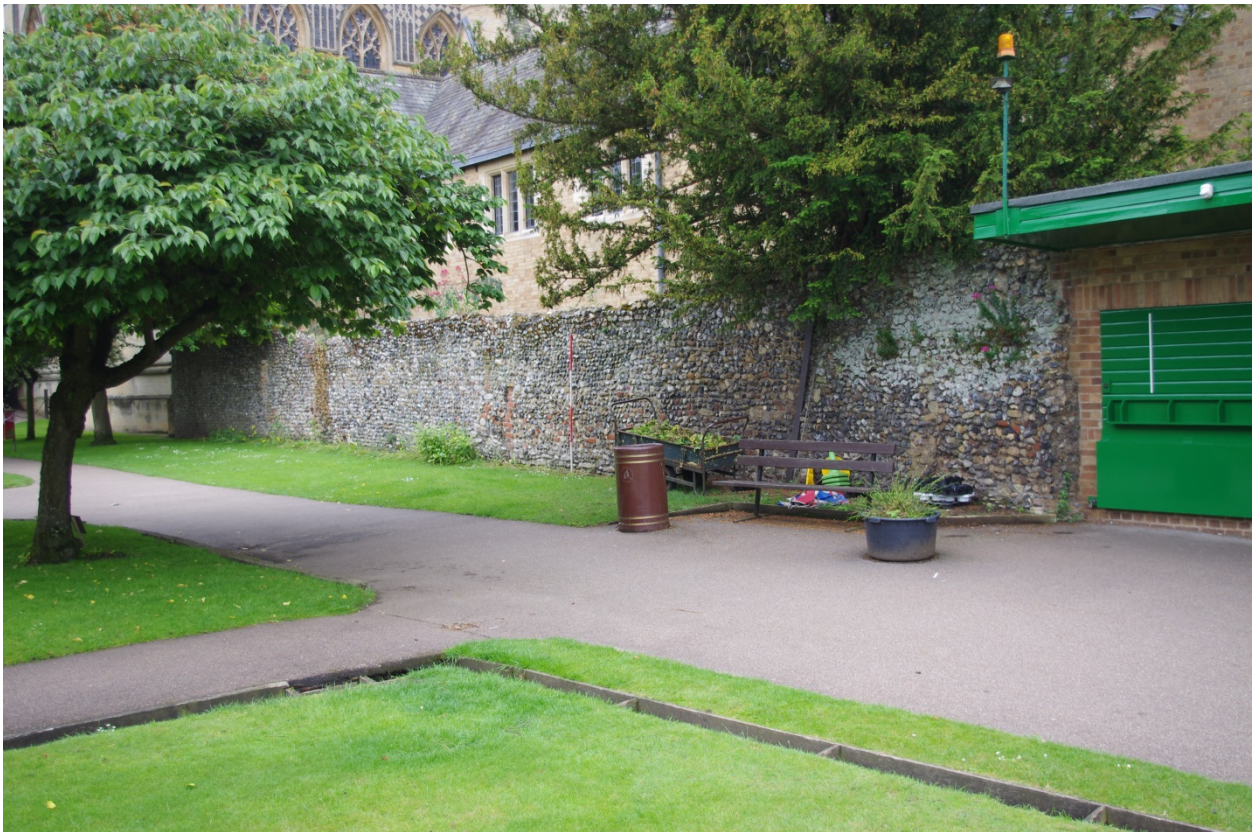
The section of rubble walling located behind the refectory (Pl. 7) which joins the south side of the bowling hut to St James' Church dates wholly to after the Reformation and exhibits no medieval stonework. It probably originates from the first half of the 17th century but these types of wall are difficult to date as they often, as in this case, have undergone regular cycles of repair. Lenny's map of the site (Fig. 4) shows that there was an entrance through this wall close to the site of bowls hut in 1823 which has since been blocked and whilst this wall is of some antiquity and its type characteristic of the post-medieval town, it is less historically sensitive than the abbey ruins. The area within the wall has largely been reduced and the already low height of the wall would eliminate the need to support the masonry over the entrance and therefore it is my opinion that the creation of an opening through this wall should be considered as an alternative entrance site.

Plate 7. East boundary wall behind the refectory viewed from the east side. The wall from the bowls hut to St James' probably has its origins in the 16th or 17th century with the sections at the far end being rebuilt in the 19th and 20th centuries.

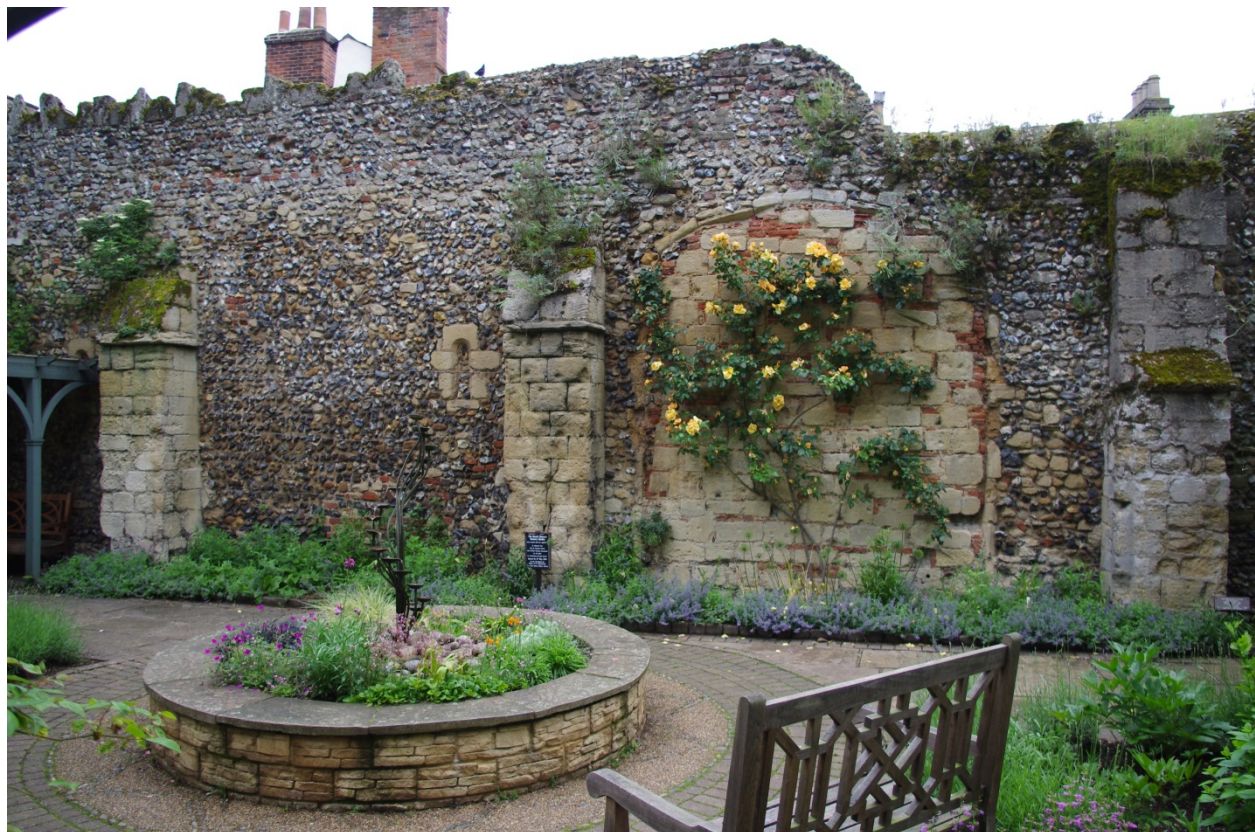
Plate 8. Stable and brew house range on the north side of the great courtyard which were also repaired following the 1327 riots. The wall exhibits pre-riot Norman features (the short buttresses and small window) together with later styles. The arch shape and stones of the large blocked gateway is similar to the surveyed door suggesting that they may be contemporary.
