Test pits at the Guildhall,
Bury St Edmunds
BSE 446

Archaeological Excavation Report

SCCAS Report No. 2014/071

Client: Bury St Edmunds Guildhall Heritage Trust

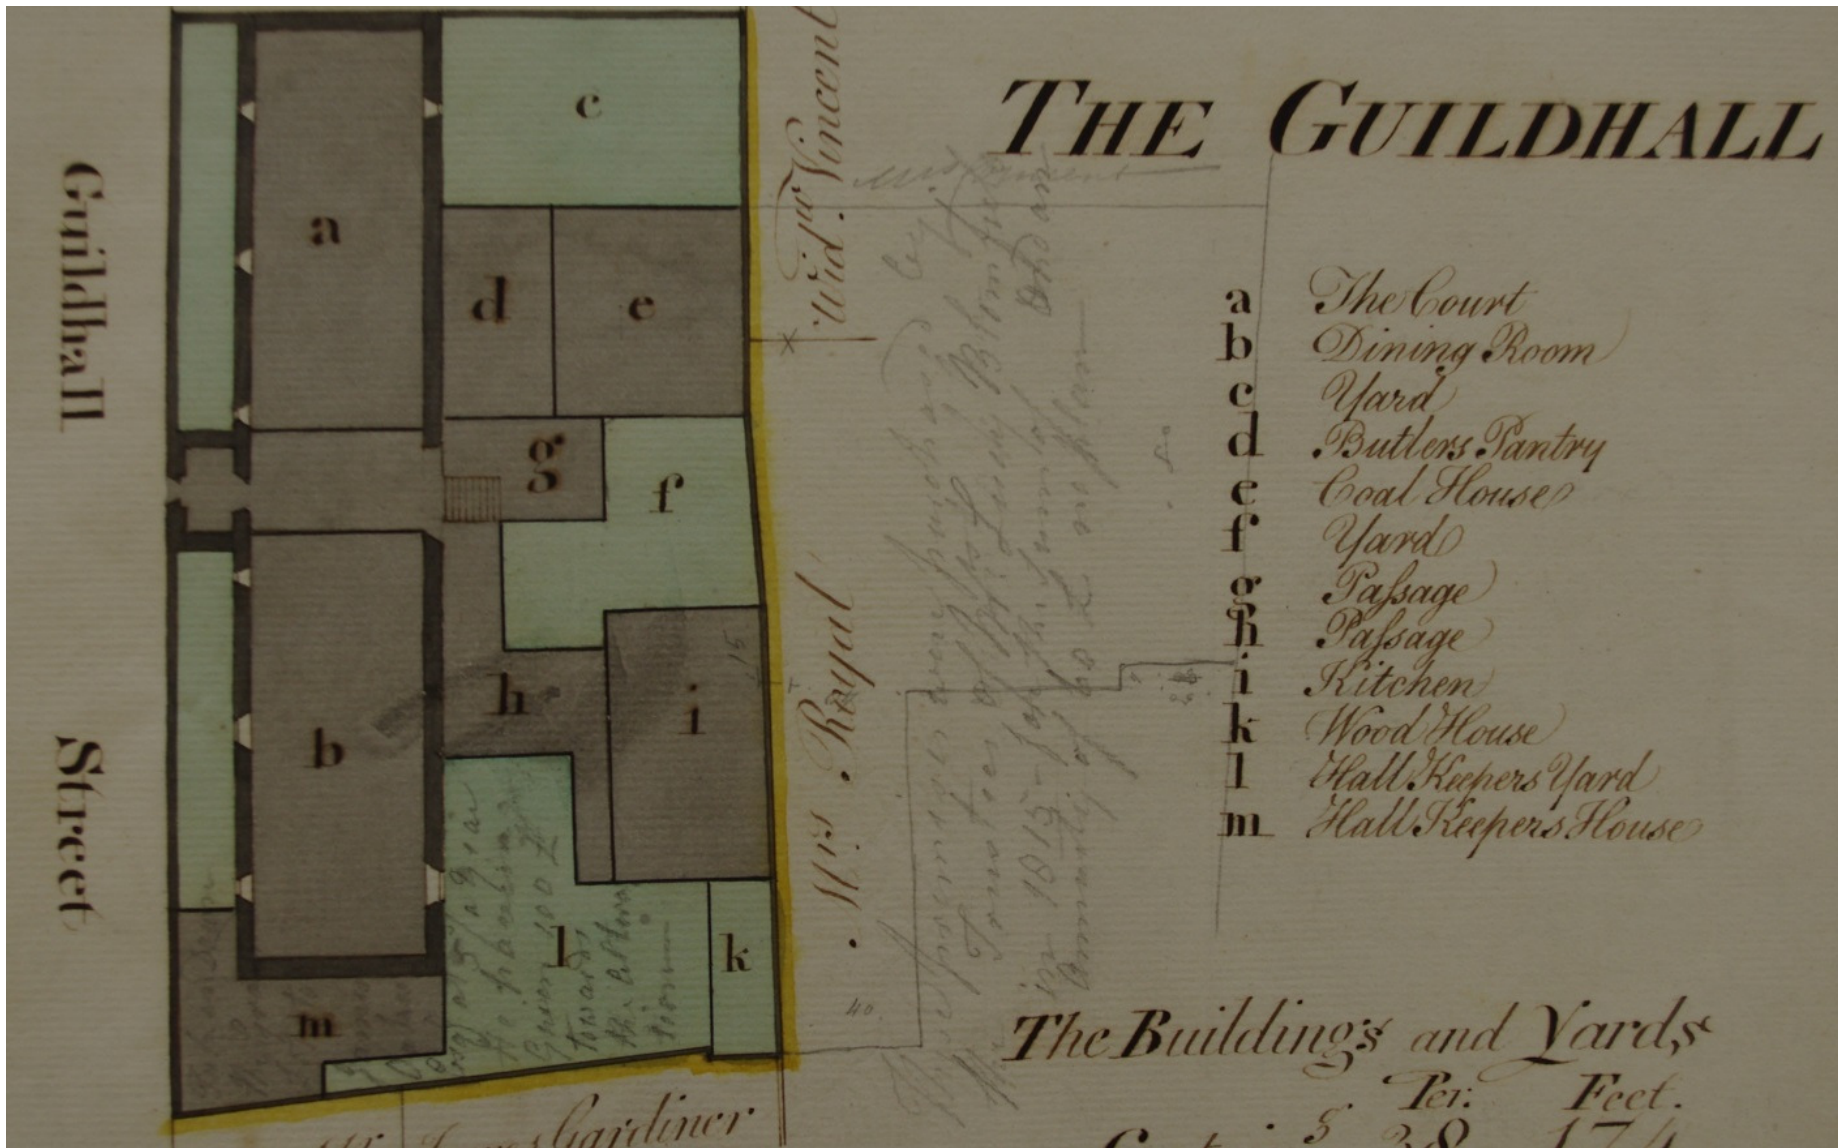
Figure 7. Plan of 1807 from the book Guildhall feoffment estates (BRO ref: H7/1/1). This shows the Guildhall divided into two rooms, separated by a central lobby, and after the removal of the cross-passage from the north end of the building. The twin doors through the rear wall as shown in 1742 appear to have been replaced with a single wide opening (still visible at the rear of the building) and access to the kitchen (i) is via a kitchen passage (h) entered from the Guildhall lobby to the south of the stair. The Hall Keeper's lodge (m) is shown attached to the south end of the building.

south end of the Guildhall to the dwelling on Whiting Street (Figs. 7 and 8). The map of the Guildhall of 1807 shows it as the property of 'Widow' Vincent, separate from the Guildhall and it is an example of an urban plot; these were considered work places and intensively used in the medieval period. The natural ground level slopes down from Guildhall Street to Whiting Street but across the garden this change in level is spanned by a cut terrace close to the back wall of No.79. The aim of the test holes was to model the original slope of the ground and to assess the depth and preservation of the medieval deposits in this area.

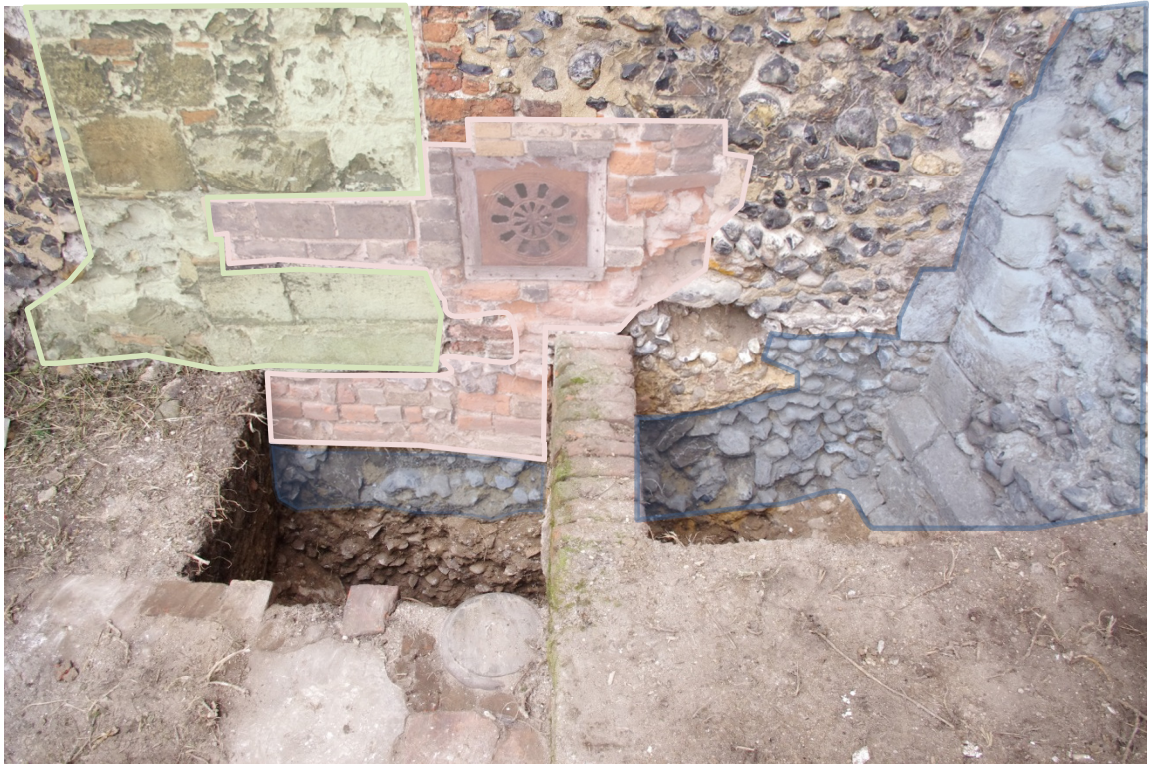
Plate 1 (above). The exterior face of the rear wall of the Guildhall at the north end of Test hole 1. This shows the 15th-century cross-passage doorway framed with brick and blocked with ashlar and clunch (shaded green). The repair/patching associated with the installation of the early 19th-century air-vent is shaded in pink and un-molested bonded medieval flint-work in blue. Below the blue-shaded area is the dry-laid flint packing which makes up the foundations, whereas above it the face has been repaired/repointed in cement.

The north end of the Guildhall's east wall has been extensively patched and repaired and virtually none of the original wall face survives in the area above Test pit 1 (Pl. 1). Aside from some heavy-handed cement repointing of recent years, there are two phases of repair work apparent. In the earliest repair the wall face is made up of large blocks of ashlar and clunch, the stones are aligned to a vertical edge in handmade red brick and so form a neatly rectangular patch. This gives the appearance of a blocked door and the bricks that make up the edging are similar to those used on the decorative banding on the front face of the porch. The setting of the limestones in the wall pre-date the refenestration of the building at the beginning of the 19th century and so the large Georgian window which pierces the east wall cuts away the upper extents of the repair work. The *terminus post quem* for the patching can only be dated broadly by the inclusion of bricks which are post-medieval (16th-17th century) in date. A large number of ashlar blocks have been dotted throughout the walls of the council chamber to pleasing effect. These stones are reputedly from The Bridewell, the feoffment's house of correction, now the site of the Guildhall Feoffment School and those used in the blocking of the putative door on the rear of the Guildhall are from the same source. Alongside and cutting into the 'door blocking' material the wall has been rebuilt in brick rubble to accommodate an air vent which was added to allow air to circulate beneath the raised dais at the north end of the courtroom in the 19th century (Pl. 1). The patching associated with the air vent extends to below the lowest ashlar block. The decorative cast ironwork of the vent is similar to the vents built into the exterior (east) wall of the Butler's Pantry (now the kitchen) suggesting that this is all part of the same phase of work.

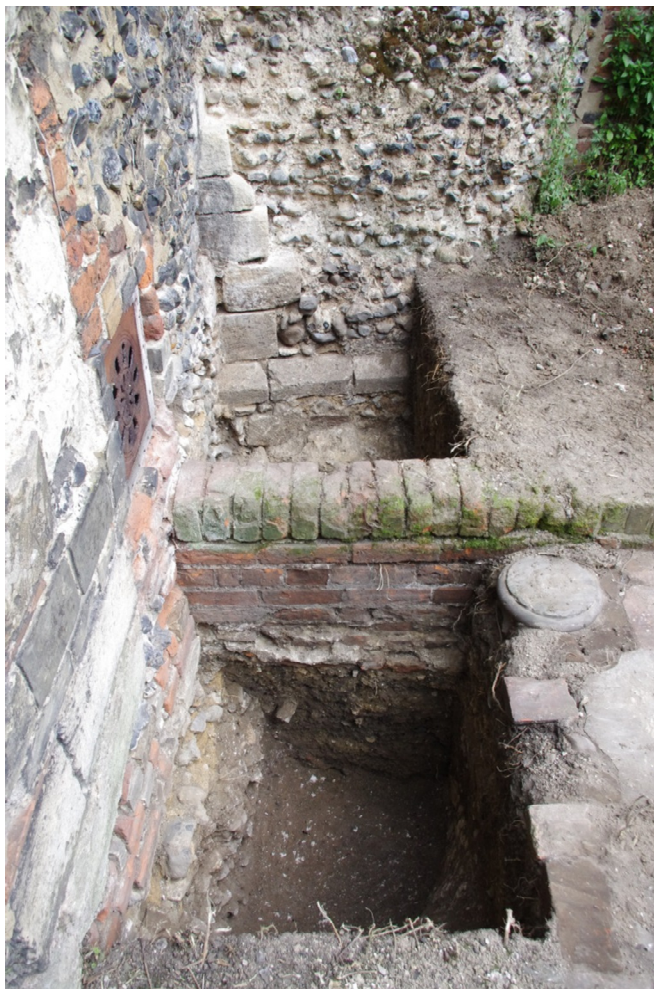
Plate 2 (left). Test hole 1 showing the remaining stub of the precinct wall projecting from the face of the Guildhall. The precinct wall is stitched into the face with a limestone quoin and has a plinth at its base indicating the former ground level. In the bottom of the test pit in the foreground is a partially excavated pit which pre-dated the construction of the Guildhall; the brick wall that bisects the test pit predated 1822 and a fragment of an 18th-19th-century column capital can be seen in the rough paving to the right of the excavation.

The stub of a flint-built wall (Pl.2) projects from the north east corner of the Guildhall. It is at a slightly obtuse angle to the face of the building and follows the line of the north boundary wall of the yard; its remains extend for 1.5m along the boundary and it is thought to be the ruins of the precinct wall – although arguably it could be a buttress. It is medieval in date and appears to be stitched into the east wall face with limestone quoins (Barnack stone) as an original feature, but the east wall face has been so extensively repaired in this area, and the limestone blocks disturbed, that it is difficult to be confident about this relationship. The core flint-work however which abuts the east wall face, is made up of a different mortar mix and there is a distinct seam between the Guildhall wall and the wall stub.

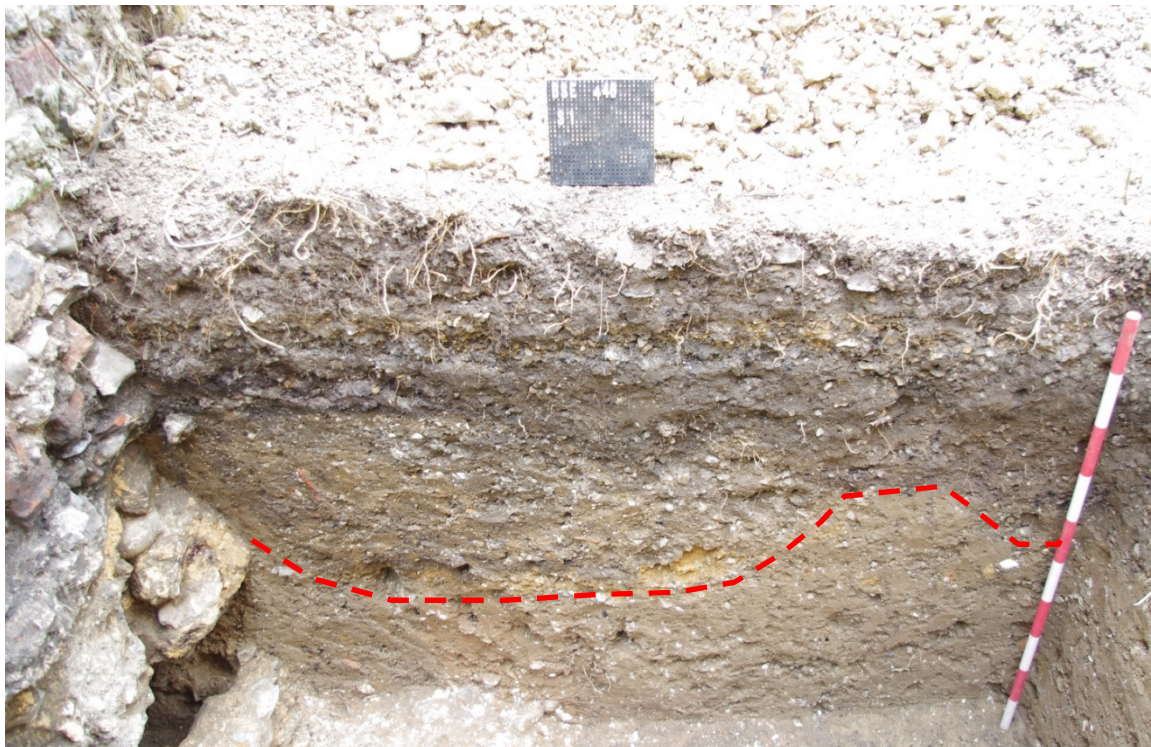
Plate 3. Test hole 2 showing the soil profile within the north yard close to the east boundary wall looking south. The chalk of the natural geology can be seen at the bottom of the picture and the scale rests on a partially excavated medieval pit. The deposits and features above the dotted line are the result of activity in the 19th century or later whilst those below are 15th century. The east boundary wall is at the extreme left and the scale is 1m.

The rubble wall that currently forms the boundary to the east side of the yard dates to the 19th century and was constructed directly over the remains of two previous versions of the boundary wall. The junction between the present and the previous wall is 600mm below the current surface, a depth made up of an imported soil (0015) over a reworked garden soil (0014). Sealed beneath these layers is a broad, shallow pit (0011) which dated to the early 19th century (Fig 4. S1 and Pl. 3).

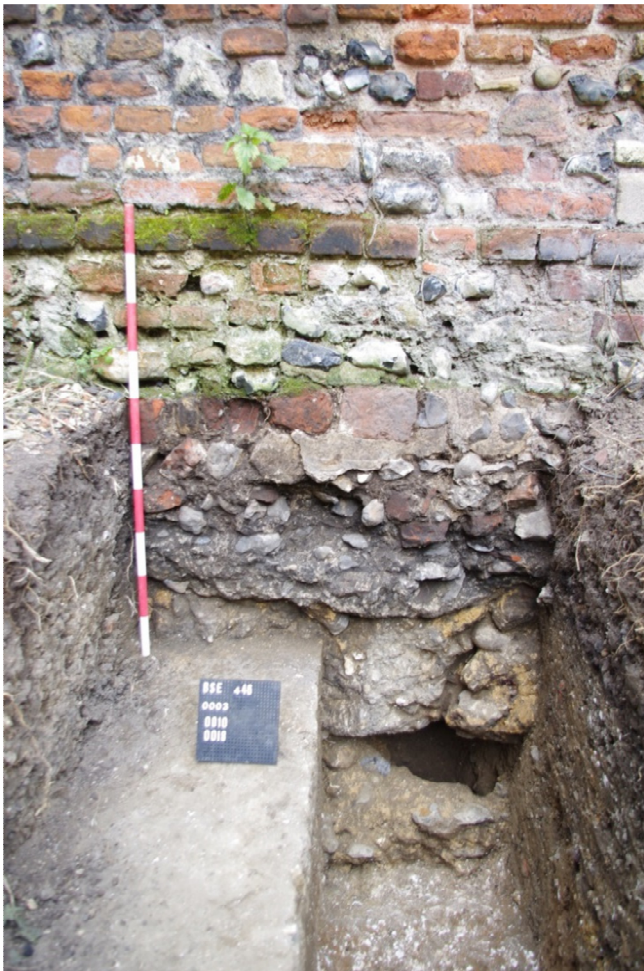
Plate 4. Test hole 2 looking east showing the bottom of the north yard's rear boundary wall. The present wall post-dates the alterations to the council chamber and is built off the remains of two earlier incarnations of the wall. The photograph shows the bonded remains of the two earlier walls built in flint with buff-coloured mortar. The evidence suggests that the Guildhall plot was enclosed behind a tall wall and that the limits of the property are unlikely to have altered from its setting out until the acquisition of the Whiting St. property in the 19th century.

At the base of the boundary wall were the severely reduced remains of a medieval flint-built wall (0003, Fig. 4 S1 and Pl. 4). The wall had been constructed within a trench (0002) cut through subsoil 0001 giving it a firm foundation on the solid chalk; the trench was backfilled with dark silt which produced Late 12th-14th century pottery. This early wall was separated from its successors by a 200mm depth of soil suggesting that the wall remains had been buried following demolition and prior to the building of a replacement. The top of the wall remains were cut by a posthole (0006) and a second posthole (0016) was located between the wall and the large pit-like feature 0008.

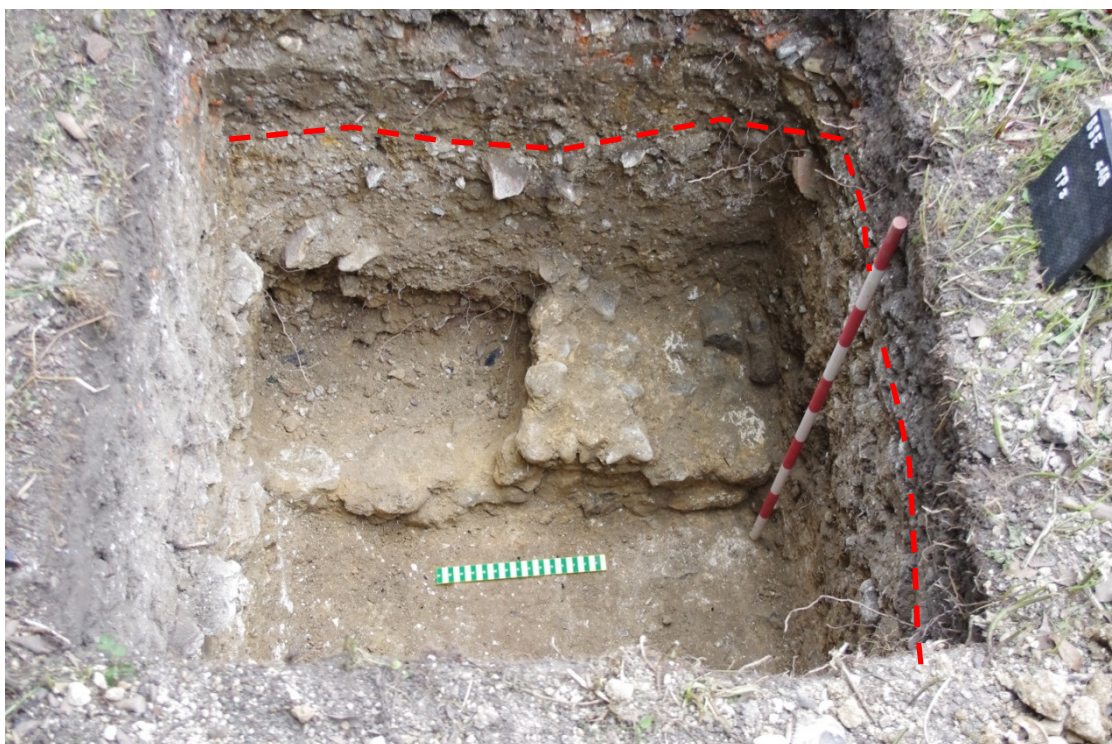
Plate 5. Test hole 3 with the remains of a bonded flint wall, part of a possible outbuilding, running east-west across the excavations. The wall overlies earlier medieval pits and was sealed by a thick layer of green clay, the floor of a later structure which was demolished no later than the 18th century; the left half of the exposed length of wall has been cut away by a foundation trench associated with the clay floor. The vertical scale is 1m, the horizontal one 0.3m; the red dotted line delineates between the 19th century garden soil and the archaeological deposits which occur at c.400mm below the current surface.

Test hole 3 archaeological features (Fig. 4, S7, 8, 9, 10 and Pl. 5)

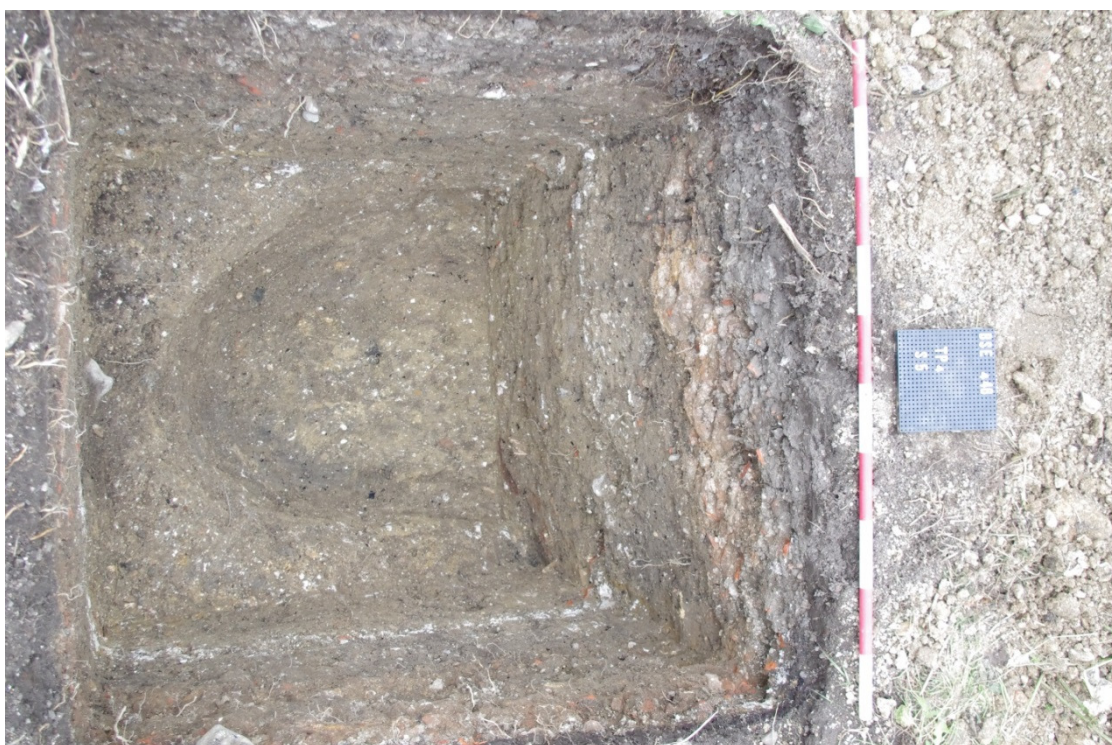
Plate 6. Test hole 4 with a clay-lined pit-like depression at the base of the excavations, part of a group of late medieval to early post-medieval drying ovens. The backfill of the final phase of the oven produced a good assemblage of pottery dating from the 16th century. The ovens were sealed by a layer of chalk and the rubble layer above the chalk dated to the 18th century.

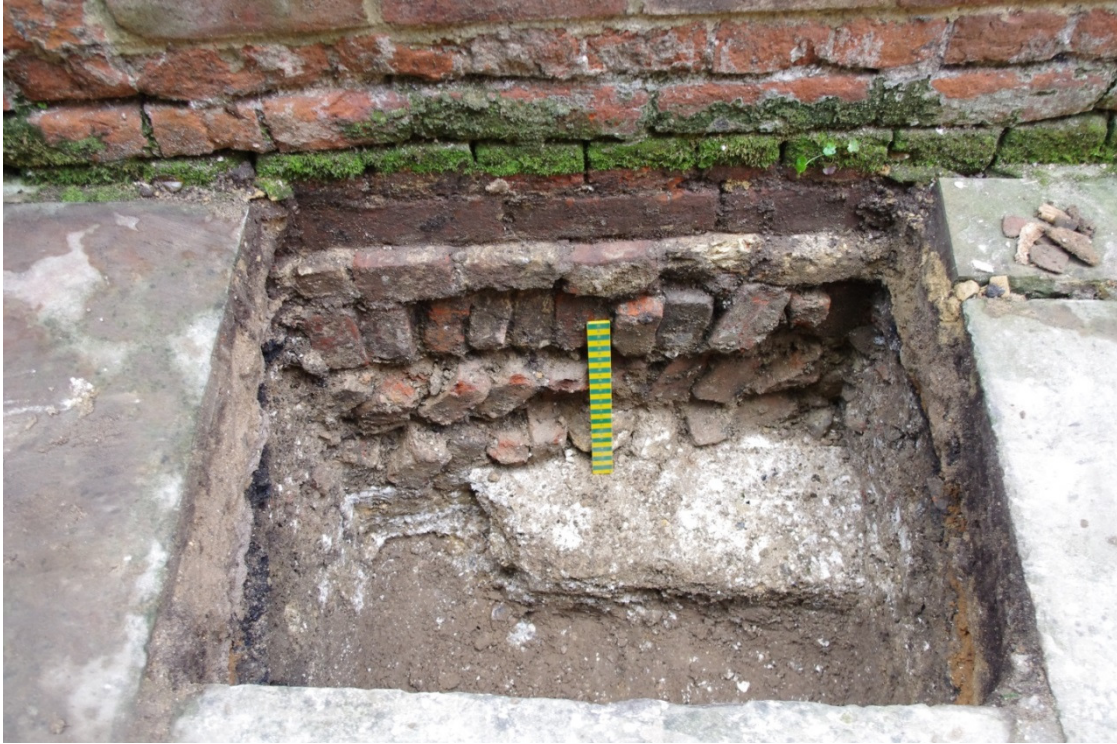
Plate 7. Test hole 5 showing the 'loose-laid' brick foundation of the detached kitchen overlying an imported layer of rammed chalk, possibly the floor of the medieval kitchen which once stood on this spot. The chalk was laid over a buried topsoil (the brown soil at the bottom of the excavation) which produced a group of pottery that is dated to no later than the 14th century. The scale is 0.3m.

Test hole 5 was excavated against the north gable wall of the former kitchen; this exposed the footings which were made of three courses of unbonded bricks laid on edge, angled in an approximate herringbone pattern (Pl. 7). The footing was in a shallow trench cut through a buried topsoil layer 0060 (Fig. 5, S11) which produced 16th century pottery.

Beneath the footing was a compacted floor surface that predated the current building and was made up of alternating layers of chalk and clay (0061). It was 250mm thick and had a straight edge parallel to and 300mm north of the kitchen gable. The floor surface was cut into the top of a buried soil layer 0062; the soil was a homogenous dark silt loam 500mm deep. It had been worked and directly overlay the chalk of the solid geology, truncating the silt subsoil that naturally overlies the chalk. Finds collected from this layer included high medieval pottery and none of the finds from this deposit post-dated the 13th-14th century.

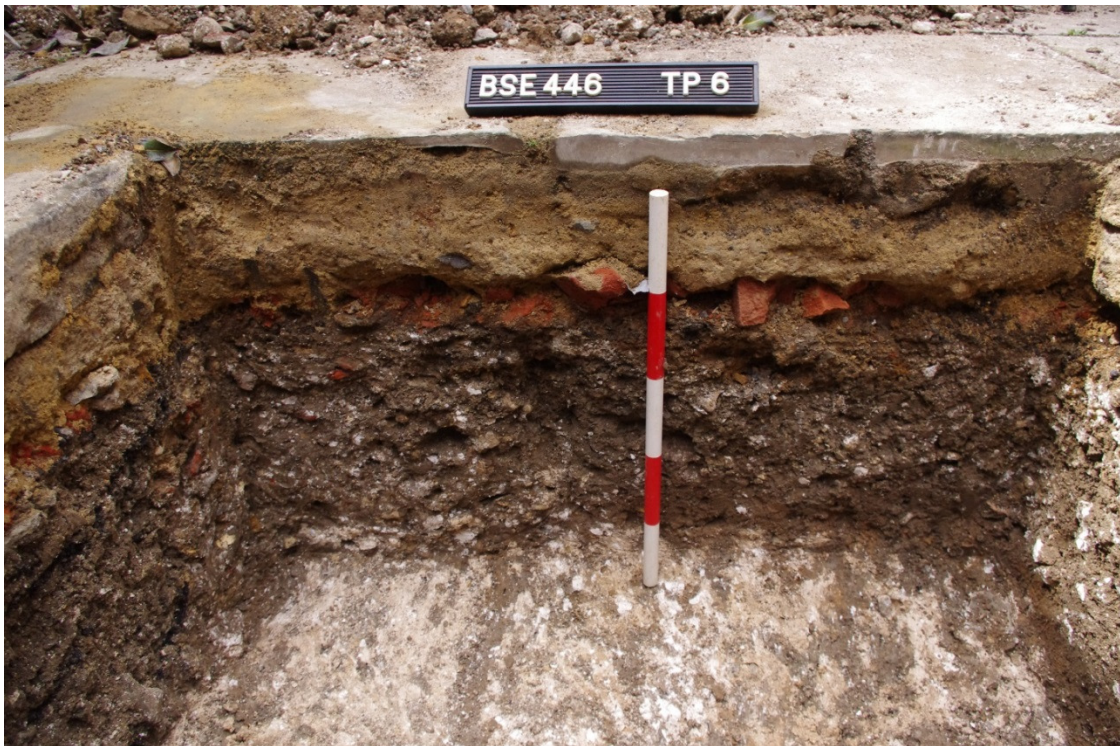
Plate 8. Test hole 8 showing the top of the geological chalk 0.55m below the surface of the kitchen courtyard. The sub-base for the courtyard lies over a reworked buried soil which was cut through by a service trench dating to the early 20th century. The scale is 0.5m long.

Test hole 6 was excavated in the centre of the yard and revealed, beneath the layer associated with the yard surfaces, a 200mm depth of reworked soil which overlay a reddish-brown silt; a natural subsoil that overlay the geological chalk (Fig. 5, S.6 and Pl. 8). The top of the chalk occurred at 550mm below the current surface and was weathered. A 2" cast-iron water pipe, laid within a trench, ran north-east to south-west crossed the western side of the excavation and the buried topsoil was cut by a second modern (19th century) feature. There was no positive indication of the covered passageway that linked to the detached kitchen, which once existed here.

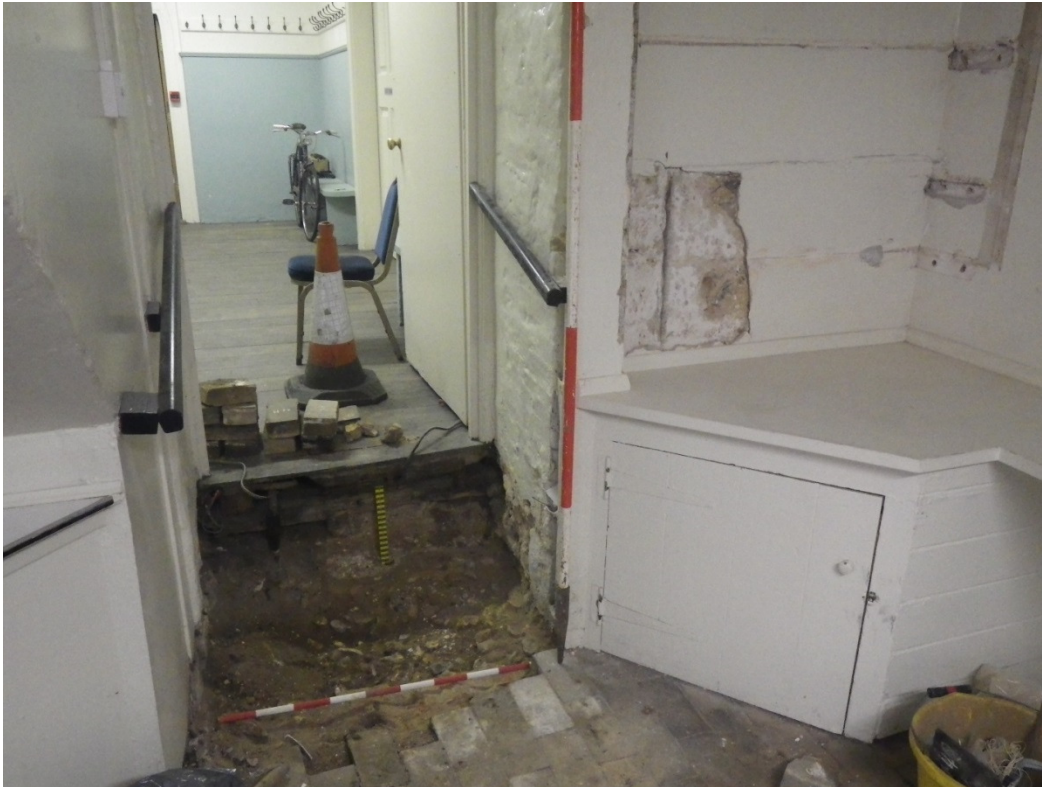
Plate 9. Test hole 7 in the doorway between the medieval Guildhall and the early 19th century kitchen. The doorway was reduced in width during the 18th century and the edge of an earlier opening, with limestone dressings, can be seen where the plaster was removed to the right of the door. The door threshold appears to have been lowered to match the brick-paved floor of the rear range truncating the original threshold and wall. The scale is marked in 0.5m divisions

A 20th century cupboard was removed from the east side of the Guildhall rear wall and a narrow strip of plaster removed from the wall face. The width of the door opening had been reduced by the addition of an infill section on the north side and the medieval jamb edged with dressed stone was recorded 320mm back from the edge of the current opening (Pl. 9). The infill panel was made up of a rubble of stone, brick and tile fragments bonded with a grey lime mortar and the materials used suggested an 18th century date. The face of the infill section, within the door soffit, had been left in-the-rough and was clearly supposed to have been covered and a simple timber frame made from rough-sawn softwood remaining in front of the north face suggested some form of panelling.

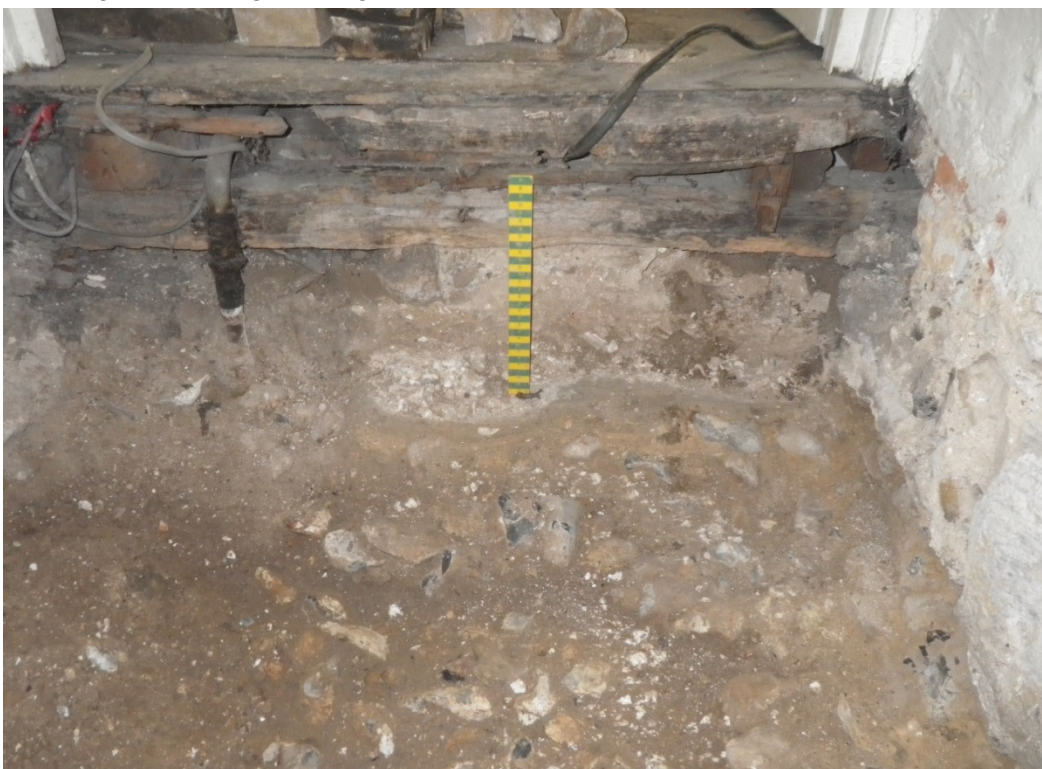
Plate 10. Test hole 7 showing the remains of the riser, for the step up to the suspended floor in the Guildhall lobby attached to the end of the floor joists. The timber floor was laid over a previous chalk floor (behind the scale) which partially covered the truncated rear wall. Of the rear wall, only a single course of bonded flint work survived where the door opening appears to have been lowered and the flints at the bottom of the picture are the packing of the foundation trench seen in plan.

The change in level from the floor in the entrance passage in the Guildhall to the rear range is 400mm. The intermediate step that once existed between the two has been removed (for the disabled ramp?) but its position can be determined by a deeply worn depression in the brick floor at the foot of the former step. The removal of the step revealed a cross section of the timber floor within the passageway, exposing the joists and timber superstructure which are raised up on 18th century bricks and rubble (Pl.10). The timber floor overlies a rammed chalk floor or sub-floor. The surface of this was 300mm below the timber floor. The chalk has been re-laid on one occasion and the difference between the two phases of chalk-laying is defined by a thin layer of mud.

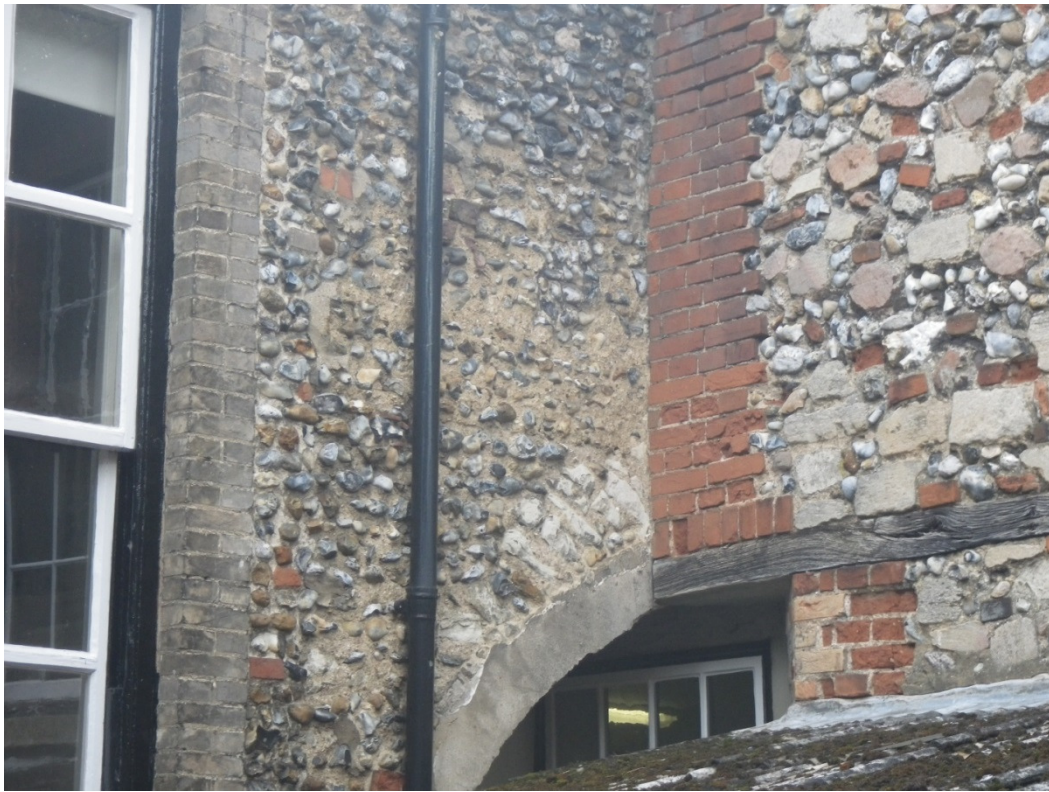
Plate 11. The top of the arch-headed opening over the central doorway through the Guildhall rear wall. The stone dressings of the arch soffit appear to have been removed and replaced with brick/tile rendered over with cement (see plate below). The strainer-course over the arch of pale-coloured clunch fragments is original and fits with the flintwork of the rear wall without interrupting the coursing; clunch is also incorporated amongst the horizontally coursed flint to the left of the arch demonstrating that this material was being used as part of the general build. The plans of the Guildhall suggest that the arch spanned two doors and the half shown in the picture gave access to a covered passage (now removed) to the detached kitchen (see Fig. 7).

The patchwork of repairs to the rear wall of the Guildhall in the north yard holds evidence of the alterations and development of the building. The large arch-shaped opening seen on the exterior face at the centre of the rear is an original feature and the position of this opening implies that the current arrangement of the opposed centrally placed doors is early. This is an unusual layout for a medieval building and requires further investigation to understand how this layout functioned with the more conventionally placed 'low end' cross-passage which is known to have existed at the northern end of the building. Although most of the arch's stone dressings have been removed part survives on the north jamb, and may provide evidence of the height of the springing point and threshold to reconstruct (as a drawing) the arch. It is recommended that the areas of repair to the rear wall face, visible in the north yard, should be drawn in detail and added to the existing survey drawing and an analysis made of the wall fabric to sequence these changes. The area of internal plaster to the north of the rear door should be stripped to record the medieval remains of the door fully. The rear wall within the current kitchen is also obscured and there is the potential for hidden architectural details here too; the value of stripping this area of the wall back to the flint face should also be considered.

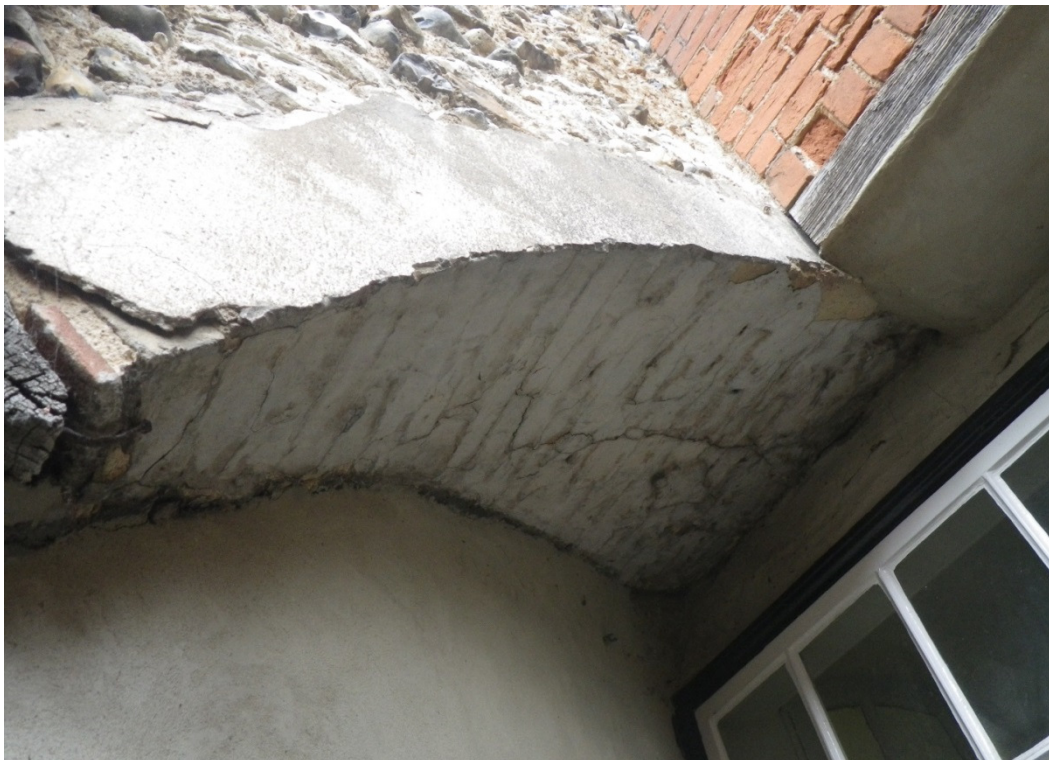
Plate 10. Soffit of the rear arch showing the impressions of brick/or tiles which contrasts with the stone work of the jamb (Pl.9). The picture shows clearly that the arch is an early feature and the council range was built butting over the arch face.

The south haunch of the arch seen on the exterior wall (Pl.10) rises to c.3.2m and the full width of the opening is 4.4m. The arch itself is made of brick and tile and rises off a timber springing point. It predates the addition of the current council chamber range, which abuts it, but probably dates to no earlier than the 18th century. Above the arch however is a strainer course made up of fragments of a clunch- type stone laid on edge; similar to the treatment of a strainer courses above medieval arches in the abbey. The coursed flintwork of the rear wall fits with the strainer course without interruption and there was no indication that the opening had been let into the wall at a later date; Clunch fragment are also used set within the horizontally coursed flintwork alongside the opening, confirming that this material was on-site when the Guildhall was under
