Street Farm, Fressingfield FSF 073

Archaeological Monitoring Report

SCCAS Report No. 2014/106

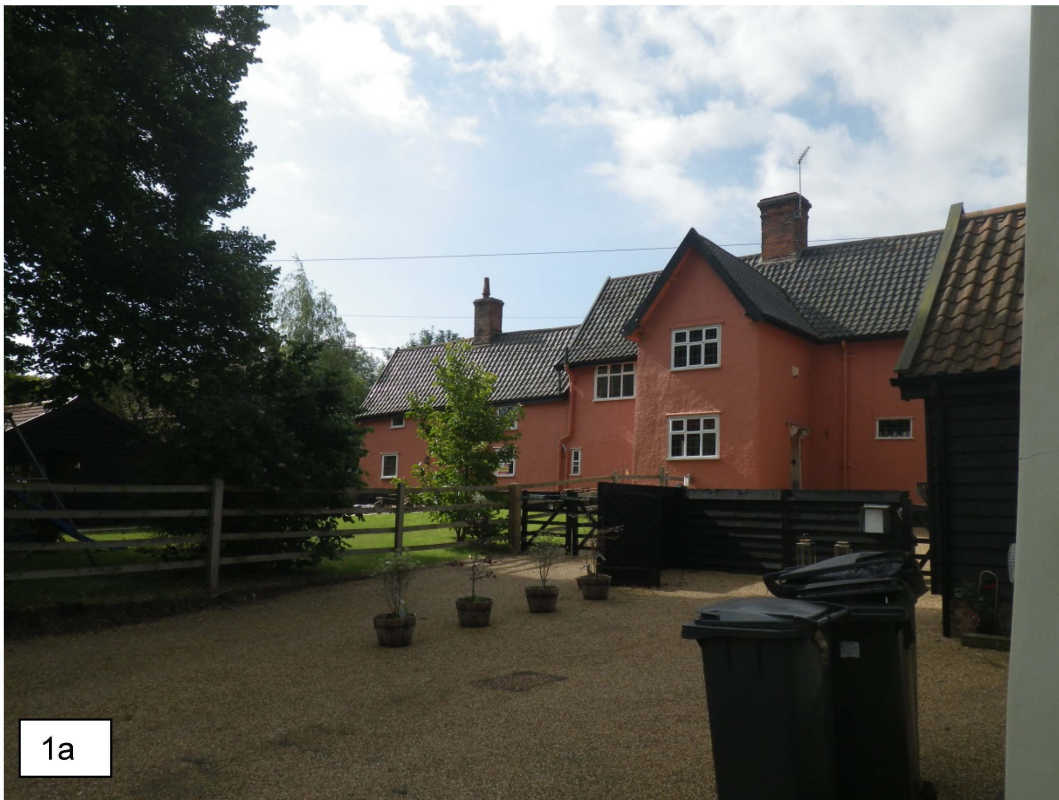
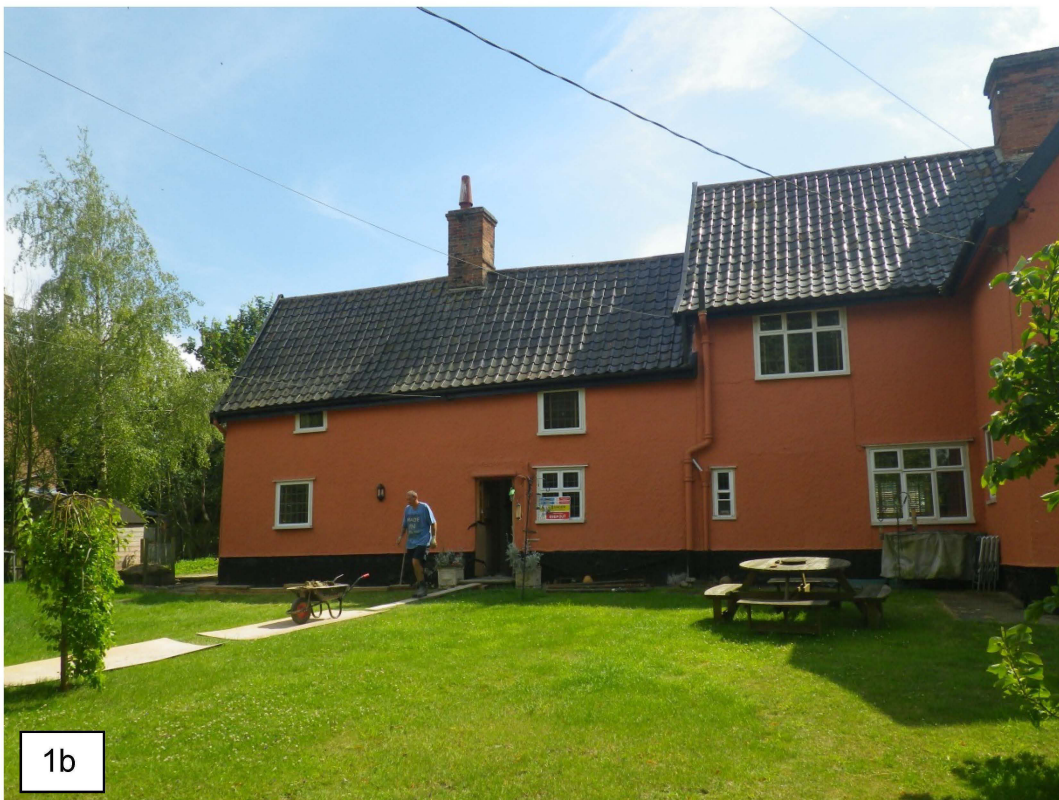
Plates 1a) and b). Street Farmhouse viewed from the north. Street Farmhouse is a Grade II listed building which in this form dates to the 17th century. The building has now been divided into two dwellings and the monitoring was in the range with the lower roof line; the end to the left of the chimney pre-dates the main house and is probably 16th century.

The monitored area was located in a modernised kitchen within the building's eastern 'lower' range. The lower range is attached to the main farmhouse but is beneath a separate roof with a lower ridge which gives the appearance of a distinct and separate build (Pl. 1).

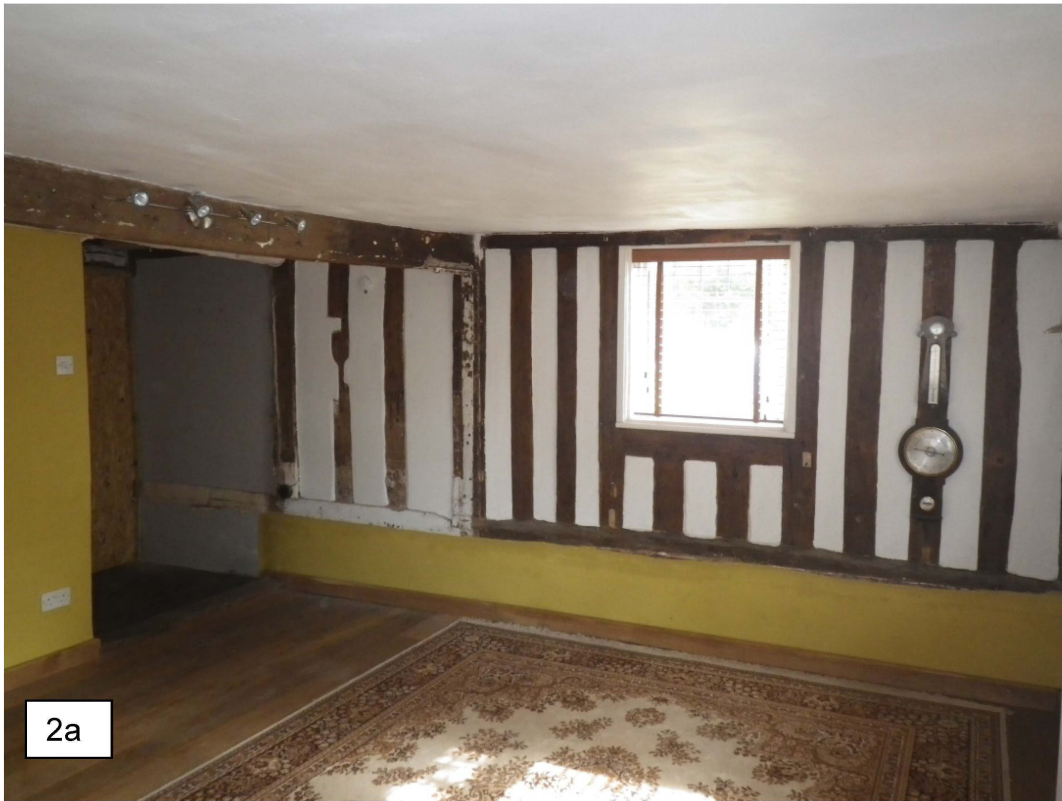
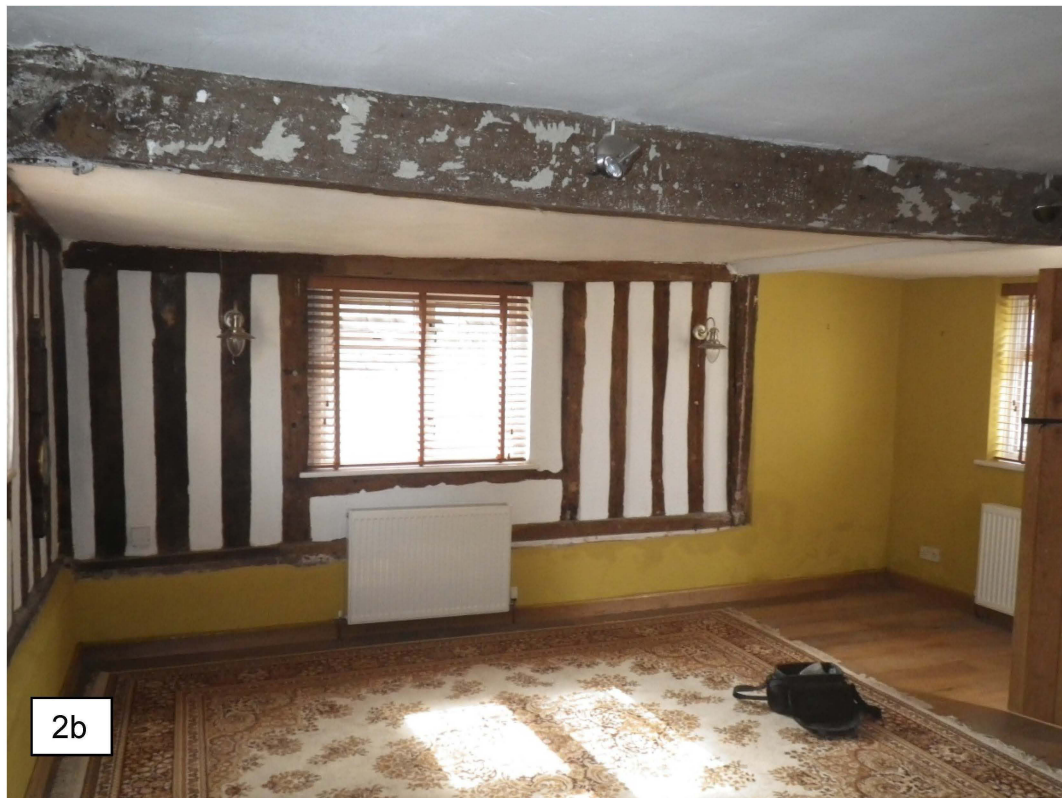
Plate 2 a) and b). Close-studding with concealed braces at the eastern end of the house which probably dates to 16th century. Inserted timbers and a crudely lap-jointed sill beam, to the left of the ceiling bridging beam (top), are the result of later modification. The limit of the framing (bottom) shows the original south east corner and line of the rear wall. The windows and ceiling retain their original positions.

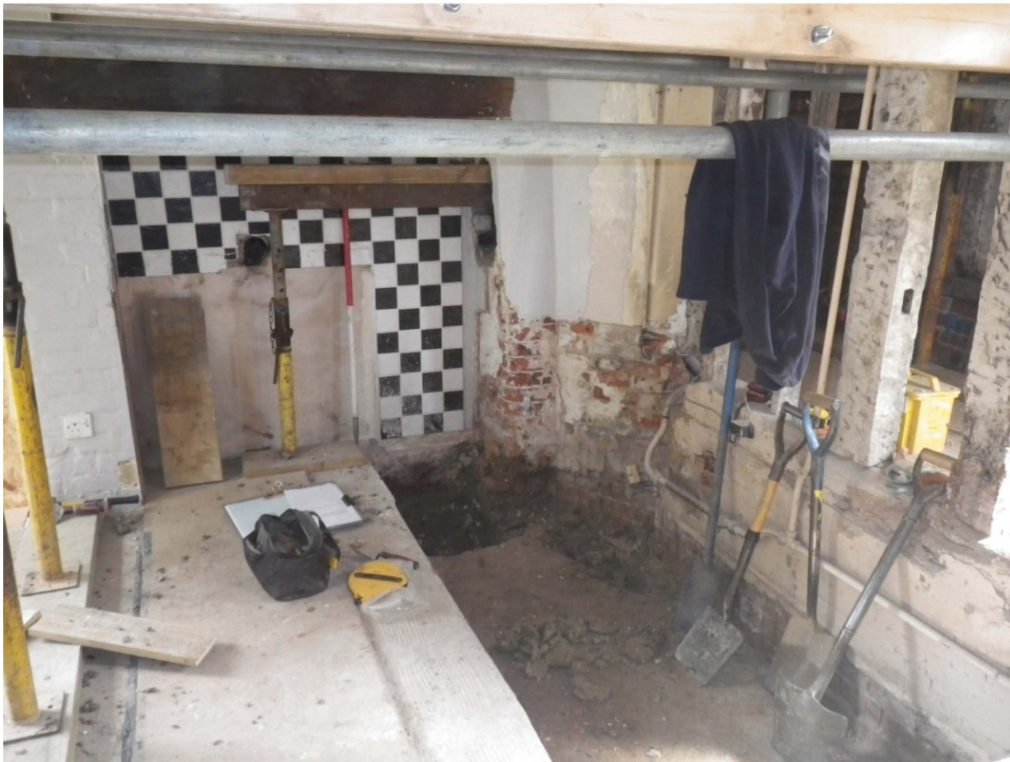
Plate 3. The kitchen of Street Farmhouse with the floor partly excavated. The fireplace probably dates from the 18th century but was greatly altered in the 19th and 20th century. The chimney has been fitted into a narrow chimney bay but partially envelopes the bridging beams that span the width of the house suggesting that this is a replacement stack. The original back wall of the house (behind the shovels) has been underpinned with brick and concrete in the relatively recent past.

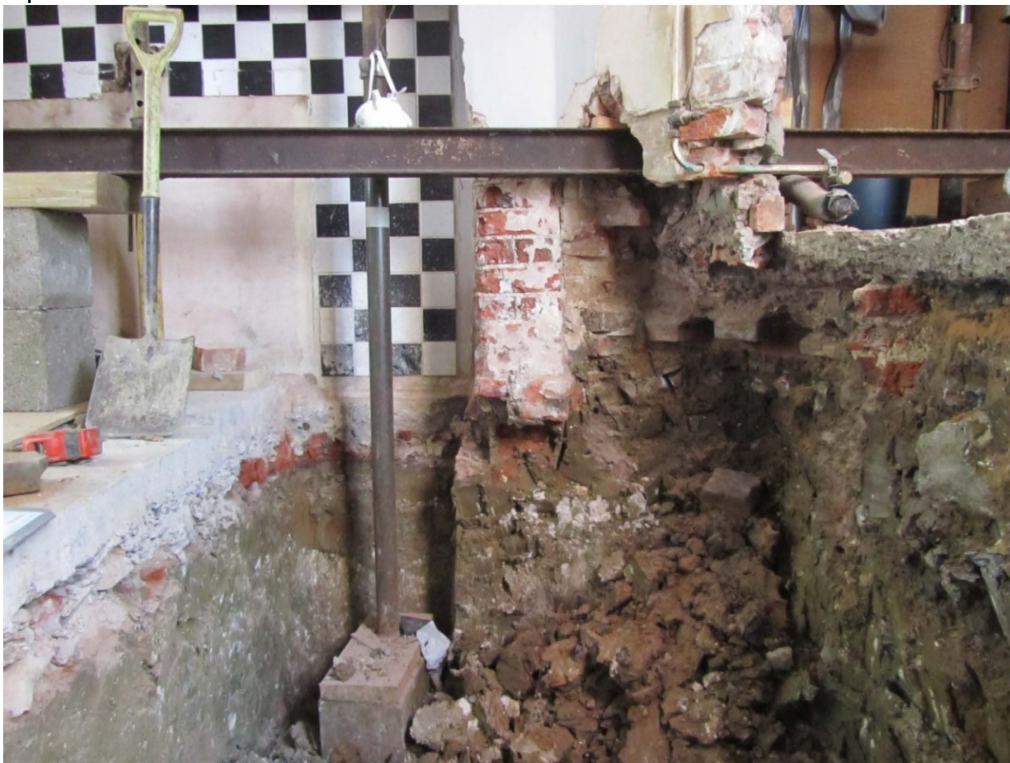
Plate 4. The large fireplace may have been reduced in width in the 18th century with the addition of the slender pier in the centre of the picture. The south (exterior face) of the chimney was subsequently altered in the 19th century with the addition of a (?) bread oven or a copper, the floor of which was preserved 300mm below the current concrete floor. The construction of the bread oven /copper necessitated the removal of a section of rear wall and was accessed from a lean-to rear range which was added to the back of the building in the 19th century.

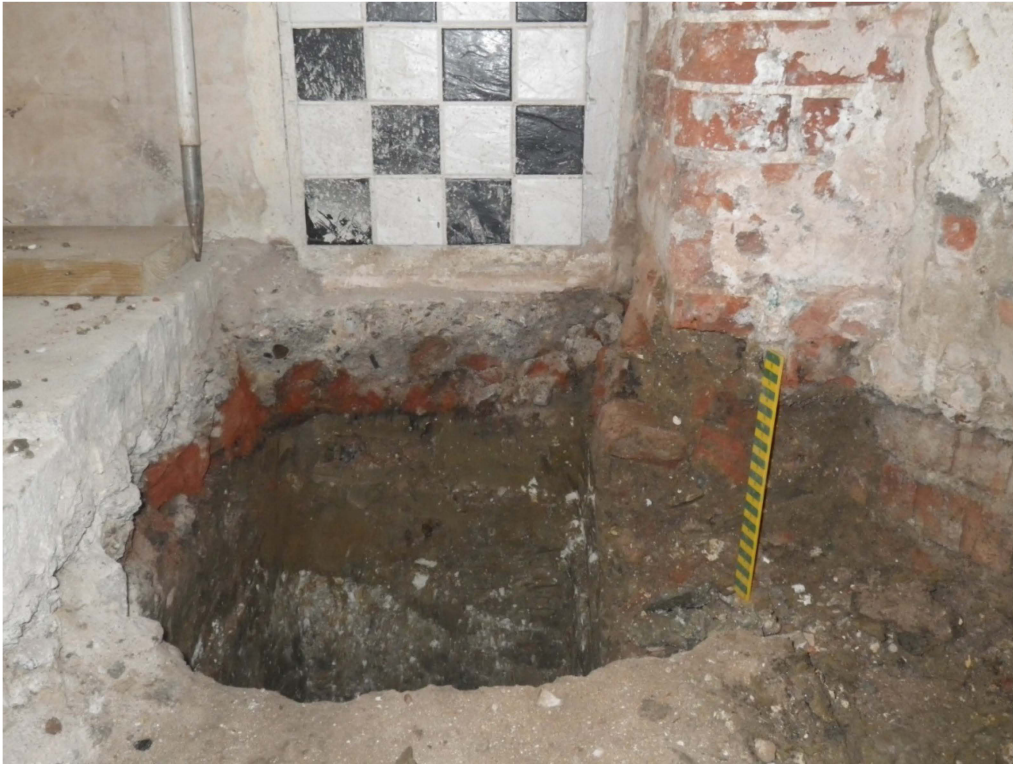
Plate 5. Excavations within the fireplace alongside the south pier, showing a layer of decayed brick, part of a previous hearth predating the existing fireplace. The extent of the hearth continued beneath the existing fireplace pier and the two were separated by an intervening layer of green boulder clay. Charcoal residue was observed over the brick hearth and beneath it was sealed a thin layer of charcoal and disturbed clay evidence of an occupation of the site that predated the existing house.

The excavations within the building were 1m deep; the laying of a solid floor in the past had truncated the internal ground level and over most of the excavation area no evidence of the building original floor survived. The exception to this was the fire place where the work revealed a layer of burnt and decayed brick (0002), part of a previous hearth pre-dating the 18th century alteration to the fireplace (Fig. 2, S 2)). The remains of the buried hearth extended beneath the south pier (Pl. 5) and were separated from the pier base by an intervening layer of green boulder clay 0003; a layer which was interpreted as the vestigial remains of a previous floor. Charcoal residue was observed over the brick hearth and beneath it was sealed a thin layer of charcoal and disturbed clay; evidence of an occupation of the site that predated the existing house.

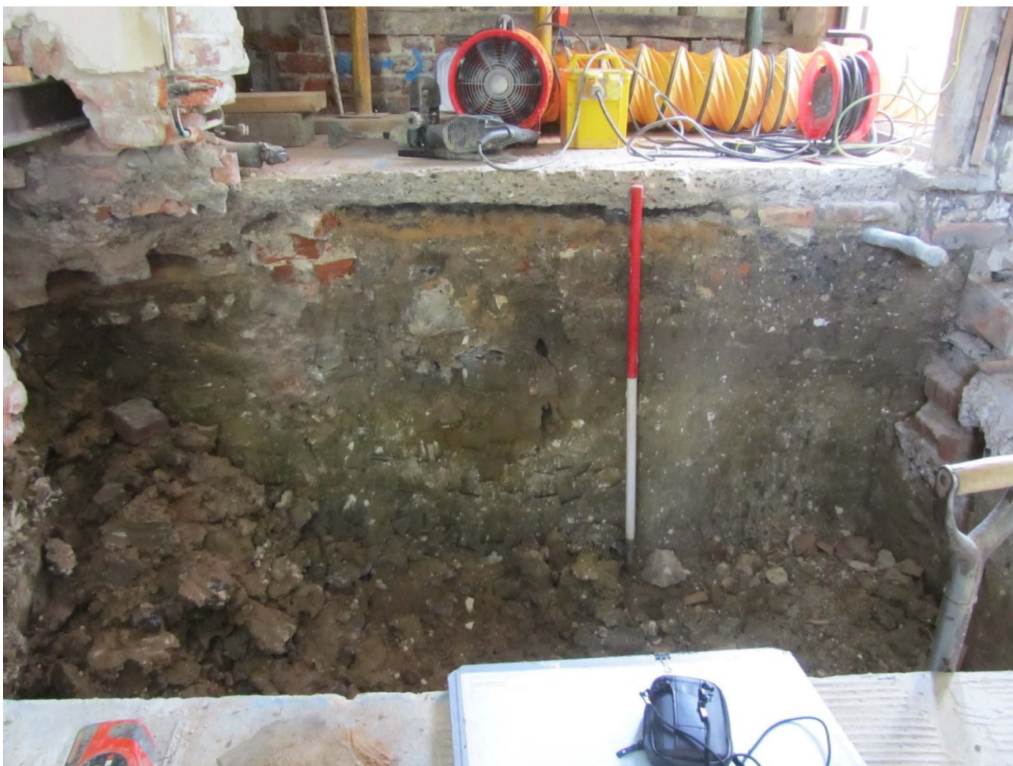
Plate 6. The soil profile beneath the floor of the rear range after the back wall of the kitchen had been removed. The concrete was laid over a brick parget floor beneath which was a 500mm depth of disturbed soil which contained brick and mortar rubble, charcoal throughout and mortared flint. The top of the undisturbed boulder clay (at the division in the scale) was riven with a v-shaped, silt-filled feature.

The removal of the rear wall and underpinning provided an opportunity to examine the soil profile which was once outside the timber-framed building but which since the 19th century had been enclosed within the rear lean-to and sealed beneath its floor (Pl. 6, Fig. 2, S1). The section showed a 500mm depth of archaeological deposits which comprised two distinct horizons. The upper horizon (0004) was made up of a disturbed/reworked, dark grey soil which contained fragments of early post-medieval brick, mortar rubble and charcoal. This was at the same level as the buried hearth inside the building and the two are likely to be approximately contemporary. The lower deposit (0005) was a dark green-brown clay with common charcoal flecks and filled a shallow flat-bottomed (?)feature cut into the top of the underlying boulder clay;

it included a small disengaged fragment of building rubble made of mortared flint but was otherwise devoid of finds. The sequence of horizon and levels observed in this section replicated that seen in the fireplace excavations described above.

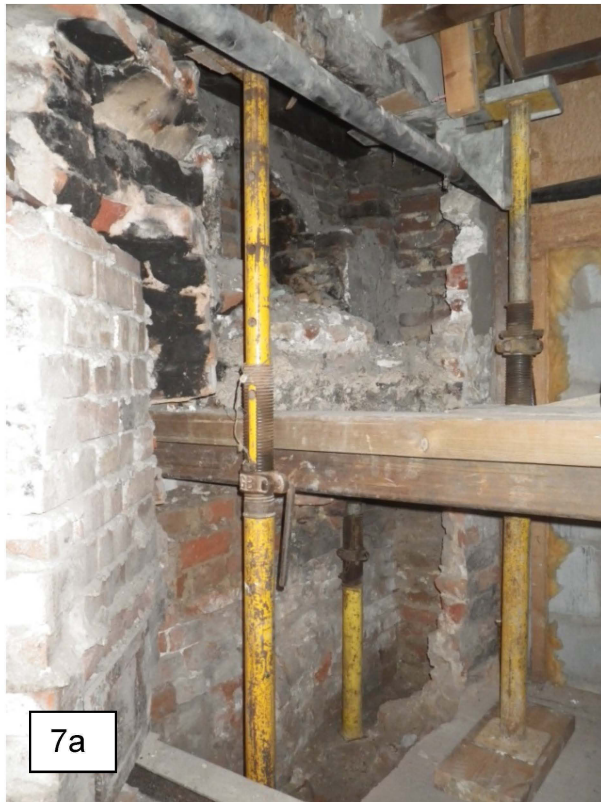
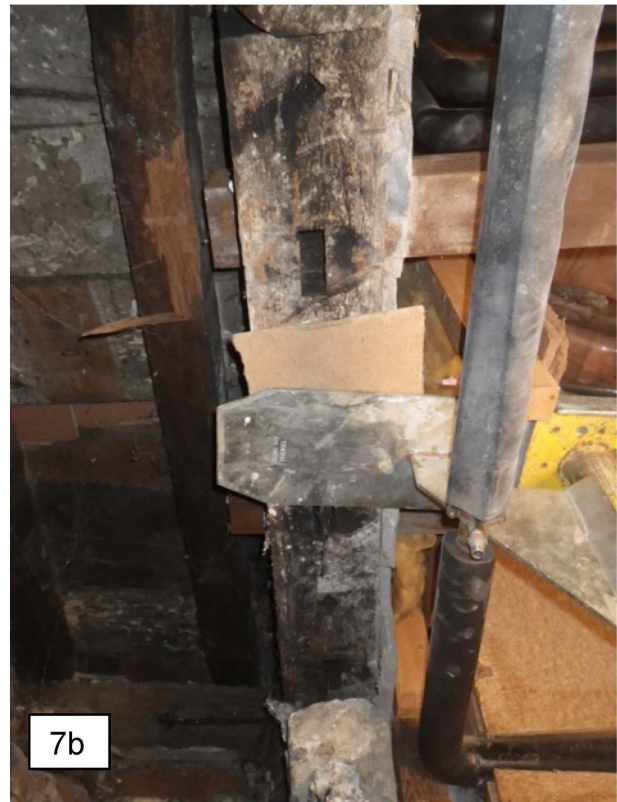
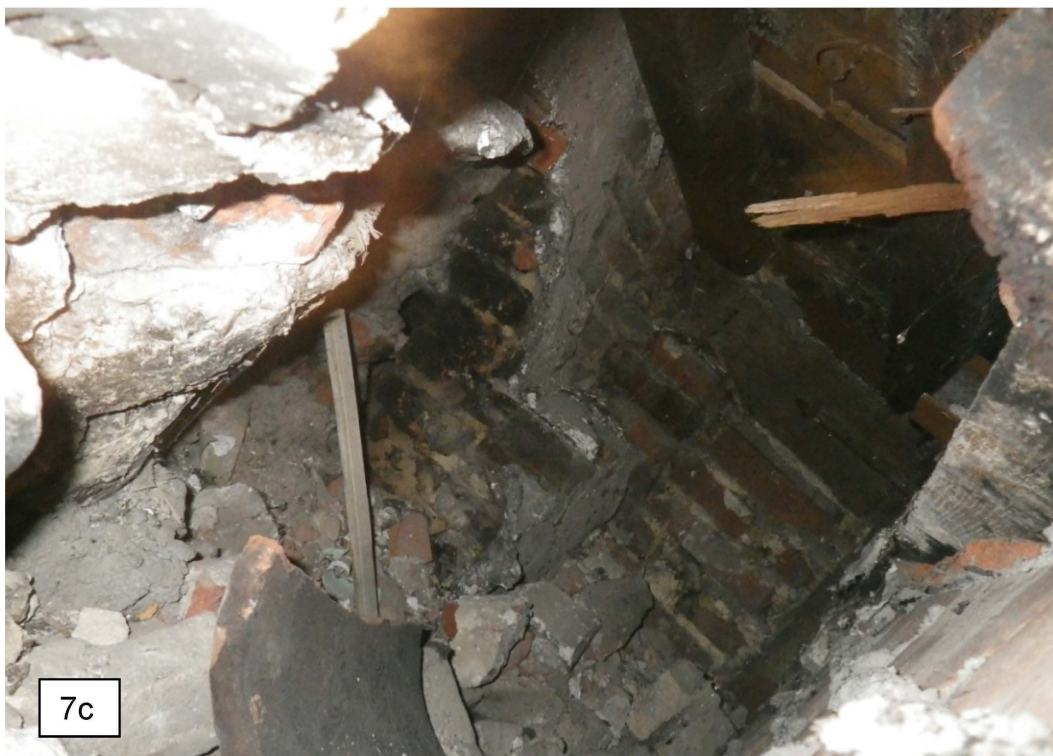
Plates 7a) b) and c) The removal of the brick-built section of the kitchen's back wall revealed a complicated void between the wall and the south pier of the chimney. Previously this space had included a possible bread oven; the sooted interior of which can be seen top left. The bread oven was a late addition which breaches the line of the original rear wall and necessitated the removal of the studs from the lower wall along with the lower half of one of the principal posts. The empty stud mortises can be seen in the underside of the mid-rail (top right) which also included the setting for two small single-bar mullion windows. The unlikely juxtaposition of a window to the fireplace suggests that either the fireplace is inserted or that the timber is reused. The bottom image shows the shoulder of the original fireplace with the cross beam on the east side of the chimney tied to back wall with an iron strap rather than jointed

The chimney was further altered in the 19th century with the addition of a bread oven or a (?)copper on to its south side (Pl. 7). The enlargement of the chimney/fireplace at this time necessitated the removal of the studs from the lower storey of the rear wall, alongside the fireplace, and the bread oven/copper was accessed from a contemporary rear lean-to which ran along the full-length of the lower range (Pl. 9).

Within the rear lean-to, the removal of an insert wall brick, which was added in the 1960/70's, from the lower storey of the kitchen's back wall part-exposed a complicated void between the wall-line and the chimney that had once contained a possible bread oven (Pl.7). The opening up of the wall revealed the underside of the timber-frame's mid-rail and showed the empty mortises of the lower storey studs that were removed when the chimney was altered. The bottom half of one of the principal bay posts was similarly removed and the underside of the mid-rail also shows the setting for two narrow, single-bar, mullion windows that were closely spaced on the rear wall. The windows and chimney would never have co-existed in this form so either the current chimney has been changed or the timber is reused from elsewhere.

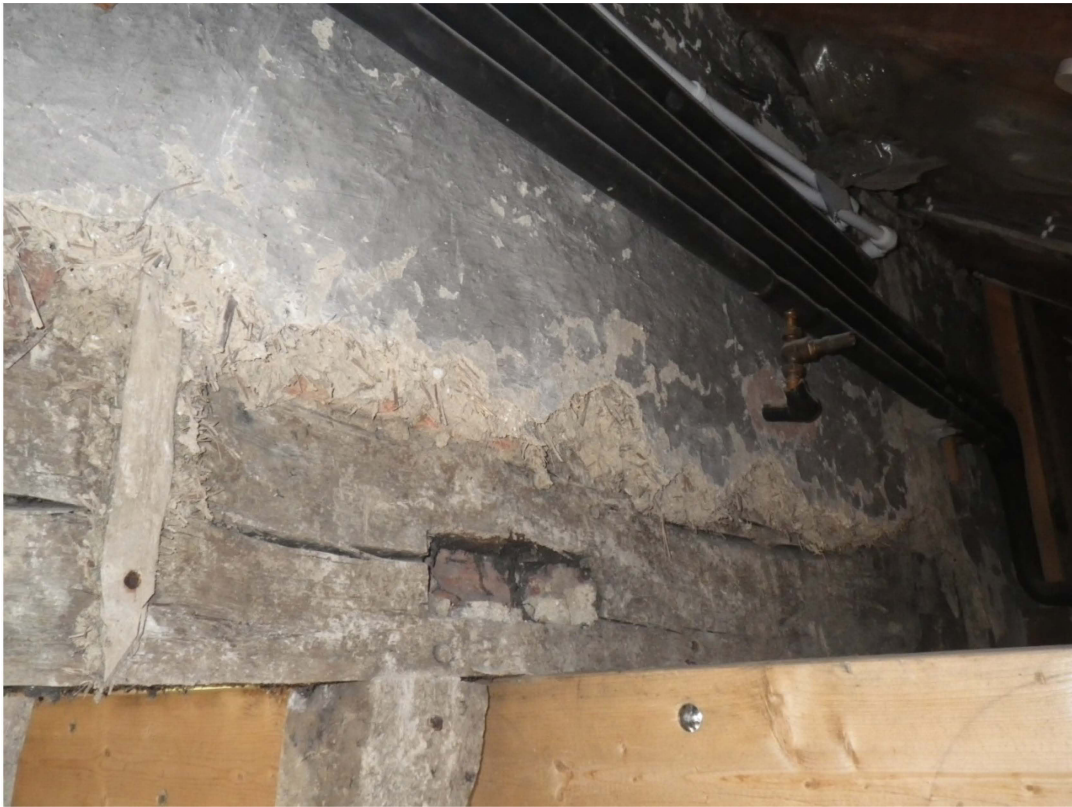
Plate 8. Rear wall of the kitchen, formerly the exterior wall just above the mid-rail. The infill between the studs was brick rubble behind split lathes nailed to the frame and rendered with a course daub; this treatment of the wall post-dates the style of the 16th century work seen at the eastern end of the building suggesting extensive reworking of the building in the 19th century.

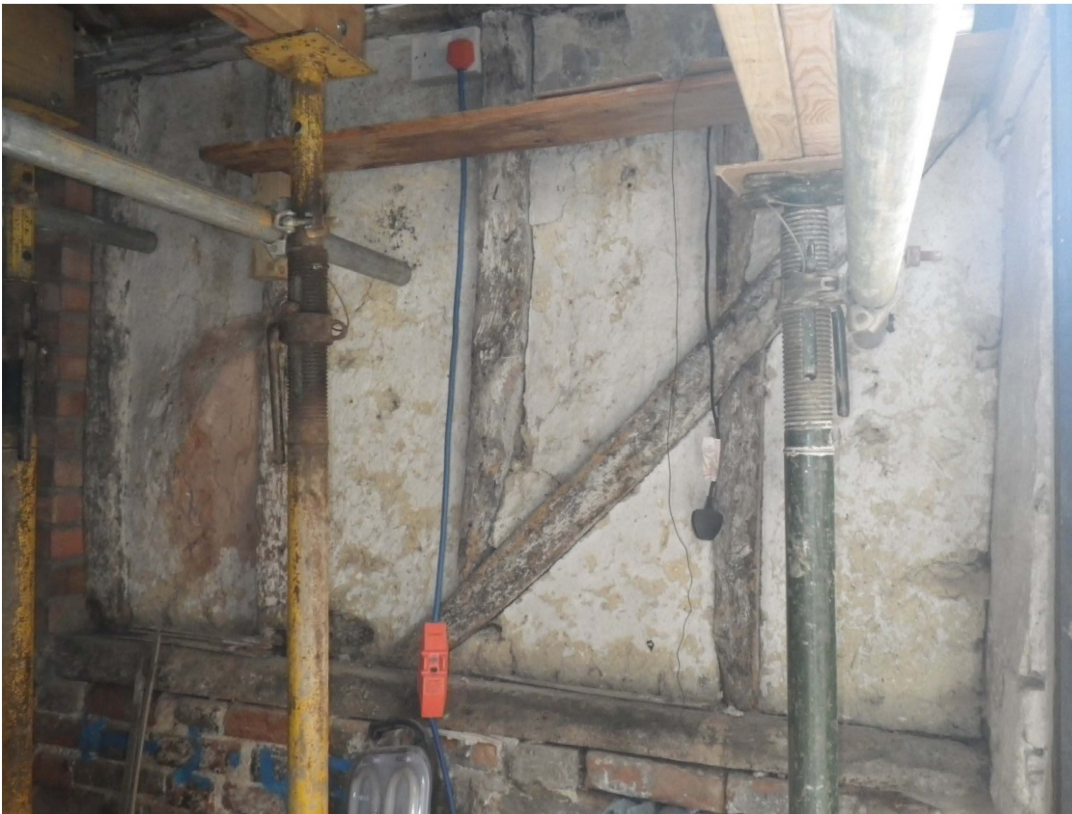
Plate 9. The timber-framed wall of the rear extension with interrupted studs indicative of 19th century framing
