**Rose Villa, Priory Walk ,  
Sudbury, Suffolk**

**SUY135**

**Archaeological Monitoring Report**

**SCCAS Report No. 201 4/079**

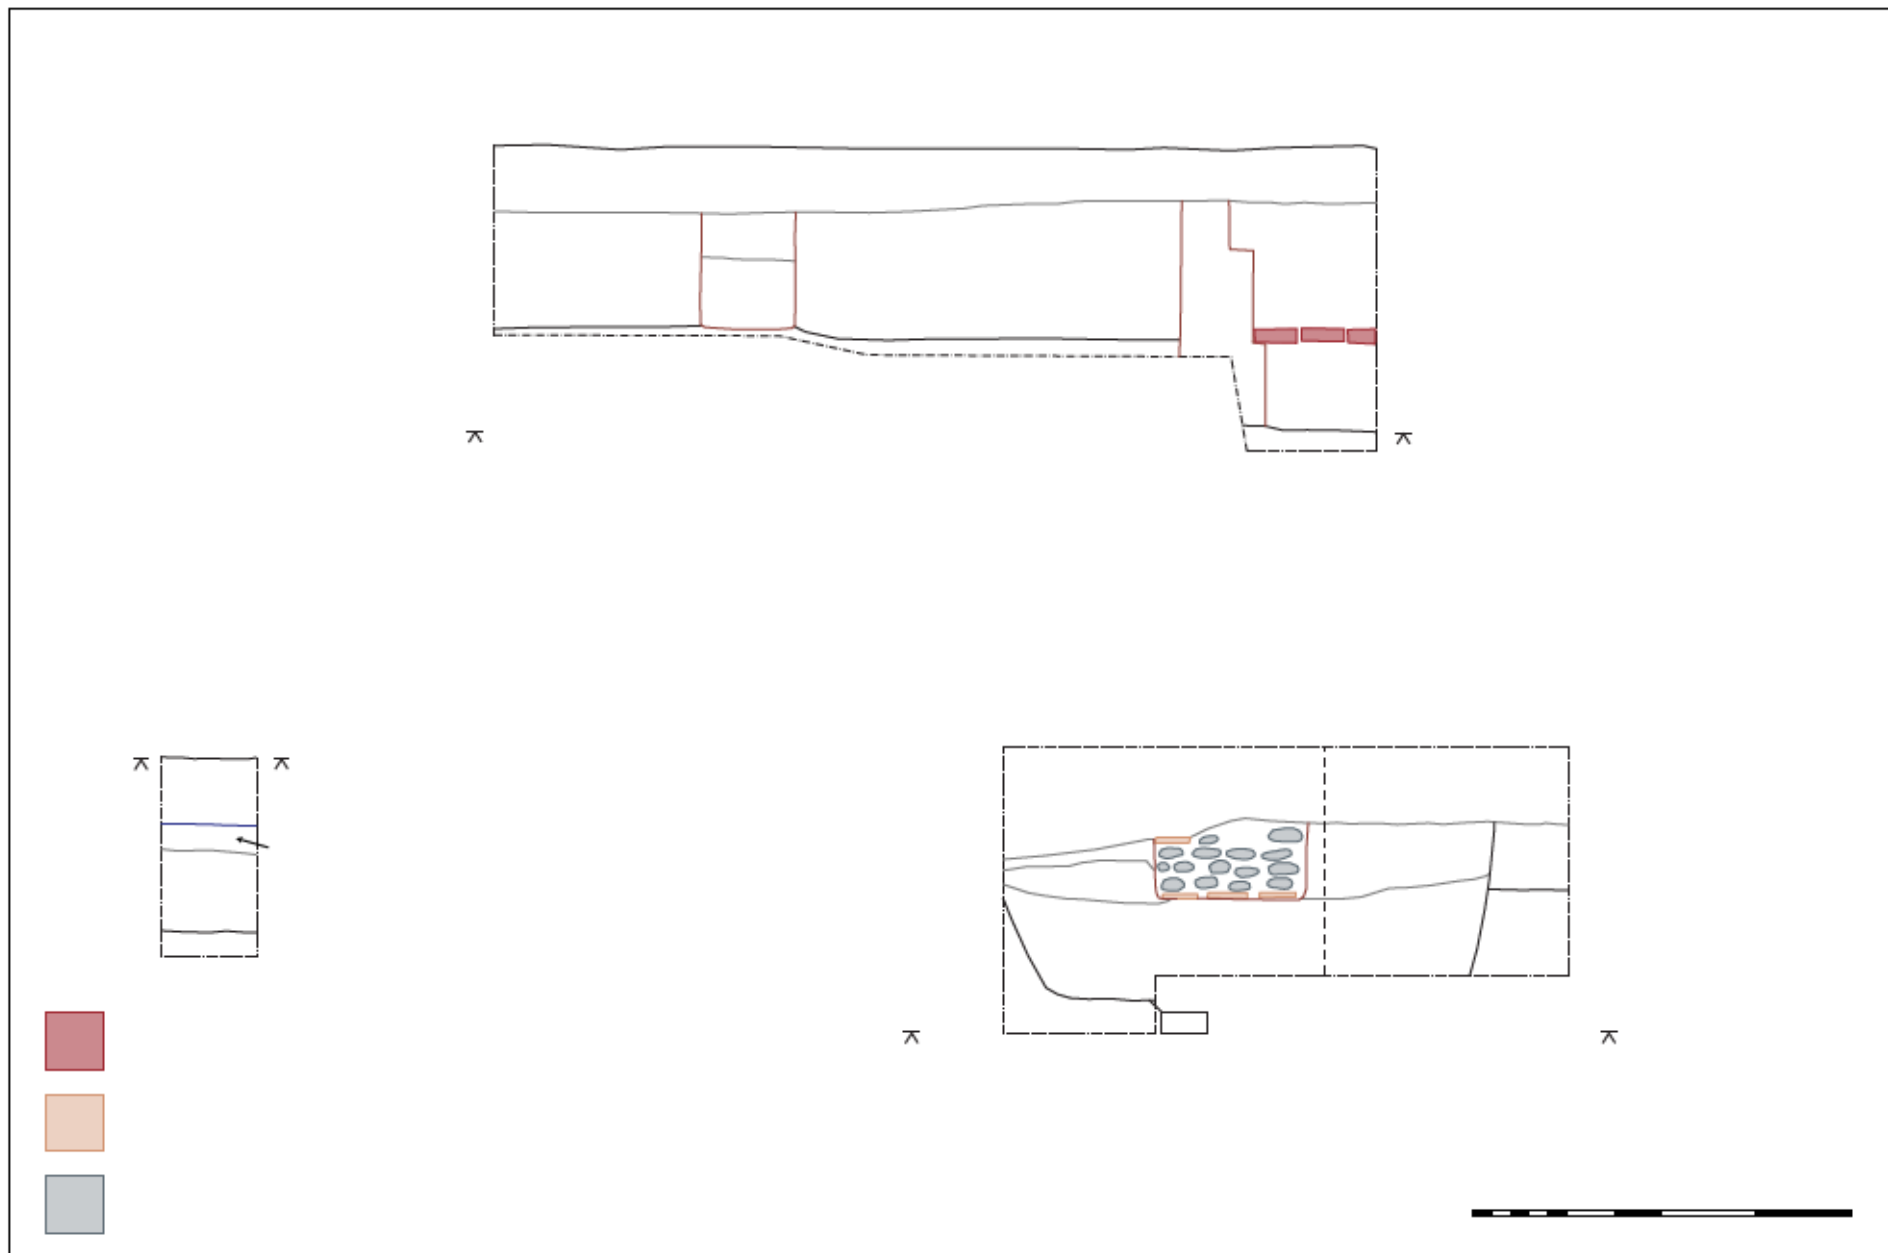
Figure 3. Sections

A natural stratum of orangey brown clayey sand and gravel, apparently surviving to its original height, was recorded at 23.54 m OD in the southwest corner of Plot 4 (Fig. 3, section S.8) and at 23.75 m OD near the west end of Plot 3 (Fig. 3, section S.9). In the eastern half of Plot 4 the natural was generally truncated to approximately 23.0 m OD by 19th-century cellaring (Fig. 3, section S.7) and at the east end of Plot 3 it was truncated to a depth of 22.77 m OD, although the cause of this truncation could not be determined.

At the southwest corner of Plot 4 the natural sand and gravel was overlaid by a layer of soft, mid greyish brown silty sand (0029; Fig. 3, section S.8; Pl. 3) with moderate pebbles and small fragments of chalk, and occasional charcoal flecks but no obvious cultural material; this deposit seemed to extend for at least 2–3 m to the north. A similar layer (0035; Fig. 3, section S.9) was seen overlying the natural stratum near the west end of Plot 3. These deposits are thought to have been layers of worked/cultivated soil, probably of medieval date.

This pit was located at the west end of Plot 3 (Fig. 2; Fig. 3, section S.9; Pl. 5), where it cut layer 0035. It measured at least 1.7 m north–south x 0.9 m east–west and was 0.95 m deep, with very steep sides and a flat base. Lower fill 0033 was principally crushed light yellowish brown lime mortar with frequent small to medium-sized fragments of red, ceramic roof tile. Seven tile fragments were recovered (267 g). They are plain peg tiles, most of which have mortar remains still adhering, both on surfaces and on broken edges. One fragment shows part of a circular peg hole. Three fragments with medium sandy fabrics which have reduced cores are medieval or late medieval in date. A further, very abraded tile made of poorly mixed clays with medium sand is also likely to be medieval. Three other fully oxidised fragments which have medium sandy fabrics could be late medieval (15th century), but they could also be as late as the 16th century.

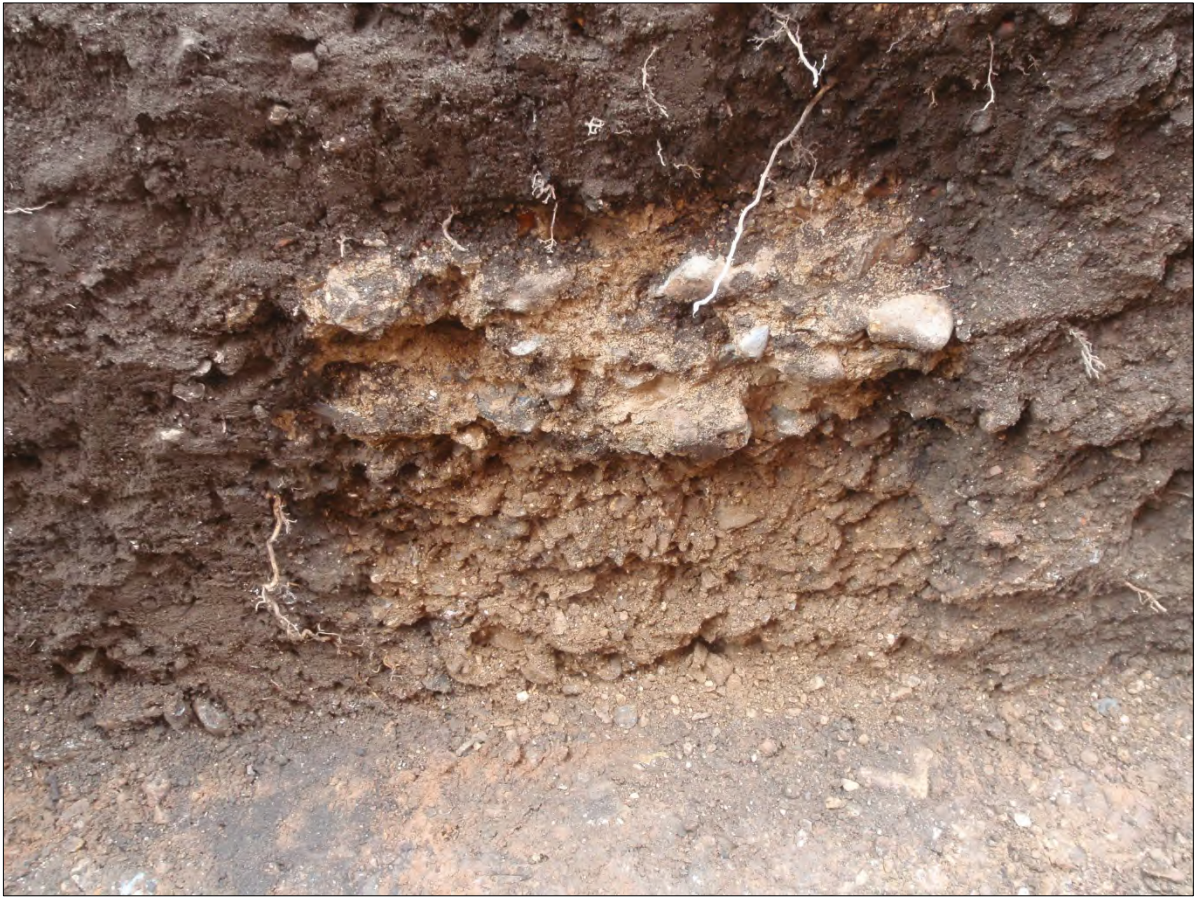
A trench-built foundation of mortared flint cobbles / nodules with occasional tile fragments seen at two locations in Plot 4 was clearly the continuation to north and south of foundation 0016, recorded originally in Evaluation Trench 3 (Fig. 2; Pl. 1). At both locations the mortared foundation was 0.50m wide x 0.25m deep, but was constructed over a deposit of loose, light brown sand and gravel 0037, 0.40m thick, that was clearly in the same construction cut (Fig. 3, section S.7). This lower deposit was not recorded during the evaluation but in retrospect it was probably not recognised. Although not observed, foundation 0016 turned to the west within Plot 3.

Plate1.Foundation0016( Plot4 , south),looking north

When foundation 0016 was recorded during the evaluation it was not clear if it was part of a building or a structure such as a boundary wall. It is now apparent that it was the east wall of a substantial building ( Building 1 ) measuring at least 7 m north– south at least 2.5 m east –west. 0036 is assumed to have been the base for an external chimney stack at the north end of the building, incorporating tiled hearth 0030. The presence of a chimney and hearth indicates that Building 1 had a domestic function, as a dwelling or perhaps part of a kitchen range, rather than an agricultural or storage function . No internal floors/surfaces associated with Building 1 were seen and the level of the contemporary ground surface is not known. It is assumed that the remains of the building were truncated in the post -medieval period, when map evidence indicates that the site was used as an orchard, or in the late 19th century when the grounds of Rose Villa were relaid out.

The only dating evidence for Building 1 comes from re -used late medieval/ early post -medieval roof tile fragments taken from foundation 0016 and from fill 0033 in pit 0034, underlying foundation 0036. This suggests that the building could have belonged to a very late phase of the priory ( *contra* Heard 2014a, 19) . However, it seems more likely that Building 1 was constructed in the period immediately after the Dissolution when the priory was granted to Sir Thomas Eden .

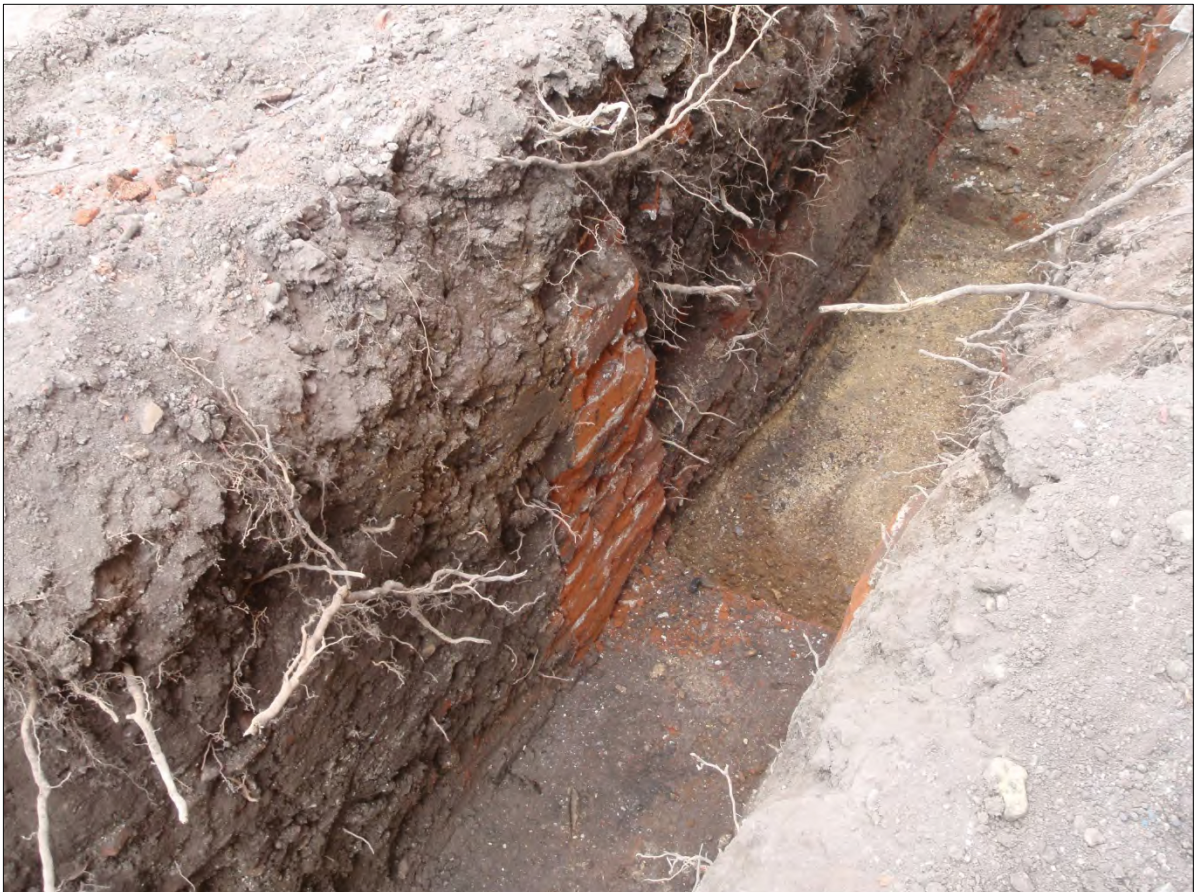
The continuation of cellar wall 0015 (recorded originally in Evaluation Trench 3) was seen on the south side of Plot 4 (Fig. 2; Fig. 3, section S.7; Pl. 2) and several other brick walls from the same building (not numbered separately; Fig. 2; Pl. 4) were recorded

Plate2.Foundation0015( Plot4 , south),looking northeast

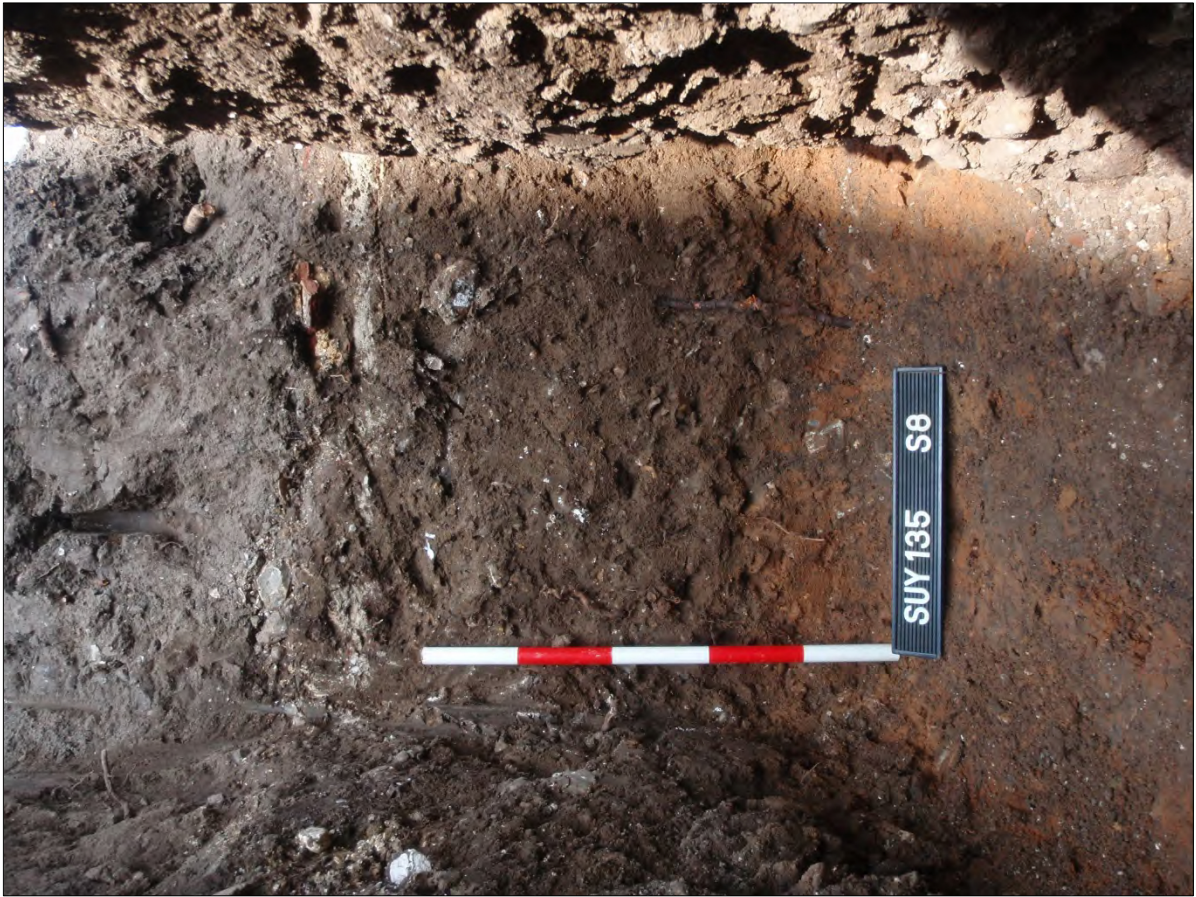
Plate3.SectionS.8( Plot4, west),lookingwest (0.5mscale)

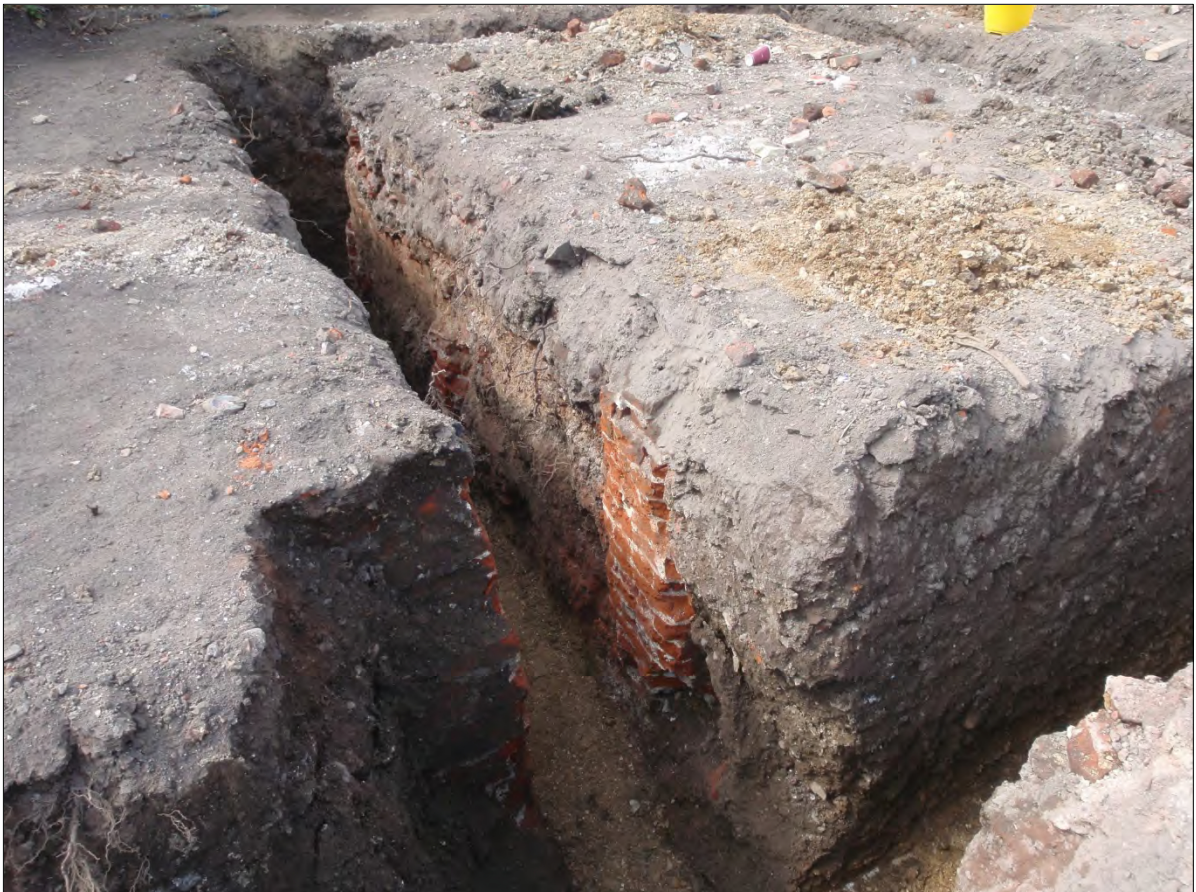
elsewhere in Plot 4, indicating that the cellar was divided into several rooms or chambers. It is likely that an H-shaped arrangement of walls in the southeast corner of Plot 4 formed the base for a chimney. Of particular note was the fact that brick floor 0014 was not in the base of the original cut for the cellar but was laid over 0.45 m of fill, suggesting that the floor level was raised for some reason.

Plate4.C ellarwalls ofBuilding2 ( Plot4 , north),looking southwest

The monitoring has allowed the cellar of 19th-century Building 2 to be planned in further detail, and the presence of a probable chimney base located at the centre of the buildings suggests that this was a dwelling. The fact that brick floor 0014 was laid about 0.50m above the base of the construction cut for the cellar ( at approximately 1.5m below current ground level ) suggests that the cellar might originally have been prone to flooding. Certainly, groundwater seepage occurred in Evaluation Trench 2 at a depth of approximately 1.6m below current ground level.

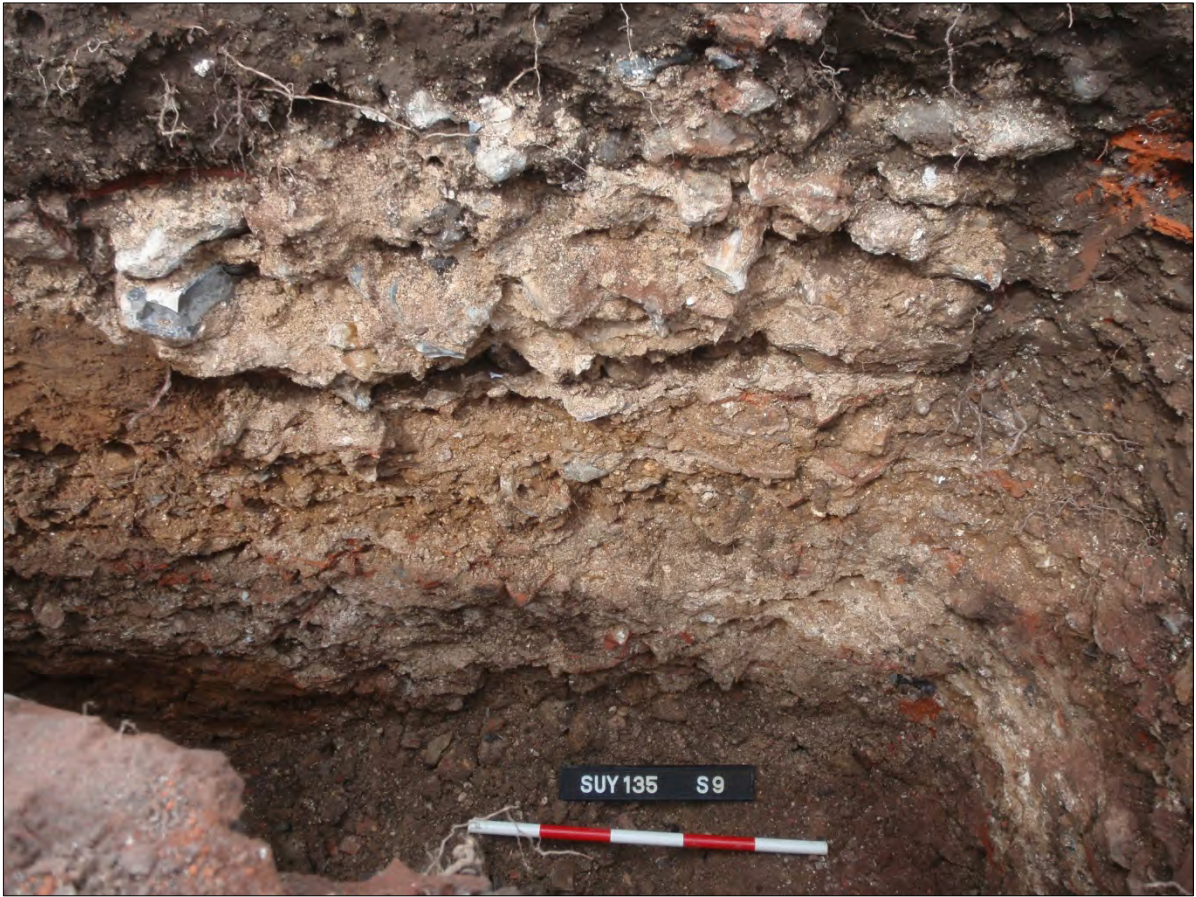
The purpose of the pit was not clear, although its extent to south and east was similar to overlying masonry 0036 (see Building 1) and this suggests that it might have had a structural function, perhaps as a localised area of ground consolidation.

At the west end of Plot 3 the continuation of foundation 0016 was recorded as 0036. This L-shaped foundation was of similar construction (mortared flint cobbles with a string course of reused roof tiles at the base) but was larger, being 0.80m wide x 0.40m deep. 0036 did not have an underlying foundation and sand and gravel, like 0016; instead, the base of foundation 0036 rested on the compacted mortar and tile fill 0033 of pit 0034 (Fig. 3, section S.9; Pl. 5).

Plate5.Foundation0036andunderlyingpit 0034( Plot3 , west),looking west (0.5mscale)

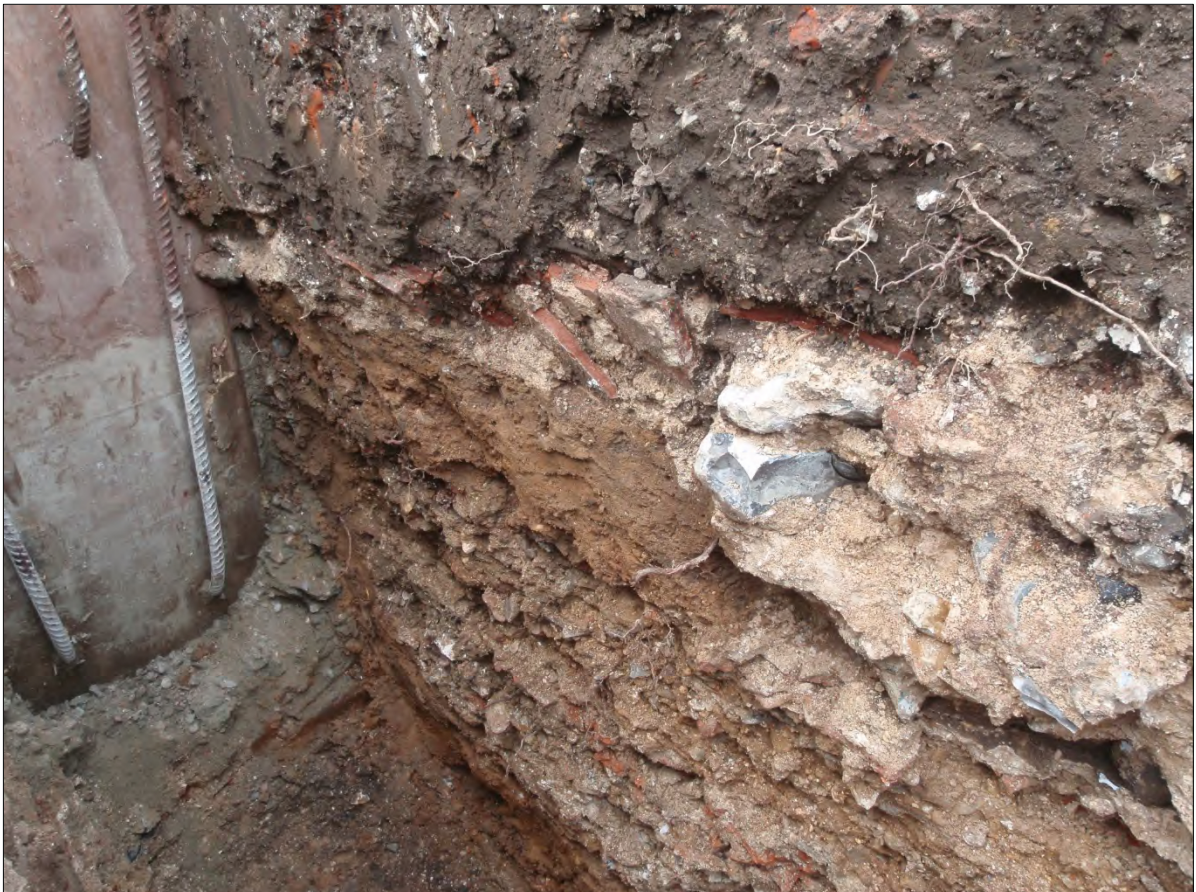
Structure 0030, interpreted as a hearth, was built in the angle of L-shaped foundation 0036 and consisted of rows of mortared roof tiles set on edge (Fig. 3, section S.9; Pl. 5). As seen in section, the tiles were not quite vertical but this might have been due to disturbance following the disuse of the hearth or to recent machine damage.

Hearth 0030 was truncated horizontally and overlaid by thick (up to 0.60m) deposits of post-medieval topsoil/garden soil (not numbered, but equating to 0019/0020 in Evaluation Trench 3) that also sealed the truncated remains of foundations 0016 and 0036.

Plate6.Foundation0036andhearth 0030( Plot3 , west),lookingsouthwest
