Land off The Street Earl Soham, Suffolk

ESO 018
Archaeological Excavation Report
SACIC Report No. 2014/118
Author: Simon Picard
© SACIC

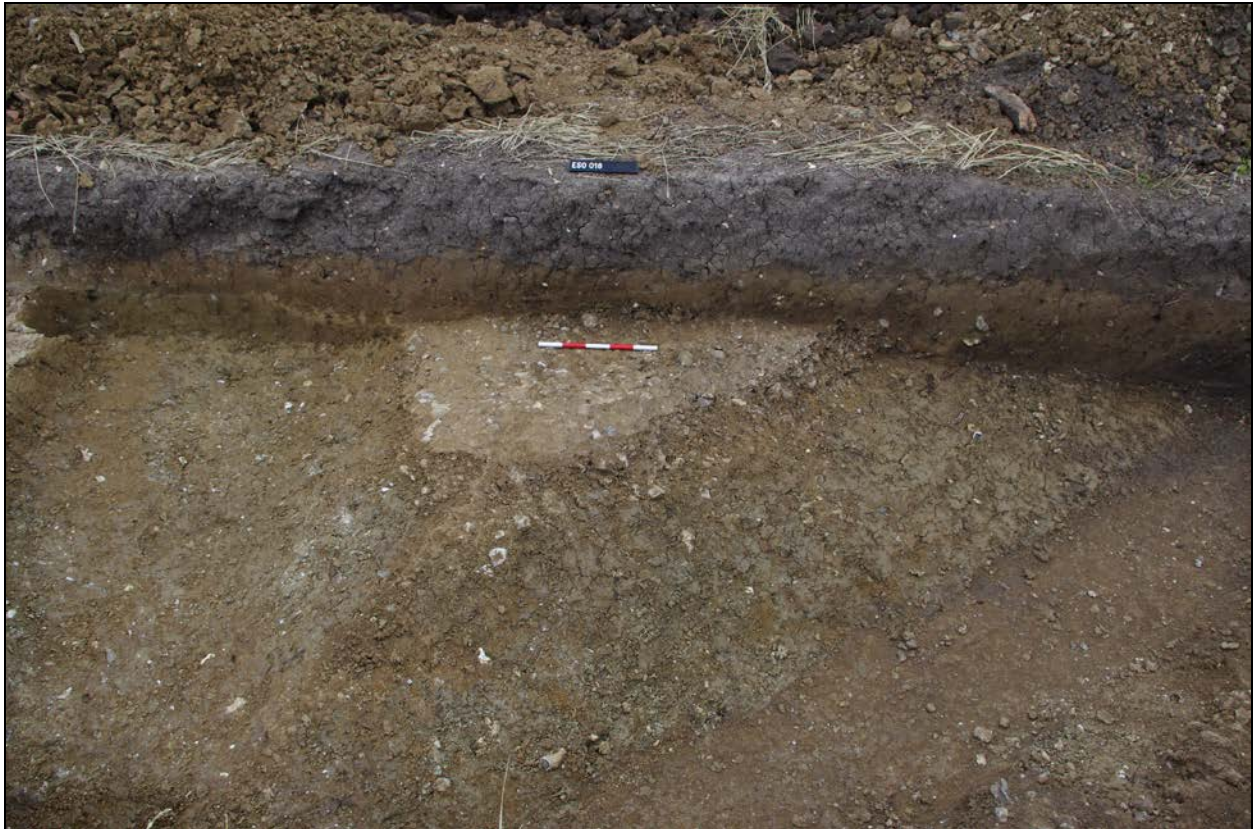
Plate 1. Metalled surface cut by modern ditch (to right) and with associated roadside ditch (to left), 0.5m scale, looking east northeast.

Although the Roman road was visible this trench was dominated by a substantial modern ditch. This was approximately 2.5m wide and, while not fully excavated, was dug to a depth of approximately 0.5m. Aligned northwest southeast the ditch cut diagonally across the road completely removing the southern edge of the road and about half of the northern edge. At its northern end the modern ditch was itself cut by an engineers test pit. A small triangle of metalled road surface (deposit 0110, described below) covering approximately 1.2 square metres survived to the east of the modern ditch. This was recorded in plan and can be seen in Plate 1 and Figure 3.

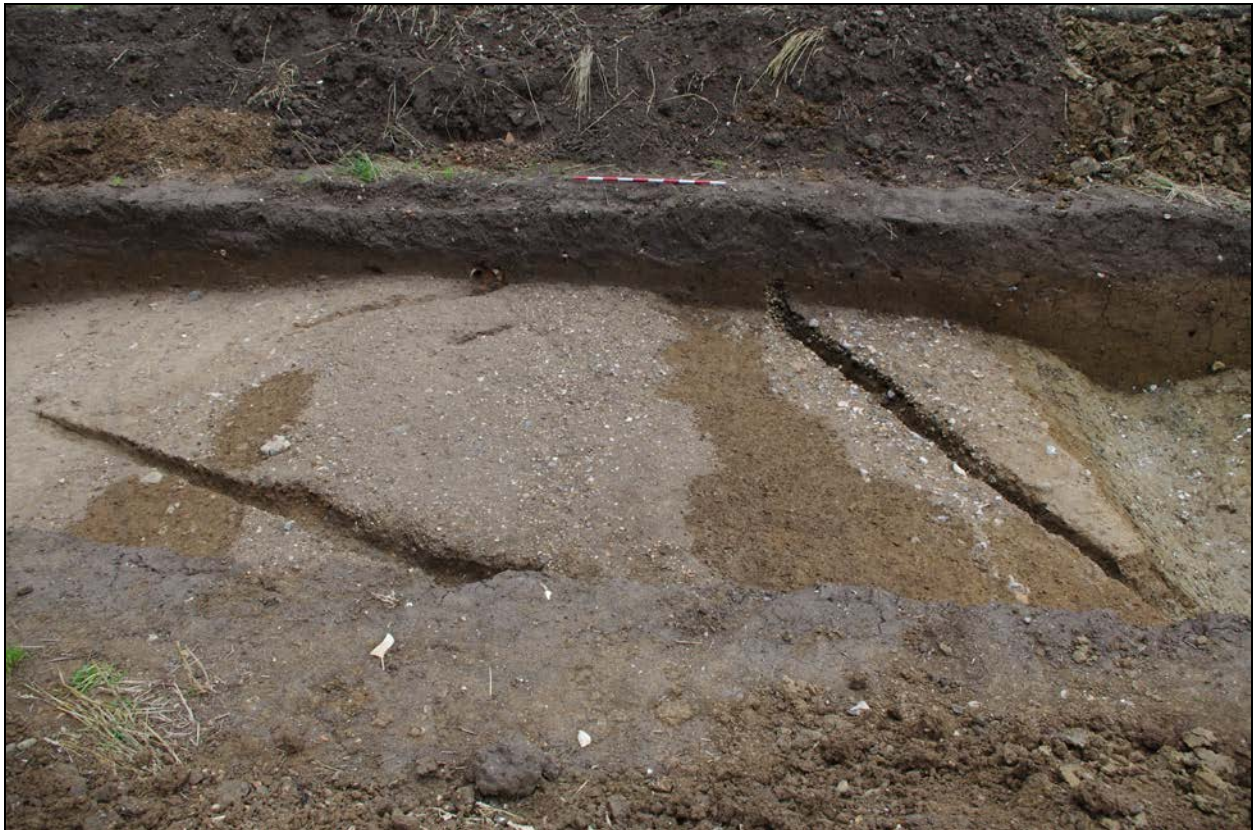
Plate 2. Metalled road surface with roadside ditch 0107, 1m scale, looking west southwest.

The road in this trench was more intact and widespread. Although three modern field drains had cut into it the full extent of the road, at 5.8m wide, could be discerned with a ditch 1.3m wide running along its northern, upslope, edge (Plate 2 and Fig. 3).

The ditch had a broad concave profile, was up to 0.44m deep and had three fills. Its upper fill (0104) consisted of firm light to mid grey clay silt varying in thickness from 0.1m to 0.15m with occasional small pebbles. The interface between this and the main fill of the ditch (0105) was diffuse. This was firm light brownish grey clay silt mottled with orangey brown ferrous staining, possibly caused by roots. The primary fill (0106, also recorded as 0124) was firm mid orangey brown clayey sand with moderate amounts of very fine pebbles and was up to 0.15m thick. This deposit overlaid the basal layer of the road and sloped down into the ditch on its southern side. It was unclear whether this

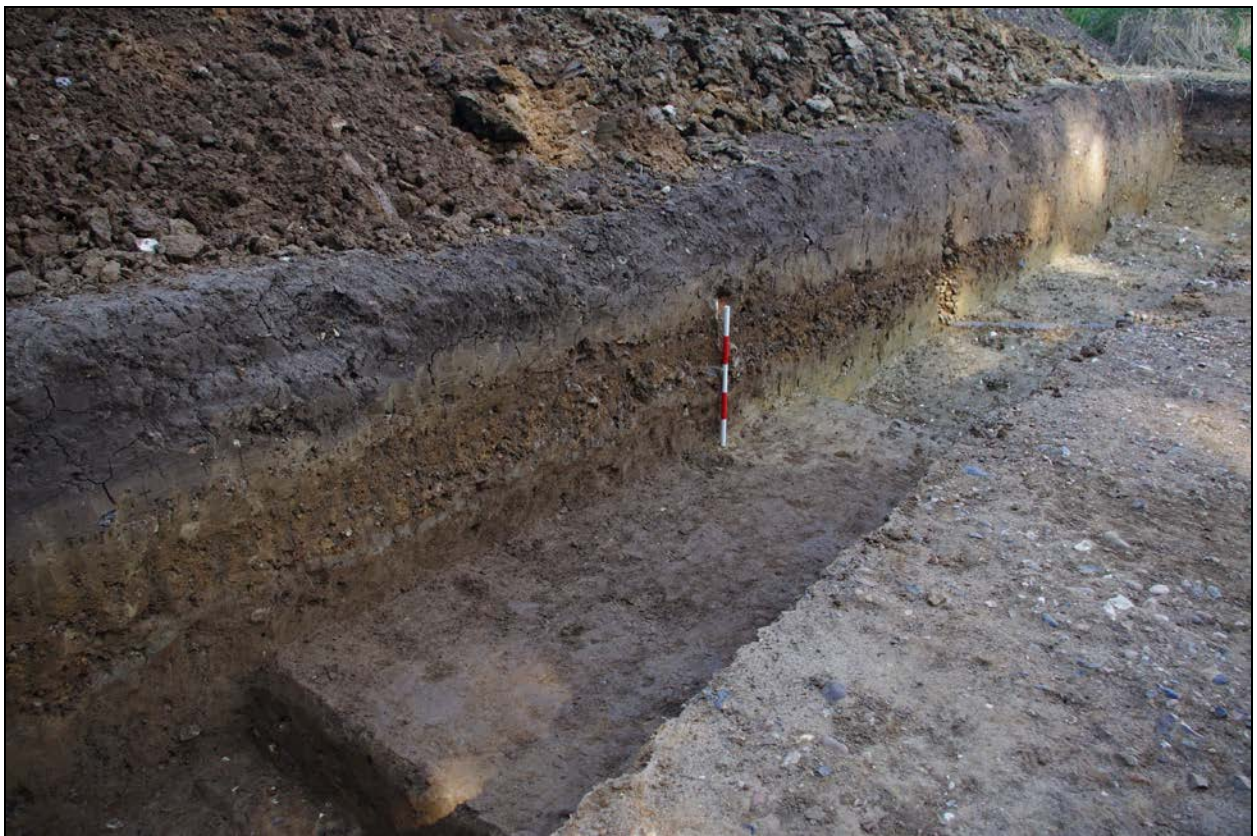
Plate 3. Trench 7, sondage through Roman road, 0.5m scale, looking northwest.

Following removal of the ditch a sondage was excavated through the road to further investigate evidence for the construction method (Fig. 4 and Plates 3 and 4). The sondage showed that the road was made up of three distinct layers (Plate 5).

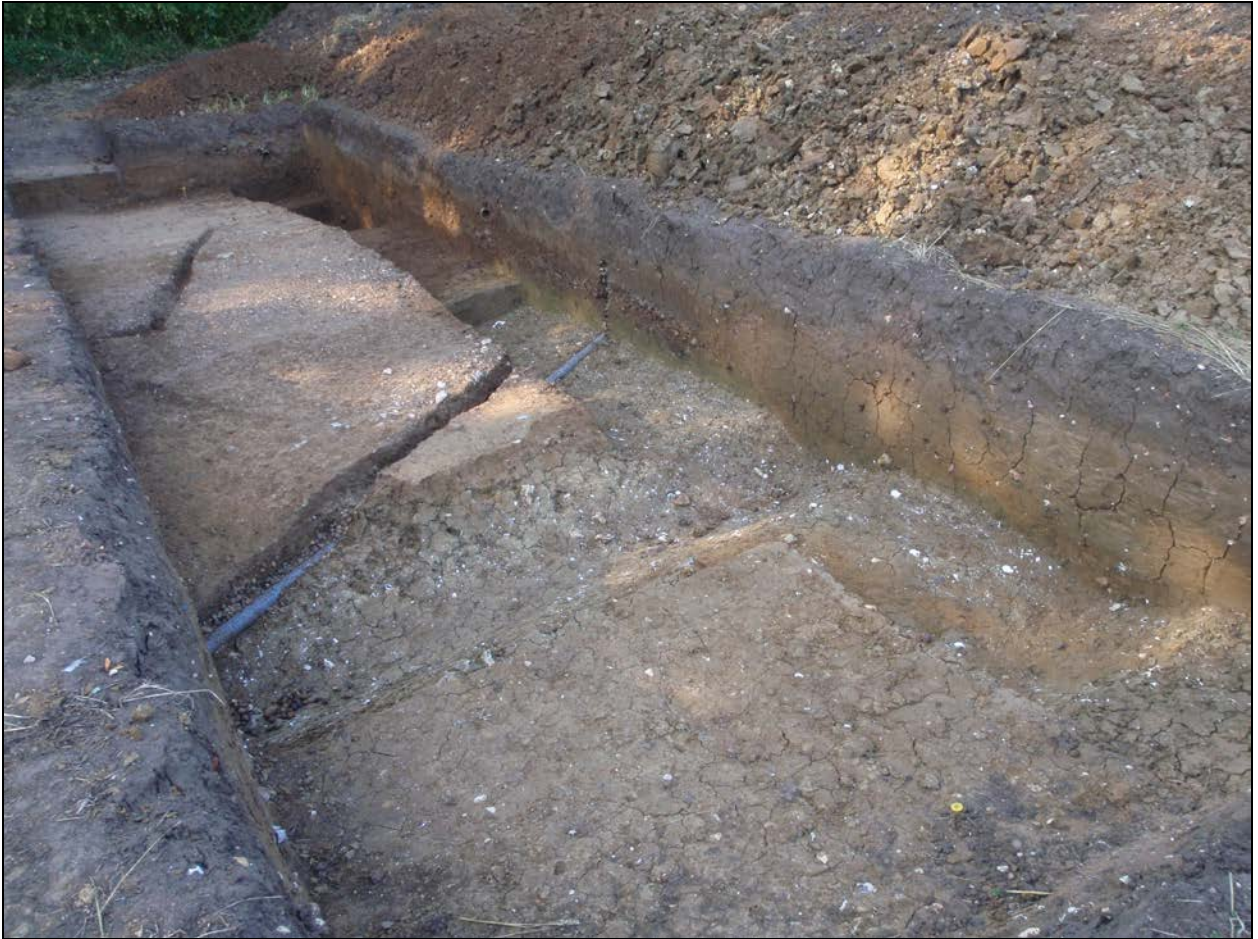
Plate 4. Trench 7, sondage through Roman road, no scale, looking south.

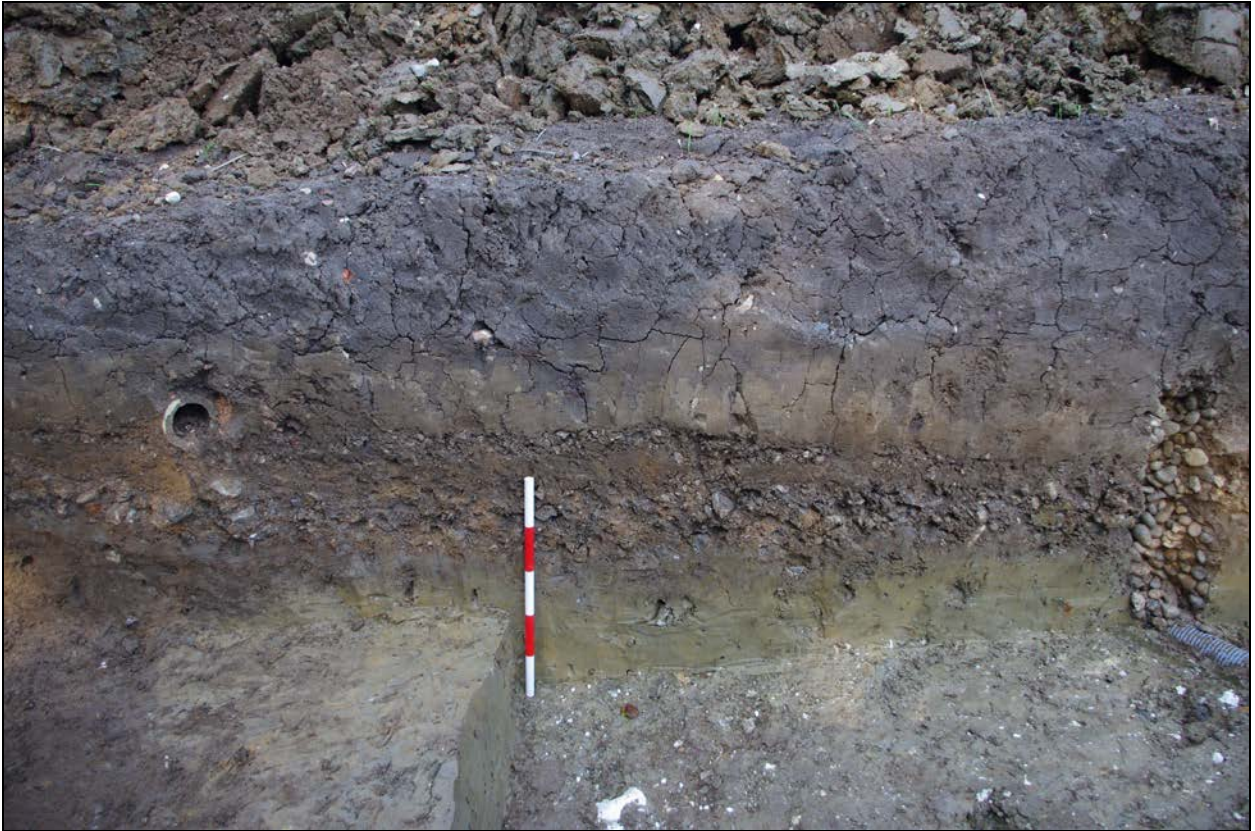
Plate 5. Layers of road material, 0.5m scale, looking west southwest.

Deposit 0108 was the uppermost surviving layer of road metalling, although this had almost certainly been truncated, indicating that an unknown number of further layers was missing and therefore a full record of the road was not present to be recorded.

0108 was a very compacted surface made up of small and medium sized, mainly sub-angular to rounded, pebbles mixed with medium coarse mid-orangey brown sand up to 60mm thick. This extended trenchwide and petered out to both the north and south. It had a slightly undulating but generally flat surface with clear interfaces with the over and underlying deposits.

Below 0108 was deposit 0109. This was a soft to compact mottled mid-grey and mid-yellowish brown mixture of clayey silt and sand (although the former is possibly due to root staining or animal burrows) with occasional quantities of small pebbles. Where this deposit was sealed by 0108 its surface was flat, although it did have an undulating base and varied in thickness from 6mm to 0.25m. This layer extended approximately 3m further to the south than 0108 above it and 2m further than 0110 below it. It also extended slightly further to the north than 0108, approximately 0.2m, but 0110 below continued for a further 1.5m towards the roadside ditch. Deposit 0110 was similar to 0108 and consisted of sub-angular to rounded flint pebbles mixed with medium mid orangey brown sand and compacted, except in this layer the stones were medium to large and included some small cobbles. This deposit had an undulating top and base and was generally 0.15m thick, petering out to the south but with a pronounced edge to the north, where it was below the primary fill of the ditch, 0106. This was the lowest layer of road construction material present on the site.

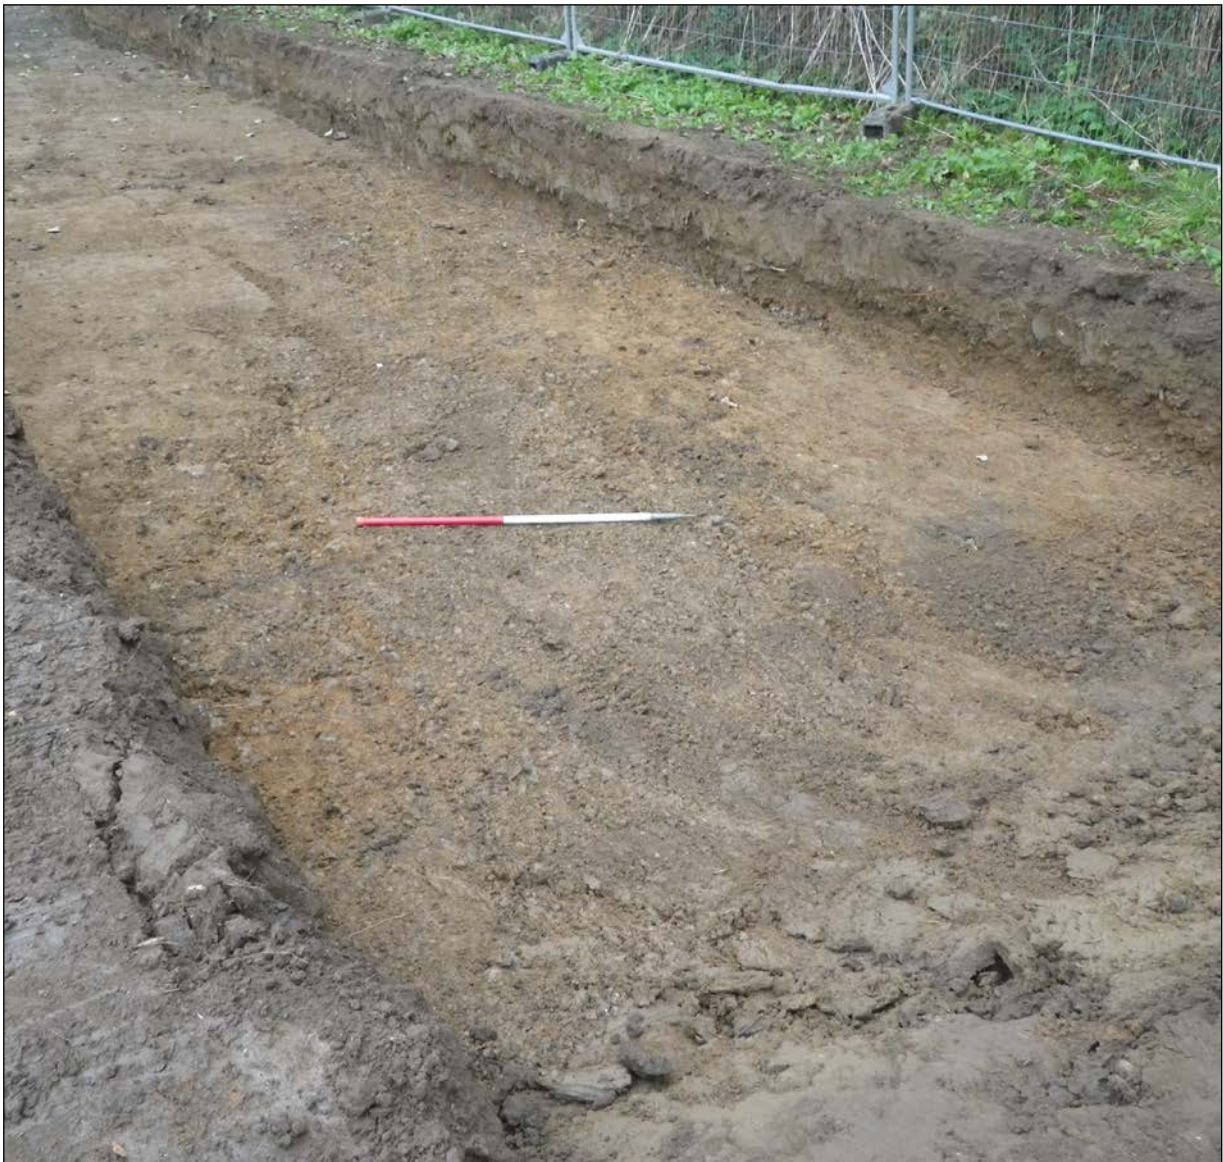
Plate 6. Exposed road surface in monitored area, 1m scale, looking east northeast.

In addition to the two excavated trenches monitoring visits was made to the site to observe the soil stripping prior to construction of the access road for the site. This covered approximately 290 square metres and encompassed parts of two trenches excavated during the previous evaluation of the site; the south eastern end of Trench 5 which was blank and the majority of Trench 4 where the road was originally recorded. Top soil and subsequent layers of subsoil were removed by mechanical excavator under the supervision of an archaeologist down to the bottom of the formation level for the access road. This was a depth of 0.6m and exposed the upper road surface.

No further interventions into the road were made; the roadside ditch was not recognised and no further archaeological features were encountered. It is likely that this is due to
