St Mary's Church, Bury St Edmunds BSE 451

Archaeological Monitoring Report

SCCAS Report No. 2014/095

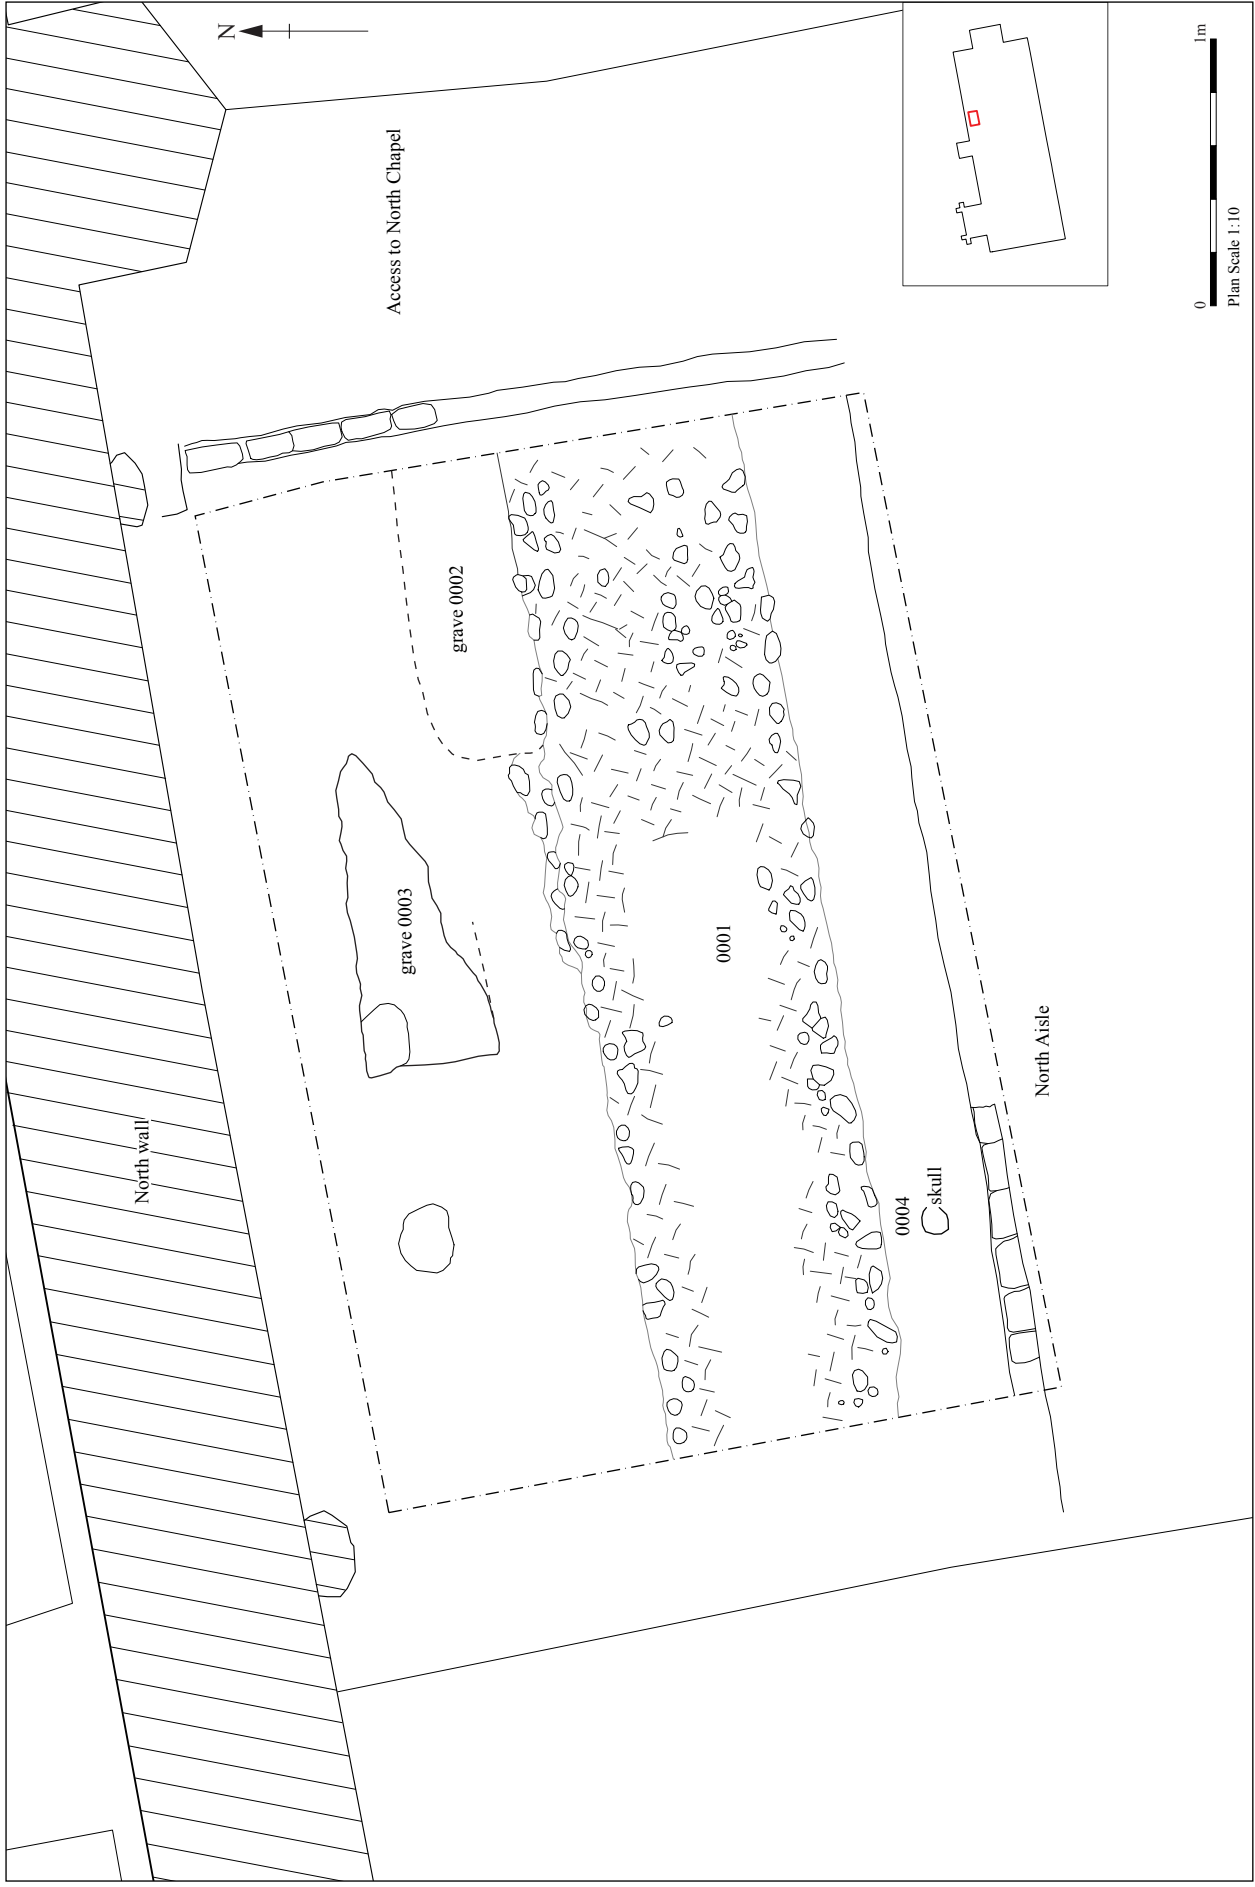
Figure 2. Detailed excavation plan

Several monitoring visits were made to the church with the main work concentrated over two days after the flagstones had been lifted on the planned location for the Cenotaph. There was a bedding of lime mortar that contained a high proportion of flint but included occasional tile fragments and brick. It was found to be a quite solid base for the flagstones and was almost certainly laid during the 19th century; sample holes were made using a pneumatic drill and although firm this layer varied in depth and required removal which was achieved by a combination of hand excavation and drilling. It became clear that there was an older fabric of cream coloured mortar which was mixed with flints of moderate size (up to c.0.10m across) beneath. This was exposed revealing a medieval wall, 0001, that was c.0.9m wide. The surrounding rubble was cleaned away, which left the wall up to 0.15m upstanding above a disturbed brown silt surface (Fig. 1).

Either side of the wall the silt was quite soft and occasional fragments of human bone were evidence that burials were located here with intercutting graves causing bones to be up-cast. Worthy of particular mention was an undamaged skull found to the south of the newly exposed wall (Fig.1); the skull was only c.0.2m below the top of the wall stub and may have been displaced although this could not be confirmed without further excavation and it was covered over. To the north, and tight against the stub wall, a probable grave was visible, which stood out as an area of silt with a higher gravel content (Grave 1). A second likely grave appeared as an area of mortar spread over the brown silty surface in the approximate shape of a grave; in the northwest corner a small area of limestone was visible (during excavations at 'Norman Cottage', BSE 182, twenty seven bodies had been buried in a space measuring 4x 5m alongside the Norman Tower and limestone had been used, along with mortar, to construct grave linings). The limestone may have been the remains of a reused stone lid from an earlier tomb that was laid directly onto the soil although this could not be confirmed.

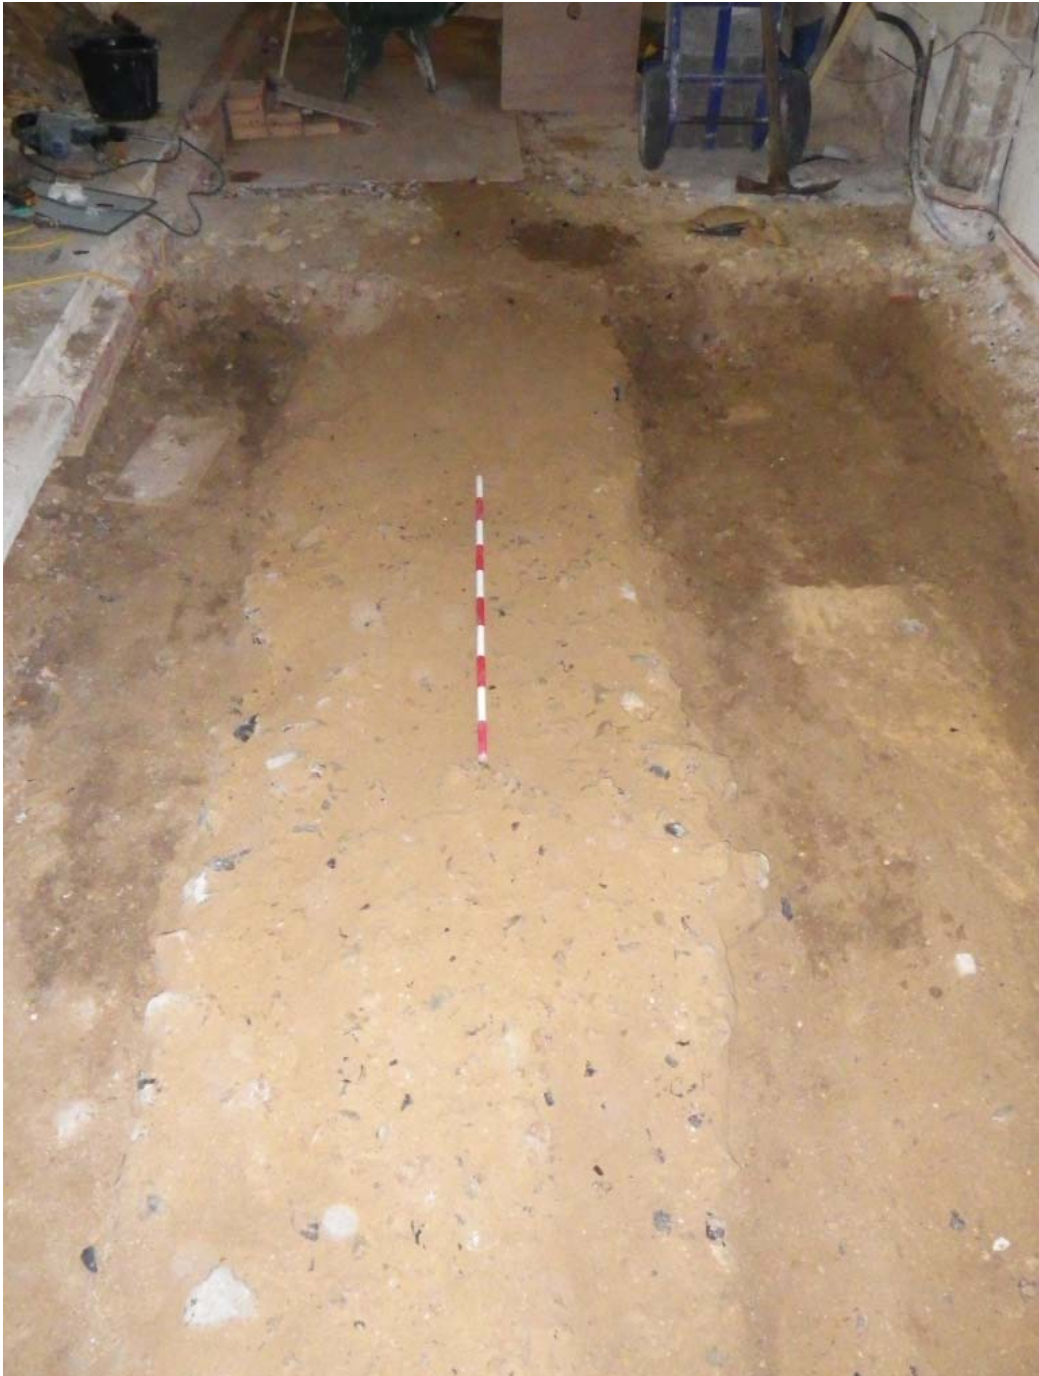
Plate 1. Looking west along the buried wall with two probable graves; Grave 1 is at the bottom right of the picture, grave 2 is middle right and outlined in mortar, the skull lies concealed beneath a piece of wood in the top left. The scale is 1m.

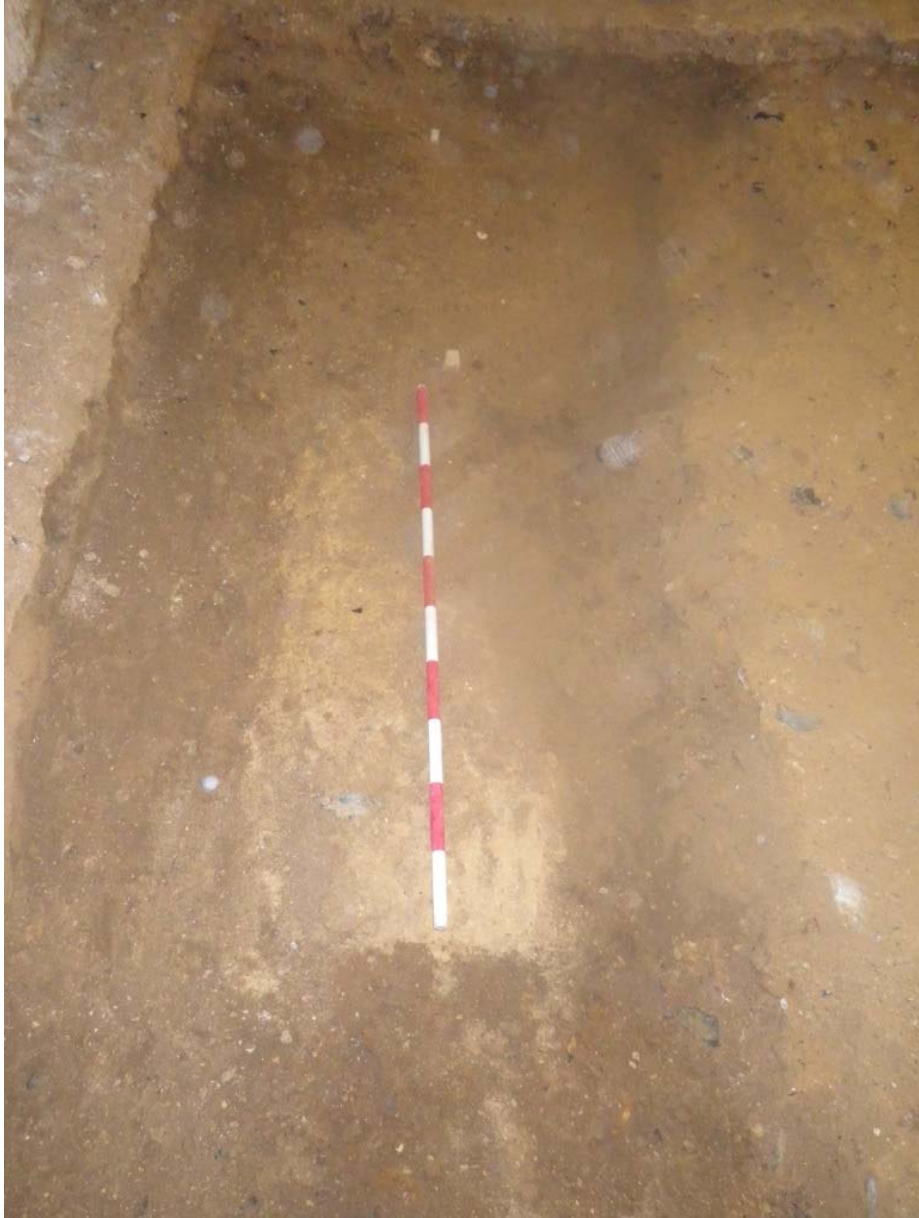
Plate 2. Looking east over Grave 2 with the buried wall to the right. The scale is 1m.

Either side of the wall stub the ground was disturbed with up-cast soil probably from multiple burials. A layer of mortar in the shape of a medieval tomb, although not complete, lay directly over brown silt and may indicate the site of an intact burial and where an attempt was made to replicate a medieval stone-lined tomb albeit on a modest scale. The suggested burials, Grave 0002 and 0003, were probably the most recent in this area with earlier cut lines obscured. Establishing the number and date of burials within this part of the church was not within the remit of the excavation but it is likely to have been quite dense given the disarticulated human remains that were found and reburied.

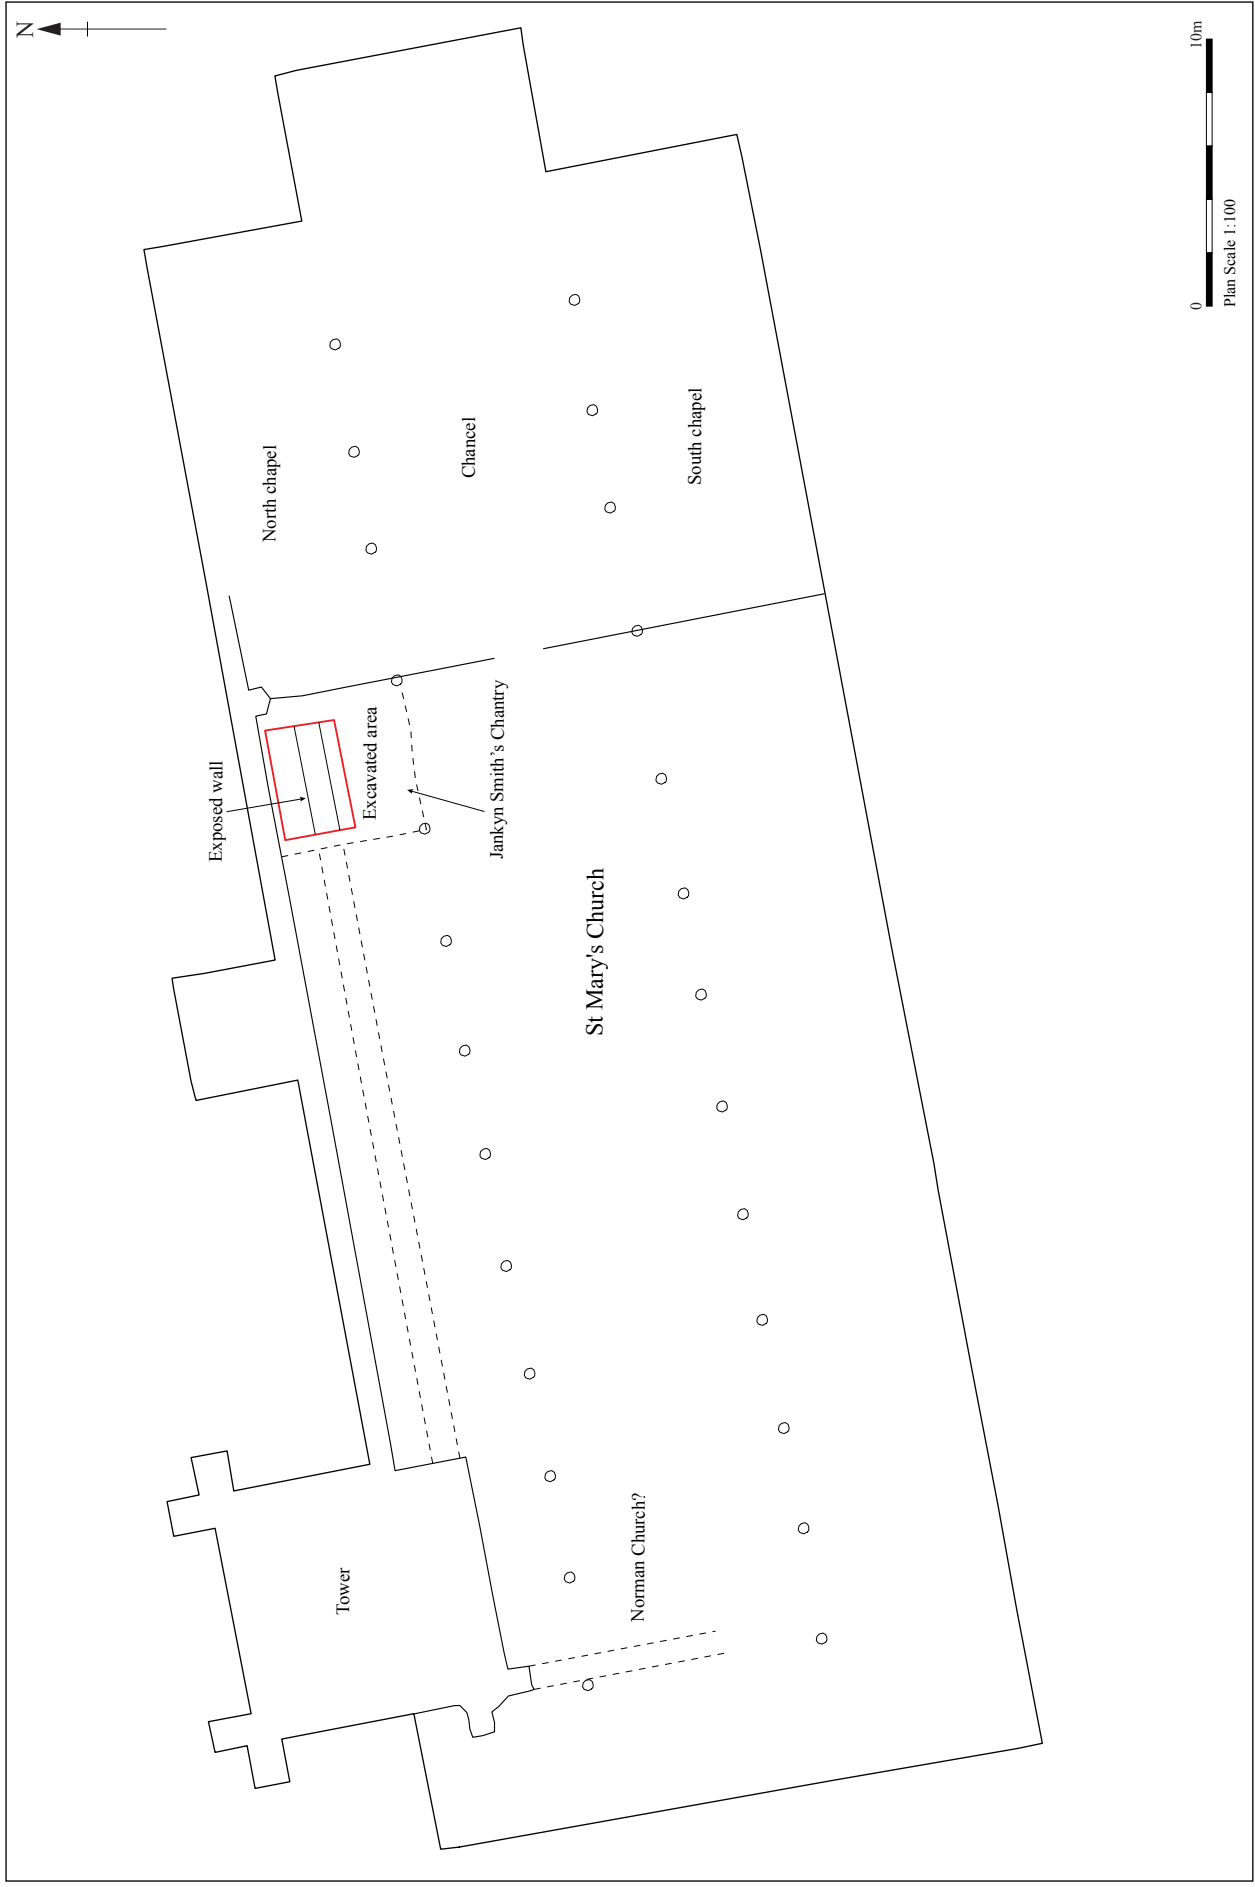
Figure 3. Projection of the stub wall onto a plan of St Mary's indicating the likely course of the Norman wall in relation to the tower and the Norman frontage of the church as suggested by Claire Paine (per.con.).

An interpretation of the stub of the substantial flint and mortar wall appears in Figure 3. It is believed to be the original north wall of the smaller Norman church built in the 12th century and reduced to ground level when the nave and north aisle of St Mary's was widened early in the 15th century. This earlier wall line provides a more symmetrical fit with the church tower, which would have stood as an adjunct to the north west corner of the church, rather than being partially inside as it became in the later medieval period.
