**Jumbos Cottage
Iken Cliff
IKN 112**

Archaeological Evaluation Report

SCCAS Report No. 2014/105

August 2014

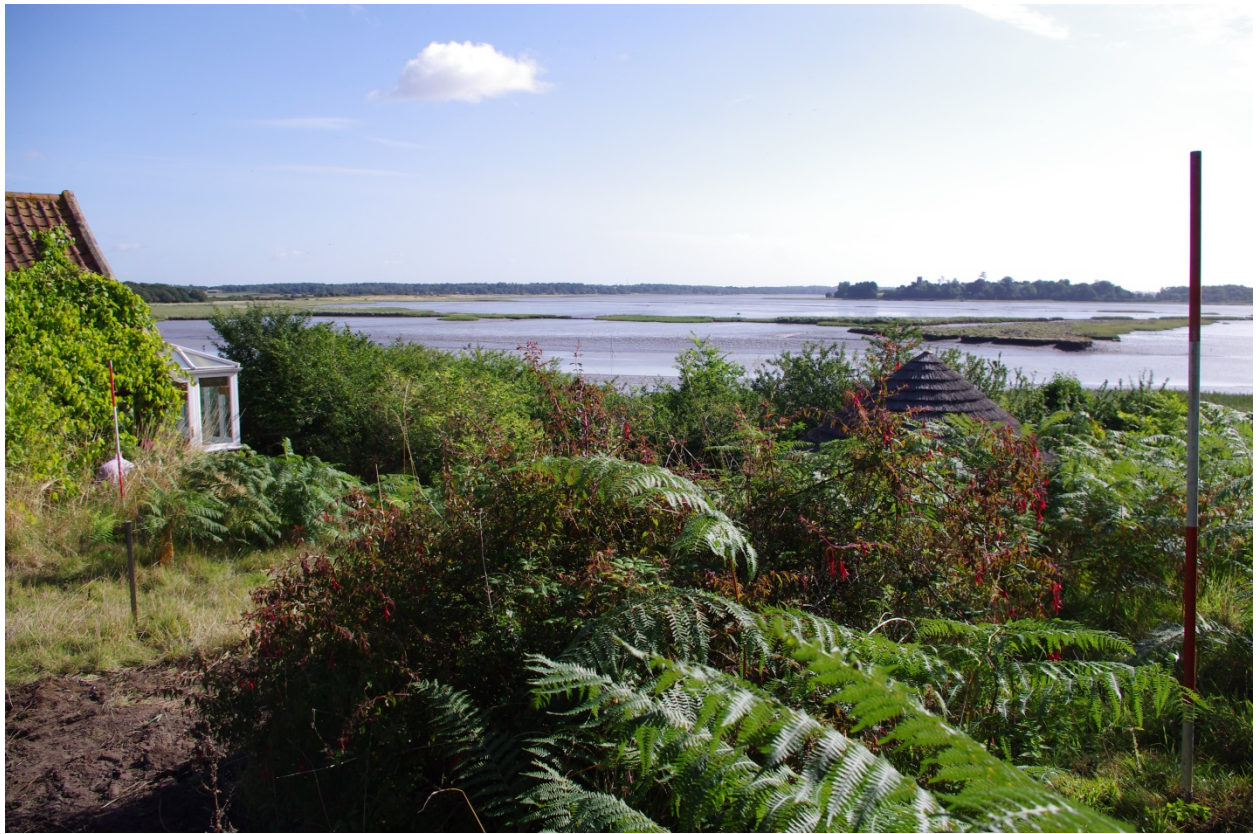
Plate 1. View of site looking across the River Alde towards Iken church. The red and white ranging rods to the left and right indicate the position of where the trench would be dug. The thatched roof in the middle distance is over the lime kiln (IKN 016)

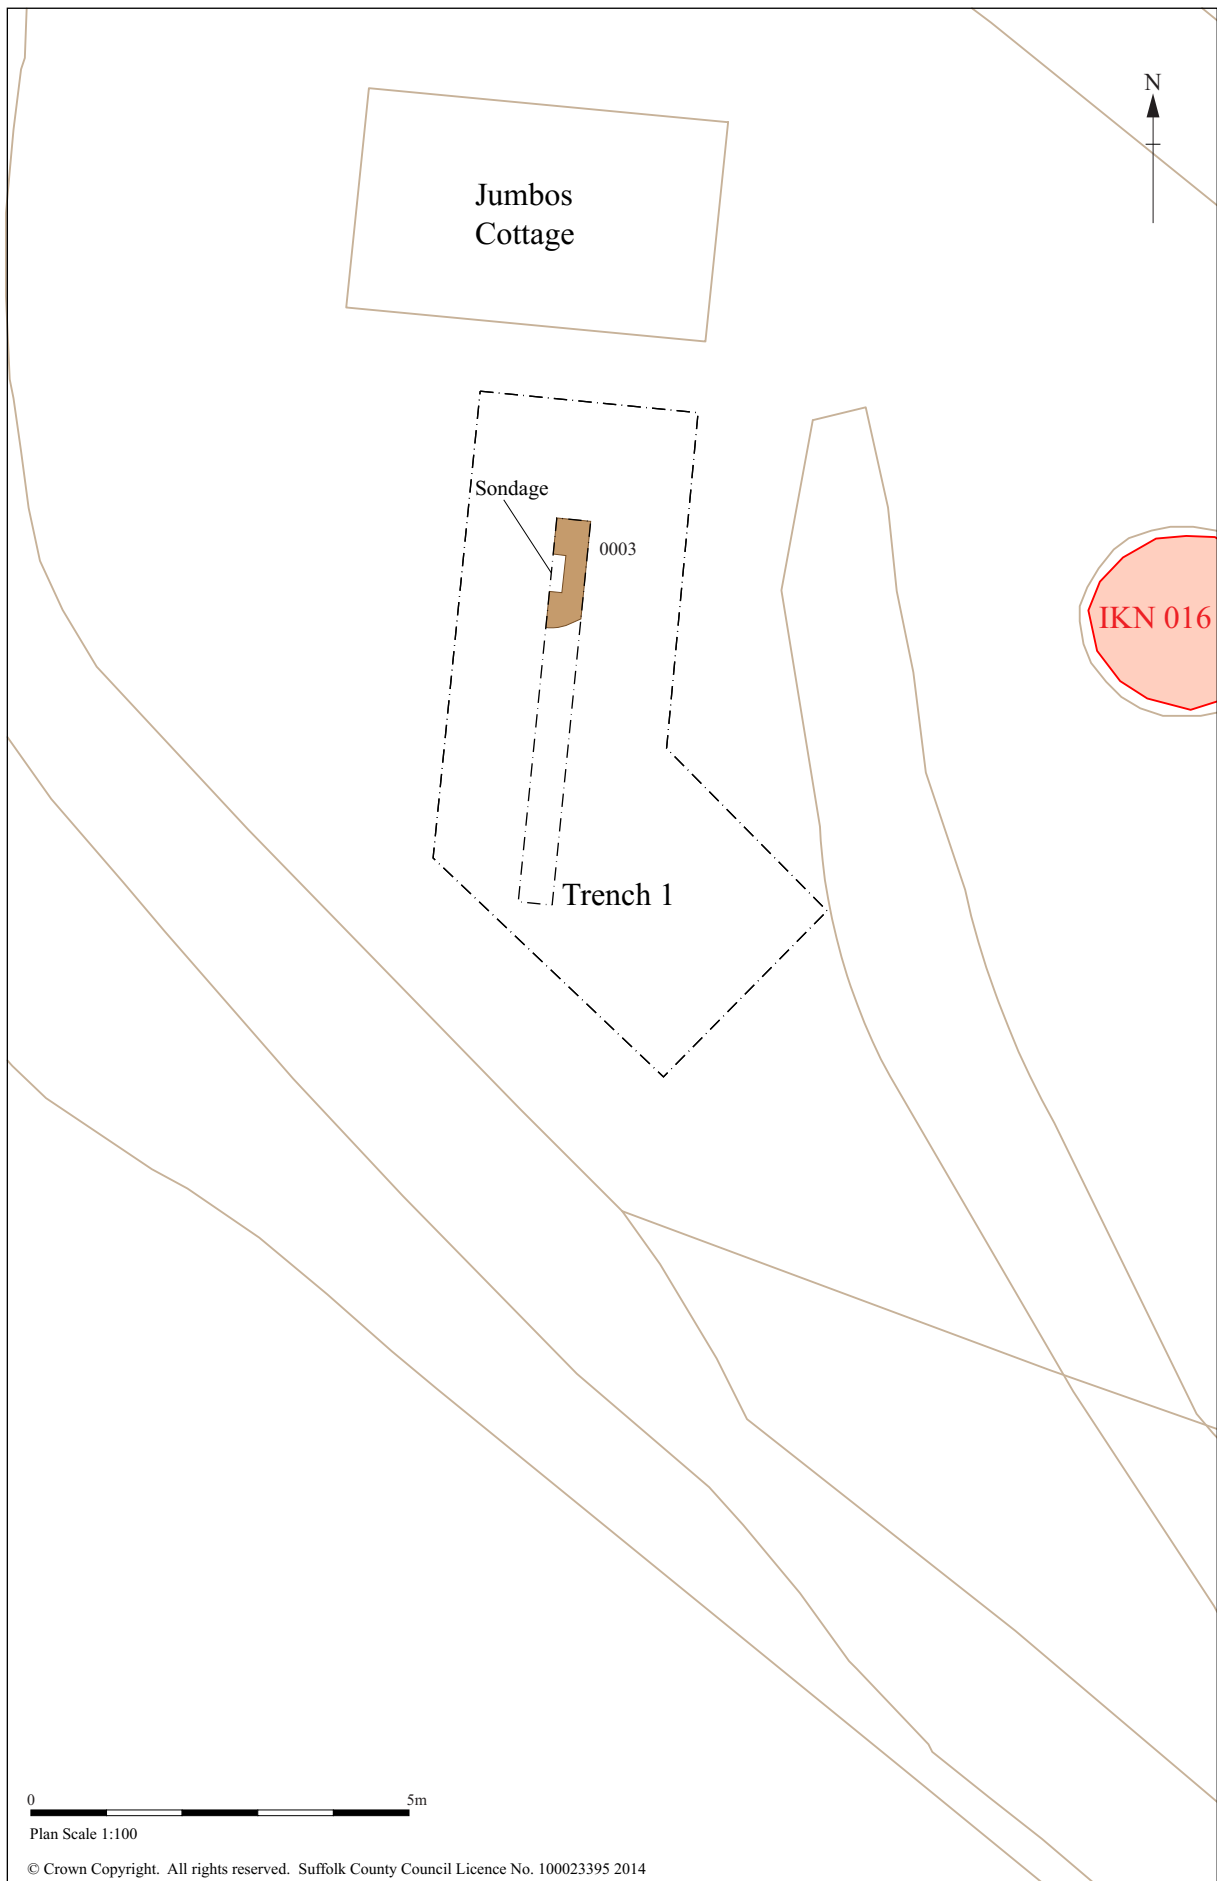
Figure 2. Trench layout

A single trial trench was dug in accordance with the WSI (Appendix 1). Due to a garden retaining wall the trench had to be moved 2.5m to the west but was still within the footprint of the proposed extension. Trenching was conducted using a 360° mini-digger equipped with a 0.9m wide toothless ditching bucket. The location of the trench is shown in Figure 2.

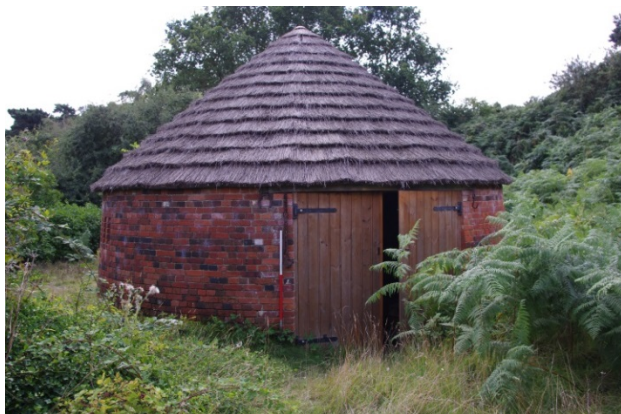
The historic monument adjacent to the site is described as a lime kiln (HER ref IKN 016). It is a circular, slightly conical structure with a diameter of c.5.5m and standing to a height at the eaves of c.2m (Plates 2 & 3). The building is now covered by a conical thatched roof over a timber and plywood superstructure of fairly recent date. North-west facing double-doors with a large oak lintel, a single southeast facing door and a partial concrete floor, occupying the north-eastern third of the building, all appear to be fairly recent additions. The top two courses of brick have new lime mortar and contain occasional sooted bricks unlike the rest of the structure so are unlikely to be original. There are areas of lime mortar repointing or possible rebuilding along the east and north-east facing surfaces that appear fresh. The building is now used for the storage of garden and sailing equipment.

The original building is of brick construction with alternating courses of stretchers and headers (English bond) with a total of 28 courses visible. The bricks themselves are handmade, soft in texture, mainly orange red in colour with some darker red and purple red examples, with very few inclusions. Brick dimensions were c.225mm (length) by c.110mm (width) by c.62mm (height) which makes them very slightly shorter and thinner than a standard 9" Imperial brick.

Plate 2. View of the kiln looking south, showing new roof and double-doors (1m scale)

The circular structure adjacent to the site (IKN 016) and described as a lime kiln was in remarkably good condition but with many recent modifications. The addition of the circular thatched roof has protected the building well and most of the other additions have been sympathetically achieved with lime mortar used in all repairs. No sooting or scorching was observed internally so the interpretation as a kiln could not be supported. It seems possible however that an internal structure (an upturned cone-like arrangement found in other lime kilns) might have been removed. If any future modifications of the kiln are planned then it is recommended that it be recorded by a specialist building historian.

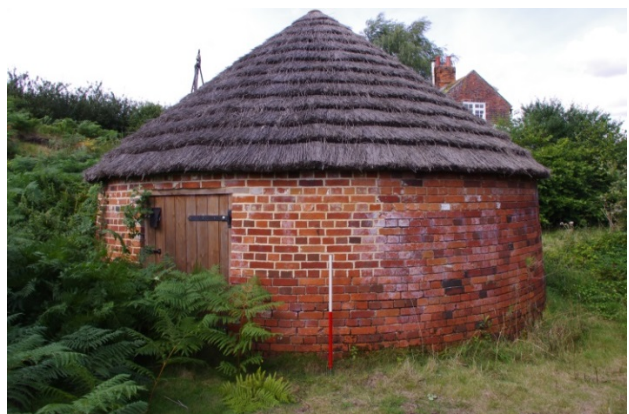
Plate 3. View of kiln looking west, showing rear single door and area of recent repointing

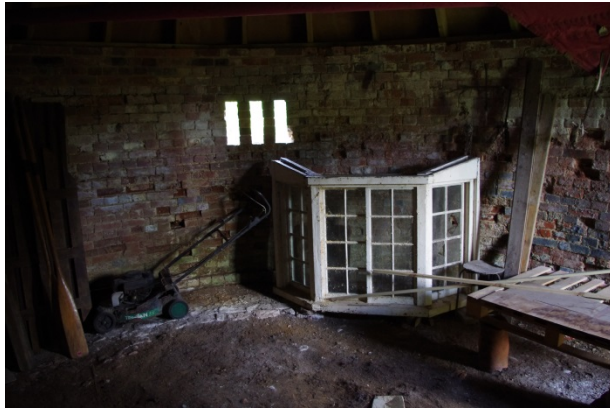
Slit windows, each with three narrow apertures face approximately north-east and south-west (Plate 4). These appear to have the same pointing as the majority of the structure and do not interrupt the bond or appear to be cut in so could be original, although the bricks chosen for the edge and mullions do seem to be slightly paler than the surrounding brickwork.

The inside of the building was very dark and difficult to see but no sooting, scorching or other evidence of it being a kiln was observed. The internal face of the wall had an offset course near its base within which pale grey to cream bricks were laid on the floor (Plate 5). These are highly damaged, removed or covered in many places but probably were laid in concentric circles towards the middle of the floor.

Plate 4. Internal view looking south-west showing slit window and partial floor of white bricks

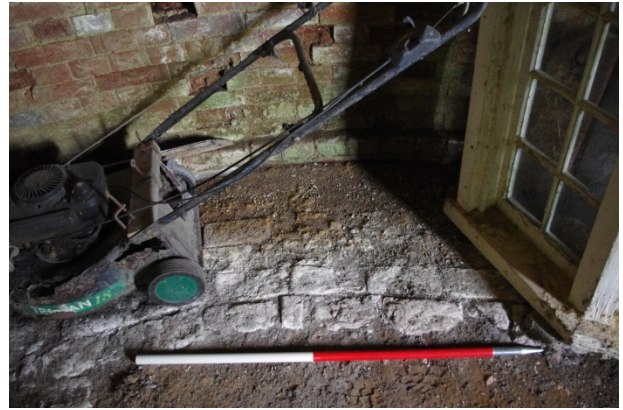
Plate 5. Detail of floor bricks with off-set red brick course above (1m scale)

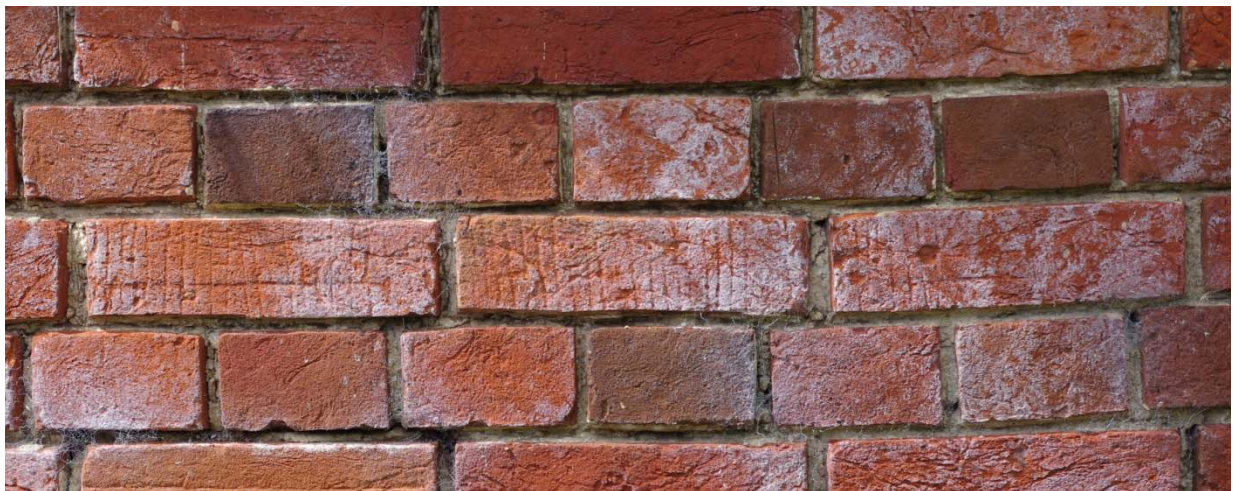
On the outside on the north-east facing surface three bricks appeared to have possible tally marks scratched into them (Plate 6). These were vertical or near vertical scratches covering the whole depth of the brick's surface. Starting from the east and working anti-clockwise, the left-hand brick had 22 striations over its entire surface, the central brick had 20 marks with a small gap at the right-hand end left unmarked and the right-hand brick had only seven scratches, positioned at its left-hand end.

Plate 6. Detail of the three bricks with possible tally marks, looking south-west

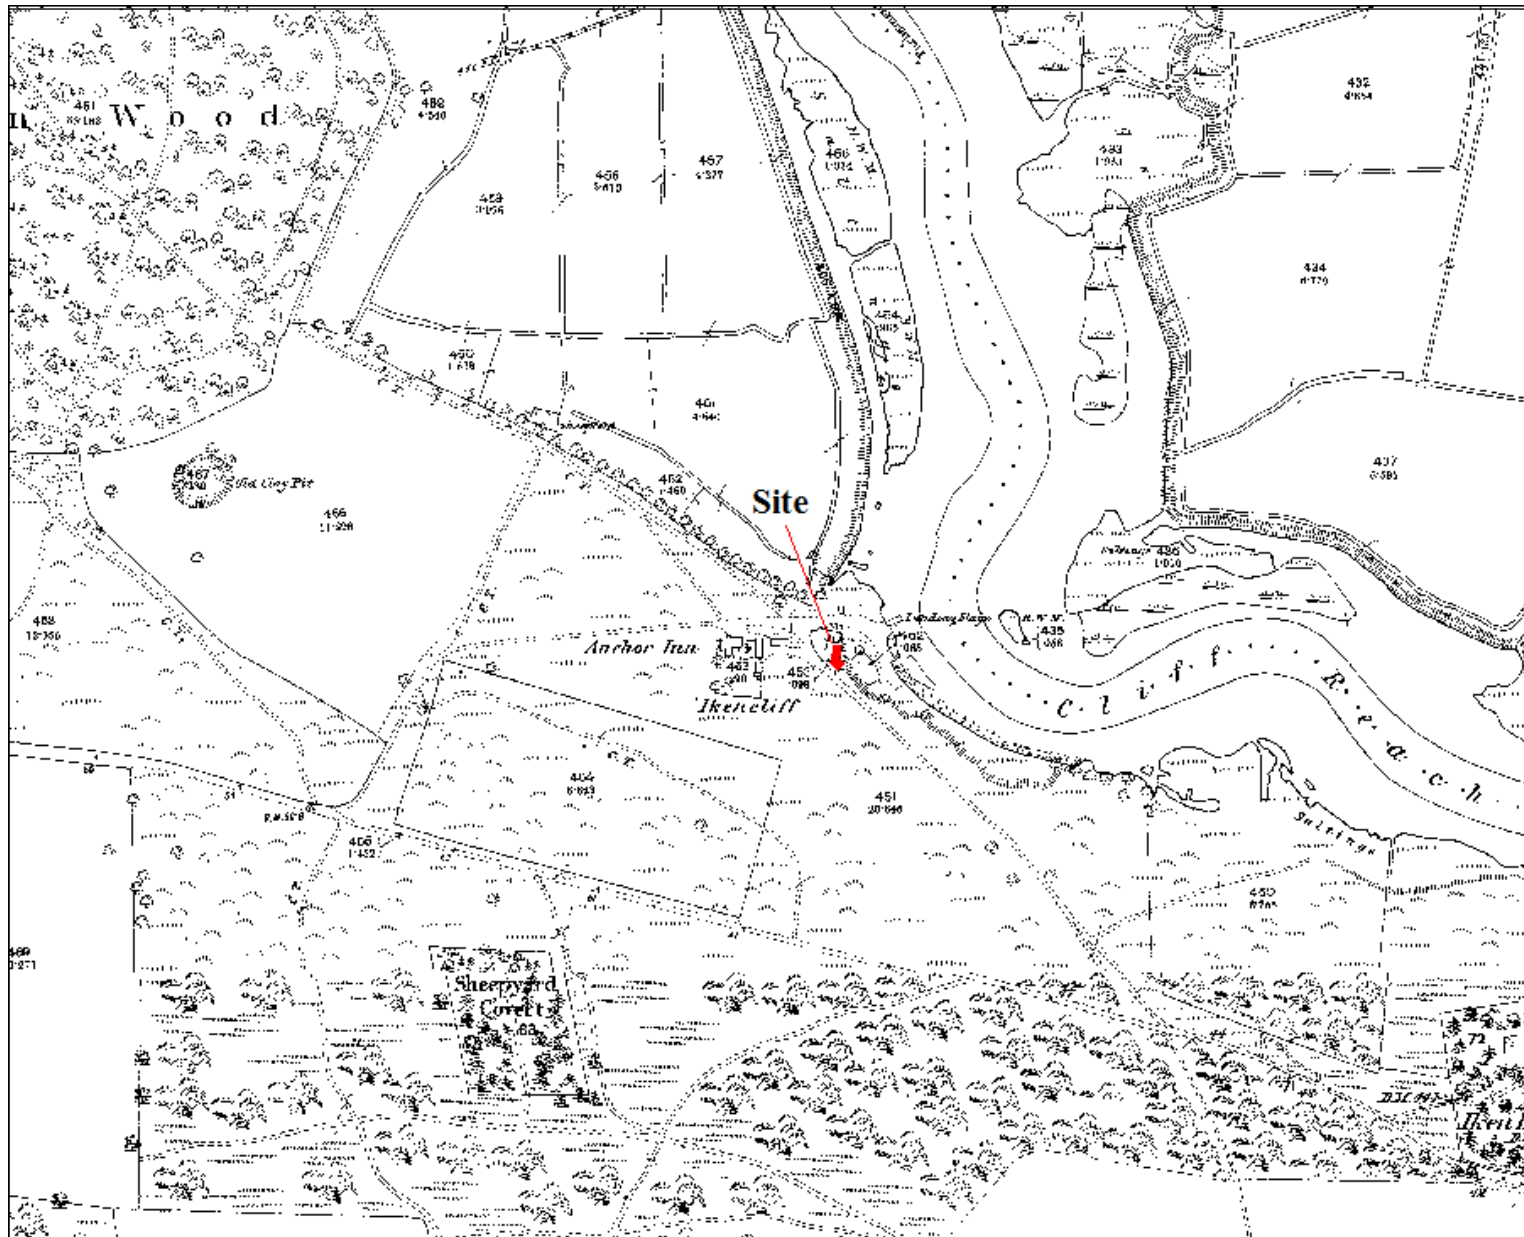
The first edition Ordnance Survey map (Fig. 3) shows that this area was a hub of activity on the south bank of the River Alde during the 1880s. This complex was associated with a landing stage while several other preserved timber structures on the foreshore (Fig. 1: IKN 020 & 090) might indicate contemporary or earlier jetties or quaysides. A notice placed outside the lime kiln links this structure to the Rope family who were local farmers, corn and coal merchants. It is uncertain where the chalk for the lime kiln came from and it might have come in by barge, perhaps as ballast. The kiln appears to be situated within an excavated quarry but it seems more likely that this was for the extraction of sand. The early Ordnance Survey map (Fig. 3) does show a clay pit to the west and this might have included chalk. A spread of chalk fragments observed within the topsoil of the excavated trench does indicate that chalk was present on site.

Figure 3. Site area in relation to the First Edition Ordnance Survey map (c. 1880)
