**St. Mary's Church,
Grundisburgh,
Suffolk.
GRU 046**

Archaeological Evaluation Report

SCCAS Report No. 2014/112

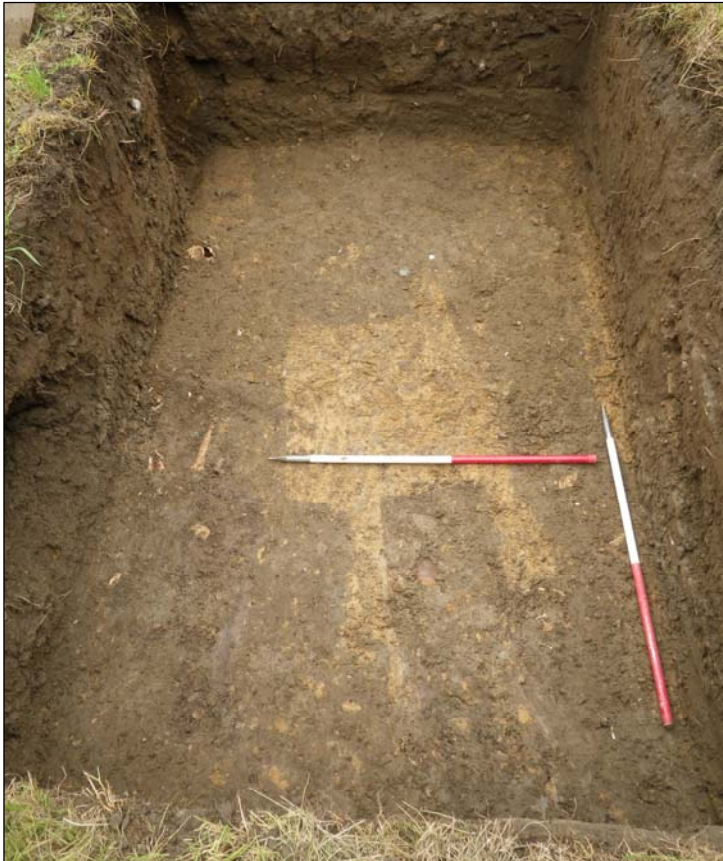
Plate 5. Trench 2, looking SW

This trench measured 3.2m x 1.8m and was excavated to a depth of 1.1m through the following soil sequence:

- *Topsoil* dark brown sandy loam. 0.16m - 0.2m thick
- *Subsoil* (0039) dark-mid brown clay silt with occasional CBM fragments. 0.36m thick. Saxon pottery recovered along with post-medieval tile and clay pipe.
- *Subsoil* (0037) dark grey brown clay silt, possibly a former topsoil from which only Saxon pottery was recovered.
- *Natural subsoil* mid-pale yellowish brown clay

At least 15 approximately east to west grave cuts were identified in the base of the trench, all of them intercutting. Grave 0031 was the only one for which an approximate age could be confidently assigned, given that it comprised the stain of a small, six-sided infants coffin measuring 0.85m long. This traditional coffin shape dates from the later post-medieval period.

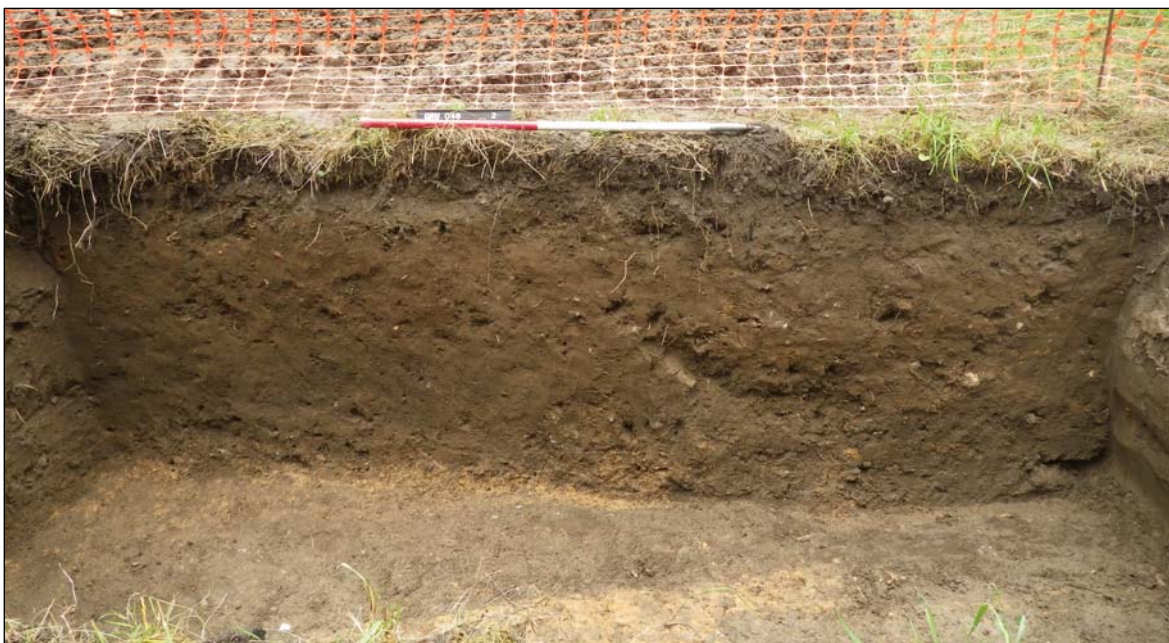
Plate 6. Trench 2, SW-NE section

The construction cut relating to the boiler house was visible in the SW corner of the trench and measured 22cm. The distance between the roof and floor of the boiler house measures 3.7m.

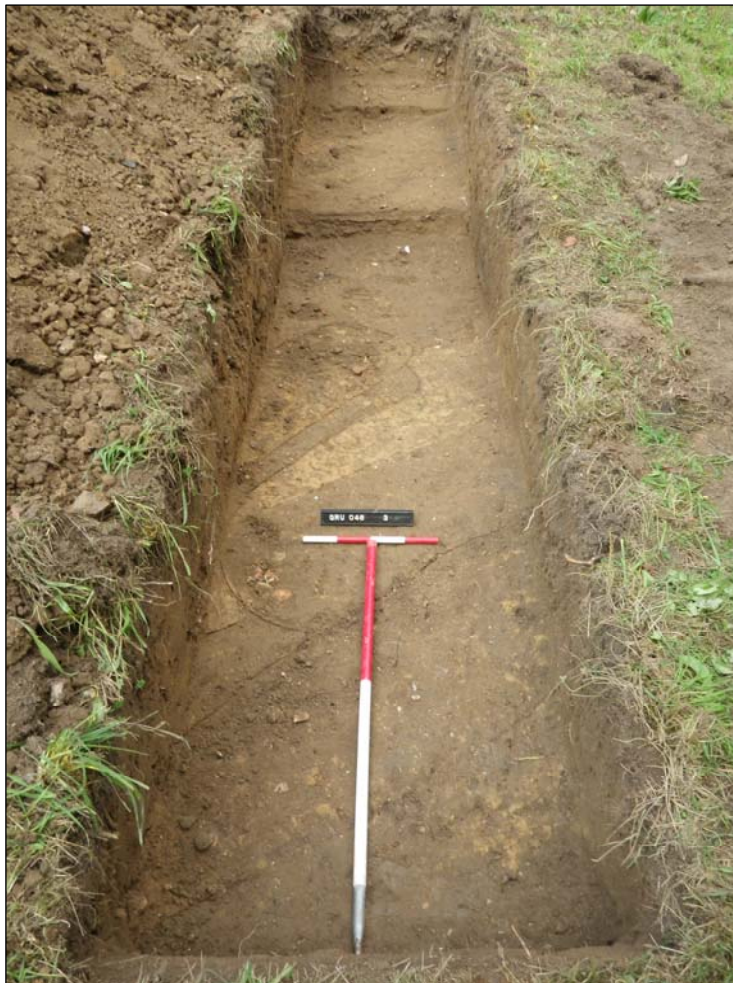
Plate 7. Trench 3, looking NNE

This trench was excavated NNE-SSW in order to assess the full stratigraphic sequence where apparent landscaping may have truncated archaeological deposits. The trench measured 5m x 0.9m and was excavated through the following soil sequence:

- *Topsoil* dark brown sandy loam. 0.18m thick
- *Subsoil (0040)* mid brown sandy clay with occasional CBM fragments. 0.3m-0.64m thick.
- *Natural subsoil* mid-pale yellowish brown clay

At least nine graves were identified, two of which (0017 and 0018) were infants buried in rectangular caskets. 0017, 0018 and 0019 cut subsoil layer 0040, as did 0016, the cut of which could be seen in section immediately below the topsoil.

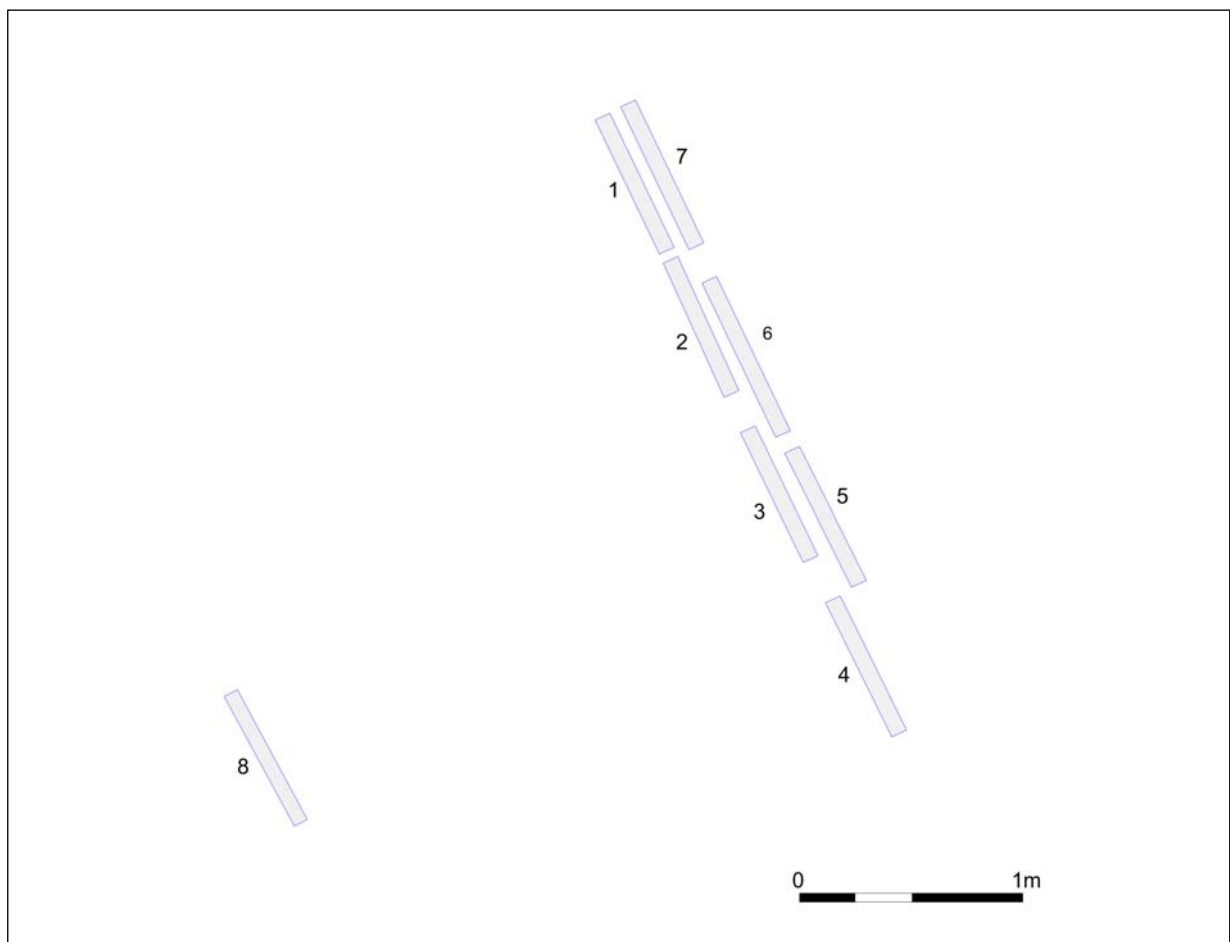
Figure 6. Locations of recorded headstones

Eight headstones on the north side of the church lie within the proposed development area, as shown on Figure 2. Each was photographed, measured and their locations in relation to each other were planned (Figure 6).

Transcriptions of each headstone were recorded, as far as possible; erosion, lichen and ivy had impacted each headstone to some degree.

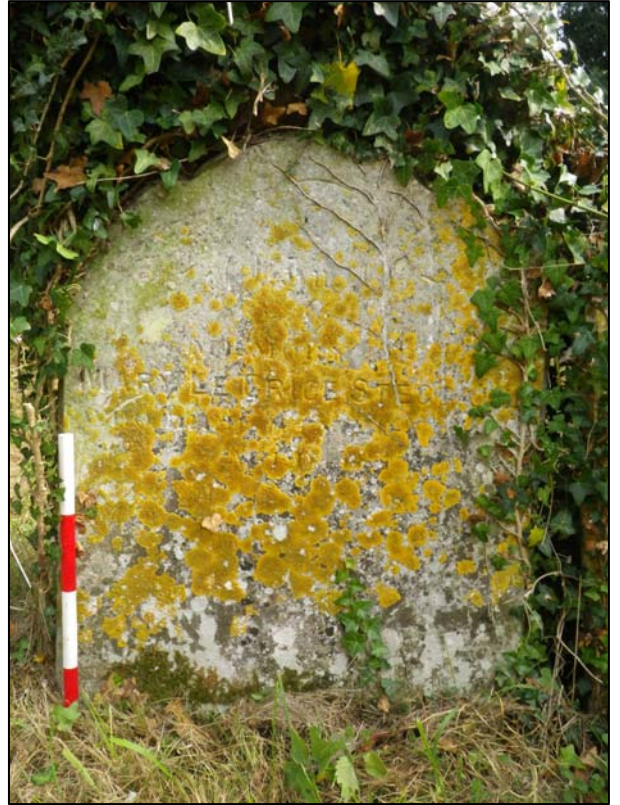
In
MEMORY OF
MARY LE GRICE STEGGALL
WHO DIED JULY [illegible] 1866
[illegible]

*burial records indicate died 29th July 1866
aged 58*

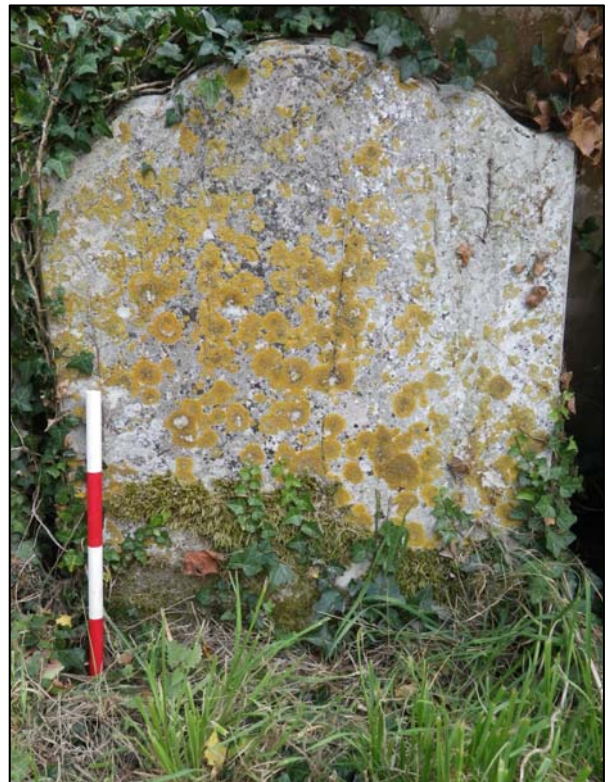
2

[illegible]
WILLIAM STEGGALL
[illegible]
[illegible]

*burial records indicate William Steggall,
died 5th January 1851, aged 67*

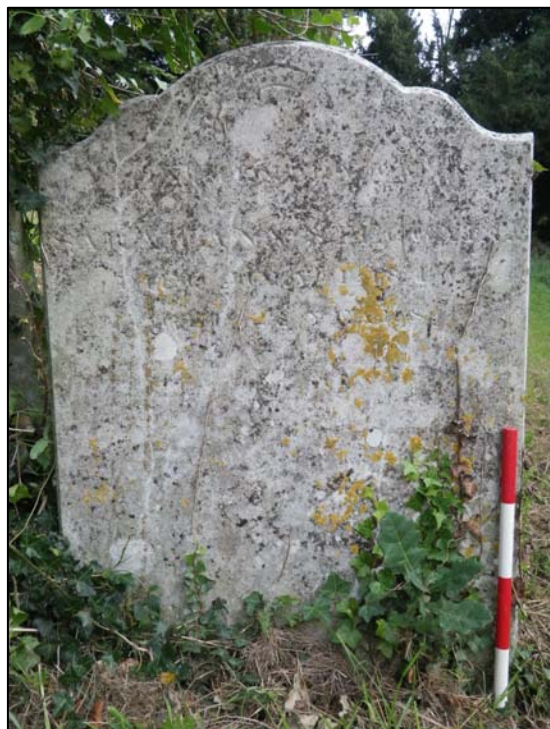
IN MEMORY OF
SARAH ANN STEGGALL
DIED JULY 4 1846
AGED 28 YEARS

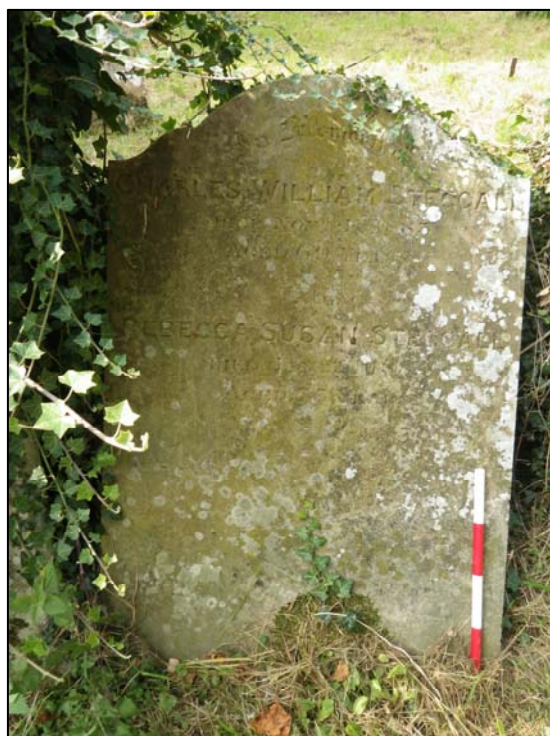
6

In Memory of
CHARLES WILLIAM STEGGALL
DIED NOV^R 4TH 1883
AGED 69 YEARS
Also
REBECCA SUSAN STEGGALL
DIED JAN^Y 2ND 1885
AGED 73 YEARS

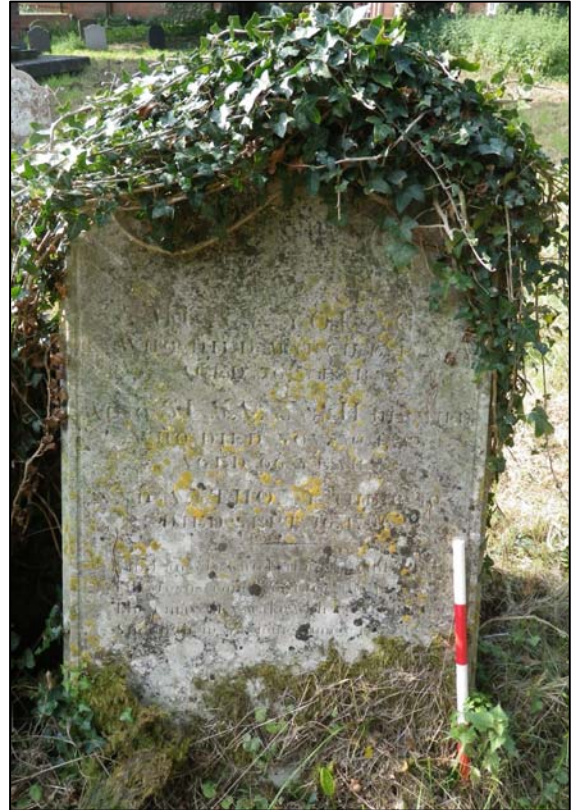
7

In Memory of
 MUNS YOUNG
 WHO DIED MARCH 17. 1828
 AGED 76 Years
 ALSO SUSANNAH HIS WIFE
 WHO DIED NOV. 30 1829
 AGED 66 YEARS
 AND ANTHONY THEIR SON
 WHO DIED SEPT. 16 1796

Kind angels watch [this sleeping dust]
 Till Jesus comes to raise the just
 Then may they wake [in sweet surprise]
 And in their Saviour's image rise.

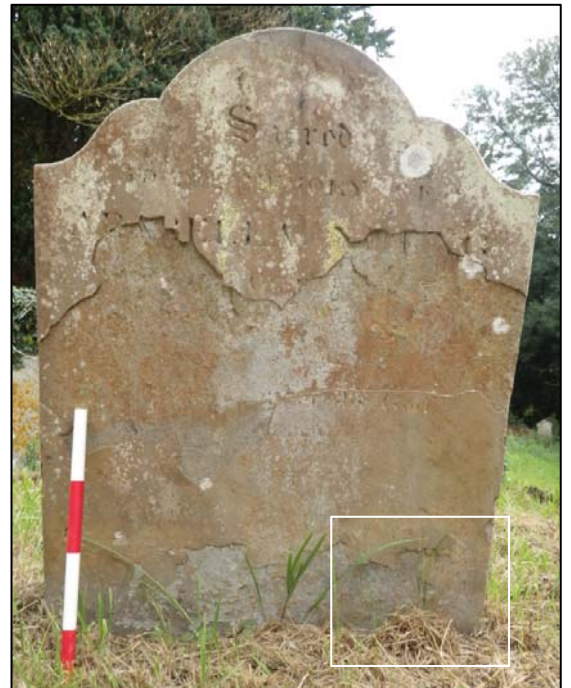
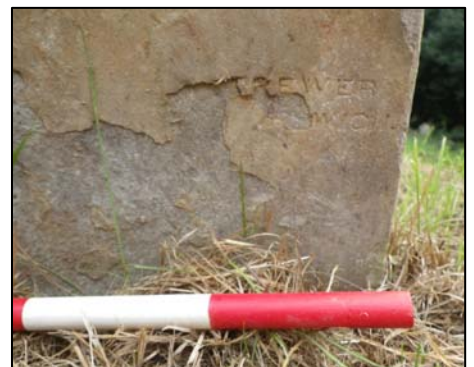
8

Sacred
 TO THE MEMORY OF
 ARABELLA YOUNG
 [illegible] OCT [illegible]
 [illegible]
 [illegible] Thy God

(likely James Frewer, Ipswich stonemason)

*burial records indicate died 15th October
 1873, aged 85*
