110-112 Handford Road  
(former Three Jolly Sailors PH), Ipswich  
IPS 716

Additional trenching

**Archaeological Evaluation Report**

SCCAS Report No. 2014/117

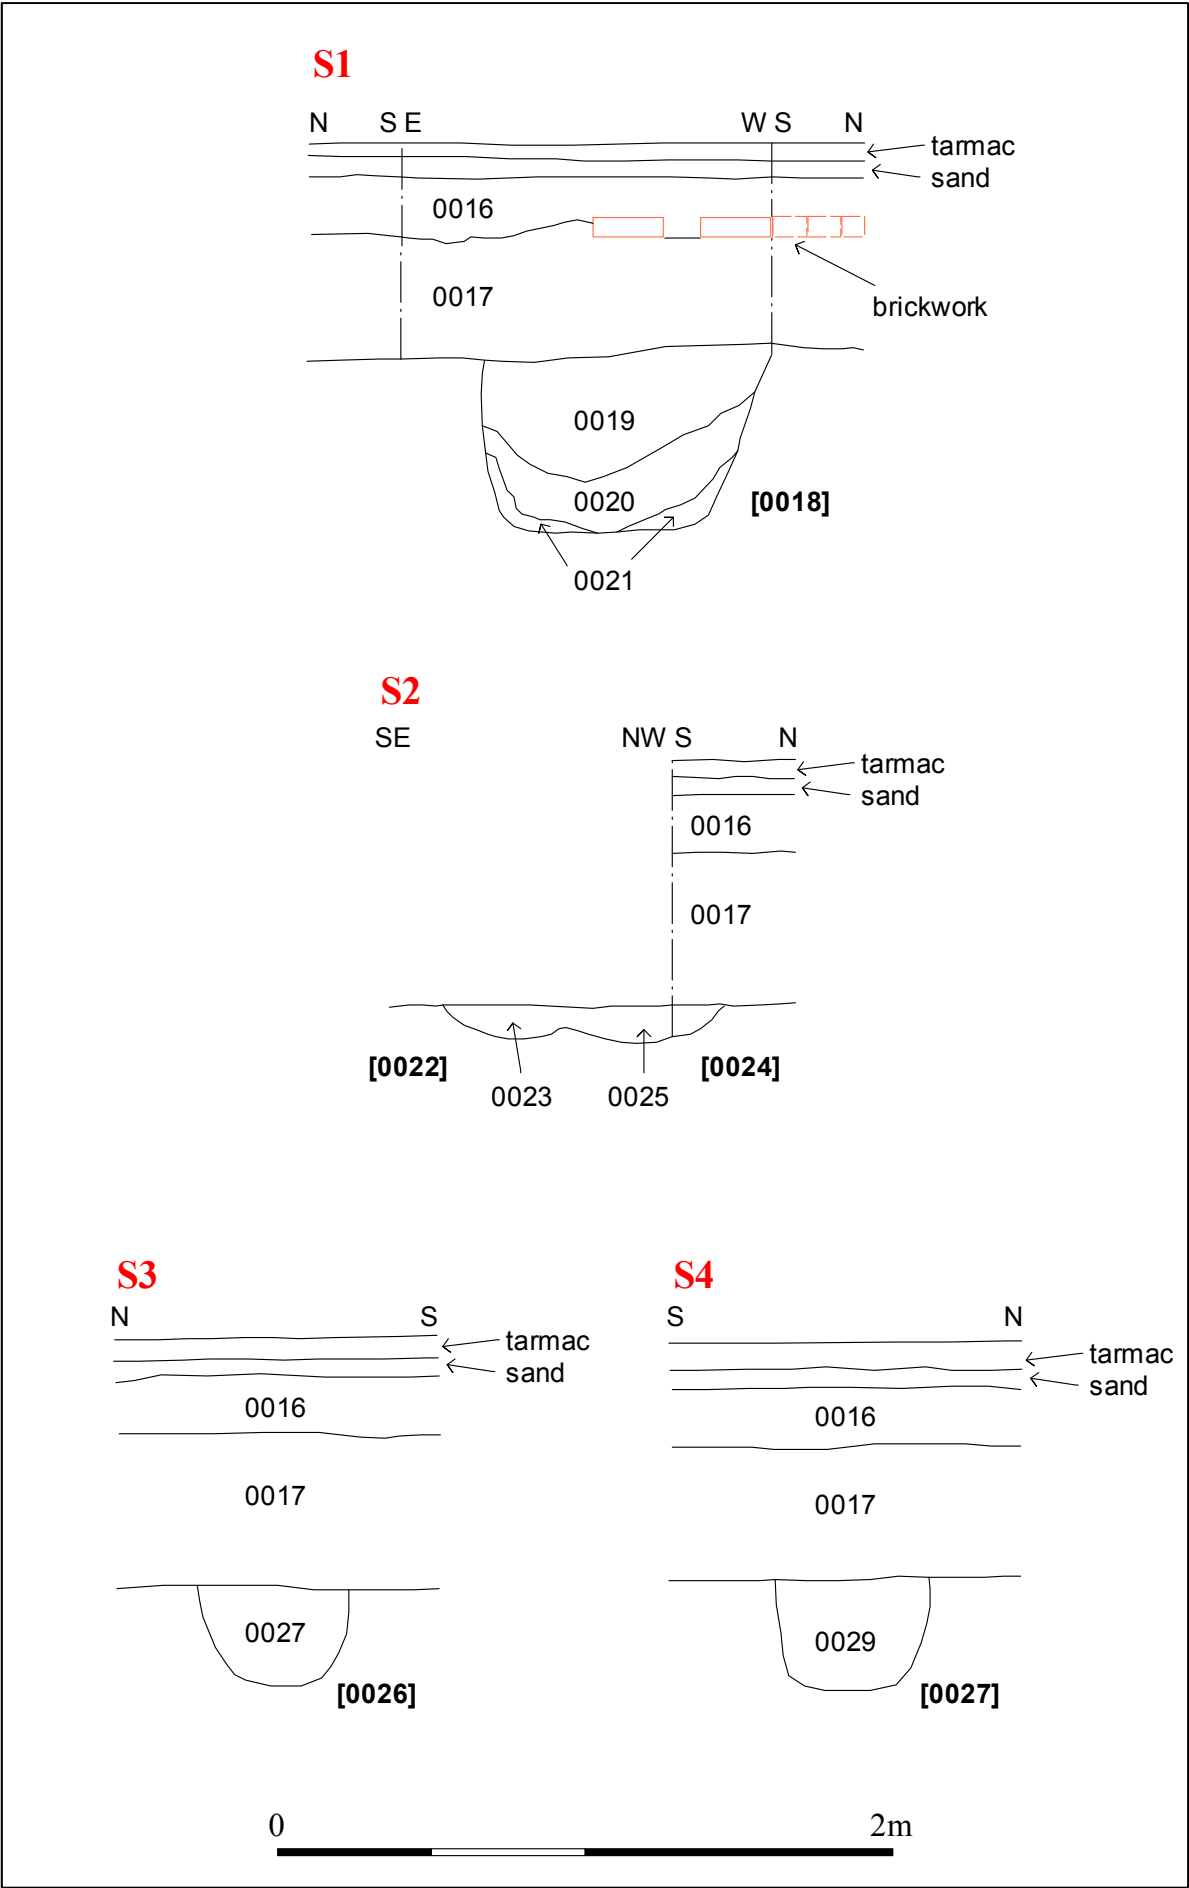
Figure 4. Sections

vertical and the base was flat (the apparently sloping western edge as seen in S1 is due to the excavated section not being exactly vertical). Three fills were evident. The primary fill (0021) comprised a very stony brown-yellow sand which was interpreted as redeposited natural subsoil that had slumped during or immediately after the original excavation of the feature. This was overlain by a deposit of grey-brown sand (0020) beneath the upper fill of mid brown silty sand (0019) from which a moderate amount of Roman tile and a single sherd of pottery was recovered. Features 0022 and 0024 consisted of a pair of similar circular shaped cuts with bowl shaped profiles (Plate 5). Each measured approximately 0.5m in diameter and 0.12m deep. The fills of both (0023 and 0025) comprised mid to dark brown silty sand from which no finds were recovered. Although the features partially overlapped no relationship was visible between these two cuts.

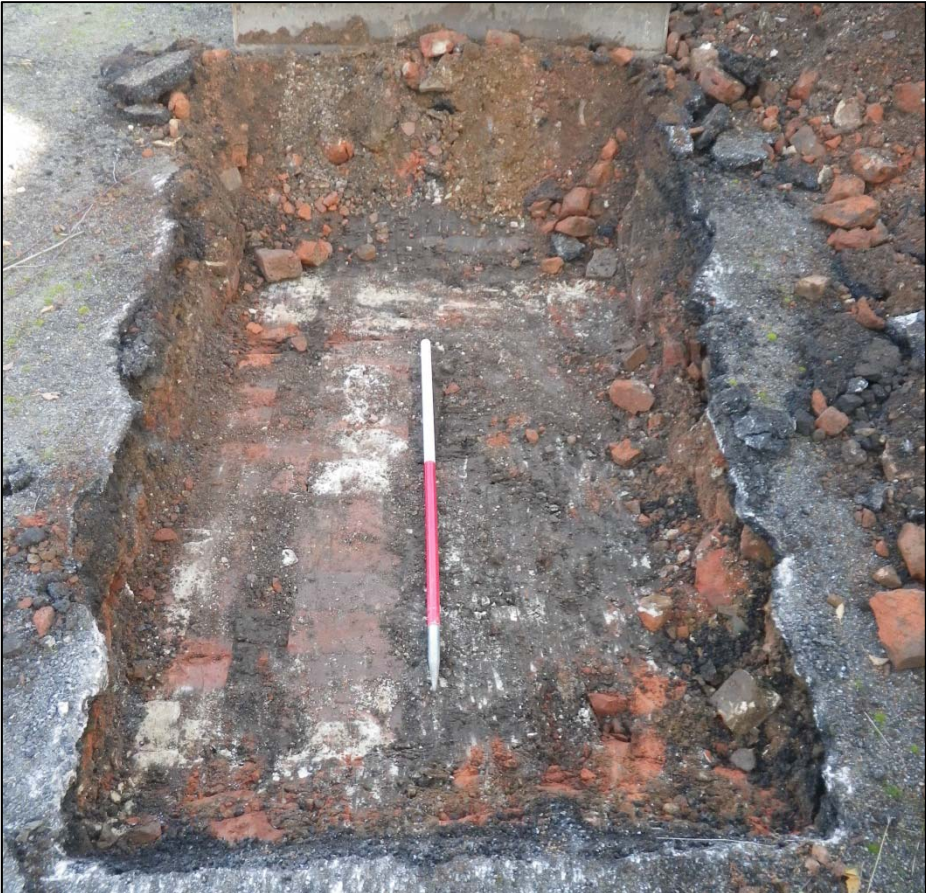
At the southern end of the trench sections of *in-situ* brickwork survived (Plate 1). These were partly cut into the surface of the dark loam (0017) and were sealed by the brick rubble layer (0016). They comprised two short parallel lengths of closely spaced wall bases which met a perpendicular, and slightly more substantial, wall base situated approximately 1.5m from the southern end of the trench and aligned roughly east west (as depicted in Fig. 3).

Plate 1. 19th century wall bases in southern end of the trench (ref. HWS 69)

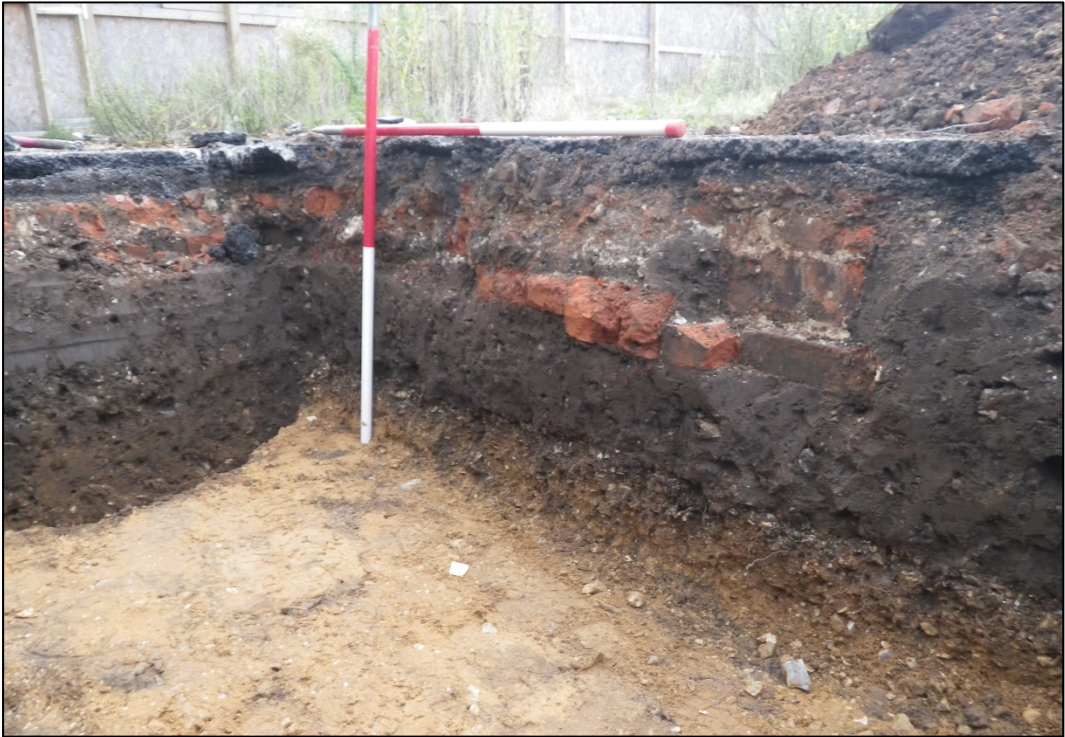
The overburden removed by machine comprised the existing tarmac surface and an underlying formation deposit of yellow-brown sand. This overlay a layer of broken bricks and crushed mortar (0016) which in turn sealed a layer of dark rich loam (0017) that contained very infrequent fragments of red brick and tile. This lower layer appeared to seal all five of the excavated features (visible in Plates 2, 4, 5, 6 and 7).

Plate 2. Brickwork and general view of overburden in southern end of the trench (ref. HWS 71)

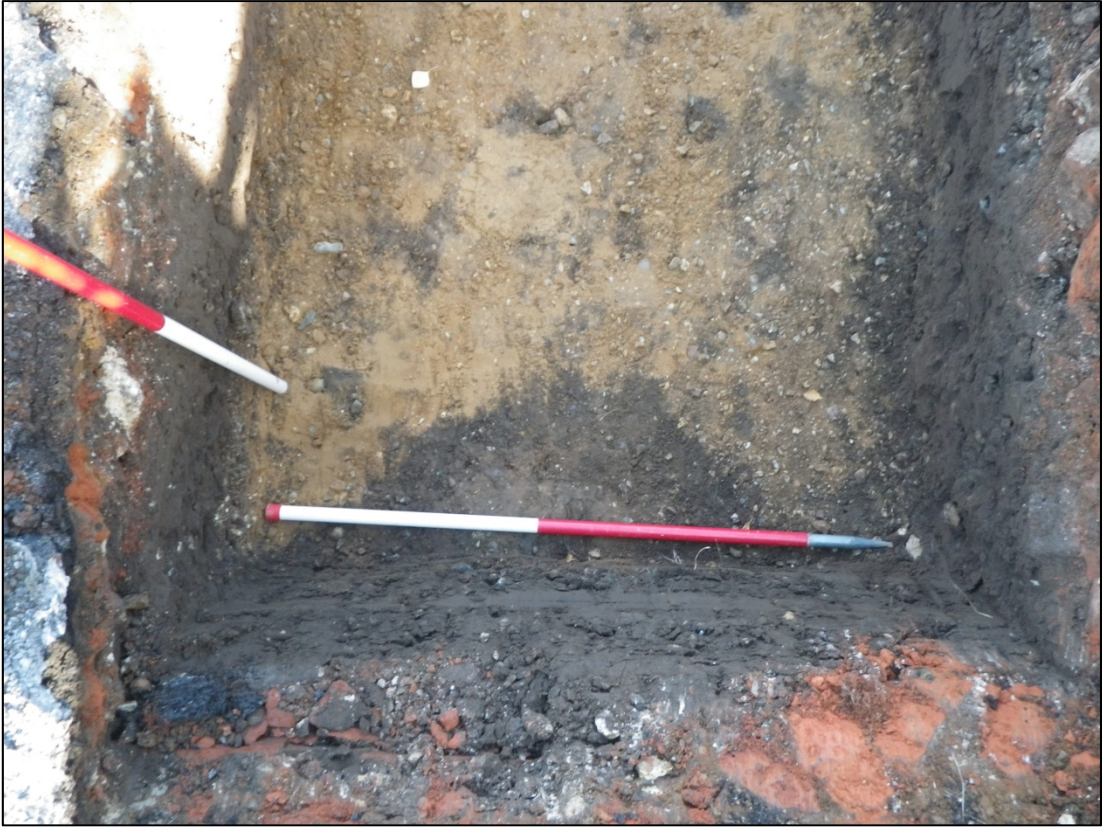
Feature 0018, interpreted as a pit or possible posthole, located at and beyond the southern end of the trench (Plates 3 and 4). The visible portion suggested a square or rectangular shaped feature with rounded corners that had dimensions in excess of 0.6m by 0.6m. The feature cut the natural subsoil to a depth of 0.65m. The sides were near

Plate 3. Pit 0018, prior to excavation, north to top (ref. HWS 73)

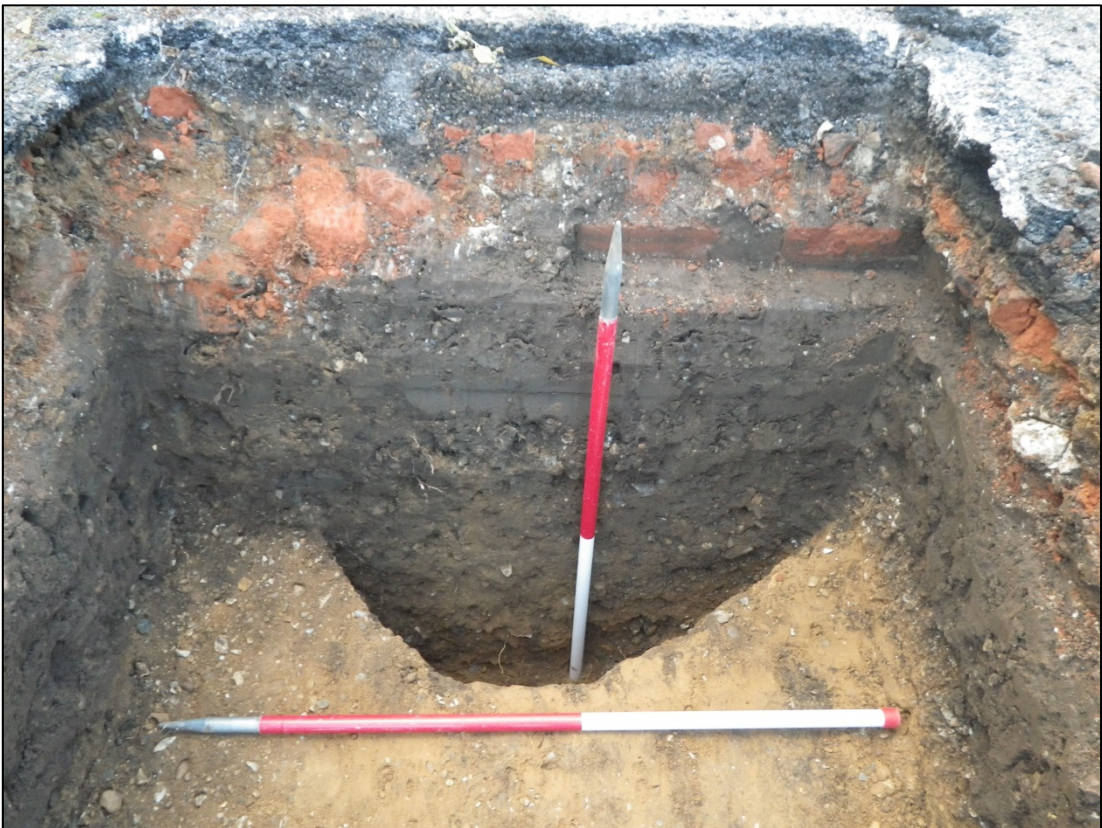
Plate 4. Pit 0018, camera facing south (ref. HWS 76)

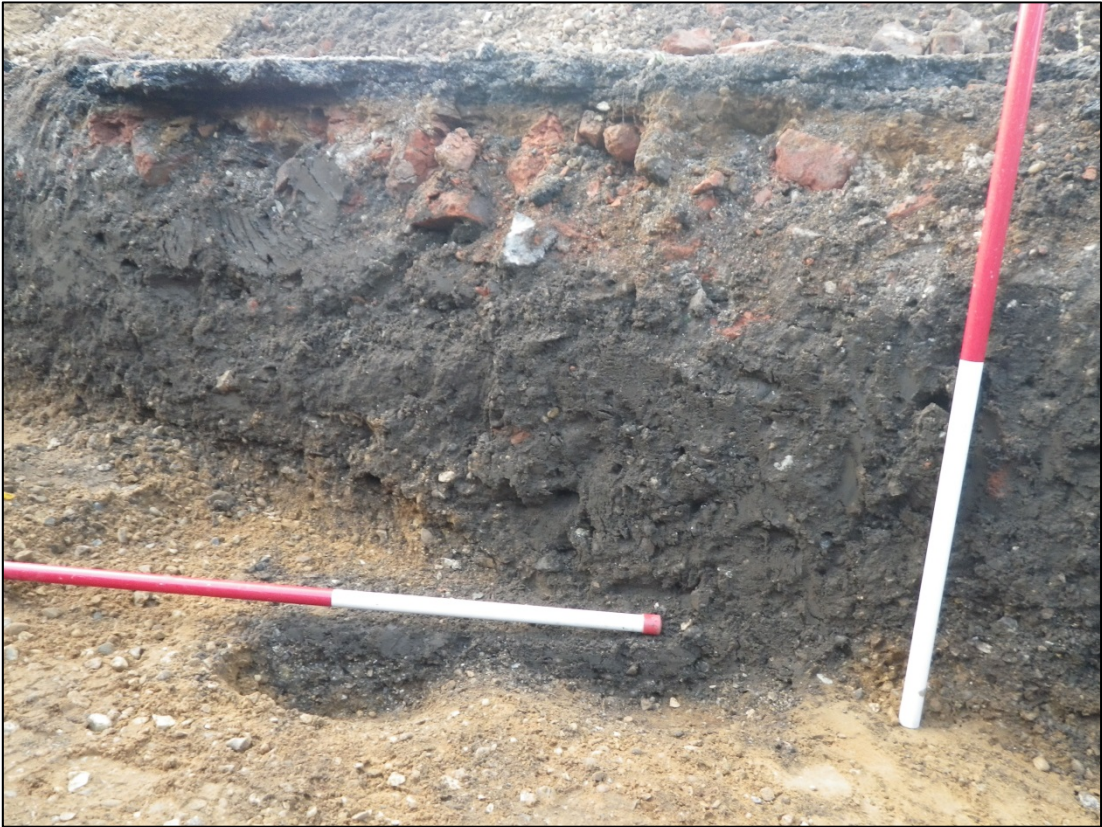
Plate 5. Postholes 0022 and 0024, camera facing southwest (ref. HWS 78)

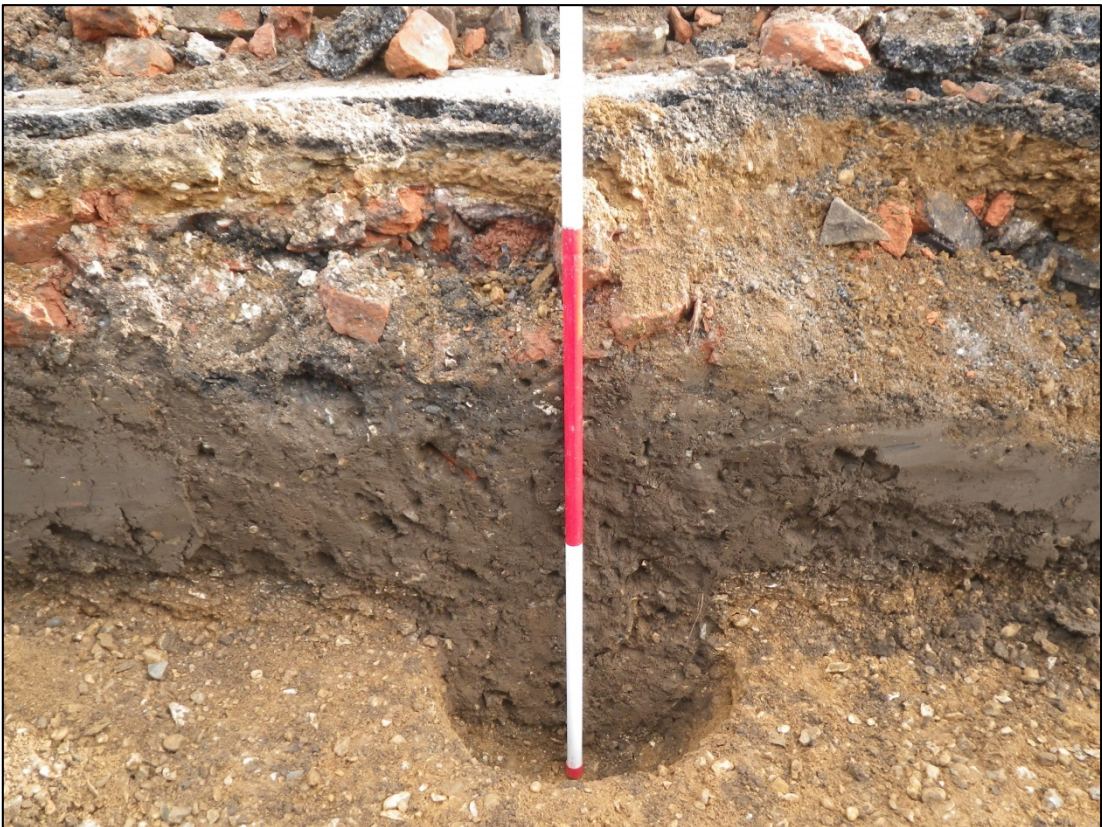
Feature 0026, a probable posthole or small pit located on the eastern edge of the trench (Plate 6). The visible portion suggested it comprised a near sub-circular cut, approximately 0.6m in diameter, which cut the natural subsoil to a depth of 0.34m. The sides of the cut were near vertical down to a flat base. The fill (0027) consisted of a mid to dark brown silty sand from which no finds were recovered.

Plate 6. Posthole 0026, camera facing east (ref. HWS 81)

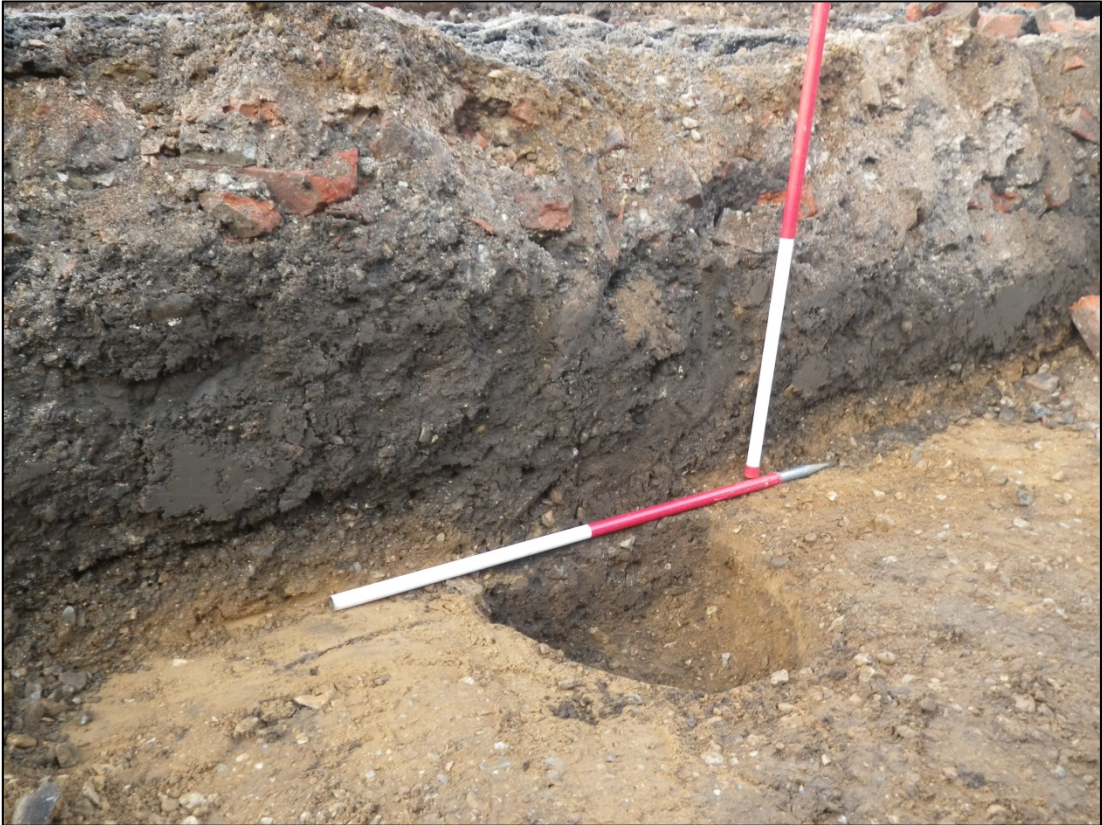
Feature 0028, a probable posthole or small pit located on the western edge of the trench (Plate 7). The visible portion suggested it comprised a near sub-circular cut, approximately 0.5m in diameter, which cut the natural subsoil to a depth of 0.32m. The sides of the cut were steep to near vertical down to a slightly dished base. The fill (0029) consisted of a mid to dark brown silty sand from which no finds were recovered.

Plate 7. Posthole 0028, camera facing northwest (ref. HWS 85)

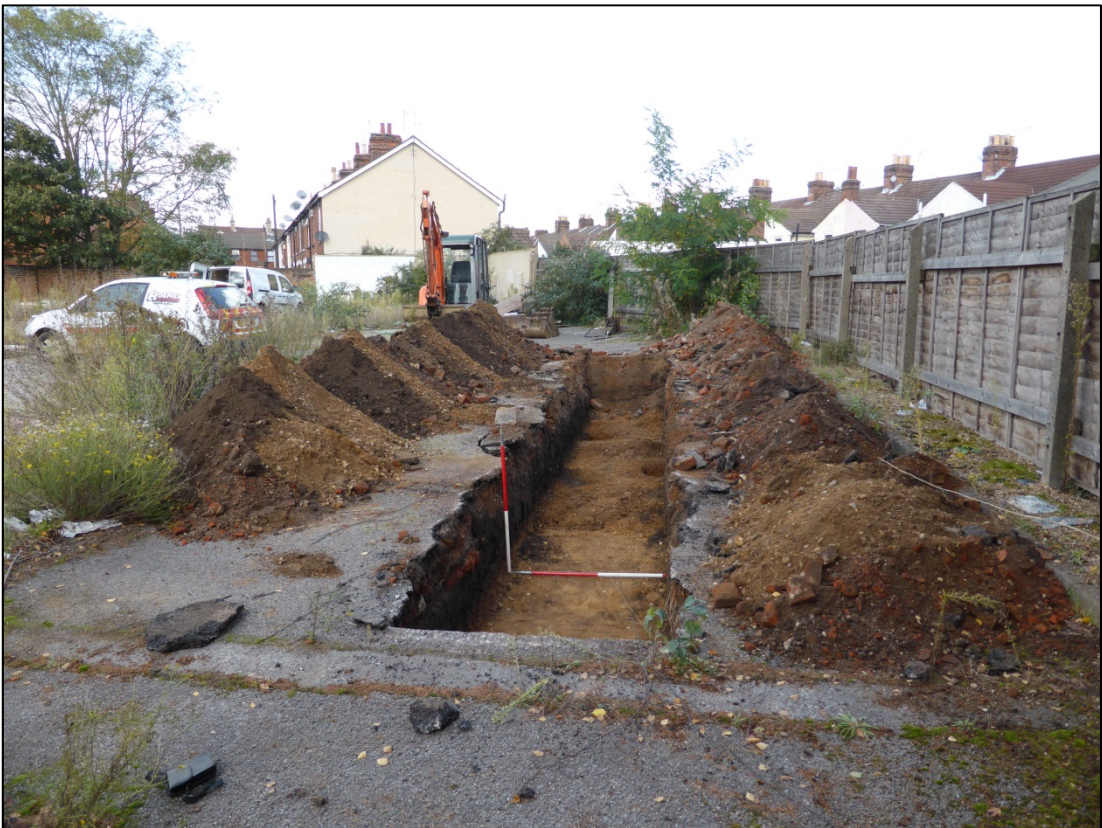
Plate 8. General view of Trench 3, camera facing north (ref. HWS 88)
