Crankles' Corner Wall Survey The Old House, Shire Hall complex BSE 010

Heritage Asset Assessment Report

SCCAS Report No. 2014/097

July/2014

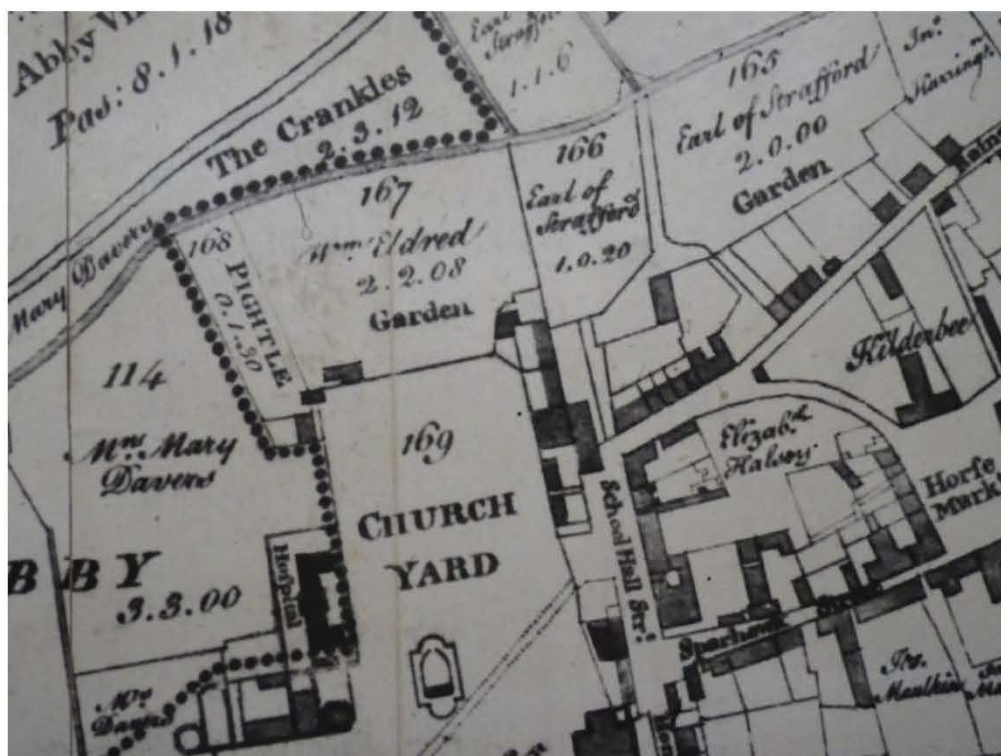
Figure 3. Extract from Thomas Warren's map of Bury published 1776 showing St Margaret's House at the centre of the map. At this time the wall forms the property boundary and the surrounding land was in separate ownership. Warren draws a distinct corner that approximates to the end point of the early section of the wall, this aligns with the north boundary of the St Margaret's House plot west of the stable block suggesting that the stable yard is an enlargement of a 16th century plot. The building enclosed by the wall is the forerunner of the stables that exist today. North is to the left. (BRO ref 373/17)

Following the Dissolution, the entire convent site was initially leased by Sir Antony Wingfield before being sold to John Eyer in 1560. It was conveyed as a single entity but by the 17th century many of the small parcels of land around the margins of the site had been transferred into individual ownership. Property deeds show that the boundaries that divide the south side of the precinct into the land parcels that we see today were already in place by the first quarter of the 18th century; the monk's cemetery was an orchard by 1727 and separate from The Great Churchyard, which was still in private hands until 1798 when it was purchased on behalf of the Borough (Breen 2007). The Warren map shows how the area was divided in 1776 and is annotated with the owner's names (Fig. 3).

level, is brick-built but is raised on the remains of an earlier rubble-built structure (the building shown on the Warren map, Fig. 3) which itself included a fragment of an earlier, possibly medieval building. The south end of the large, early 18th century wall, which separates the car park from the great churchyard, was rebuilt when the stables was added and was possibly realigned to accommodate it.

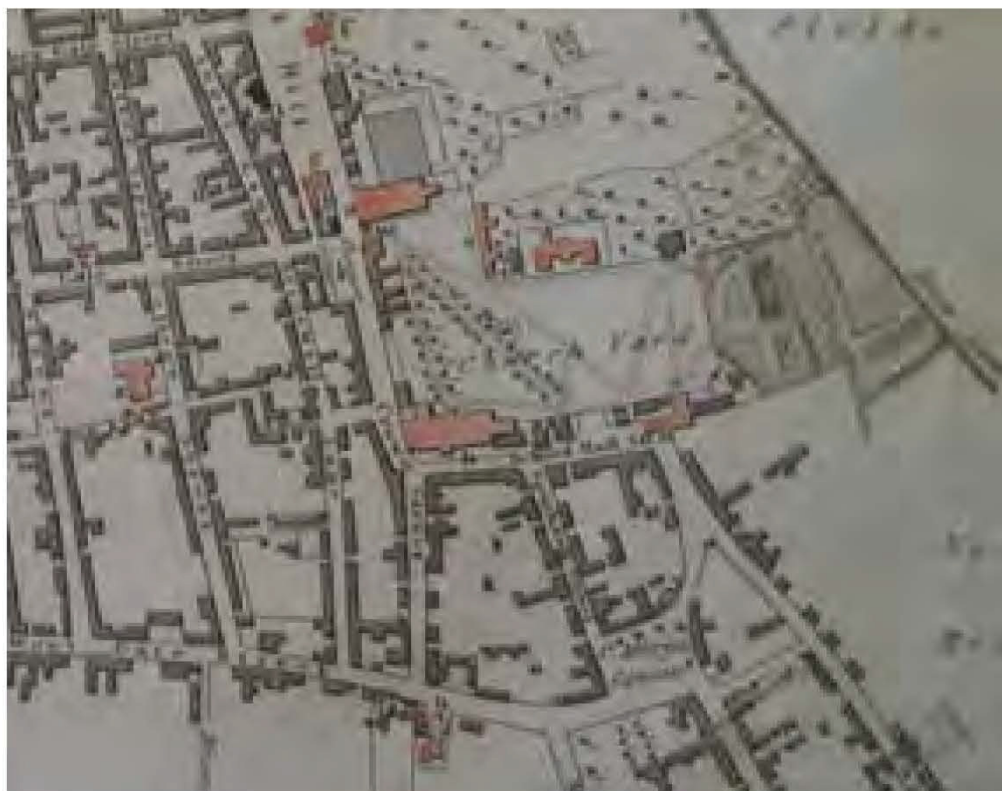
Figure 4. J.G. Lenny's map of Bury, 1823 showing Hudson's famed botanical gardens within the area of the monk's cemetery (now the SCC car park) and the Crankles. North is to the top.

In 1820 the land to the north of the precinct wall (which was being referred to as 'Pleasure Gardens' in earlier deeds) was leased from the Benjafield family for £60 per annum by Nathaniel Hodson, a pioneering botanist who established a garden on the site as a home for his collection of plants. The garden was supported by subscription from the nobility and gentry of the town and stocked with specimens gathered from around the world. Such was the interest in the garden that Hudson was offered the site of the Great Courtyard of the Abbey in 1830 and thus the fore-runner of the Abbey Gardens was opened in 1831. Hudson's original botanical garden is shown on Payne's map of the town of 1823 (Fig. 4).

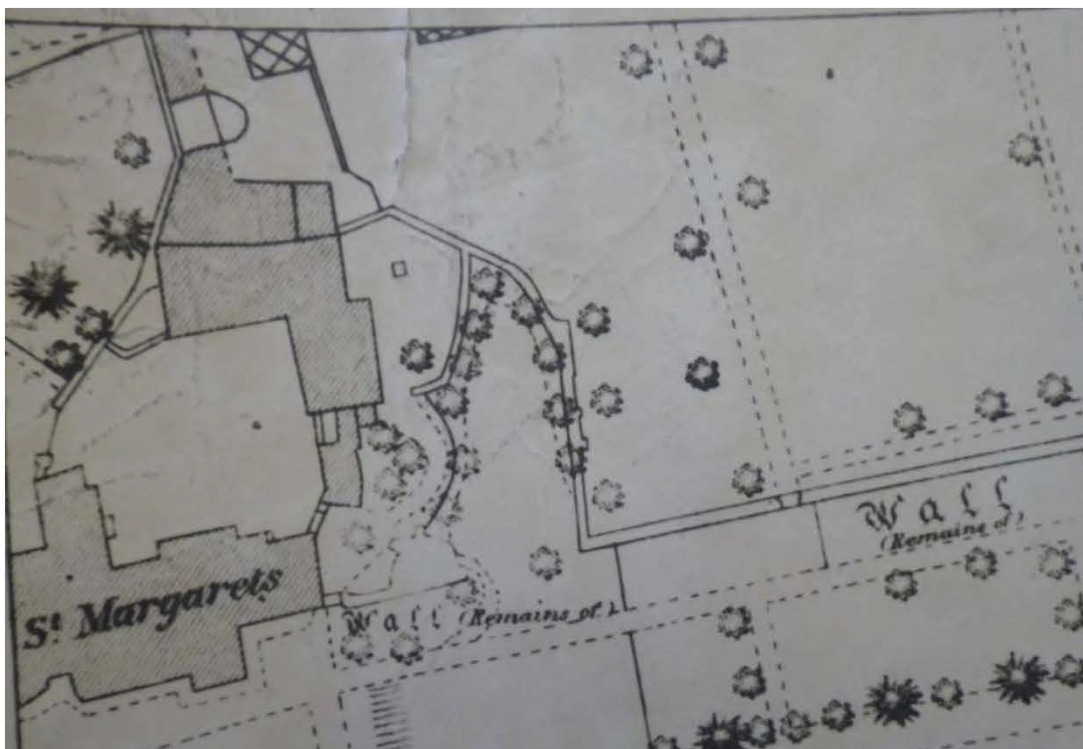
Figure 6. First edition Ordnance survey 1886 showing the breach in the precinct wall and the area to the west of the surveyed wall at the same level as the gardens to the south. The elevated position of the stables and St Margaret's are maintained by a lobed revetment wall closer to the buildings. The plan shows that the size and location of the gap created in the precinct wall was determined by the medieval tower to the west and the surveyed wall; the gap was probably punched through after 1833 when the garden to the south (the new shire hall site) was added to the St Margaret's property.

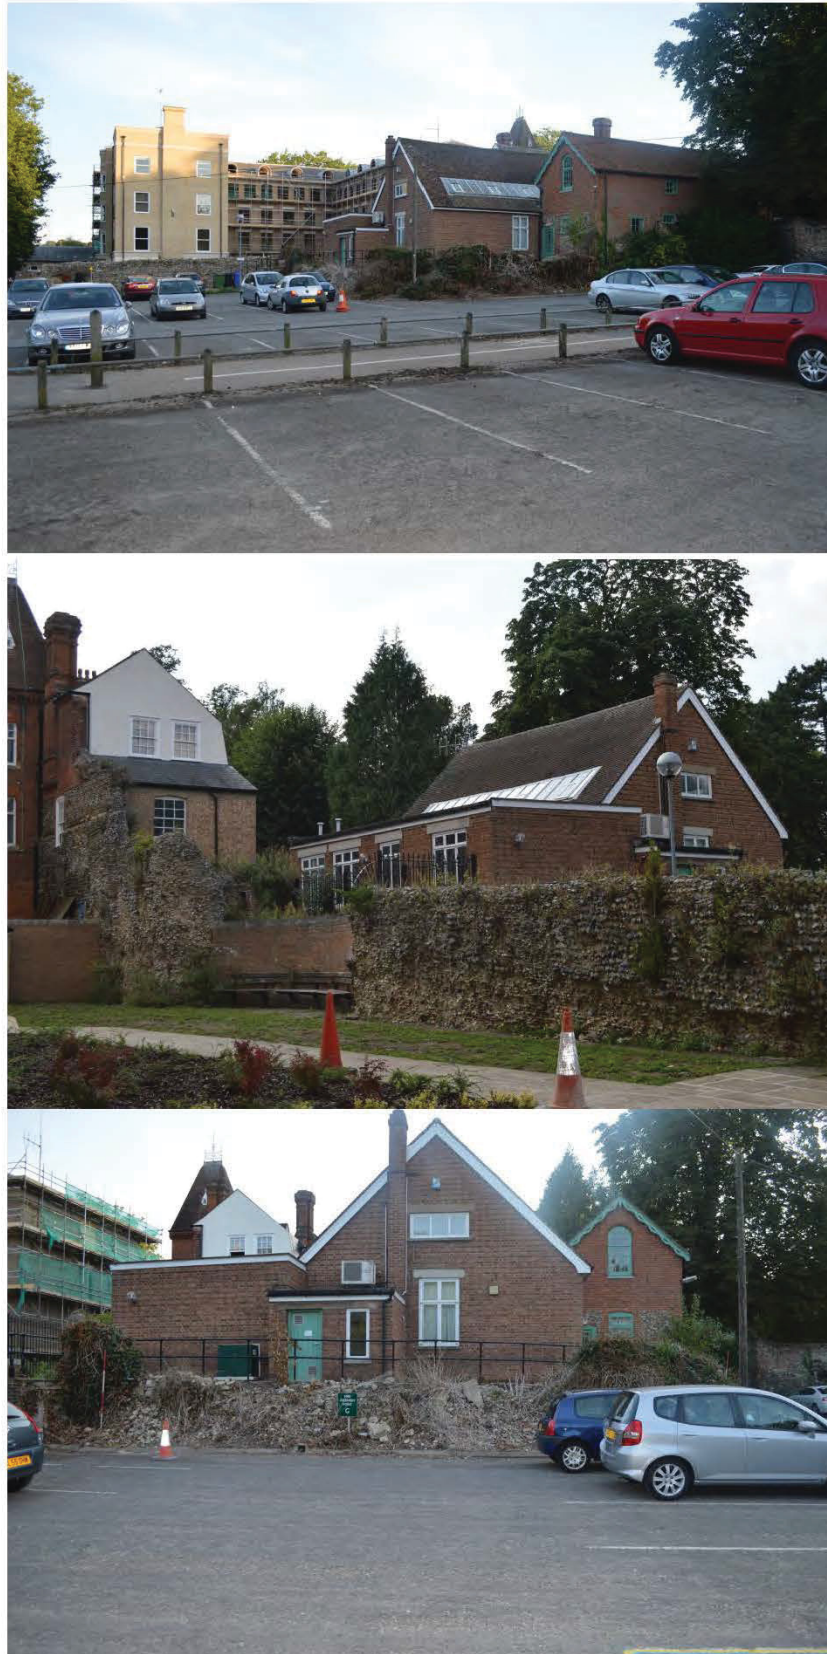
Plate 1. Views of Crankles' Corner from the north (top), south east (middle) and east (bottom) showing its elevated position above the former SCC car park and proximity to the medieval abbey's precinct wall. This section of precinct wall was built during the abbacy of Anselm and dates from between AD 1120-48. The top and bottom pictures are taken from within the abbey precinct, the centre picture from the Sacristy Yard.

The wide breach in the precinct wall, which is visible from the south side (Pls. 1 and 11), is clearly related to the position of the surveyed wall, as the east side of the opening aligns with it. The break in the precinct wall was probably punched through after 1833 when the garden to the south (the 'new' Shire Hall site) was added to the St Margaret's House property. At this time the ground levels in this location either side of the precinct wall were the same and the elevated position of the stables and St Margaret's were maintained by a lobed revetment wall closer to the then buildings (Fig. 6). The lower level immediately behind the surveyed wall was still in place in 1937 and the full width of the raised terrace as we see it today was not created until the library building was constructed after WWII; the bow-back brick alcove, which now fills the break in the precinct wall, was built in the 1960's.

Flanking the west side of the gap is a 12th century tower (Pl. 11) which even the Victorian garden designers were loath to pull down. To the west of the tower the precinct wall survives to a greater height and the tower seems to be the transitional step to the change in the wall's height; St Margaret's chapel was located here and the greater wall height is likely to be part of this building. The quite steeply sloping site of the Abbey precinct (which has been accentuated on the west side of the SCC car park by the continued use of the Great Churchyard after the Dissolution) would have had to have been managed by the builders of St Margaret's chapel and therefore the platform that the current house stands on is likely to be the work of the church's medieval architects. The now buried earlier revetment (Fig. 6) could be part of this system and it is interesting to note that the medieval wall fragment below the brickwork close to the north east of the stable is close to the line of the previous revetment.

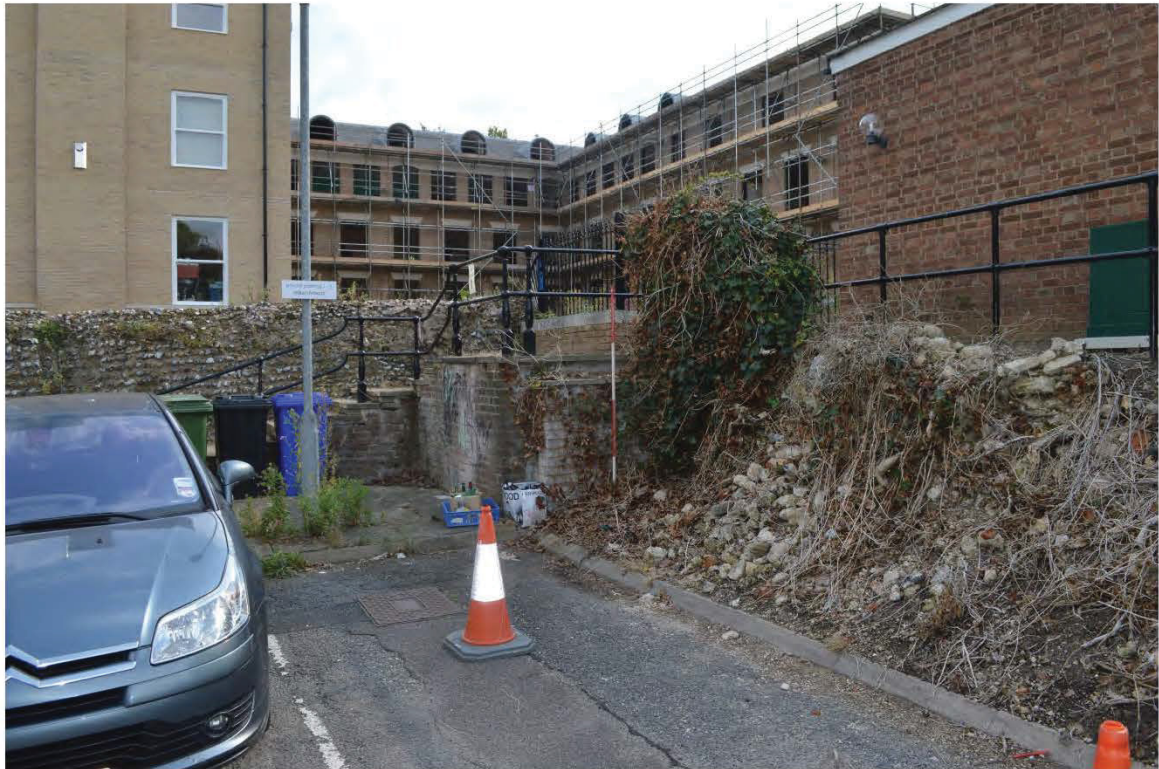
Plate 2. The earliest length of the surveyed wall, which dates to the 16th century, is shown on the right with the 12th century precinct wall behind the car. The junction between the two walls has been destroyed by the steps in the centre of the picture. The former 19th century parapet is banked up as rubble in front of the wall; a section of the parapet still remains beneath the tall ivy but otherwise it has been replaced with the metal handrail.

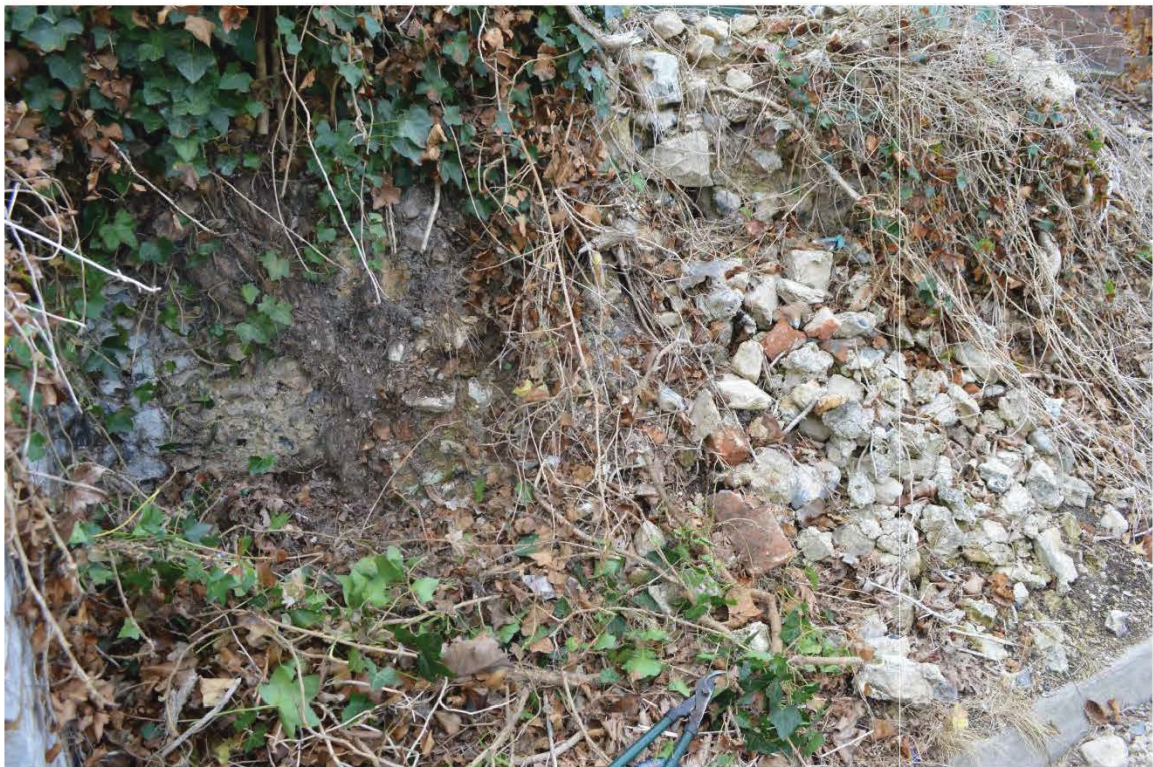
Plate 3. The blind alcove at the south end of the wall can be seen behind the ivy. The remains of brick dressing on the edge of the alcove indicates the position of the 16th century wall face, the full width of the alcove has been cut away by the modern steps; the rubble to the right is all 19th century.

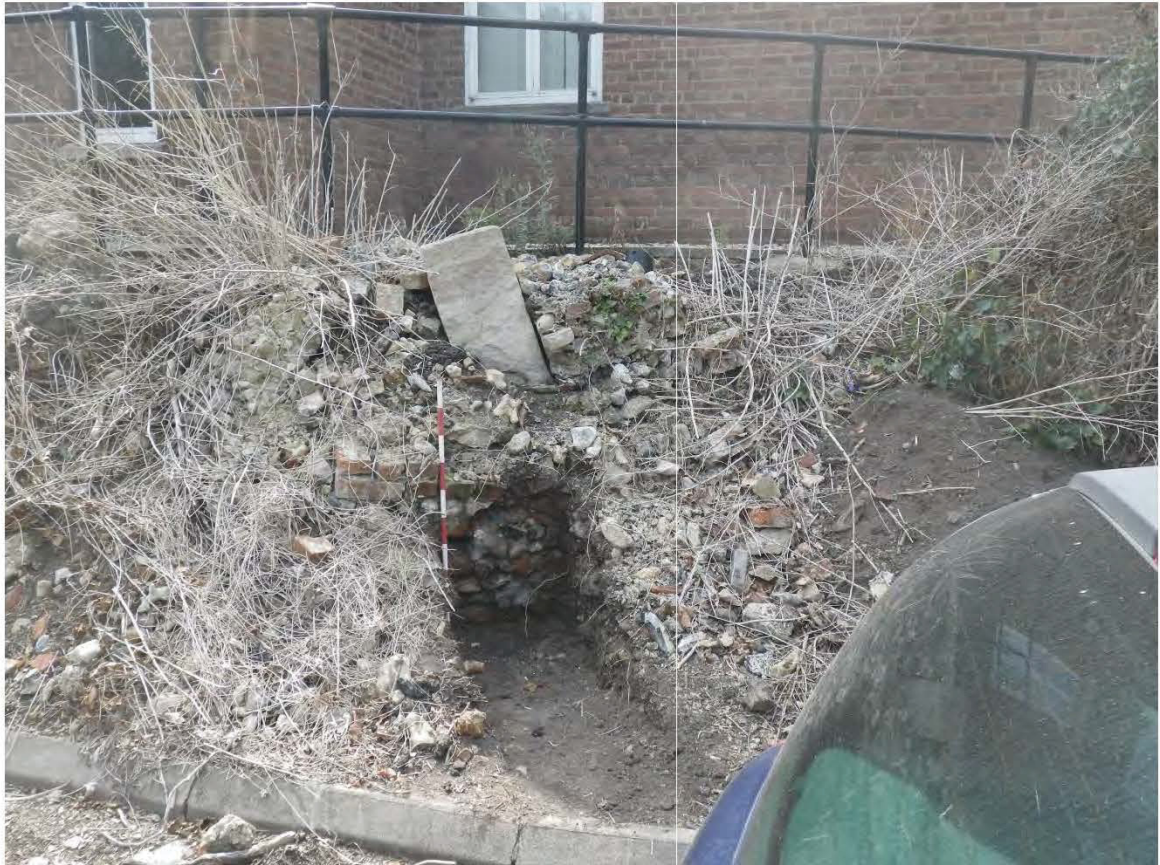
Plate 4. Excavation through the rubble in section B to show the face of the length of wall dating to the 18th century. The south end of this length terminates with the column of brickwork (to the left of the 1m scale) where it attaches to the wall remains from the 16th century. Jutting out from the top of the wall is possibly a fragment of a stone coffin lid.

The collapsed rubble banked against the wall was excavated here within a narrow 500mm wide slot back to the wall face (Fig. 7 and Pl. 4). The wall remains here are 1.4m high to the terrace and the excavation exposed an intact face of 0.6m. The wall is faced with large (double –fist sized) flints and 9" bricks. The bricks vary from $2\frac{3}{8}$ - $2\frac{1}{4}$ " in thickness suggesting a 16th-18th century date and the mortar is a white lime with the large flint (1-2cm) inclusions. The composition of the core is indistinguishable from that of the wall face; the same mortar mix has been used and the mix of brick and flints are similar. Although this section of the wall uses considerably less re-used limestone than the earlier wall. A notable exception is the inclusion of a large slab which has parallel straight sides and a square end, one face has been split away but the other has a shallow angled pitched top and could be part of a stone coffin lid. It is set into the core of the wall on edge and would have acted like a vertical tie. The existence of the wall face gives a measurable wall thickness of 1m.

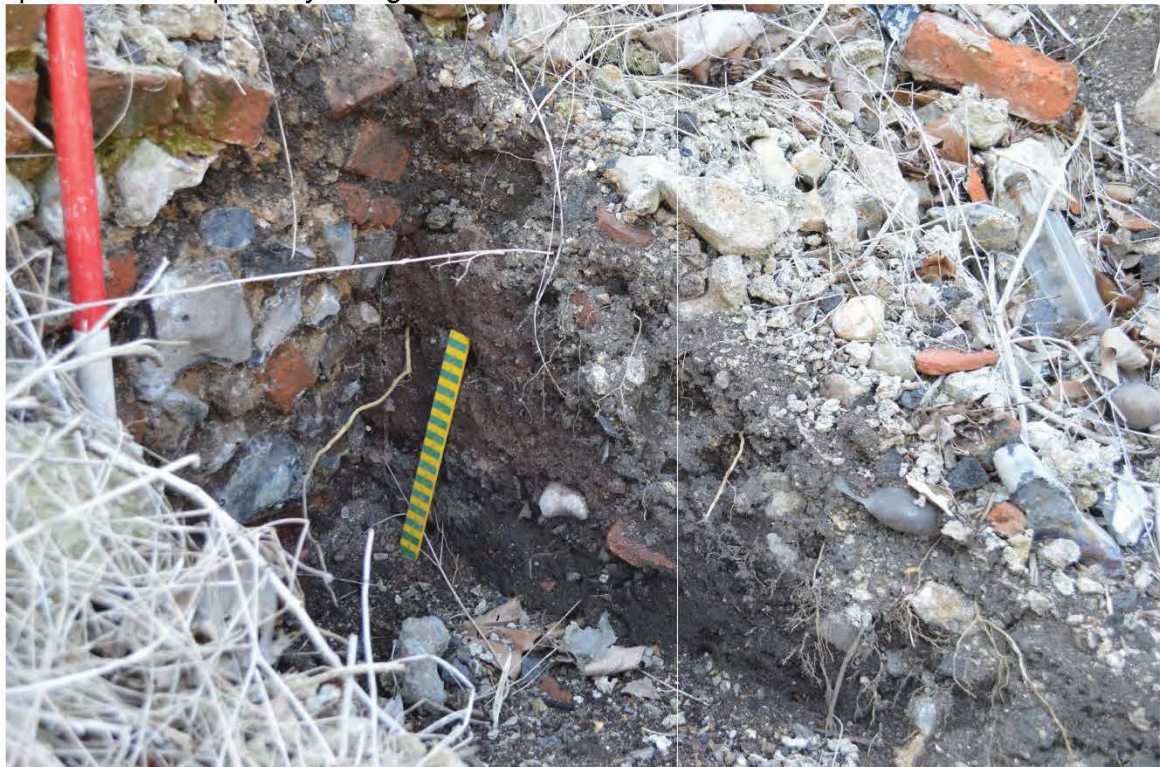
Plate 5. Excavated section showing a dump of cinders against the face of the 18th century wall which were deposited before the parapet of the wall collapsed over them.

The material banked against the base of wall included a thick deposit of fine, gritty cinder/ ash from a coal fire; this has been dumped against the wall and seals the former ground surface (Pl. 5 and Fig. 7). The fire residues were dumped before the collapse of the parapet, the rubble of which has tumbled over the cinders. The overlying rubble includes a large amount of vesicular slag or furnace waste; this is in large lumps and has been used as a building material as it has mortar attached to it. The furnace waste does not appear in the upstanding part of the wall and the rubble material is clearly part

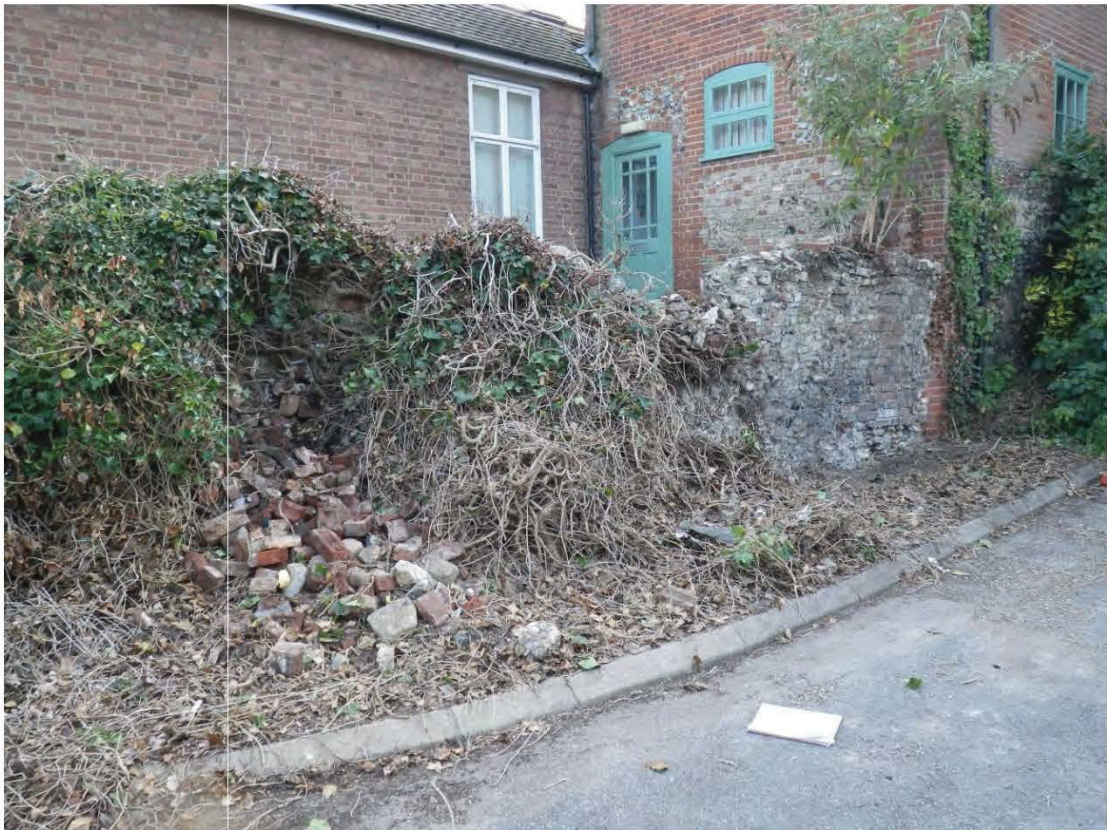
Plate 6. Section D and E with the remains of the parapet lying at the base of the wall. This section of the wall dates from the 18th and 20th centuries.

Where the wall was examined in section D the wall face included red-bricks with the mix of large flints, with the bricks concentrated towards, but not exclusively, the top of the wall remains (Pl. 6). The bricks were a mix of slender 16th century types but late 18th/early 19th century ones are present; the later bricks are all 'handmade' without 'frogs' and tempered with added burnt flints- the composition of the face and the brick sizes were similar to that seen in Section B. The wall is bonded with a hard, buff-coloured, lime mortar tempered with fuel ash/charcoal which is similar to that used in the parapet and unlike the mortar noted in Sections B and C.

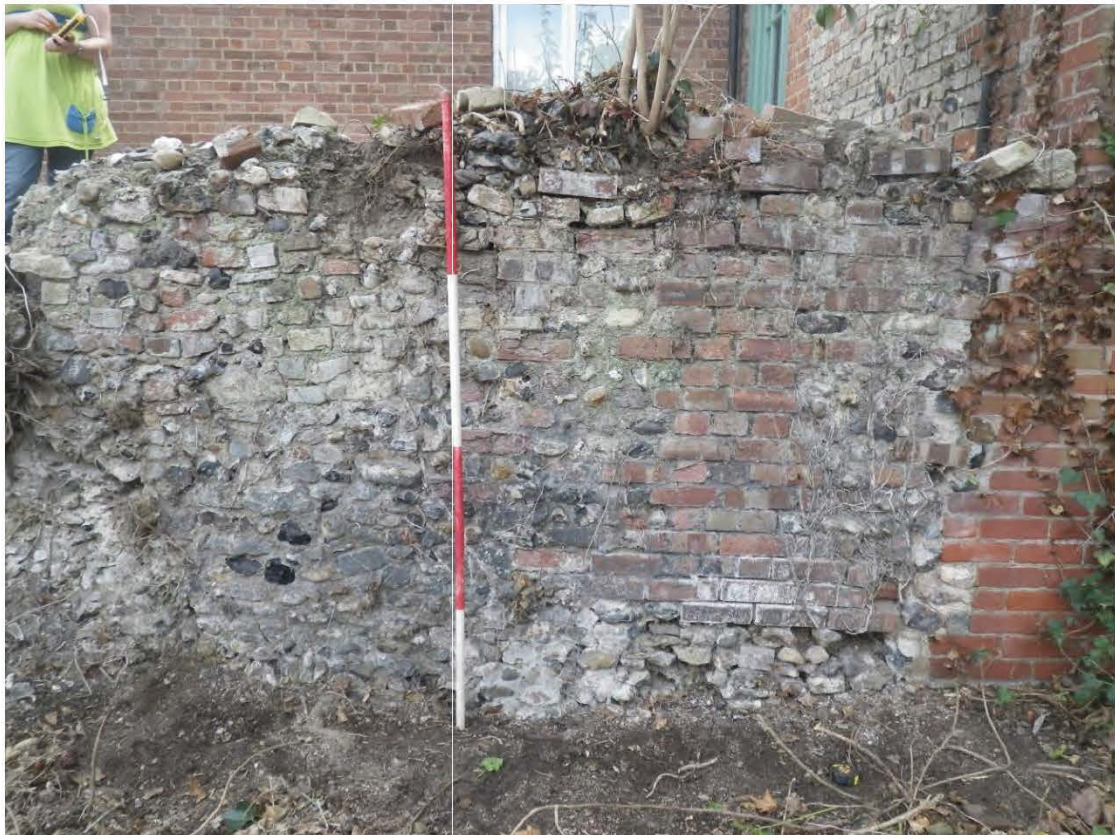
Plate. 7. The north east end of the wall has been refaced in the 20th century. An SCCAS staff member can be seen standing at terrace level (left) and the parapet wall survives to its greatest height (600mm) at this point. The end section of the wall (extreme right) is a more recent repair and the absence of rubble at the foot of the wall and the less established ivy growth is probably the result of both being cleared previously to gain access for the repairs. The scale is 2m.

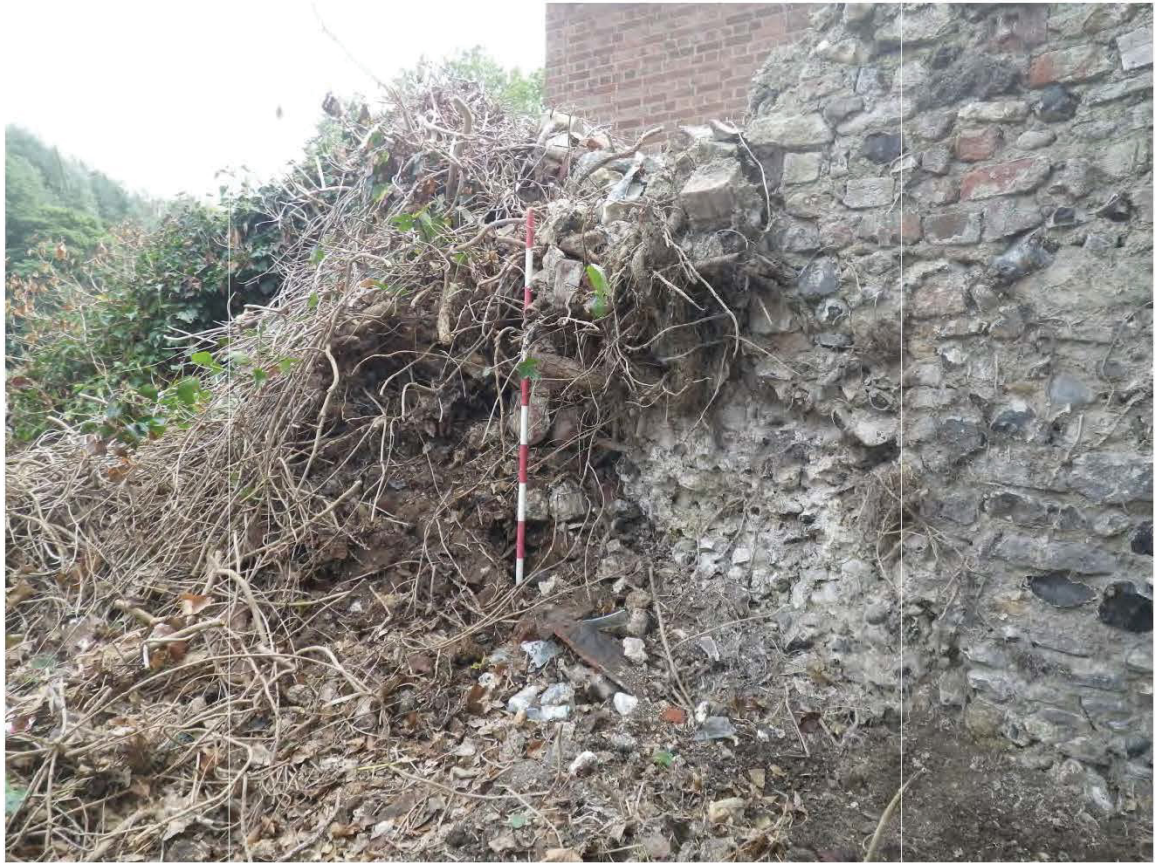
Plate 8. East end of Section E where part of the wall face has collapsed revealing the inner core composed of small flints in a white, high chalk, soft mortar, probably of an 18th century date, and includes no brick and tile in the mix. The core behind is unlike the facing material, suggesting that this section has been re-faced. The scale is 1m.

At the east end of this section part of the wall face has collapsed revealing the inner core, this is composed of small flints in a white, high chalk, mortar and includes no brick or tile in the mix (Pl. 8). The core behind the Section E wall face is unlike the facing material and more akin to the wall core in section C suggesting that this is a re-facing of an existing wall.

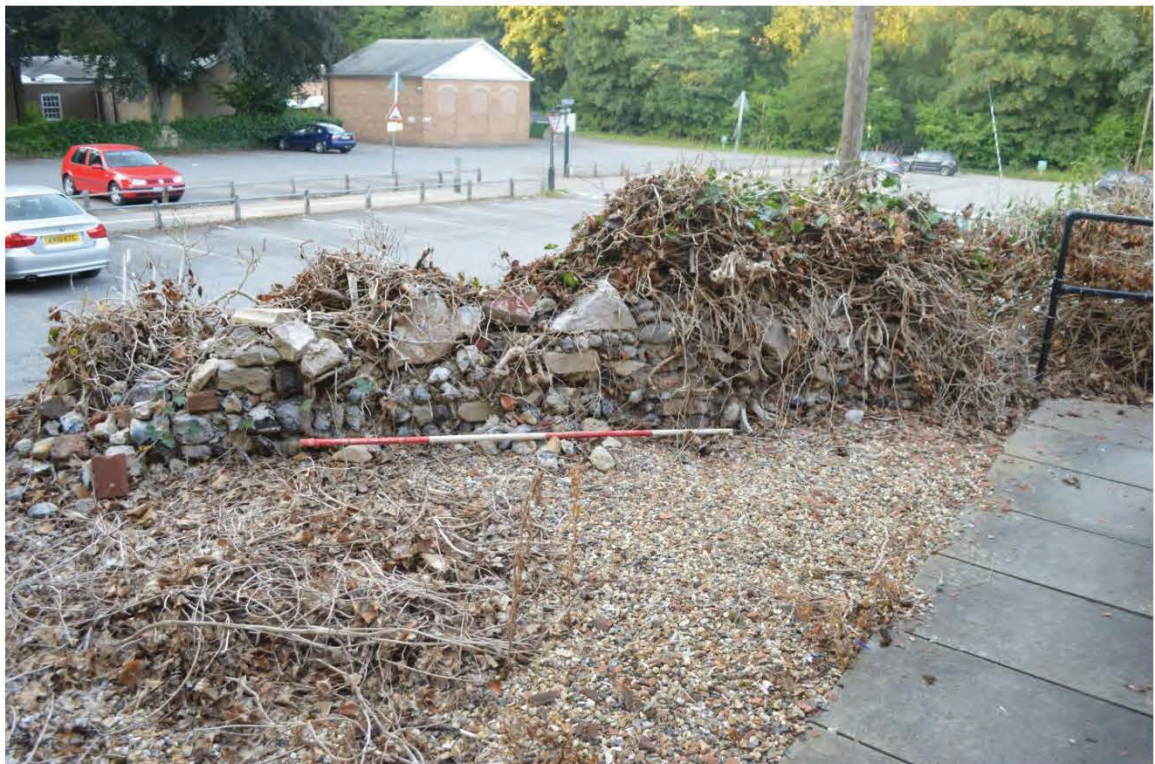
Plate 9. The internal face of the parapet, looking south-east. The setting for the end stanchion of the railing has cut into the top of the wall.

wall and only exists as fragments at the two end of the wall; almost all of the rubble at the base of the wall is the remains of the parapet. The surviving parapet is only 300mm thick and slimmer than the main body of the wall (Pl. 9).

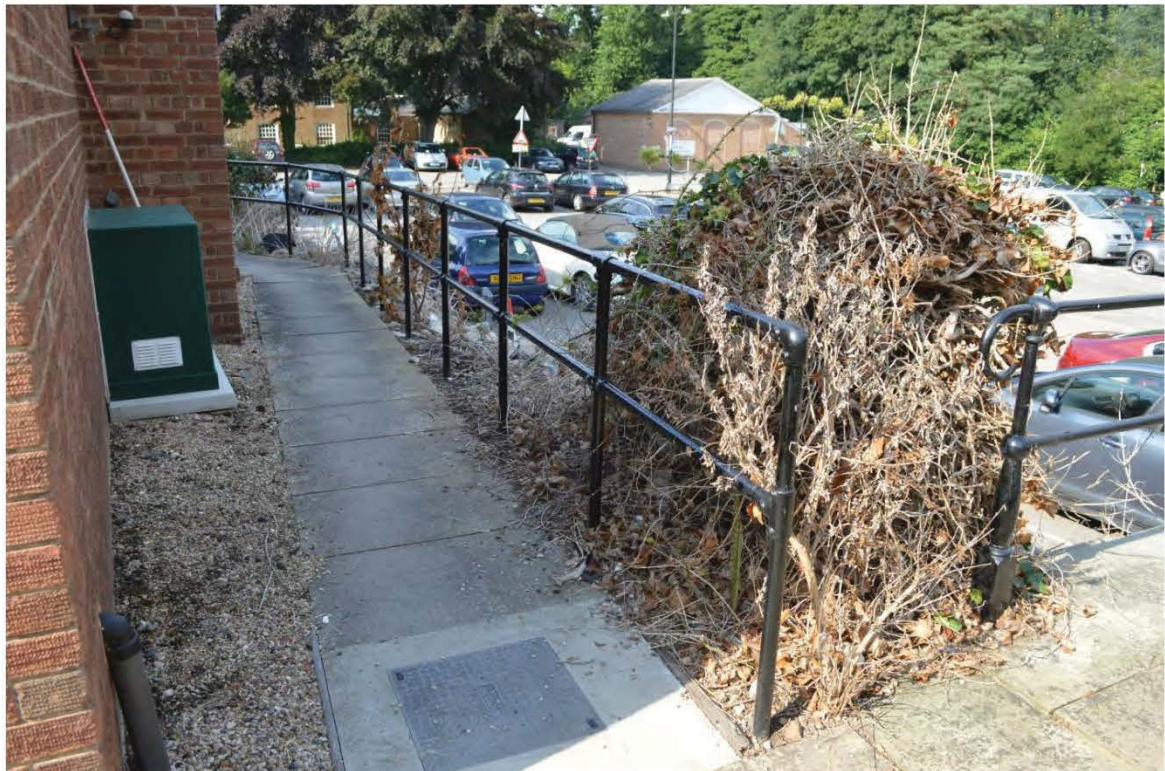
Plate 10. The railings bordering the path to the rear fire exits are set inside the line of the wall in the 'imported' material used to raise this part of the site to extend the terrace. The clump of ivy in the foreground obscures a remaining stub of the parapet wall. Note the railings are a simpler style to those on the steps; a reflection of the council's diminishing resources?

The back (west side) of the wall, as seen from the path on the terrace (Pl. 10), is the true rear face and here the estimated wall thickness is 1.40m. The top of the wall has been truncated flush with the level of the terrace and at the extreme south end there is the remains of a later built parapet but generally all of the visible fabric in Section A is contemporary with the estimated 15th-16th century date.

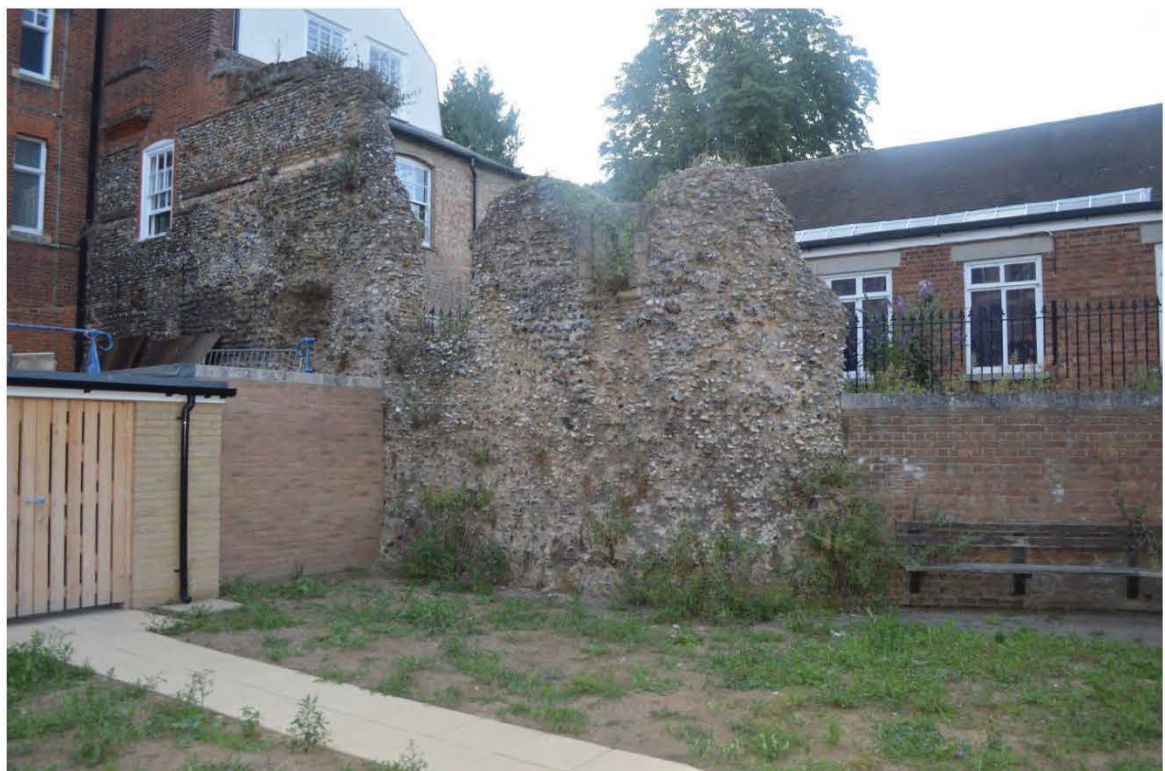
Plate 11. The south side of the precinct wall with the Crankles' Corner offices behind showing the 12th century tower (centre) and the much taller precinct wall, associated with St Margaret's chapel beyond. The break in the wall was probably cut through after 1833 when site of 'Crankles' corner was linked to what had become the garden (the area in the foreground) of St Margaret's House.

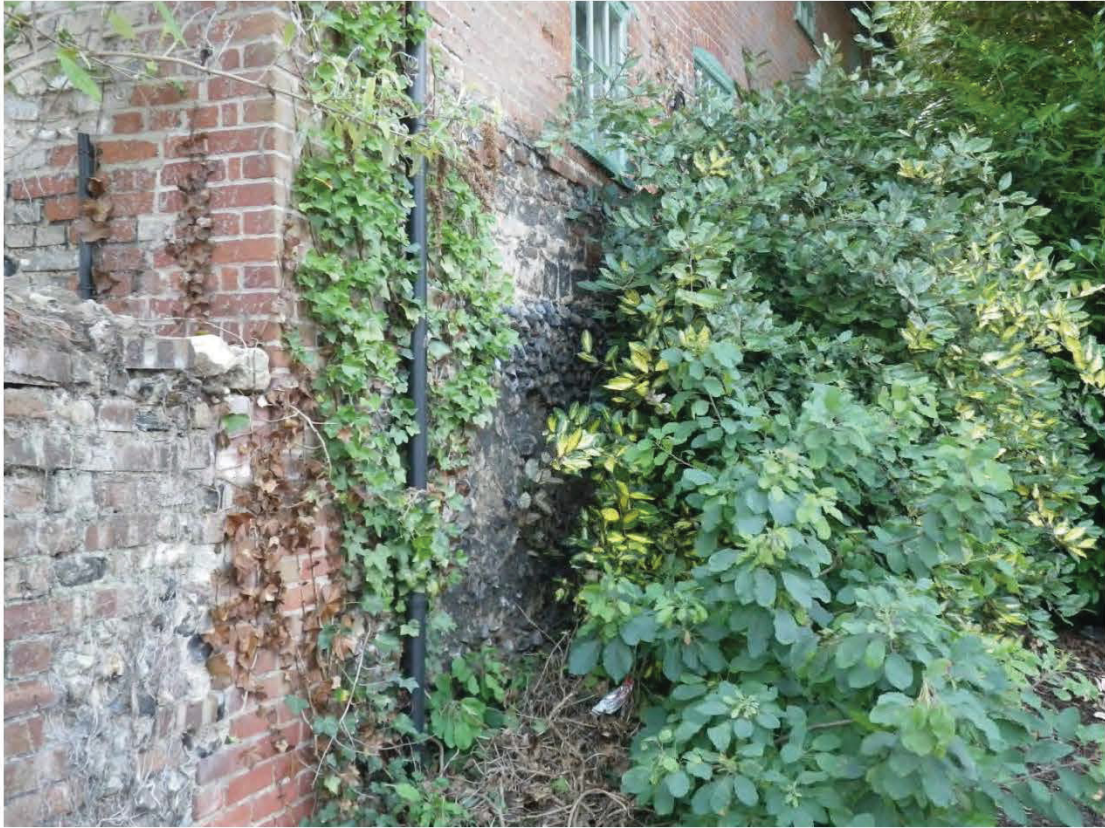
Plate 12. A small section of medieval wall (right of the downpipe) at the base of the stables, possibly a relic of St Margaret's chapel.

The rubble wall directly beneath the stables is the remains of a previous incarnation that has its origins in the 17th or 18th century (Pl. 12). Included within this build is a section of an earlier wall; the mortar is a pale brown colour, with a coarse gritty texture and is consistent with the mortars used in other buildings on the convent's site. This fabric appears only in a narrow strip and may be a stub seen in cross-section.

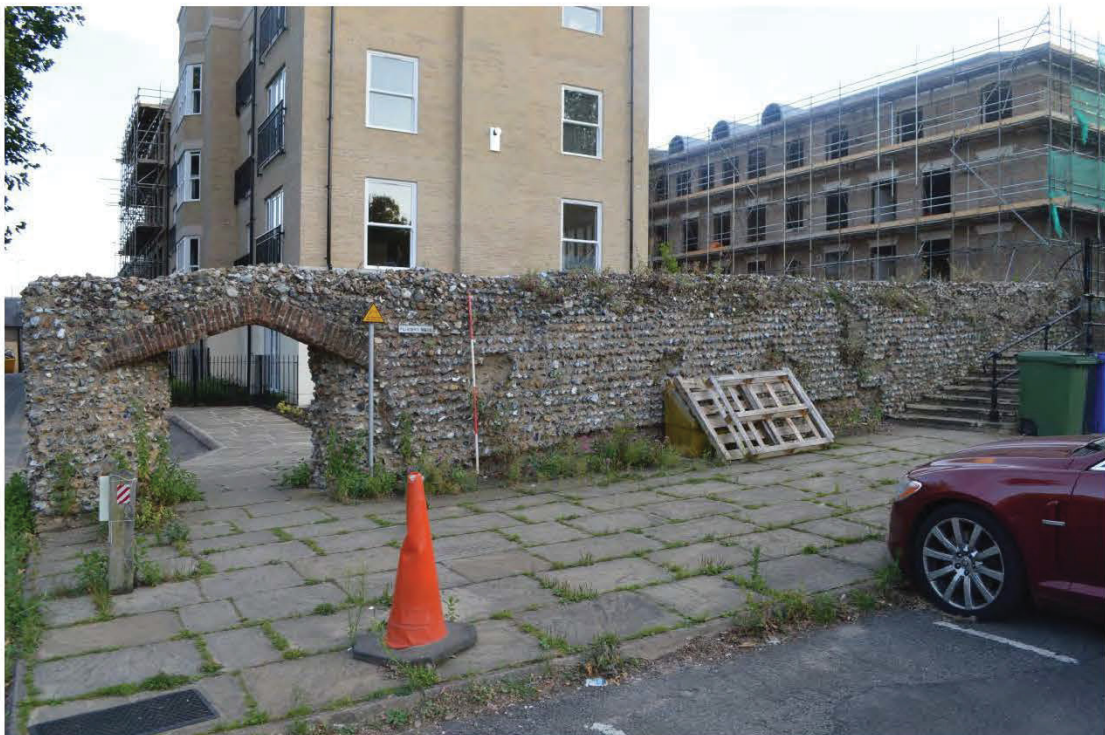
Plate 13. Pedestrian door cut into the precinct wall just to the east of the site; the bricks and arch shape suggest a 16th century date and are contemporary with the earliest length of the surveyed wall; both are thought to be the result of immediate post-Dissolution activity. The scale is 2m.

The bricks used in the earliest section of the wall date to the 16th century, although whether it was built as part of the abbey complex or, as seems more likely, soon after the Dissolution is uncertain. The wall was an addition to the Precinct wall and the bricks are similar to those used to create the arch over the pedestrian door cut through the wall just to the east of the survey area suggesting that the two are contemporary; the arch shape of pedestrian door would place it in the middle of the 16th century.

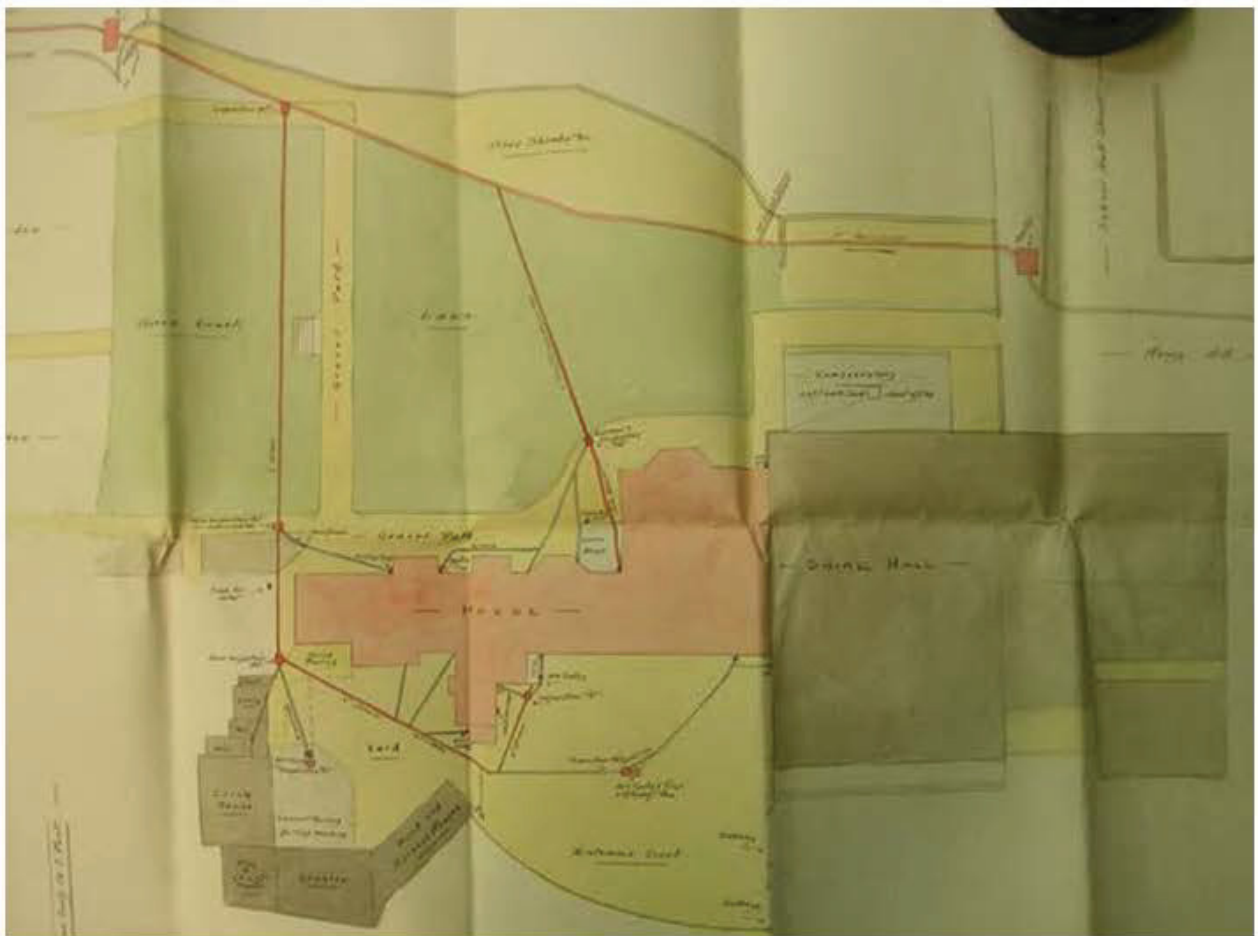
Appendix 2. Plan of proposed drains in 1914 showing the stable block in detail.

North to the bottom of the picture .
