Goldings, Stonham Aspal SAL 035

Archaeological Monitoring Report

SCCAS Report No. 2014/131

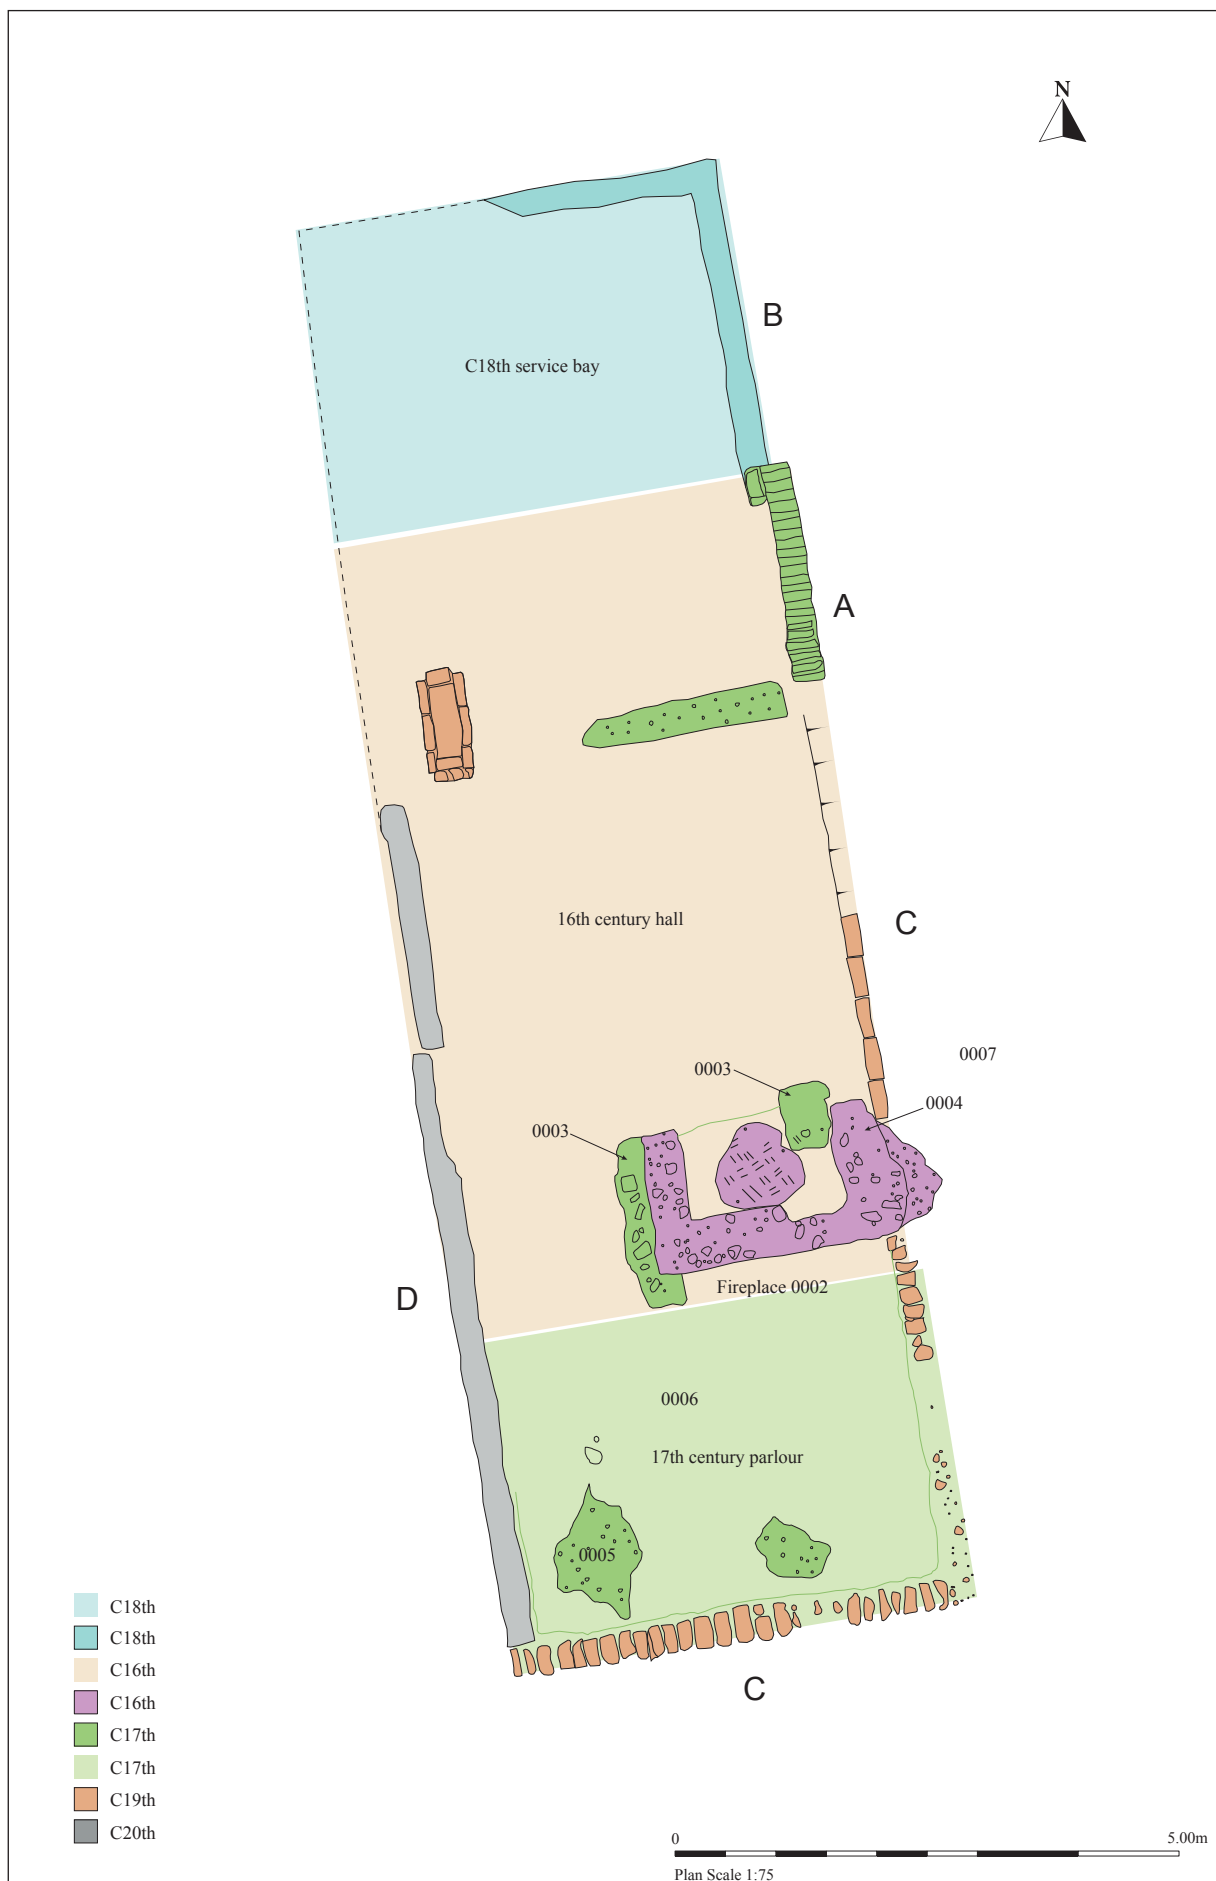
Figure 2. Plan of the archaeological evidence for the west wing of Goldings, recorded at the surface of the subsoil horizon

Over the course of the late 18th-19th century the complete circuit of the timber-frame's sill-beam was underpinned with brick. The underpinning was clearly added retrospectively to the construction of the frame; it required the undermining of the floor levels and was completed piecemeal probably over the course of a century. The brick 'bonding' was improvised and rusting, necessitated by the awkwardness of working beneath extant walls, and in each case the bottom course of bricks was laid without a mortar bed directly onto the ground. Four periods of underpinning were identified and are labelled in chronological order A-D on the plan (Fig. 2).

The earliest stretch of underpinning by fabric was a short length of 'Tudor' bricks (A) dry laid on edge and these together with two courses of plain bricks laid in English-bond were either inserted during the 17th century or were contemporary with the service bay added to the north end of the building in the 18th century. Plain, 'handmade' bricks used below the central section of the west wall (C) were heavily sooted on one face; it is likely that these were salvaged from the 17th century chimney when it was pulled down and rebuilt and therefore dates this underpinning episode to the 19th century.

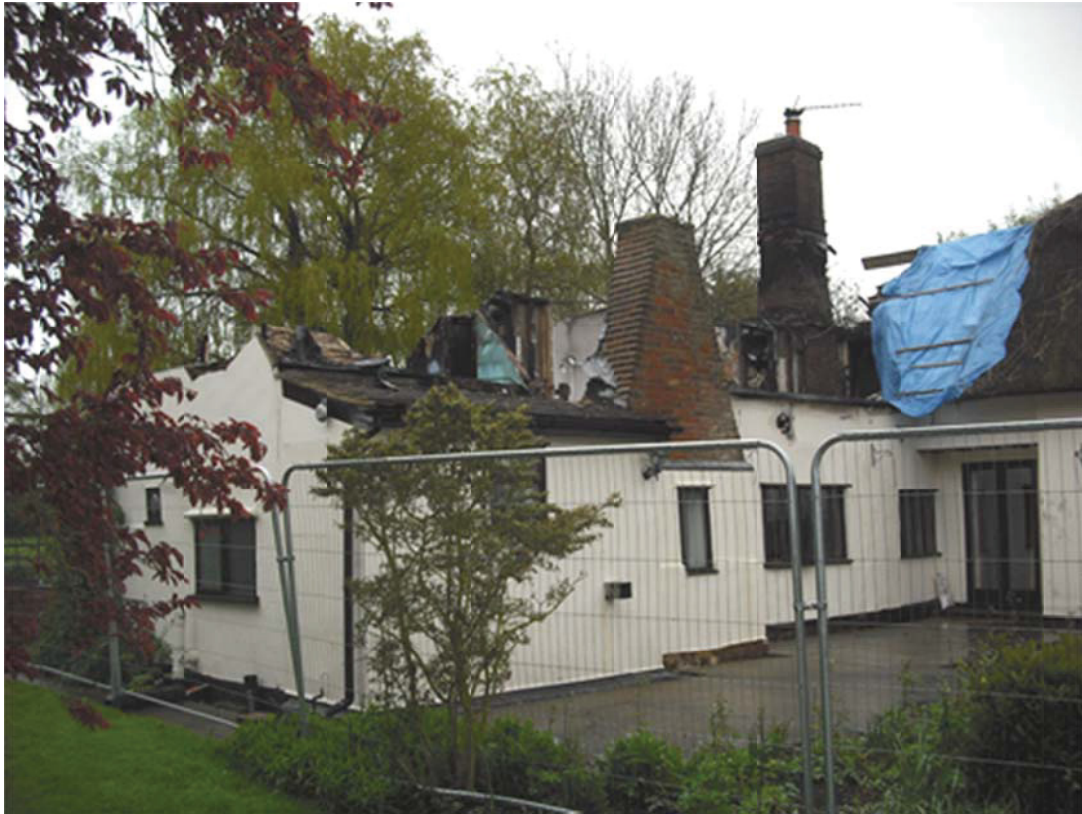
Plate 1.' Goldings' viewed from the NW showing north-south wing of the house which is based around a former detached bake-house dating to the 16th century. The tall chimney is a 19th century replacement which stands directly on the site of its 16th and 17th century predecessors

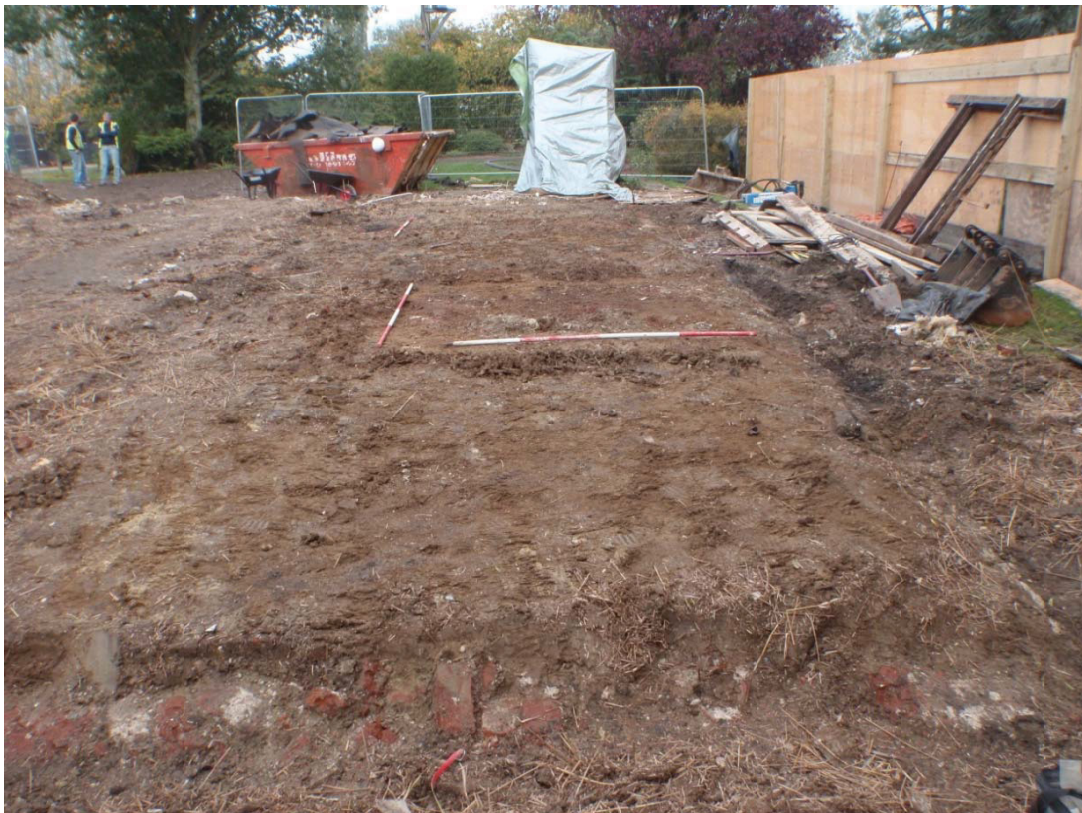
Plate 2. The site of the north-south wing following the dismantling of the frame looking north. The building has been demolished to the original 16th century floor level; underpinning of the timber sole plate with brick (foreground) during the 19th century necessitated the lower of the surrounding external ground, creating the effect that the internal floor area is raised.

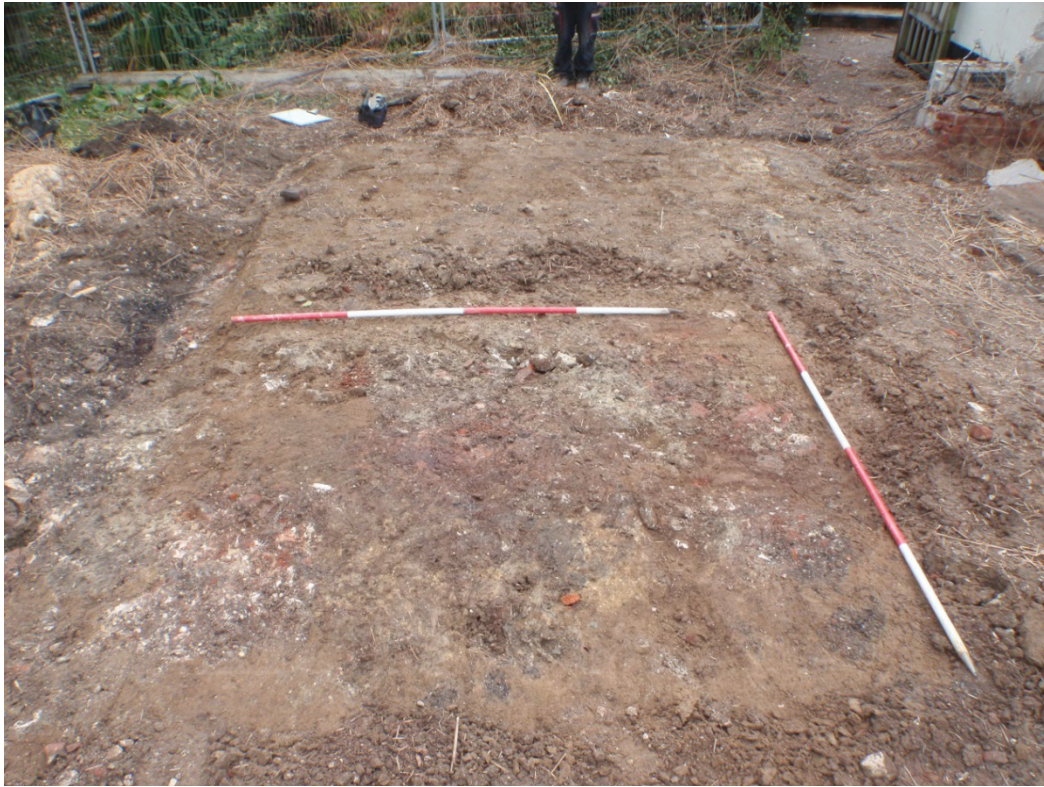
Plate 3. The position of the fireplace at the south end of the 16th century open hall which was retained throughout the subsequent developments of the house chimney. The burning is indicative of the hearth and demonstrates that the excavation surface is at, or close to, the 16th century floor level. The smudgy rubble alongside the scale on the right is all that remains of the 17th brick fireplace; the scale division are in this and all pictures are 0.5m

Analysis of the framing identified the central part of the building was originally laid out as an open-hall, part of a detached kitchen dating to the 16th century. Goldings's main chimney was located at the south end of the hall within a chimney bay in a position which did not alter throughout the building's life. For its final incarnation the chimney had been rebuilt in the 19th century but retained the brick-built piers of a previous 17th century fireplace which was itself a replacement for the original kitchen fireplace.

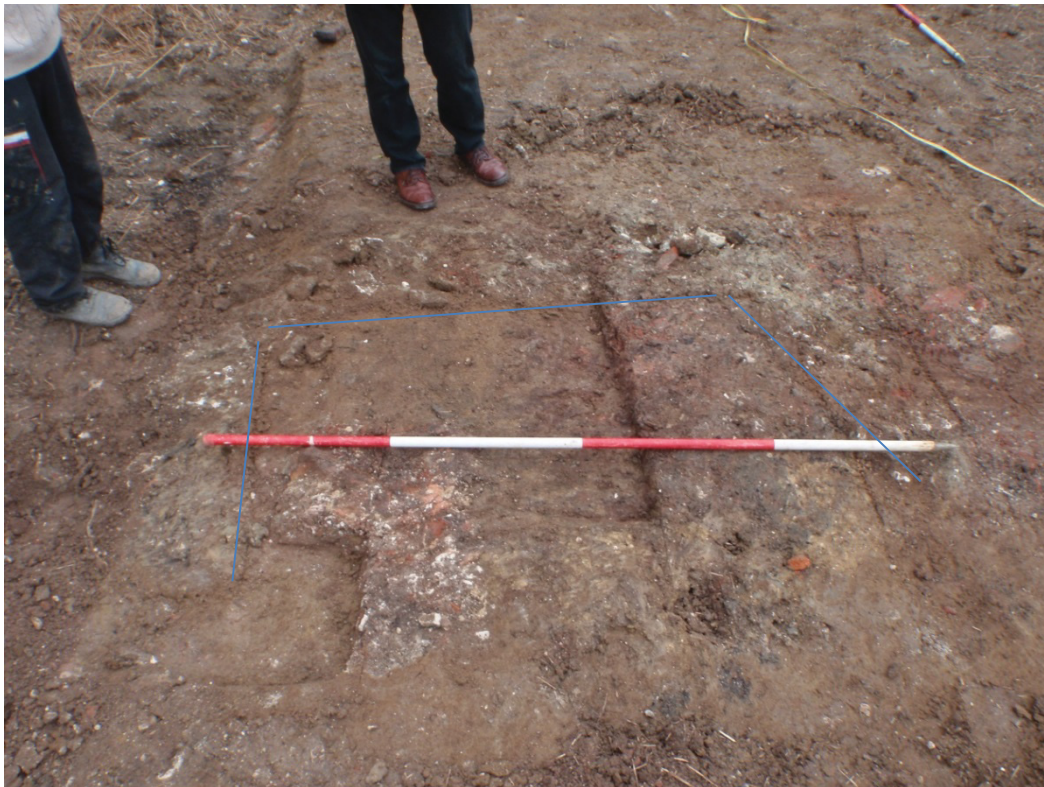
Plate 4. The foundation composed of green clay over flints for the fireback and piers of 16th century fireplace. The large hearth (1.5m wide) faces toward the bottom of the picture and served only the open hall; the hearth (the interior faces of the fireback and piers) are highlighted in blue.

Although the original, pre-17th century, fireplace was completely rebuilt evidence of its footing still survived. This comprised a shallow, flat bottom trench packed with flints; in plan it described three sides of a rectangle (Fig. 2, 0004) and would have formed a hardstand for the fireback and side piers. The trench was 0.35m wide and 0.12m deep, along its base was packed fist-sized flints which were dry-laid in two courses and were sealed in place by a covering layer of soft green clay. The fireplace was single-sided which faced north, heating the kitchen's open-hall, and the internal width of the hearth was 1.55m by 0.85m deep. The fireplace was off-centre in the room and the line of the east pier would have projected into the line of the framing, so that the brick of the chimney would have formed an exterior wall face – in the manner typical of late 16th – early 17th century houses (e.g. Pottery Cottage, Wattisfield and Street Farm Fressingfield). There was no structured hearth floor remaining but an area of burnt, broken-up clay and discoloured subsoil within the centre of the hearth attested to the site of the fire.

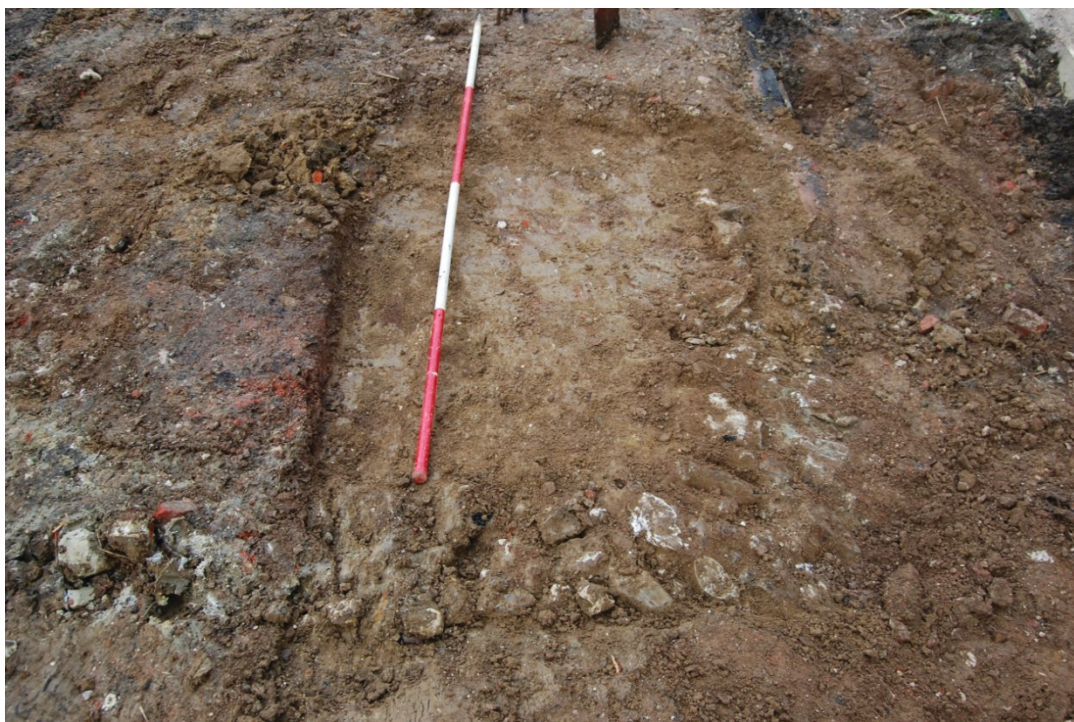
Plate 5. (above) The foundation of the 16th century fireplace part excavated showing a dense packing of flint sealed below a layer of green clay.

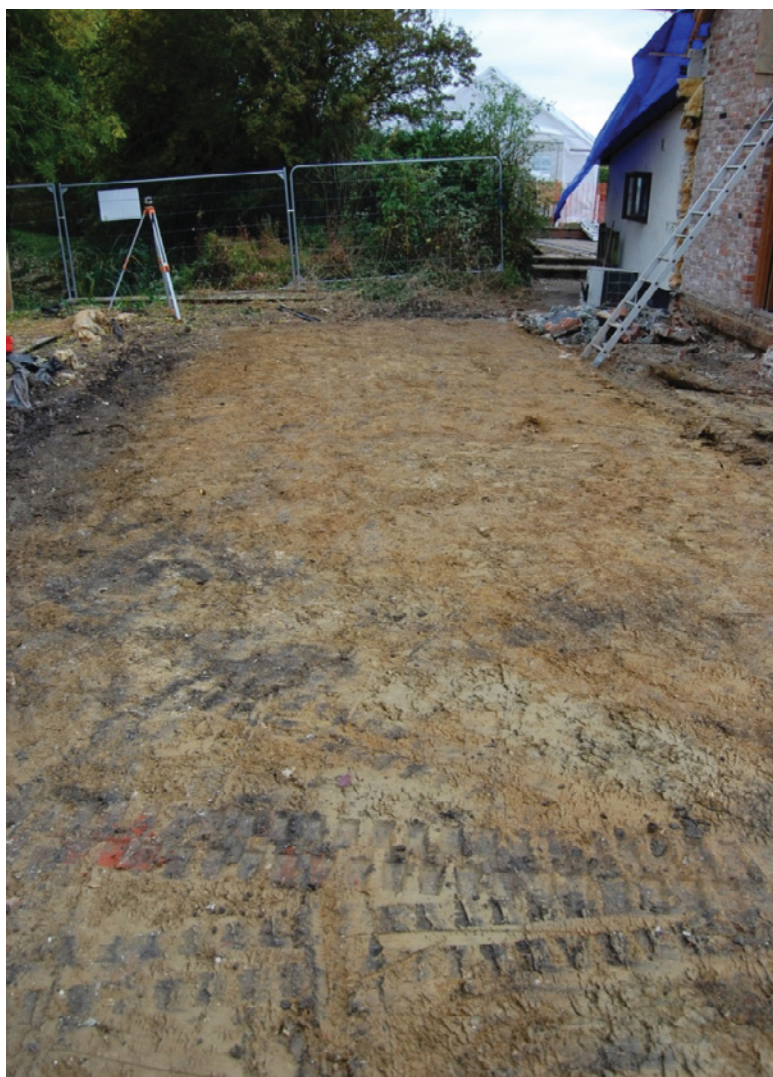
Plate 6. The site of 'Goldings' following machining of the subsoil to the surface of the geological clay (a depth of c.200mm). This shows not a trace of what was a substantial structure only days before and demonstrates why there is a void, quite literally, for this type of building in the archaeological record.

Following the recording of the features directly associated with the building, the site was stripped by machine to the surface of the underlying natural clay. This is the depth to which archaeological sites are often stripped in rural contexts and the aim of this was to observe how the building manifested itself at this level and to record any archaeological features that might have pre-dated the building. Stripping the area revealed a completely featureless expanse of clay, which whilst suggesting that the building had been erected on a virgin site was a stark demonstration that all reminders of a building which had been in occupation for over four hundred years had been completely expunged.
