All Saints Church, Mendham  
New meeting room  
MDM 132

**Archaeological Evaluation Report**

SCCAS Report No. 2015/003

**Client: Mendham Parish Council c/o Haward Architects**

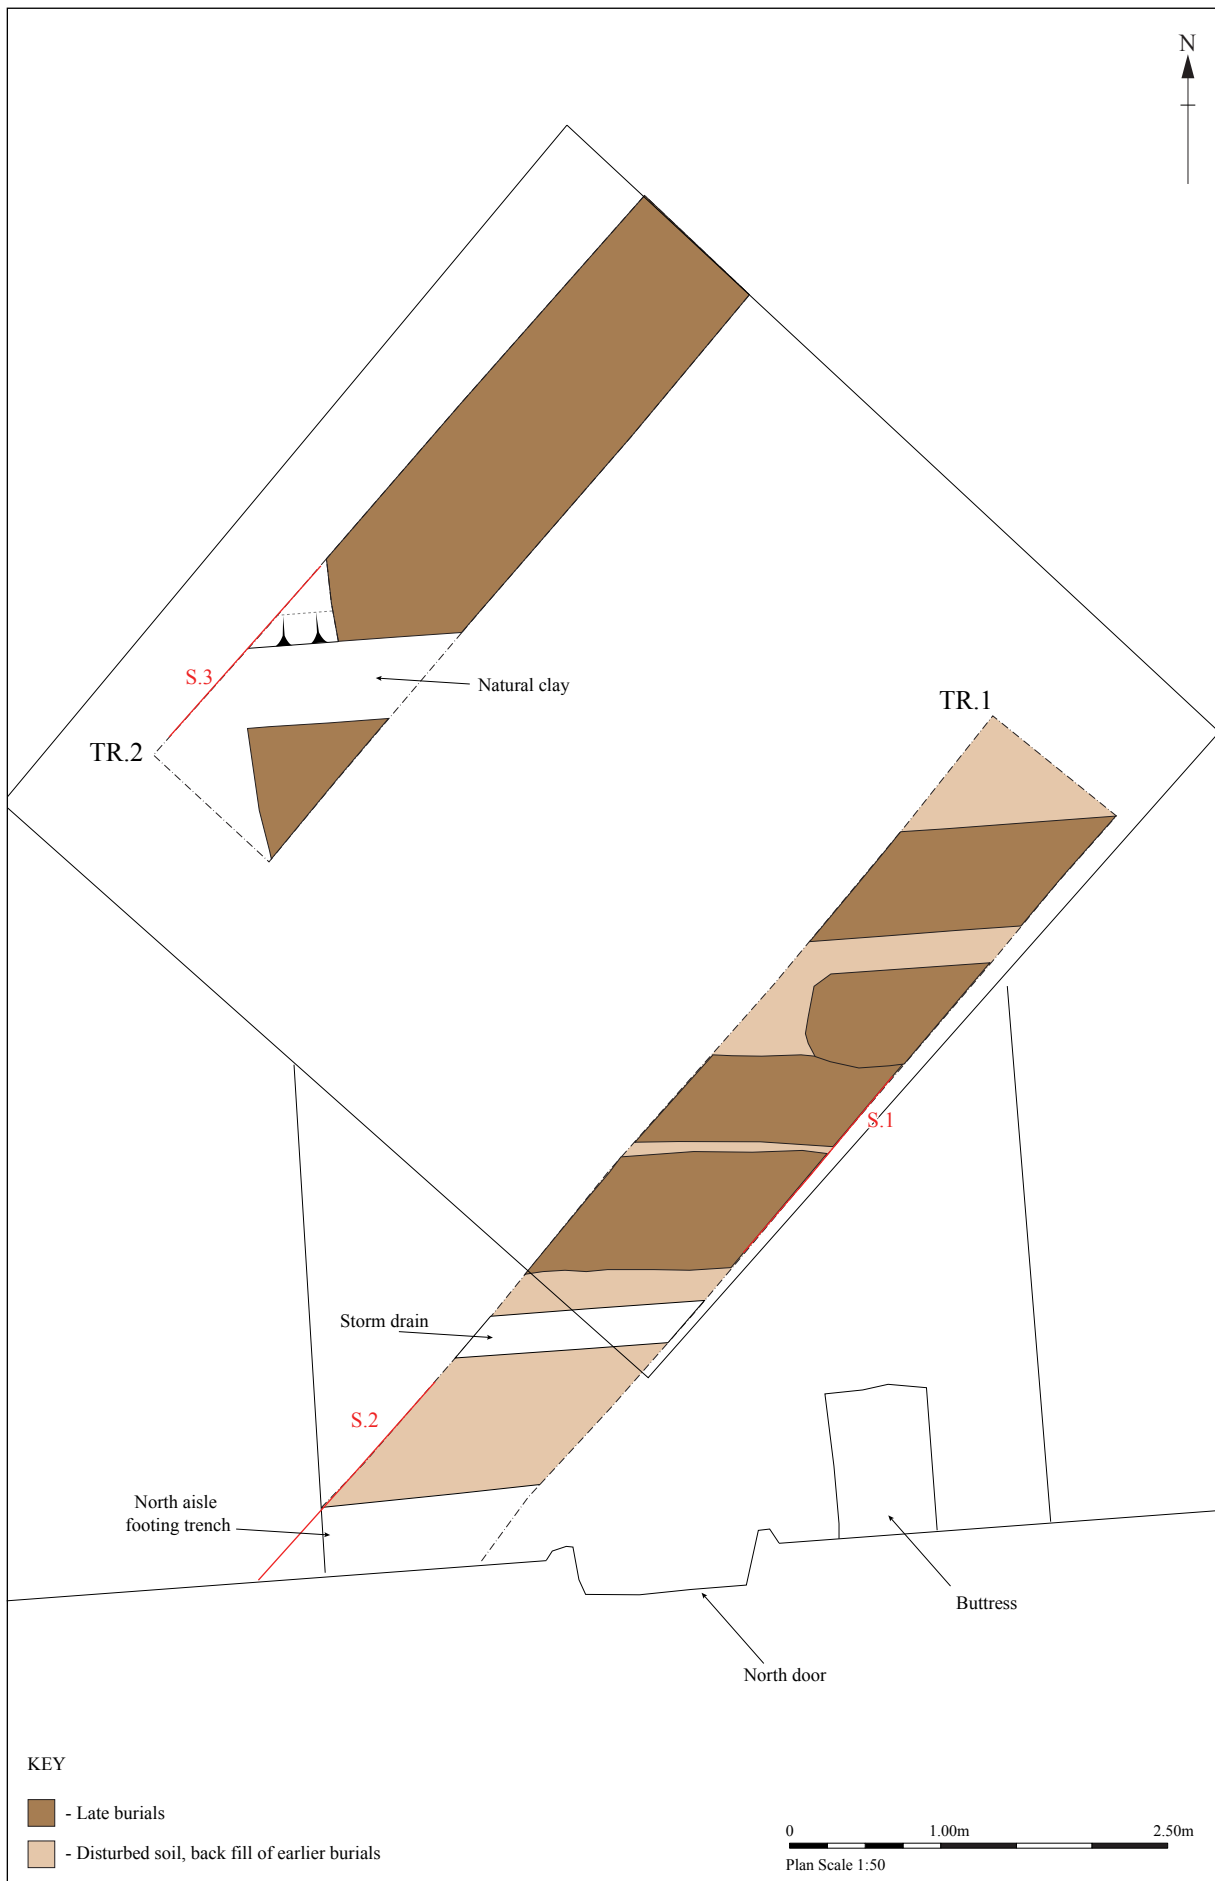
Figure 2. Trench plan

A plan showing the position of the trenches is presented in Figure 2 and described by trench below. The trenches were located alongside the north aisle; a neat grass path bordered this side of the church and within the development area the path was bounded by a short linear bank formed from discarded spoil from grave-digging and, on the west side, a tangle of shrubs and a large yew tree. In the graveyard to the north of the site, all the headstones had been relocated and aligned along the western margin to form, what

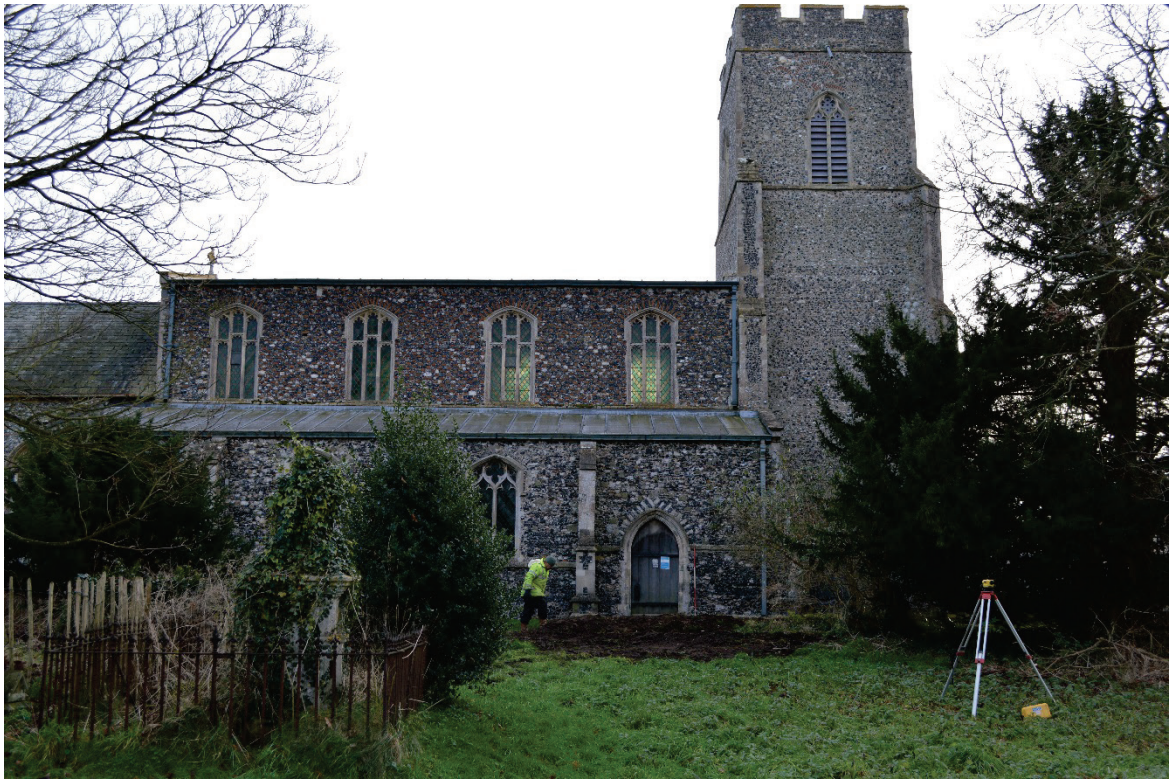
Plate 1. North side of All Saints Church. The proposed new building will occupy the area of disturbed soil in the centre of the picture and be connected to the north aisle by a linking vestibule that will be accessed from and enclose the north door.

Planning permission (planning ref 1577/14) has been given for the construction of a meeting room on the north side of All Saints Church, Mendham (Pl. 1). The meeting room will take the form of a separate annex-building that will be joined to the aisle of the medieval church by a linking vestibule, enclosing and making use of the existing north door (Pl. 2). The church grounds have high archaeological importance as they are thought to relate to an Anglo-Saxon episcopal site; in addition the proposed building will in all probability be located in an area of buried human remains.

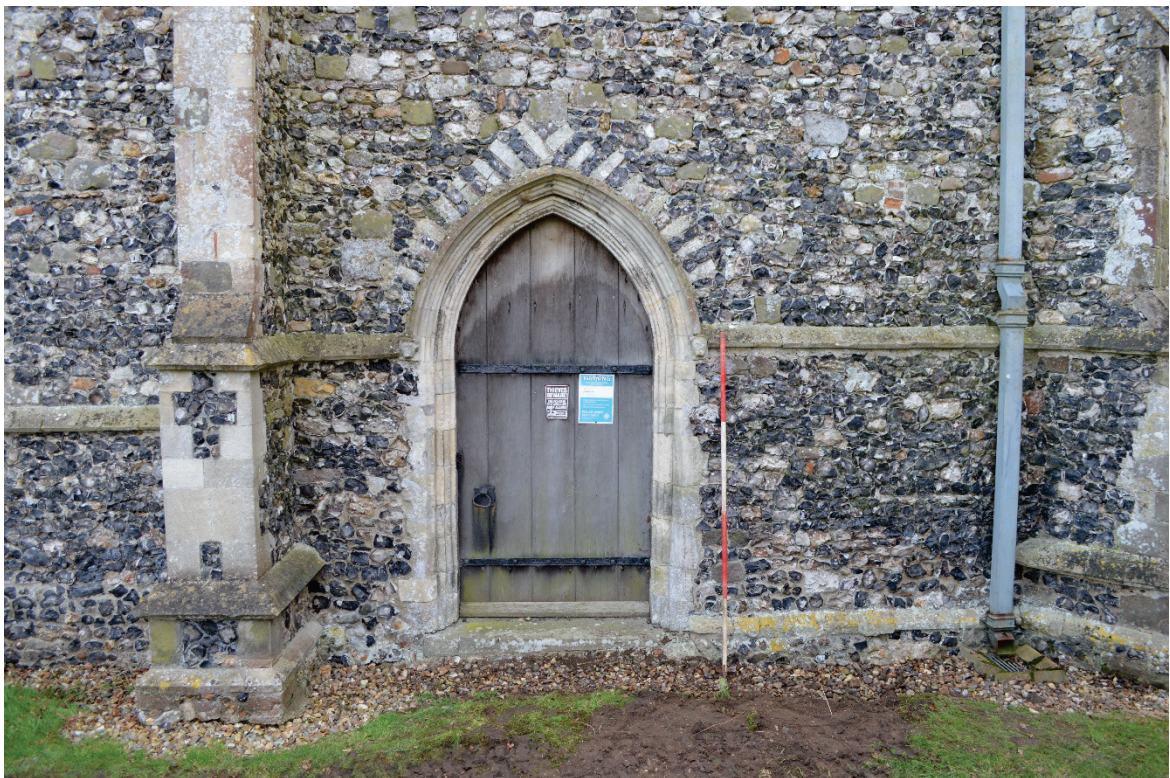
Plate 2. The north door is original to the 15th century aisle and was restored during the 19th century. The new building will extend from and incorporate the buttress on the right and the finished floor level will approximate the existing threshold step.

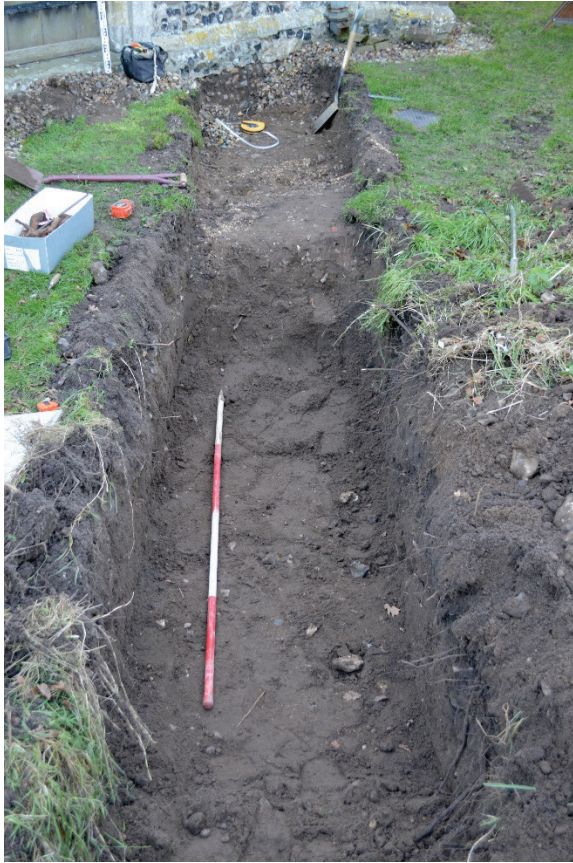
Trench 1 extended from the north wall of the aisle, just to the west of the door and was 6.50m long (Pl. 3). A storm-water drain pipe was encountered at 370mm below the TBM and at the base of the north aisle wall was a modern 'French-drain'; a gravel filled trench 400mm deep which surrounded the entire building to combat damp. The bottom of the north aisle wall was found at 650mm (BTBM), the bonded fabric was built over a sand/gravel filled footing trench. The stratigraphic sequence seemed to suggest that the upper part of the backfill of the footing trench post-dated the disturbed soils (the result of grave digging) within the churchyard. This suggested that the church footing and the base of the wall had been revisited relatively recently probably when the church was comprehensively refurbished at the end of the 19th century.

Away from the church wall the remainder of the trench was cut through the soft, disturbed soil backfill of centuries of grave-digging. The trench was excavated in general to a depth of 850mm (BTBM) without encountering undisturbed articulated skeletons or geological soil. Individual grave cuts could be identified from a depth of 450mm (BTBM) and four E-W aligned graves were recorded and are shown as the darker fills in the figure 2 plan; the nearest visible grave to the church was 2m from the aisle wall. The visible graves represented only the final phase of grave digging in this area and had been cut through the infill of previous burials (shown as paler brown on the plan). The later grave backfill included patches of green clay brought up from the underlying geology indicating that the final burials were the deepest and probably

Plate 3. Trench 1 showing disturbed soil of backfilled graves at a depth of 850mm below the north door step.

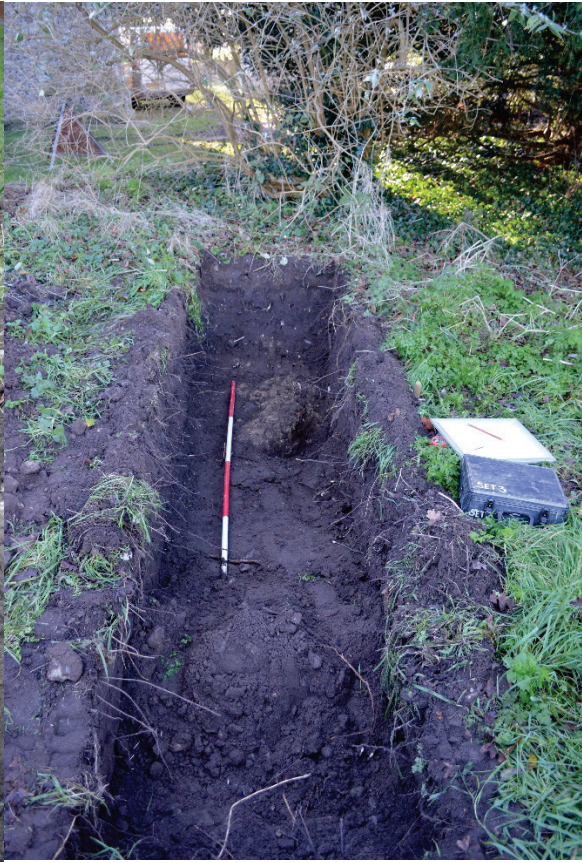
Trench 2 was positioned parallel to, and was just inside, the line of the north west wall of the proposed new room and was 5.6m long (Pl. 4). The ground here was the rough, meadow-like grassland of a country churchyard and the south west end of the trench was amongst shrubs; the ground surface at the NE end of the trench was 280mmm below the new-build's intended finished floor level (FFL).

The upper soil level in this area was made up of dark, fine textured topsoil, which was 500mm deep. The soil gave the appearance that it had been reworked, or put through a riddle, and was completely stoneless. This soil may have been imported, brought in to raise the ground level and it sealed an underlying topsoil that, by contrast, was full of

large building-flints and a sparse rubble of early post-medieval brick (15th-16th century) and pammments. This buried stony layer was encountered across the entire trench length, at depths of 650mm at the NW end and 750mm (BTBM) at the SE, and was 200mm thick. A small area of undisturbed natural geological clay (PI.5) was recorded at the southwest end of the trench at a depth of 870mm (BTBM) but the remainder of the trench was completely disturbed by grave-diggings. A small section of the trench, within the area of cut graves was excavated to a depth of 1.2m BTBM and at this level the excavations were still shy of finding intact burials or the undisturbed ground.

Plate 4. Trench 2 showing disturbed soil of backfilled graves at 870mm below the north door step.

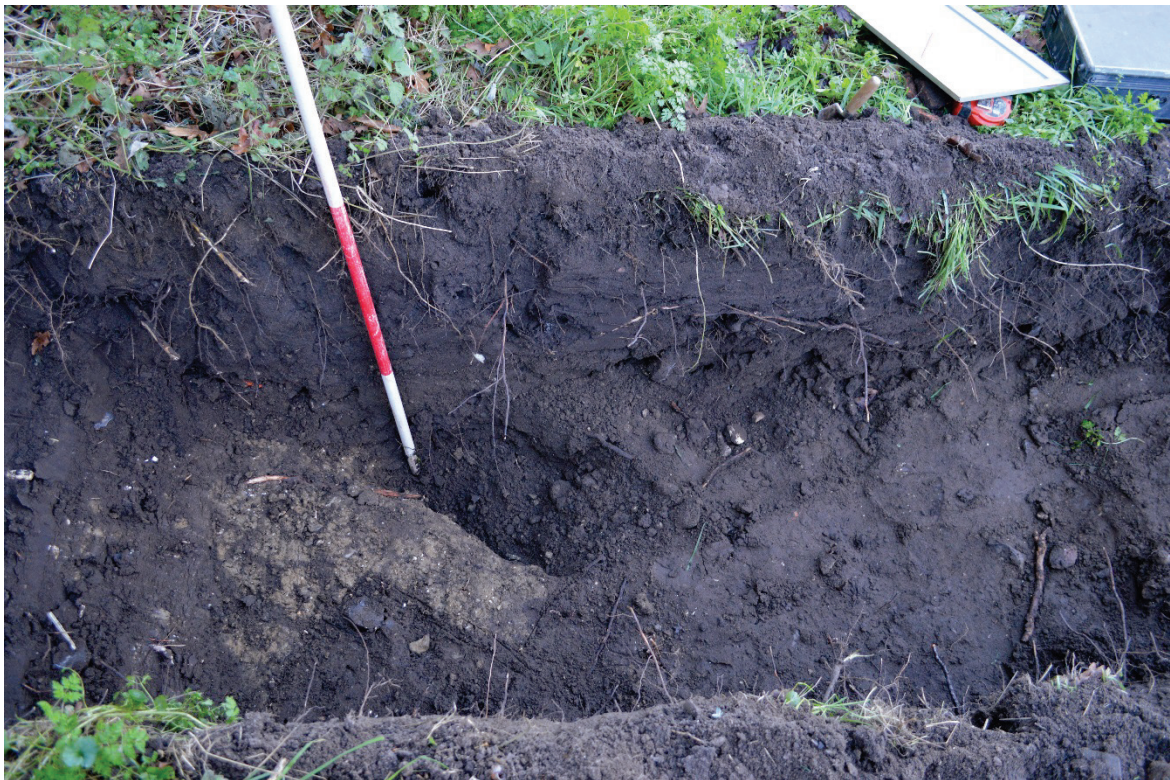
The presence of surviving natural clay in Trench 2 indicates the natural ground profile and the degree of truncation across the graveyard. Finding intact ground within a churchyard is quite unusual and there must have been a longstanding reason which prevented burials in this spot. There is a large yew tree nearby which would make grave

Plate 5. A small area of natural geological clay surviving between grave cuts at the SW end of Trench 2.

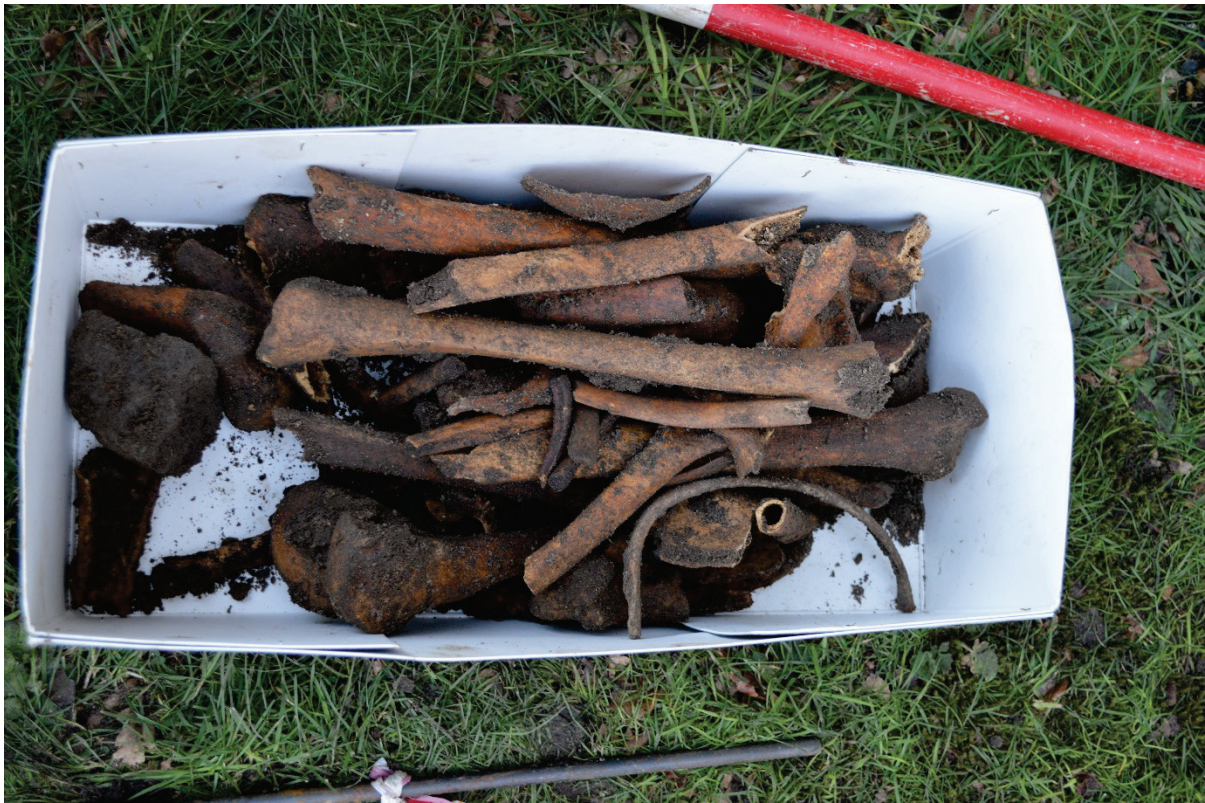
Loose, disarticulated human bones (Pl. 6) from disturbed earlier graves occurred commonly across the entire length of the trench and included a mandible with an enviably full set of teeth which were caries-free, generally a sign of the sugarless diet of the pre-industrial age, but worn low from eating stone-ground bread. In addition to the bones the finds assemblage comprised a sherd of local medieval unglazed pottery (a Norfolk-type) dating to the 12th-14th century, a base of an internally green-glazed, late medieval-transitional pot (15th-16th century) and a body sherd of green-glazed pottery with a slipped lattice decoration of a similar` date.

Plate 6. Disarticulated human bones collected from Trench 1. The bones are from earlier graves disturbed by the final phases of burials.

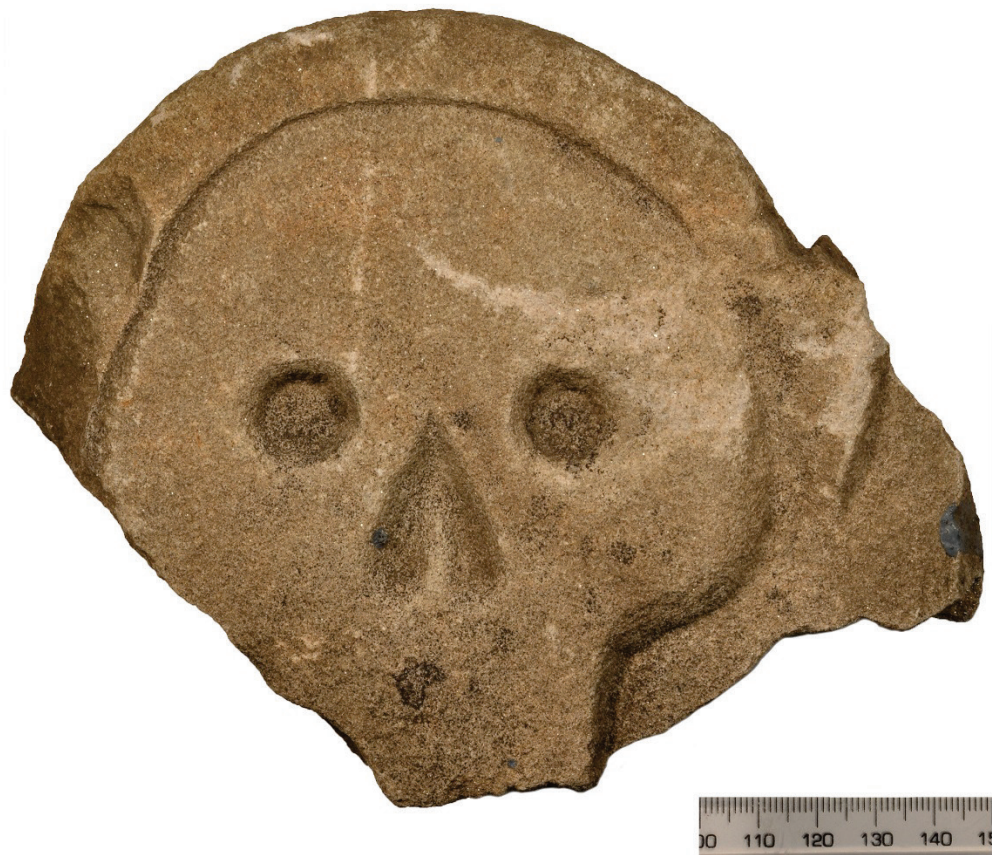
Fragments of a quernstone made from volcanic lava together with hand-made bricks were recovered from the rubble and part of a gravestone depicting death with a representation of a skull (Pl. 7). The human skull was a common motive on headstones of the 17th and 18th century, but atypically for the region this one was made from a sandstone (rather than a limestone) and the representation was in an interesting, unfamiliar naïve style.

Plate 7. Fragment of a headstone carved to depict a human skull. The skull was a common motive on headstones of the 17th and 18th century, atypically for the region this one was made from a sandstone and the representation is in an interesting naïve style.
