# Lidgate Castle topographic survey LDG 018

## **Archaeological Evaluation Report**

**SCCAS Report No. 2015/002**

**Client: UK Power Networks**

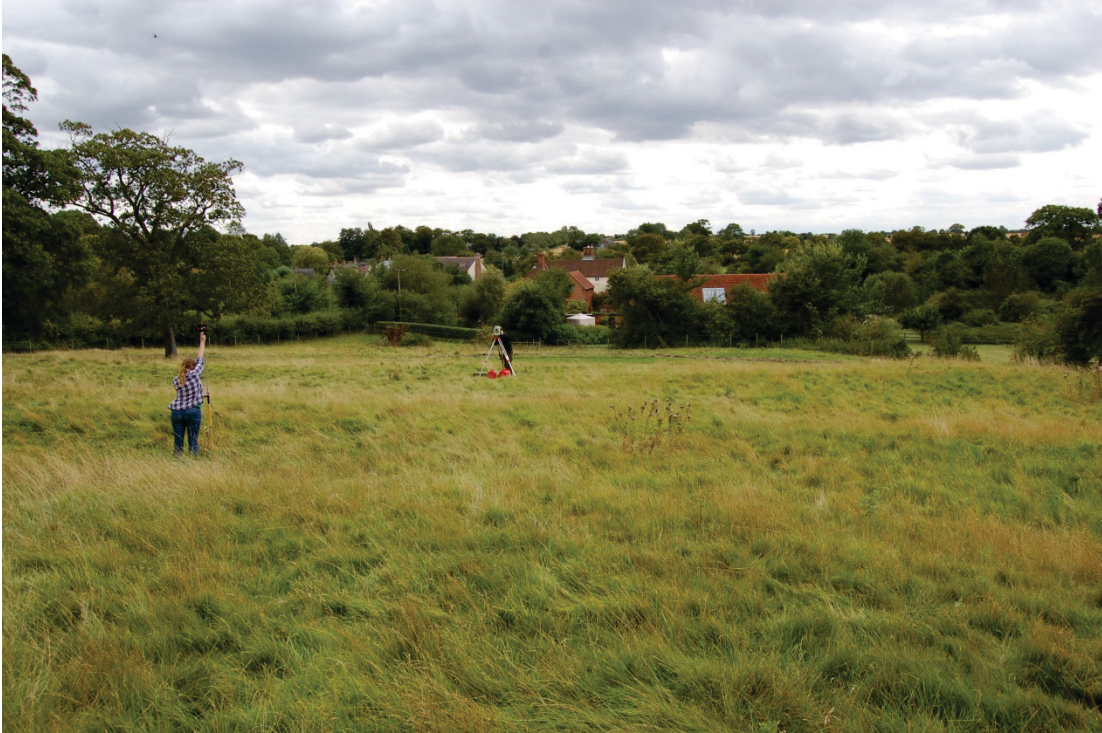
Plate 1. Western half of the survey area looking downslope from the north west, showing the natural incline broken into a series of stepped terraces.

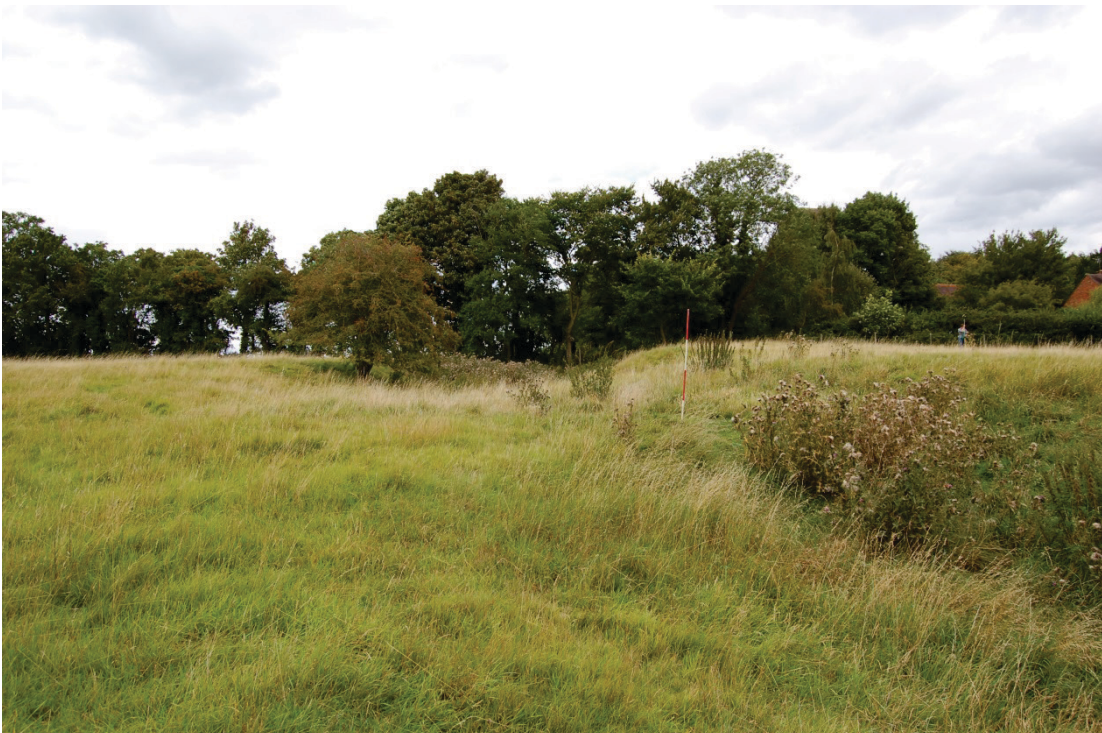
The bailey ditch (A) (Pl. 2) measured 17m across, it was 1.5m deep at the north end and became shallower and less well defined as it progressed downslope. The ditch bottom was wide (7m) and flat suggesting that it had lost most of its depth through silting up (or deliberate backfilling), its original profile has been imagined in the section drawing in Fig. 3 suggesting a true depth nearer 4m; there is no indication of an accompanying bank alongside the ditch. At the north end the ditch is crossed by a trackway, the continuation of the ancient sunken lane that meanders toward the castle via 'Tinkers Close' to the west. Viewed from the surveyed area it appeared that the ditch had been filled in to create the crossing point and a dip in the ground over the line of the ditch is traced out by the contours of the modern fence (Pl. 3). The sunken lane, however, suggests that this approach to the castle is early and a crossing here is likely to have been part of the castle's original design. The current track enables farm vehicle access and the apparent infilling may be a widening of a pedestrian causeway.

Plate 2. The large enclosure ditch on the western edge of the survey area viewed from the south. The trees line the trackway that approaches Lidgate Hall from the west, the castle church is located in the woods just beyond brick gables (right).

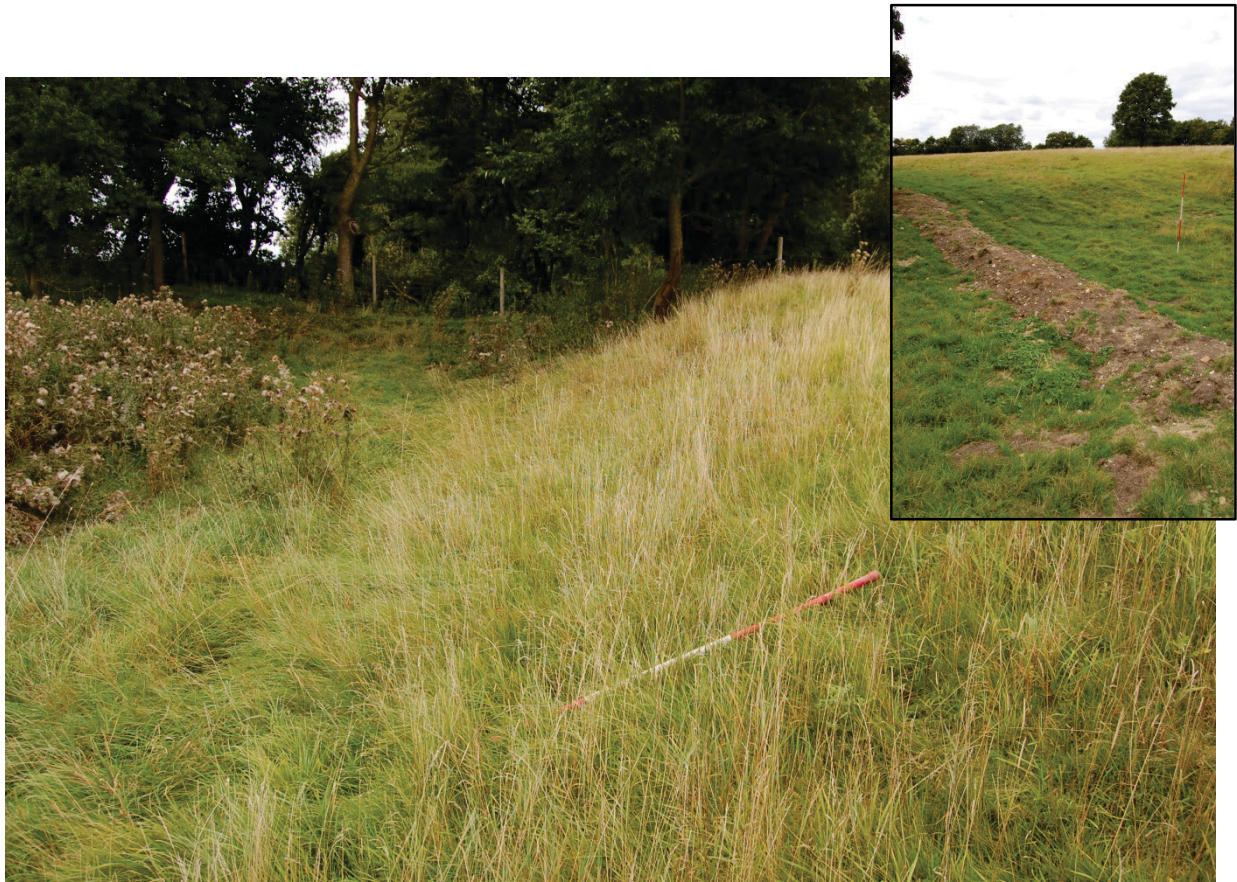
Plate 3. The north terminal of the western enclosure ditch where it is crossed by the trackway. The slumping seen on the line of the fence posts in the distance may suggest some infilling may have occurred. The inset picture shows the backfilled cable trench at the south end of the ditch.

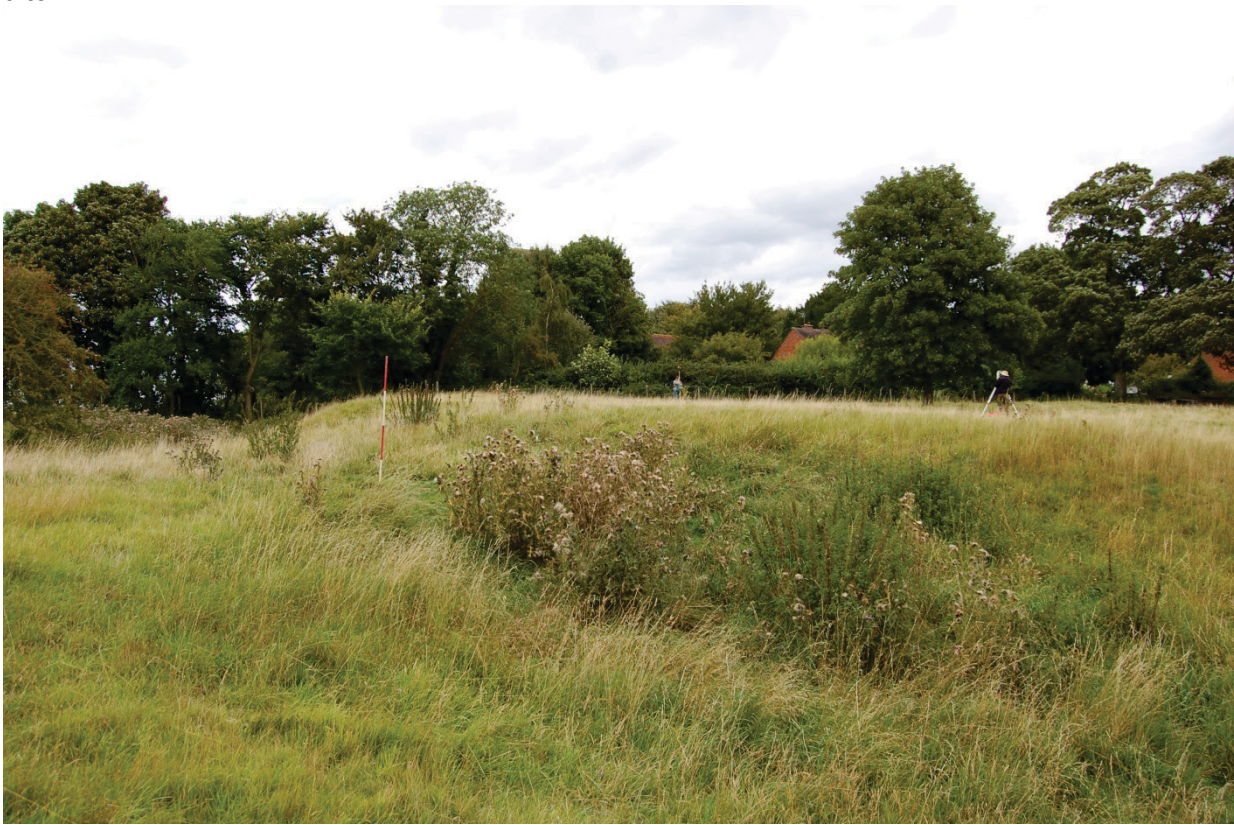
At its south end the ditch has eroded out to an open funnel shape (Pl. 4) which is difficult to interpret but which may be the corner of the enclosure; the southernmost extent of the ditch also aligns with the edge of the 'Bailey Pond' in the area to the east. The garden of the neighbouring property to the south has been landscaped to create a level lawn and is considerably lower than the surveyed area. The change in level is by means of a steeply excavated escarpment; this may be the result of a remodelling of the southern arm of the bailey ditch but any evidence of the original layout has been severely compromised. Interestingly there is no indication of the south ditch or defences on this line alongside the approach road at the southernmost end of the survey although at this point the road is slightly raised above the surveyed area, perhaps hinting at a causeway. The survey area was screened from the approach road by a hedge but the height values of the road surface taken from the OS data indicate that the road height generally is the same as its surroundings.

Plate 4. South end of the ditch where it opened out in a funnel shape, this possibly marks the SW corner of the enclosure.
